SAFETY FLYER TO FISHING INDUSTRY

Fishing vessel *Apollo* (INS 179), fatal man overboard accident, 18 April 2016

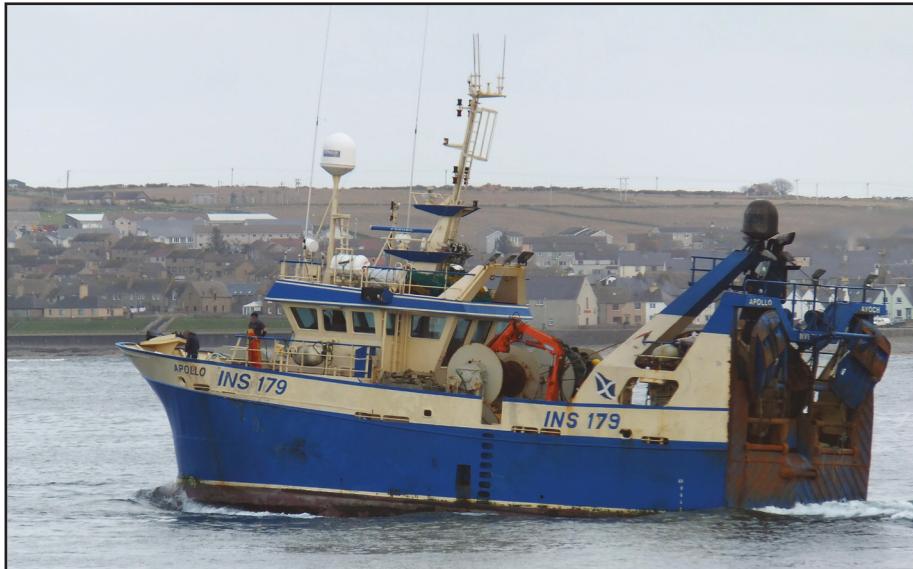
At 0630 on 18 April 2016 a crewman fell overboard from the stern of the fishing vessel *Apollo* while its trawl net was being hauled in heavy seas north-west of Orkney. The water temperature was 9°C.

The crewman had been standing on a 1 metre high raised ledge at the stern of the vessel to avoid the large waves that were occasionally washing over the deck while he waited to remove the shooting pole¹ as the net was hauled in. As the trawl wire was being hauled it fouled the shooting pole, which was pulled violently out of its socket before it fell noisily to the deck. As this happened the crewman, who had not been wearing a lifejacket, lost his balance and fell overboard into the water. The alarm was raised and a lifebuoy was thrown towards the man, but he was unable to reach it.

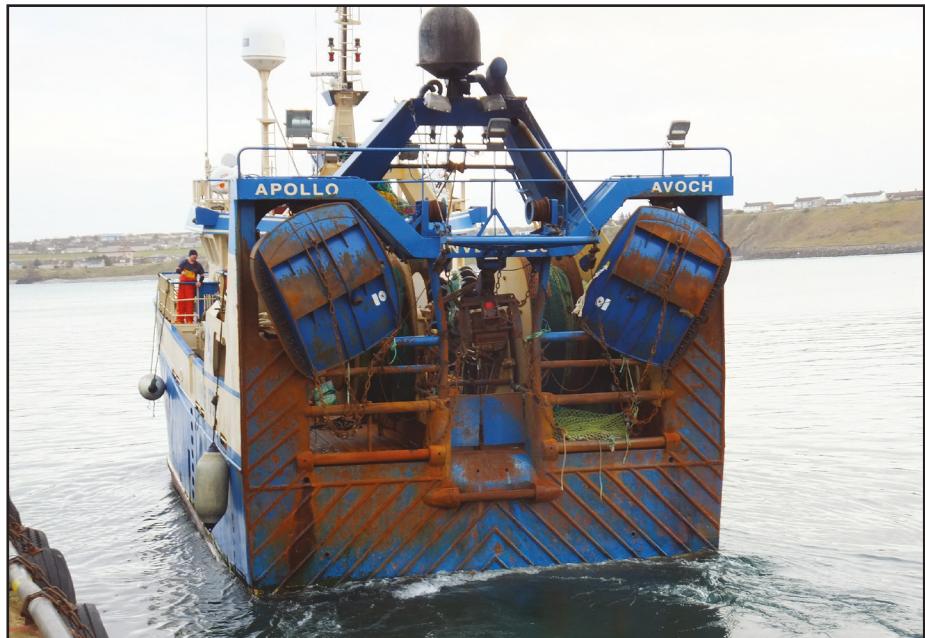
The incapacitating effects of immersion in cold water (less than 15°C) are generally not taken into account when fishermen consider how to recover a man overboard back onto the vessel.

In this tragic case, although the manoverboard procedures had been discussed by the crew, no realistic manoverboard emergency drill had been undertaken.

MAIB analysis of many similar accidents shows that in UK waters a person who falls overboard, without a lifejacket, typically loses the ability to help themselves within 10 minutes of entering the water.

1. The crewman fell overboard while undertaking a task that had not been effectively risk assessed. After the accident the task was reviewed and the need for a crewman to be in an exposed position, to remove the shooting pole, was removed by the installation of a mechanical system.

2. Although the need to wear a lifejacket on the working deck had been identified following a fatal man overboard accident on the same vessel 9 years earlier, the crew had become accustomed to not doing so. The crewman's chances of survival once in the water were significantly reduced as he was not wearing a PFD.

3. MOB drills should always take into account the effects of cold water incapacitation on the victim. The crewman was a fit young man in good physical health, and he could swim. However, cold water incapacitation resulted in him being unable to retain his hold on the lifebuoy after just 7 minutes in the water.
