## The flooding of fishing vessel *Fredwood* after taking the ground on a drying berth Maryport, England 6 April 2016

### SUMMARY

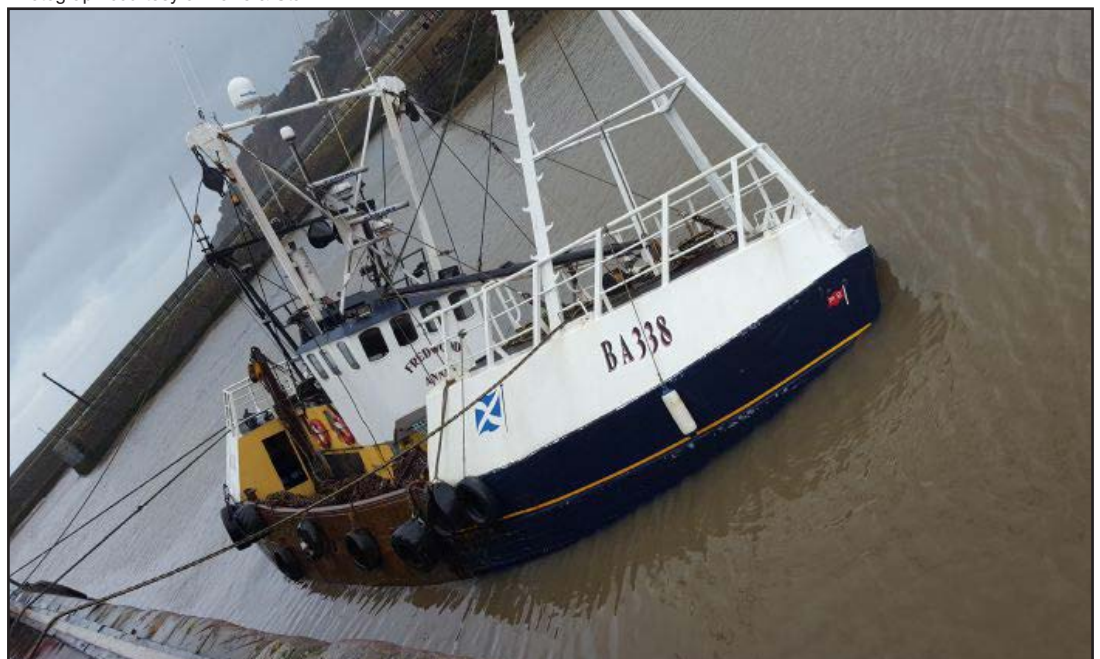
On 6 April 2016, the UK registered fishing vessel *Fredwood* flooded and sank on a drying berth in Maryport, England. When *Fredwood* took the ground, it listed away from the quay wall and the weight of the vessel came to rest on a sonar tube that protruded from the bottom of the hull. The tube was pushed upwards and the hull planking around it was damaged. This caused the vessel to flood on the rising tide (**Figure 1**). All of the crew were rescued by local fire service personnel and there were no injuries or pollution. However, the vessel was declared a constructive total loss.

Figure 1: *Fredwood* flooded on the rising tide

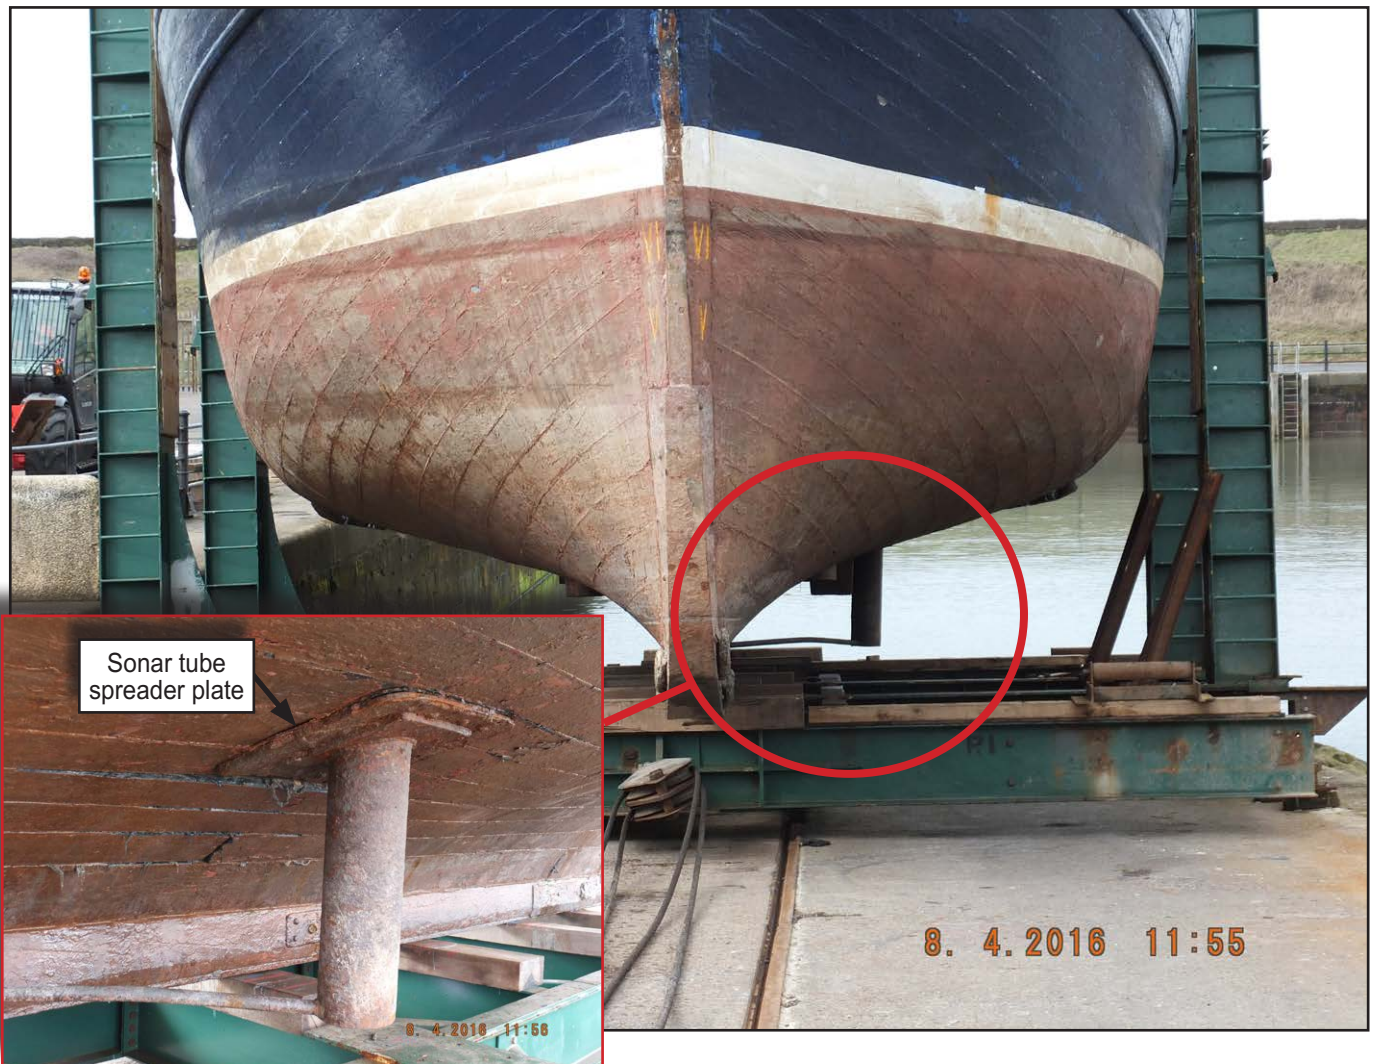
*Fredwood* had a steel sonar tube fitted to the bottom of its hull on the port side of the keel (**Figure 2**). It was welded to a steel spreader plate and protruded about 0.5m below the hull planking. The sonar system had been installed 15 years earlier to help locate the best scallop grounds when the vessel was being operated off the south-west coast of England. The system was still operational but had not been used for many years.

Figure 2: *Fredwood*'s sonar tube

*Fredwood* began to flood on the falling tide, shortly after it grounded, because several of its hull planks had been damaged when the weight of the vessel came to rest on its protruding sonar tube after it had rolled away from the quay. The skipper realised that *Fredwood's* list had probably been arrested by the sonar tube, but did not appreciate the likelihood of this causing a breach in the hull.

- *Fredwood* flooded because several hull planks were damaged when the weight of the vessel came to rest on a protruding sonar tube when the vessel grounded on its drying berth.

- The sonar tube presented a constant hazard to the vessel on drying berths; its removal once the device had become redundant would have eliminated the threat of damage to the hull planking.

Some flat bottomed vessels are specifically designed to sit on the ground at low water and some are less suited than others. *Fredwood* had no bilge keels and its sonar tube presented an obvious hazard when taking the ground. This was the case even before the dredging works had been carried out because at any time the tube could have landed on an unexpected underwater obstruction. The sonar tube presented a foreseeable risk to the vessel and, as it was no longer in use, it should have been removed.

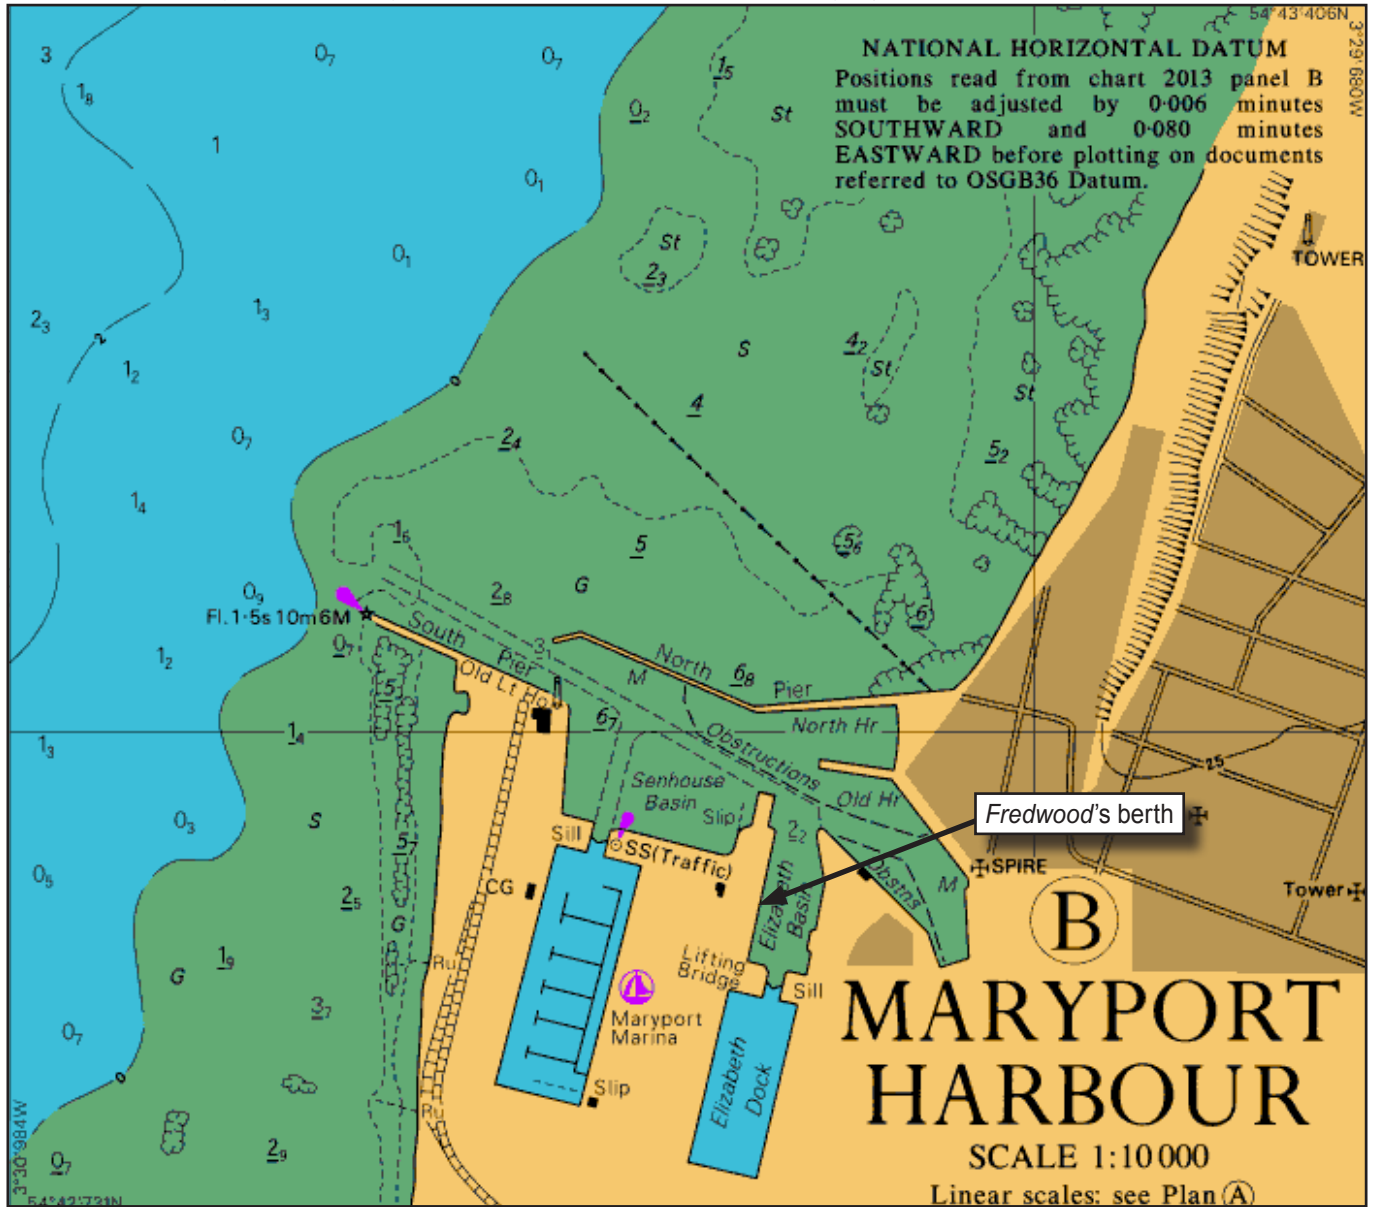
At about 2200 on 5 April 2016, *Fredwood* entered Maryport's Elizabeth basin (**Figure 3**) and was manoeuvred starboard side onto its usual berth. The crew secured the vessel alongside with four mooring lines: a headline, a sternline and forward and aft spring lines. During the following 2 hours, the crew offloaded the catch into waiting trucks and then cleaned the vessel. At about 0045 (6 April), the crew stopped the vessel's electricity generator and went to bed.

Figure 3: Maryport harbour

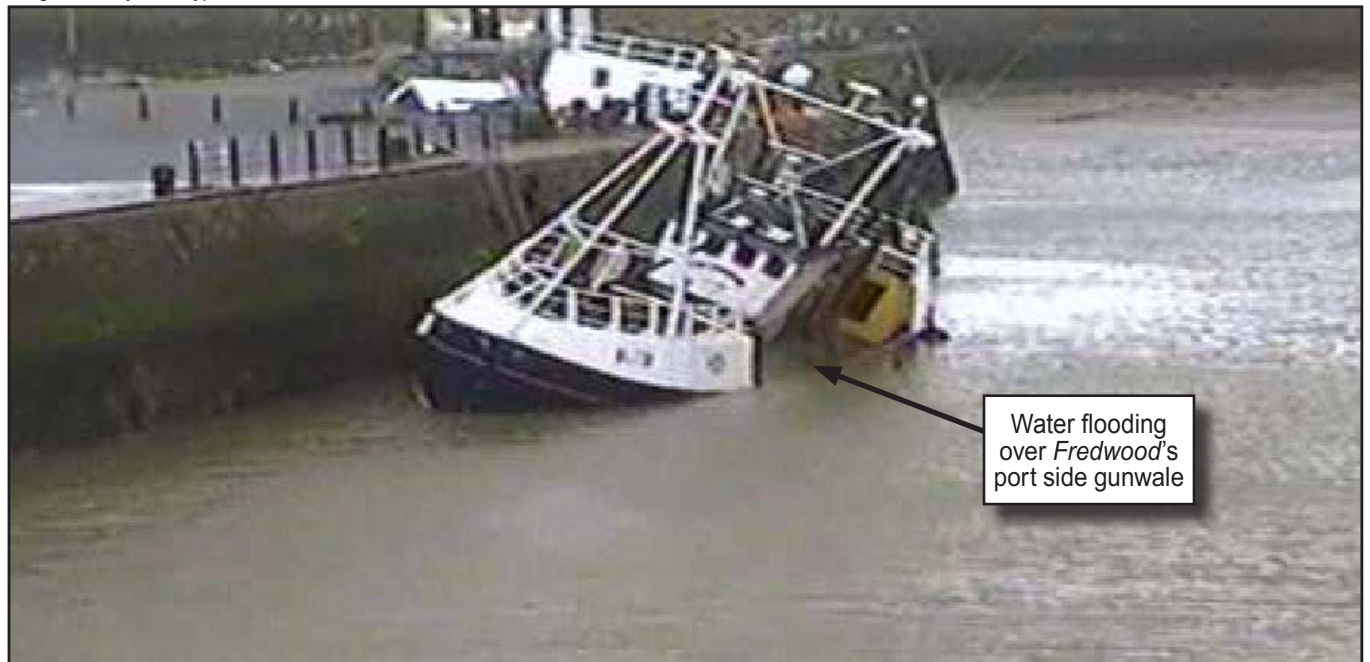
Figure 4: Maryport harbour CCTV snapshot of *Fredwood* at 0822 on 6 April 2016

Given the skipper's familiarity with *Fredwood*, it is almost inconceivable that he did not fully appreciate the danger that his vessel was in as the tide started to flood over its deck (**Figure 4**). Because no one on board took action until the bilge alarms sounded, it is most likely that all of the crew, including the skipper – who was in the wheelhouse – were asleep as the boat progressively flooded on the rising tide.

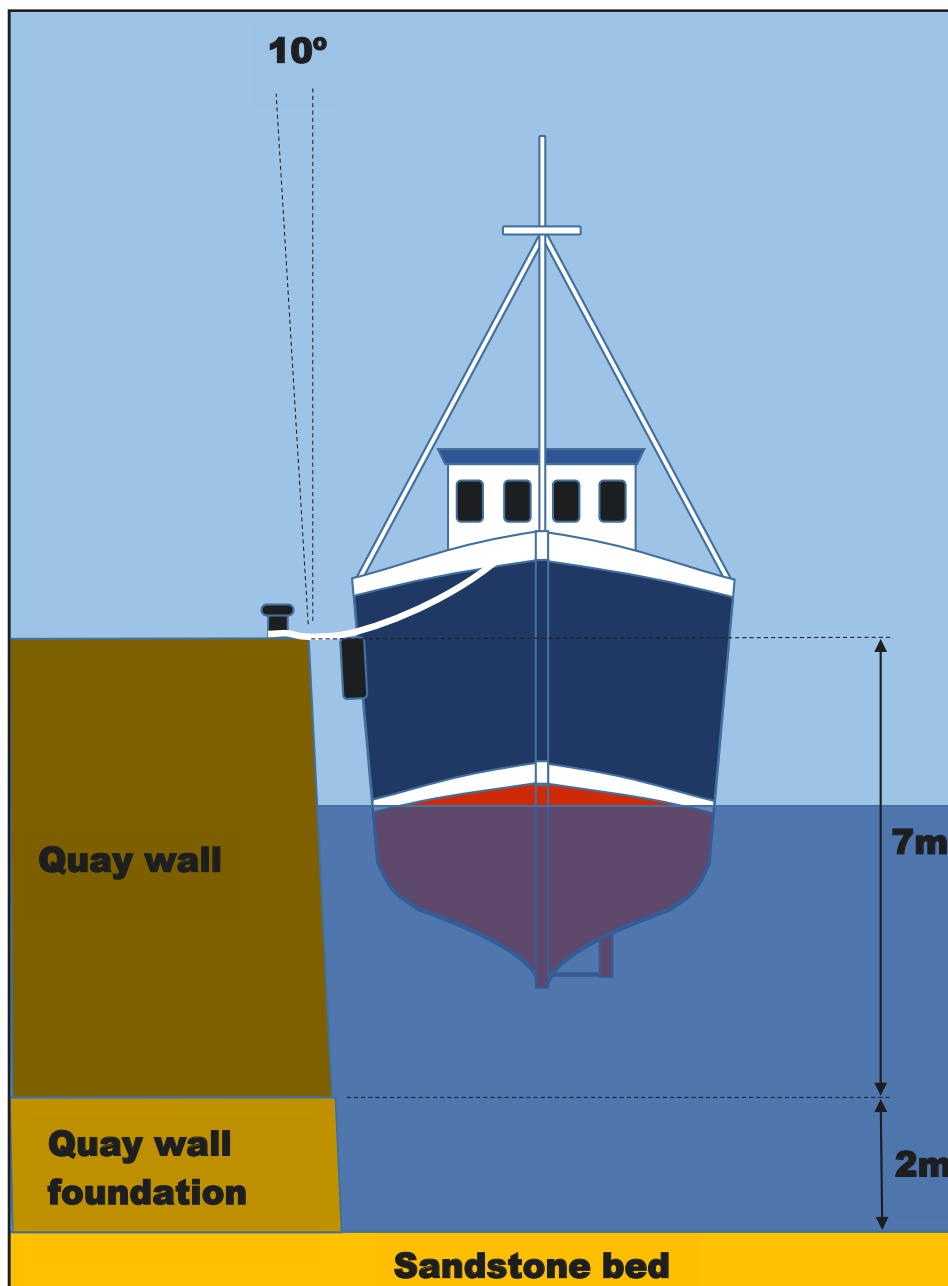
The docks and their basins were originally constructed in the mid-19th Century, with their 7m high walls and 2m high foundation stones laid on a bed of sandstone (**Figure 5**). The dock walls and their foundation stones sloped towards the quay at an angle of about  $10^\circ$ . The base of the walls was set back about 20cm from the edge of the foundation stones.

Figure 5: Elizabeth basin walls

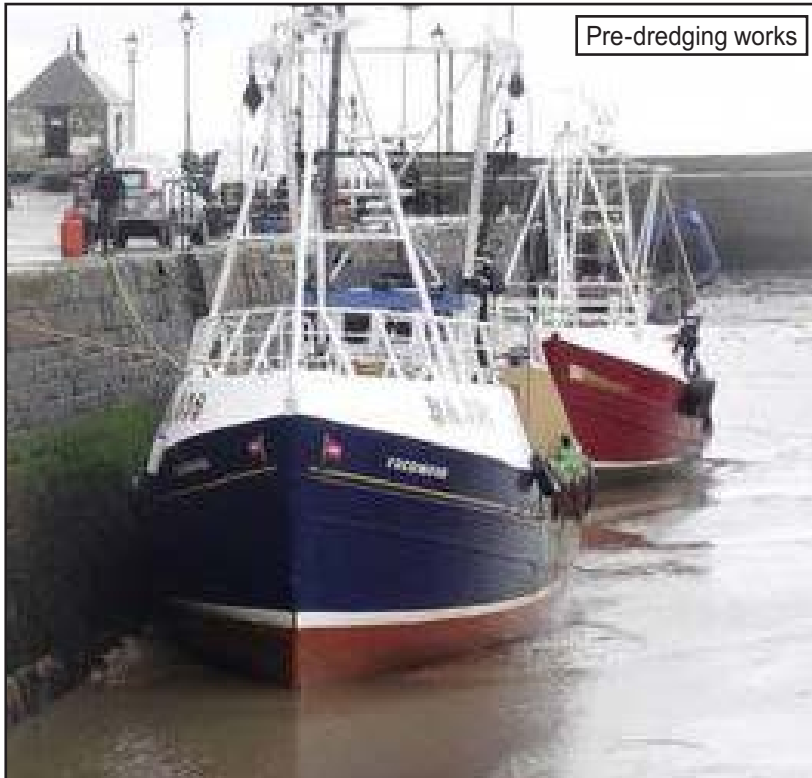
Prior to the 2016 dredging operation, *Fredwood* had always settled on the mud in the Elizabeth basin at low water (**Figure 6**). When *Fredwood* first visited Maryport after the dredging work had been completed (15 March 2016), it sat about 1m lower at low water and rested against the quay wall (**Figure 7**). *Fredwood* remained on the berth for several days and, during this time, the skipper had concerns about the close proximity of the quay wall to *Fredwood*'s hull.

**Figure 6:** *Fredwood* sat in the mud in Elizabeth Basin  
March 2014

It was evident from *Fredwood's* visit to Maryport in March 2014 (**Figure 6**) that, prior to the dredging operation, the skipper was not concerned about ensuring his vessel listed to starboard while on the quay. This was because *Fredwood's* hull settled into the soft mud at low water and the vessel always remained upright. It was equally evident from *Fredwood's* first visit to the port after the dredging operations (**Figure 7**), that the skipper was aware of the increased depth of the basin. The skipper had also witnessed a fishing vessel topple over during that visit, and was therefore aware of the risk of his vessel suffering a similar fate.

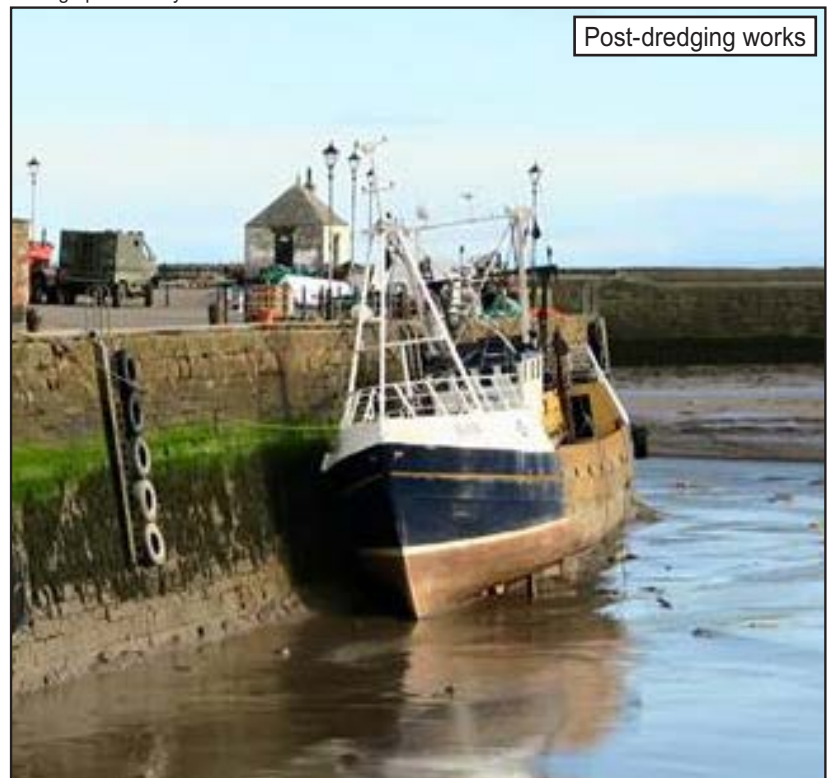
**Figure 7:** *Fredwood* leaning on quay wall in Elizabeth Basin  
March 2016

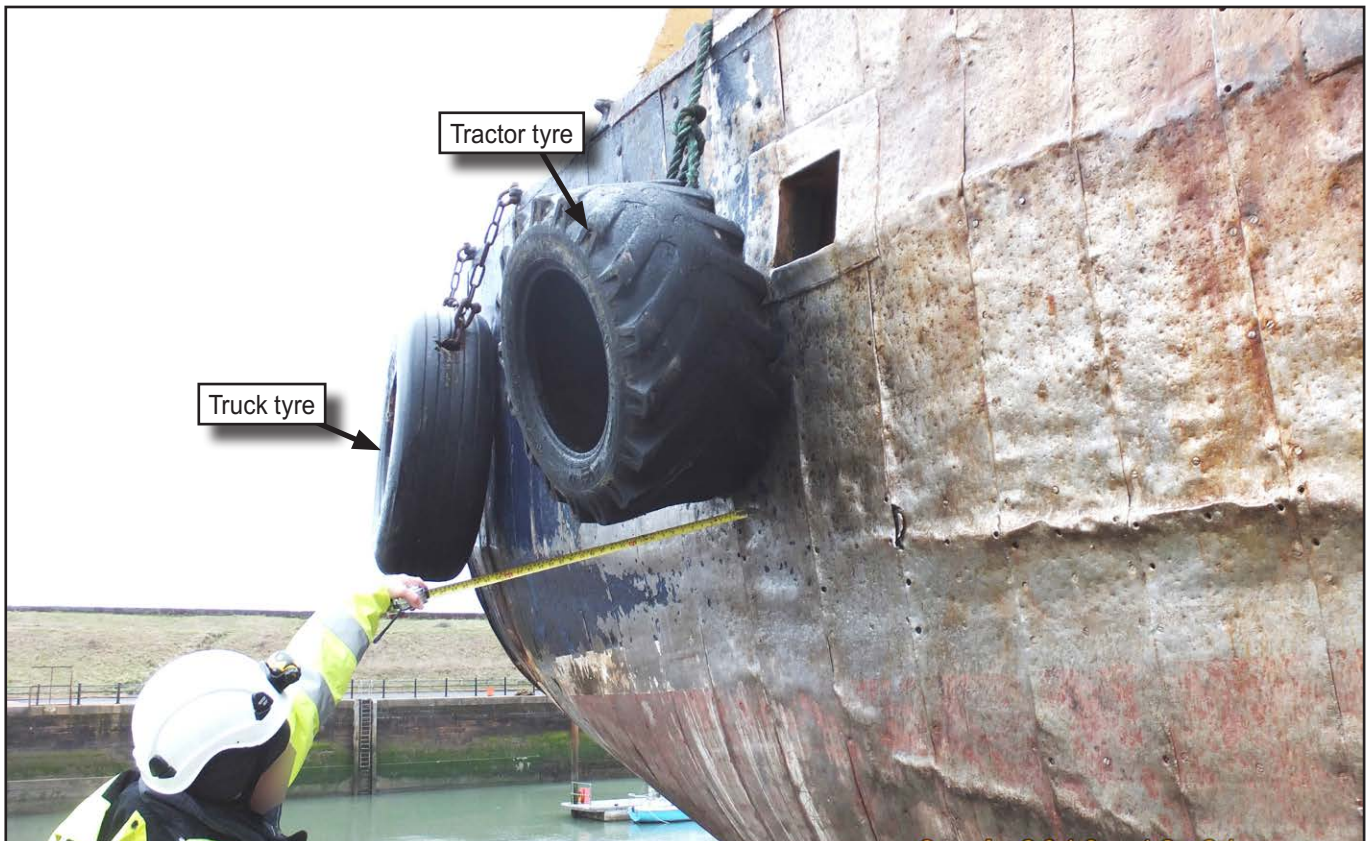
While in Garlieston, the skipper purchased two used tractor tyres and rigged them as additional fenders on the starboard side of the vessel (**Figure 8**). At the end of the maintenance period the skipper sailed *Fredwood* from Garlieston to Maryport.

**Figure 8:** New tractor tyre and existing truck tyre

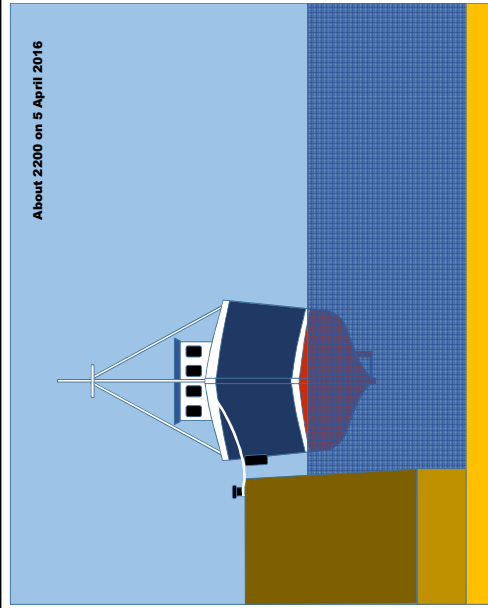
**Fredwood moored starboard side alongside the quay wall about 1 hour before high tide on 5 April 2016.**

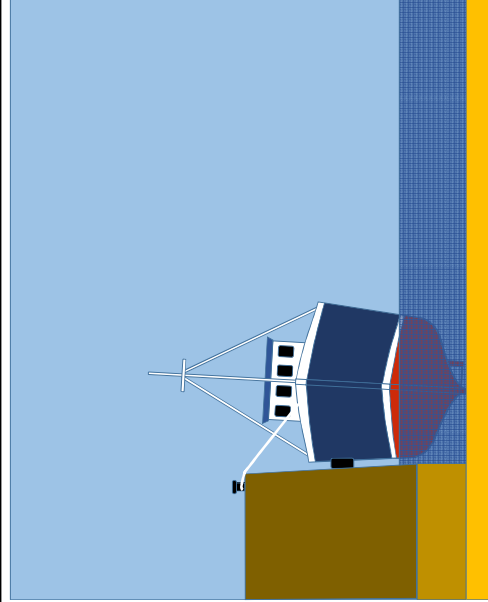
It was apparent that the skipper and his crew had not allowed sufficient slack in the forward mooring line to prevent it pulling *Fredwood* onto the harbour wall prior to its keel touching bottom (**Figure 9**). This might have been because the wind was pushing the vessel off the quay when it was first moored and/or because the tractor tyre fenders were significantly thicker and more rigid than the older fenders. The skipper fitted the new tyres because he thought they would protect *Fredwood* from damage by holding its hull clear of protrusions and snagging hazards when leant on the quay wall. However, the tractor tyres probably held *Fredwood* upright as the tide fell, and might even have acted as a pivot point to initially induce the port list.

**Fredwood's headline became taught on the falling tide and pulled vessel against the quay wall; the tyre fenders held the vessel off the wall.**

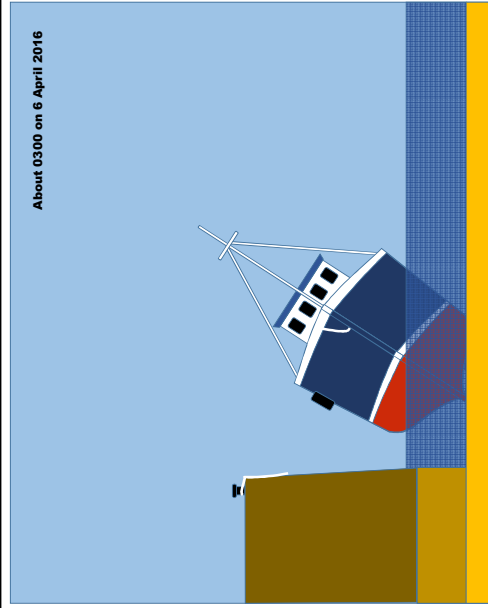
**Fredwood's mooring line parted as, or shortly after, the vessel grounded. As the tide continued to fall Fredwood rolled over to port about 30°.**

- *Fredwood* was pulled onto the quay wall and started to list away from the quay wall because its mooring lines became taut and were not tended as the tide ebbed. This caused *Fredwood* to roll to port and its weight came onto the protruding sonar tube.

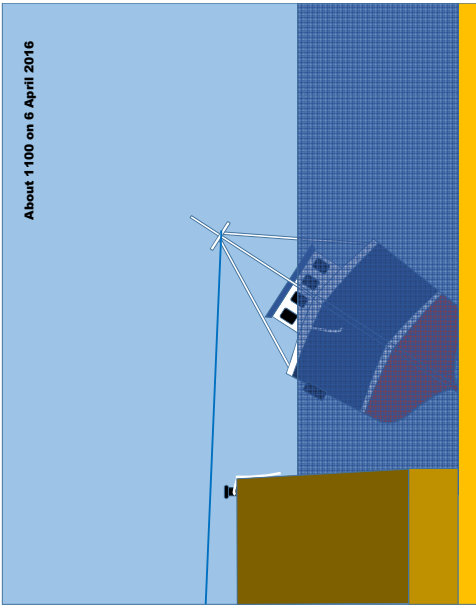
**Fredwood flooded on the rising tide.**

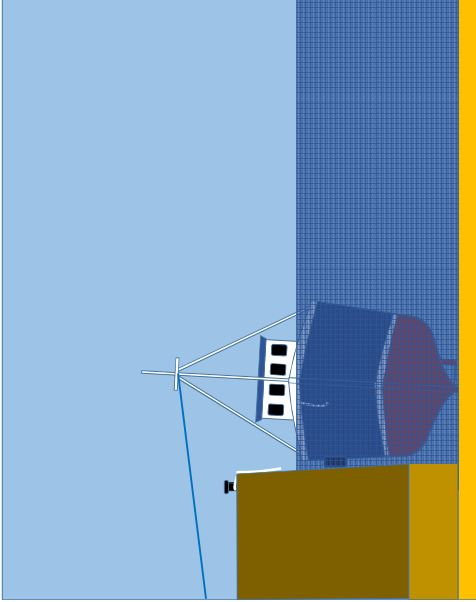
**While submerged, a line was secured to Fredwood's mast and the vessel was pulled upright.**

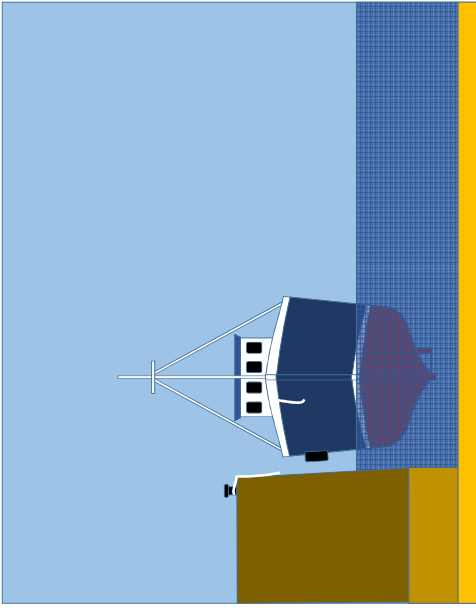
**Fredwood refloated on the next tide after a temporary repair had been made to the hull.**
