**Loss of a crewman overboard from the potter
Our Sarah Jane (NN710)
English Channel
9 June 2016**

SUMMARY

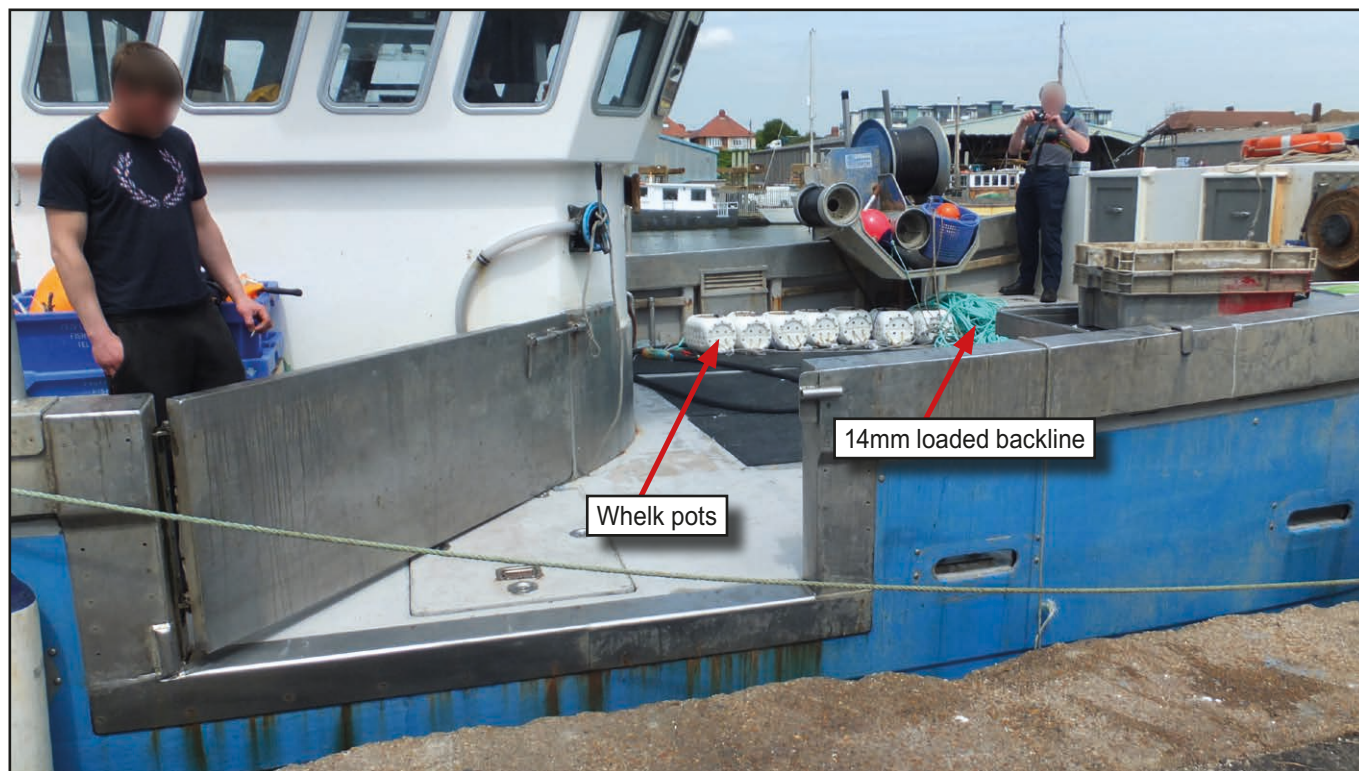
Figure 2: Shooting gate

Between 1120 and 1145, *Our Sarah Jane*'s crew hauled, emptied and re-baited a second string of pots. The pots were stacked on the port side of the working deck, forward of the wheelhouse. The vessel was then turned onto a heading of 135° at a speed of 3kts². At 1151, the crew started to shoot the pots on deck. The skipper was in the wheelhouse, one of the deckhands was preparing bait aft of the wheelhouse, and the other deckhand, Darren Brown, was on the port side of the working deck, throwing each pot in turn towards the shooting gate on the vessel's starboard side (**Figure 2**).

At around 1158, one of the spinners (toggles) used to secure the whelk pots to its line jammed between the underside of the hinged side of the shooting gate and a rubber deck mat (**Figure 3**). The skipper immediately reduced the speed of both engines to idle and the two deckhands then released the snagged pot. However, the 14mm backrope connecting the pots was under tension and, as it ran overboard, two of the remaining nine pots on deck were pulled into the water. The starboard engine stalled and the skipper realised that the lines attached to the pots had fouled the starboard propeller. He then put the port engine to 'neutral'.

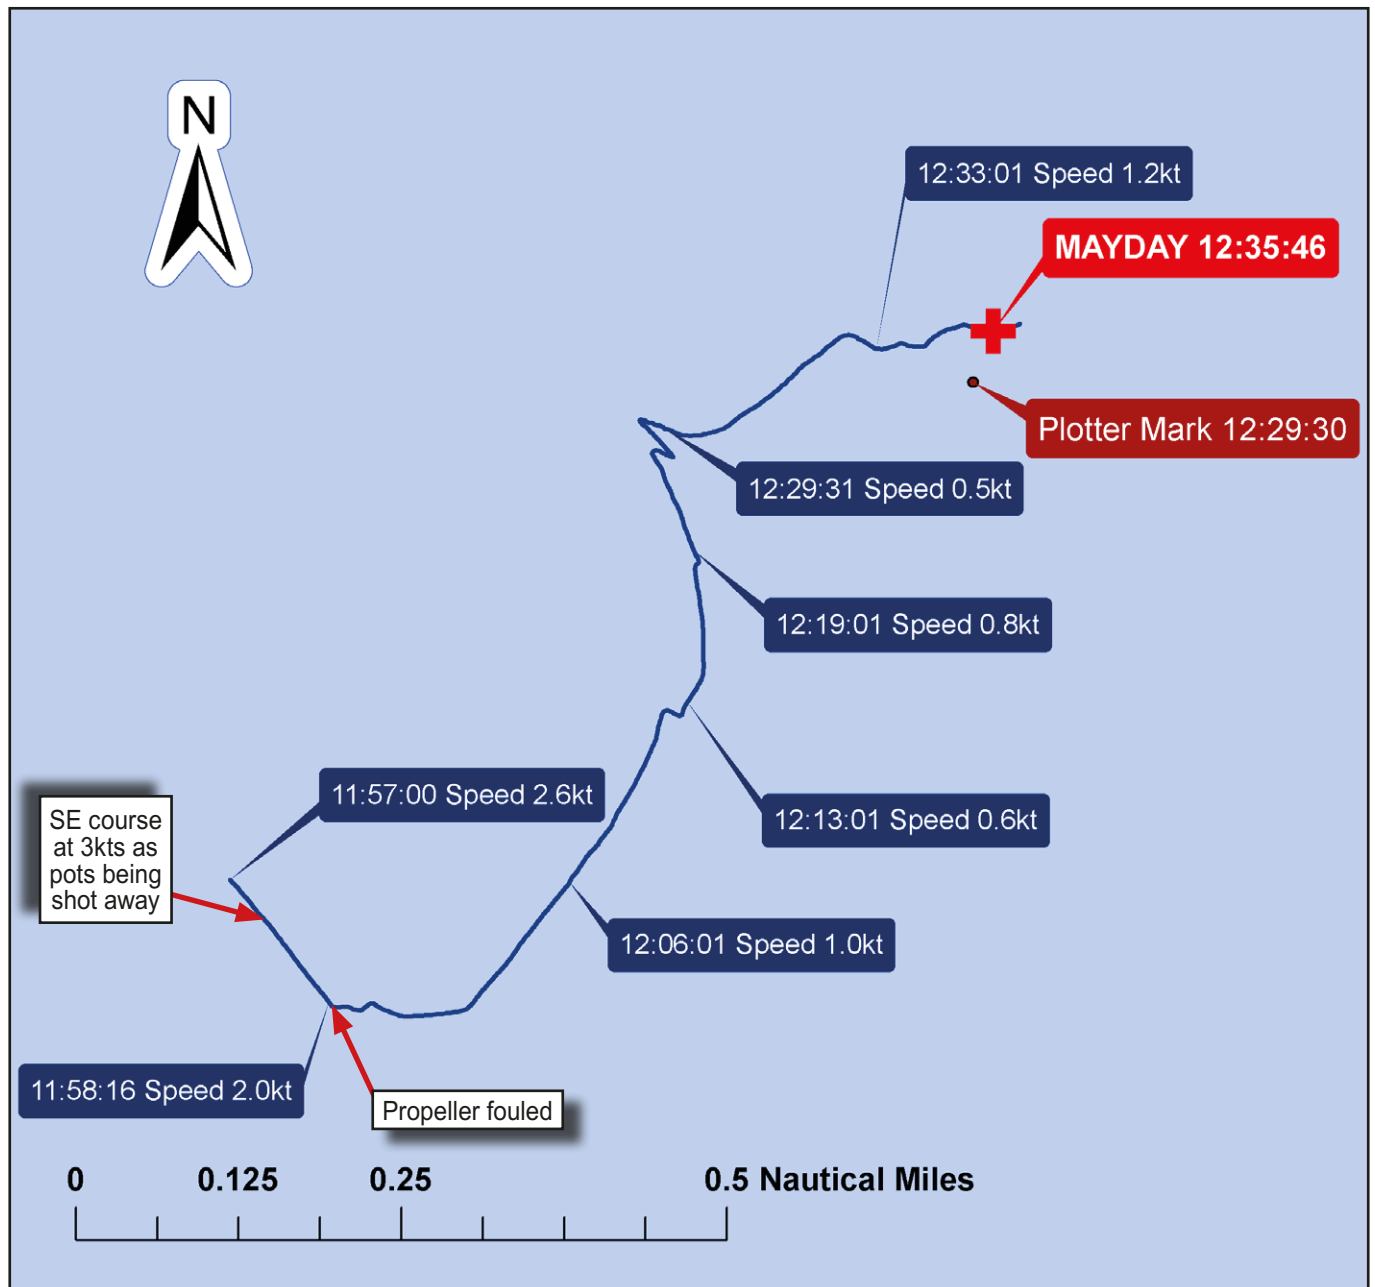
Figure 4: Plot of vessel's track (1157 - 1236)

Our Sarah Jane's skipper immediately informed *Billiris* that Darren had jumped into the sea. He also, at 1229:30, input a mark into the Furuno Max Sea electronic chart plotter (**Figure 4**); the plotter's man overboard mark function was not used. The skipper then went to the shooting gate. By the time he arrived at the gate, Darren was 1m forward of the bow and was shouting for help. The rate of the tidal stream was now over 2kts.

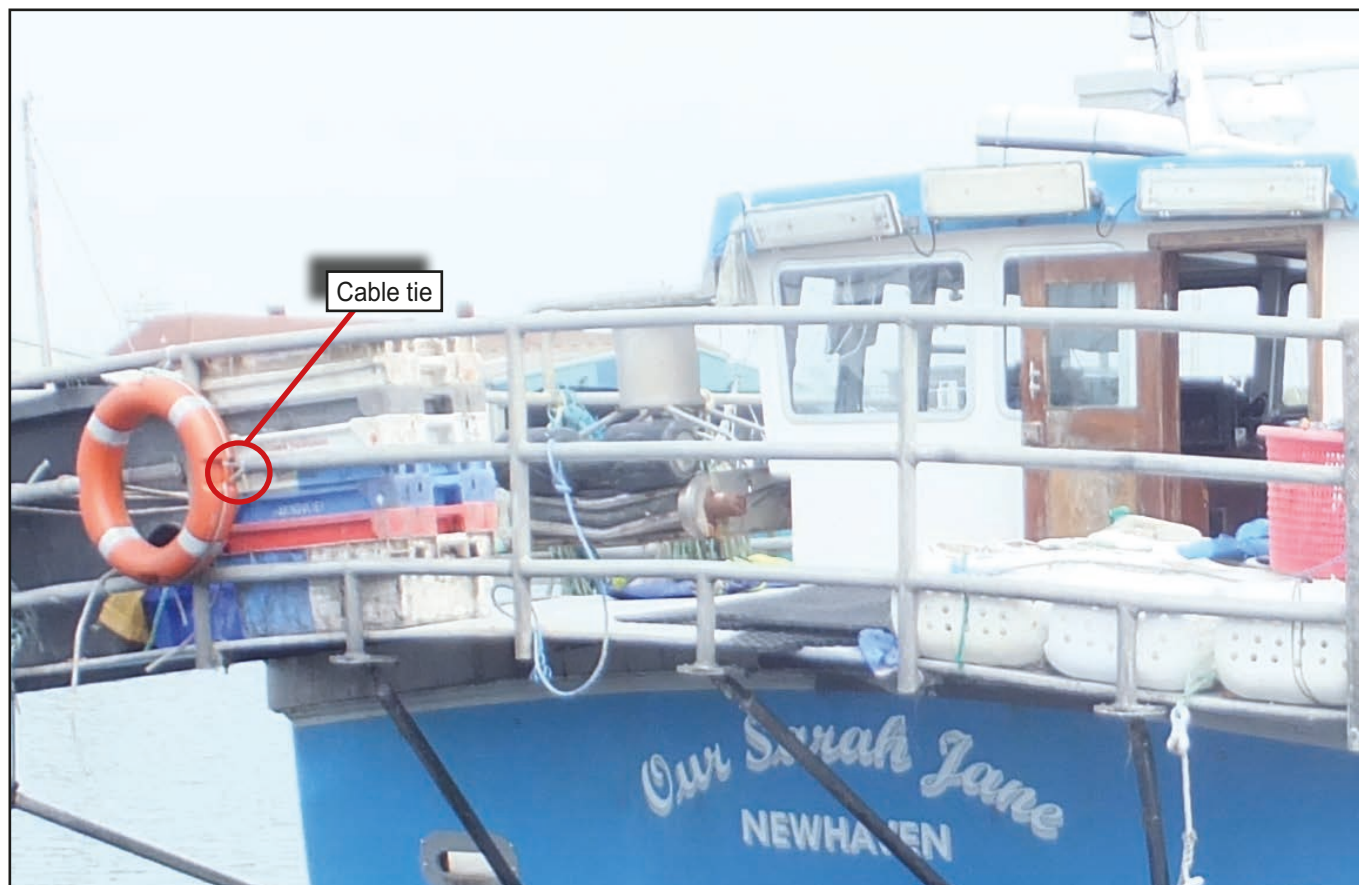
Figure 6: Port lifebuoy

Two lifebuoys were secured to the aft rails on the cat catcher. The lifebuoy secured on the starboard side was secured with rope using a clove hitch and the lifebuoy on the port side was secured with cable ties (**Figure 6**). Neither of the lifebuoys on the cat catcher had a line attached. A third lifebuoy fitted with a 10m length of 6mm polypropylene was stored in a deck locker along with two lifebuoy brackets. The skipper was not aware of the lifebuoy in the locker and none of the lifebuoys were marked.

However, the lifebuoys secured on the cat catcher were not fitted with lifelines and the skipper was unaware of the lifebuoy and lifeline in the deck locker. Although it would have taken only seconds to tie the polysteel rope to the lifebuoy, Darren was being carried away at a rate of about 3m every 6 seconds. Consequently, when the lifebuoy was eventually thrown into the 20kts wind, it landed too far from Darren for him to reach. In hindsight, Darren's likelihood of survival might have been increased by the immediate deployment of a free floating lifebuoy without a lifeline attached. However, it is likely that the skipper was concerned at the rate at which Darren was being carried away from his vessel.

- Introduced a policy requiring all fishermen working on the open deck on board *Our Sarah Jane* and *Imogen Leigh* to wear a PFD.
- Attached throwing lines to *Our Sarah Jane's* lifebuoys.
