Runaway and derailment of a rail vehicle near Bury, Greater Manchester, 22 March 2016

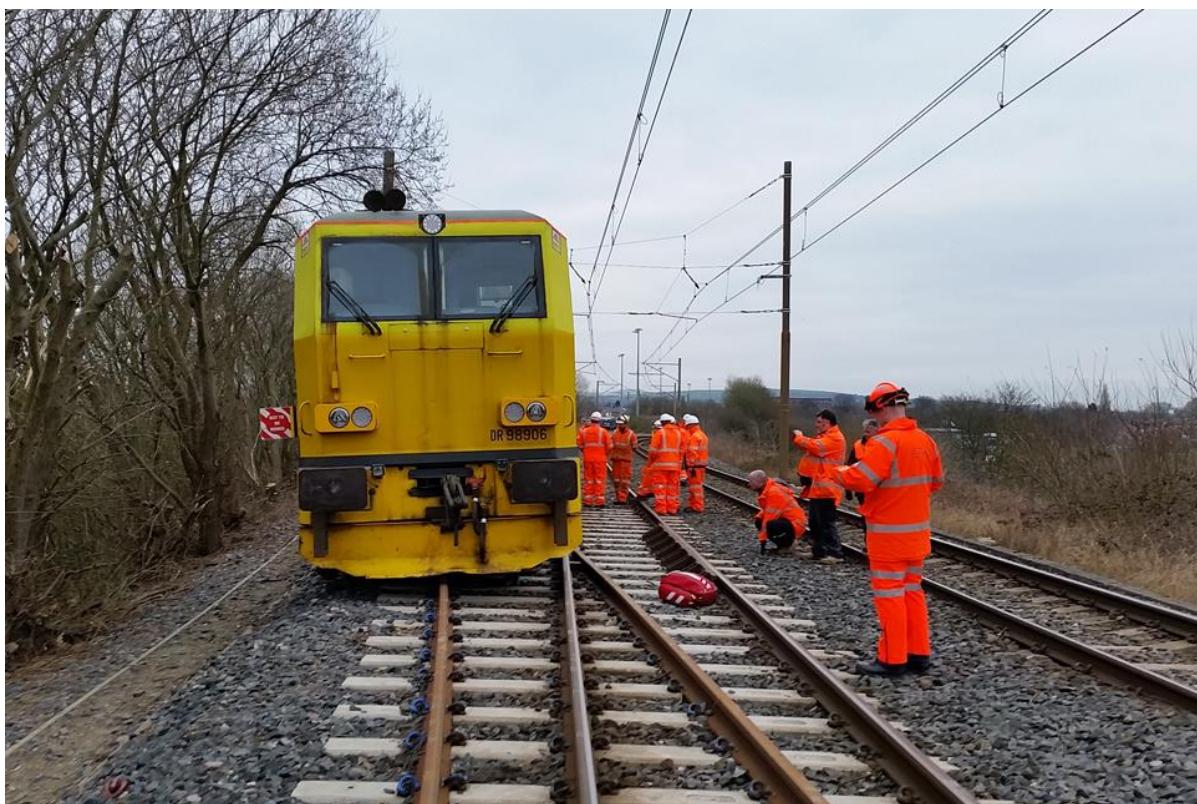
A multi-purpose vehicle (MPV) ran away down a gradient during fault-finding of the vehicle's air braking system. The MPV left the East Lancashire Railway's infrastructure and entered the off-street section of the Manchester Metrolink light rail system, where it derailed on a set of trap points. No-one was injured as a result of the accident. However, the MPV was damaged and came to rest foul of the northbound Metrolink line between Radcliffe and Bury tram stops.

The derailed MPV

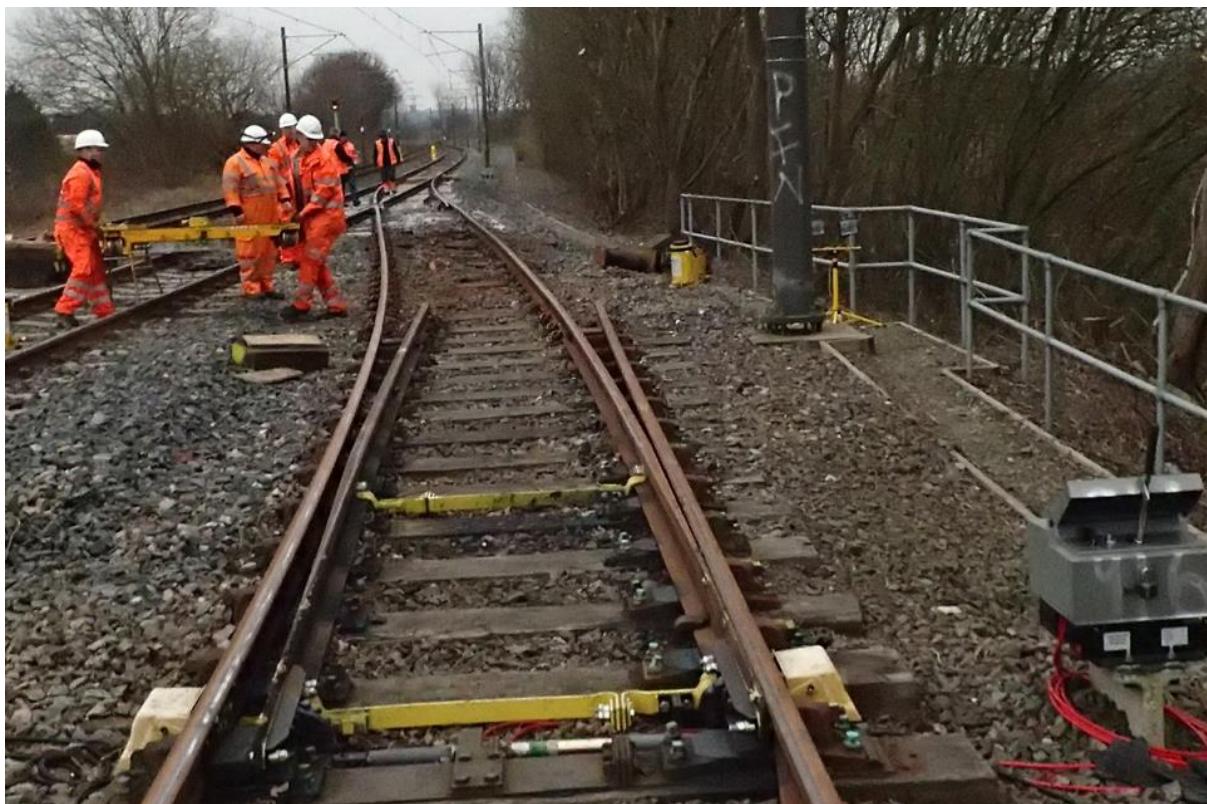
Once on Metrolink infrastructure, this connecting line passes over a set of hydraulically operated points (304 points, which consist of an 'A' and a 'B' end). When set normally 304A points direct northbound trams to Bury, while 304B points act as trap points which are intended to derail movements from the yard towards the cess and away from the tramway. The cess is bordered at this location by trees and an embankment.

304B points. Shown set to 'reverse'
