Derailment at Paddington, 16 June 2016

2. Summary of the accident

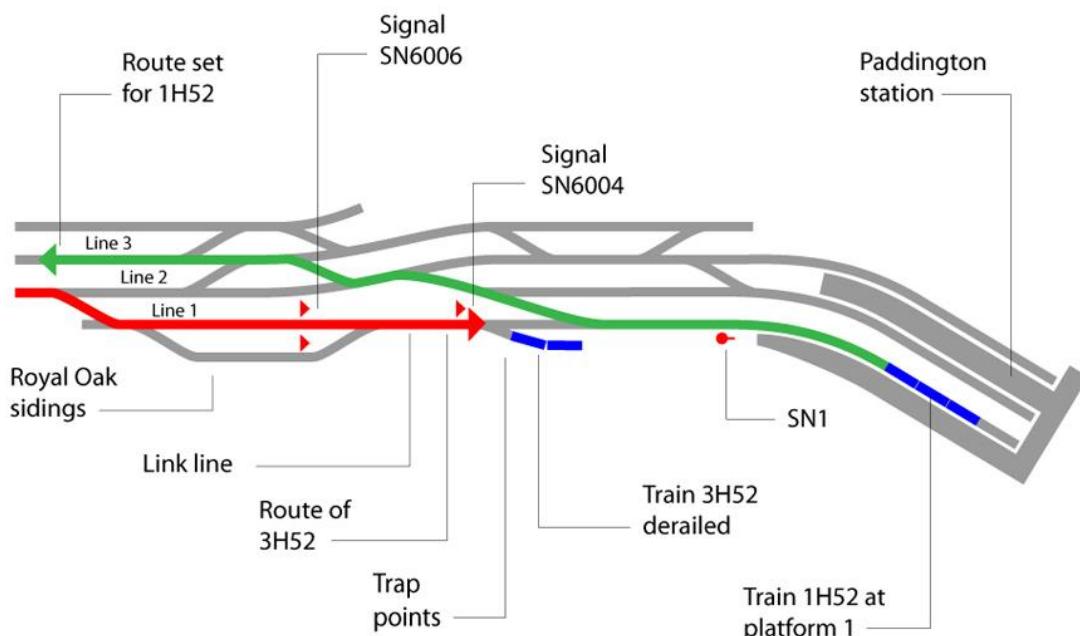
The approaches to Paddington platform 1 showing the routes set and the position of the trains after the accident (not to scale)

At 18:11 hrs the signaller set the route for 1H52 to depart from platform 1. One minute later he cleared ground position-light signal SN6006 for 3H52 to leave the siding. The signal displayed two white lights to the driver, which authorised the train to run along the link line as far as the line was clear, up to a similar position-light signal, SN6004. Train 3H52 would then be ready to run into platform 1 as soon as 1H52 had departed.

The driver of 3H52 started his train a few seconds after signal SN6006 cleared. He drove along the link line towards the station, reaching 25 mph (40 km/h), which is the maximum permitted speed on that line. Although he had not seen a train leave platform 1 since his conversation with the signaller, the driver had formed the impression in his mind that the clearance of signal SN6006 meant that the route was set all the way into platform 1. Signal SN6004 was clearly visible, but the driver did not realise that it applied to his train, so he drove past it although it was showing two red lights, meaning 'Stop'.

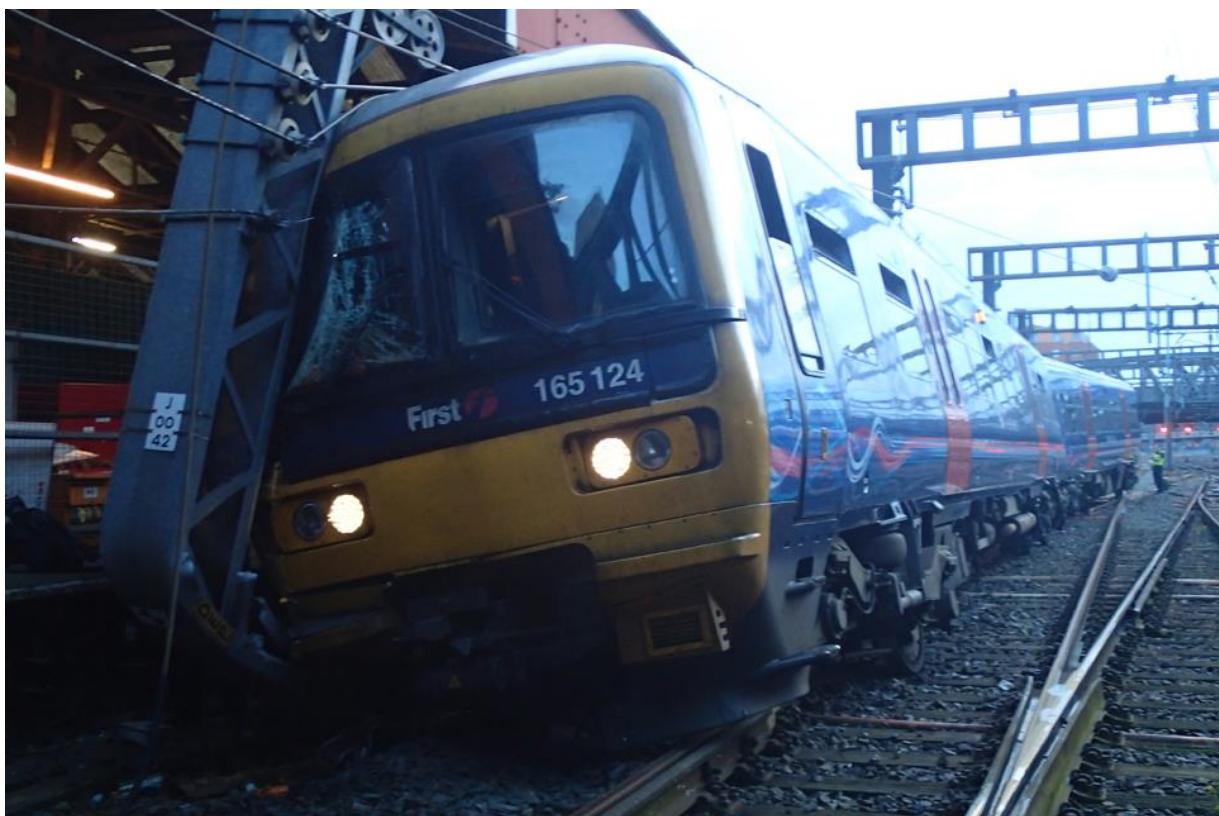
Immediately after he passed the signal the driver realised that his train was being diverted to the right, off the track, and so he made an emergency brake application. However, it was too late to prevent the derailment, and the first three bogies of the train ran off the end of the rails. The right-hand front corner of the train struck the mast of a cantilever structure (J 00 42) which supports OLE on line 1. The impact distorted the mast, and the cantilever dropped far enough to become a hazard for trains travelling on lines 1 and 2. The train was still moving at about 8 mph (13 km/h) when it struck the mast. The trap points diverted the train itself clear of the other running lines, and the derailed vehicles did not obstruct any other routes, so there was no risk of collision with another train.

The front of the derailed train and the OLE mast, after the accident

The OLE mast that was struck by the train is positioned 46 metres, the length of a two-car train, beyond the toe of the trap points. Network Rail's standard for the provision of trap points (former Railway Group Standard GK/RT0064) requires trap points to be located so as to guide derailed vehicles away from other lines, structures, and any other hazards. In the congested area close to Paddington station, there is little scope for varying the relative positions of trap points and OLE structures, and the distance available beyond these trap points would normally have been regarded as sufficient for a train that derailed on them to be stopped. In this case, because the train was travelling at the maximum permitted speed, and its brakes were not applied until after it had derailed, the space was not sufficient and the structure was damaged.

- Assessing the risks of using trap points to protect lines and why assessments should include an examination of the potential consequences of derailing, such as the possibility of vehicles fouling running lines or encountering other hazards.

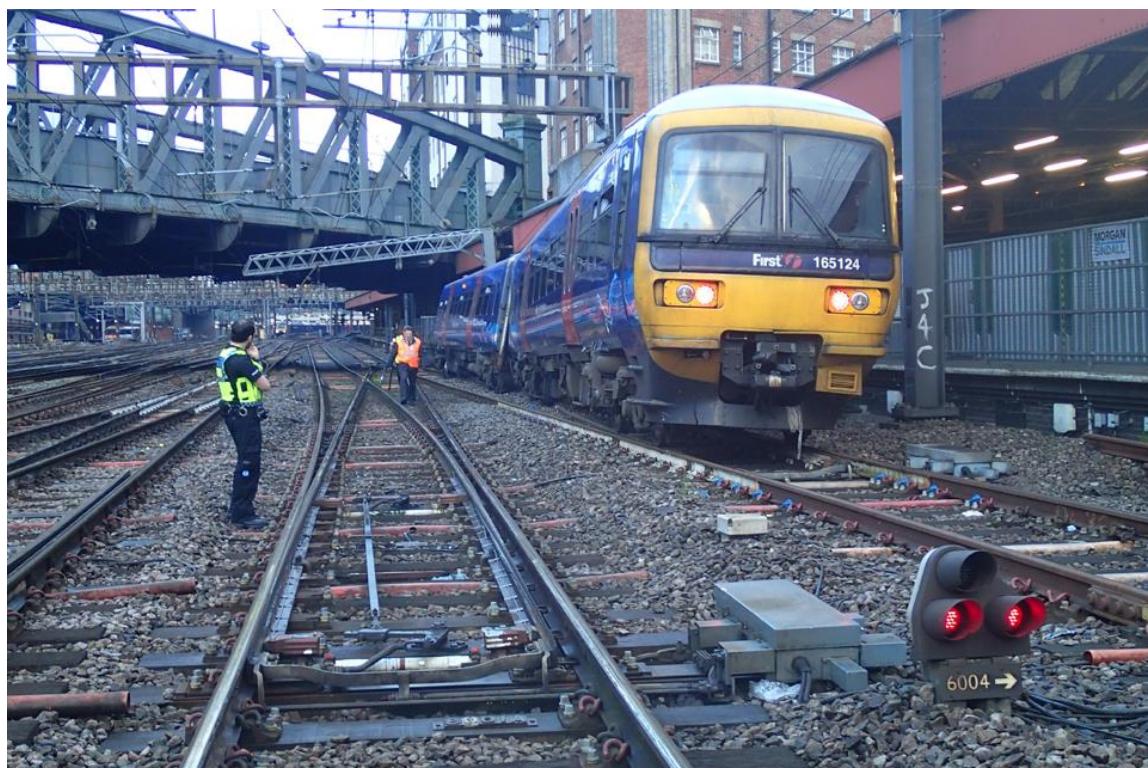
The train from the rear after the derailment. Signal SN6004 is at the bottom right
