Overspeed incidents, Somerset, 19 July 2016

2. Summary of the incidents

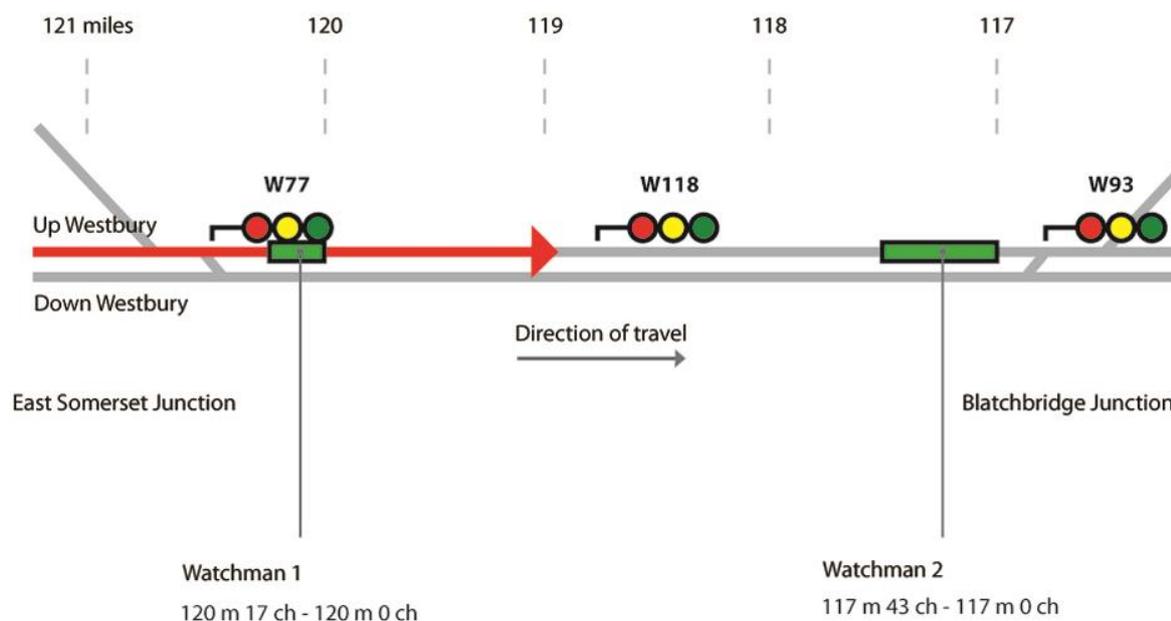
Simplified diagram showing relative positions of the speed restrictions (not to scale)

On 19 July, two sites were being monitored on the up line between East Somerset Junction and Blatchbridge Junction. Watchman 1 was deployed to a site 0.21 miles (0.34 km) long which extended between 120 m 17 c and 120 m 0 c , and watchman 2 to a site 2.5 miles (4 km) further east which was 0.54 miles (0.86 km) long, between 117 m 43 c and 117 m 0 c.
