# Level crossing collision, near Dymchurch, 10 September 2016

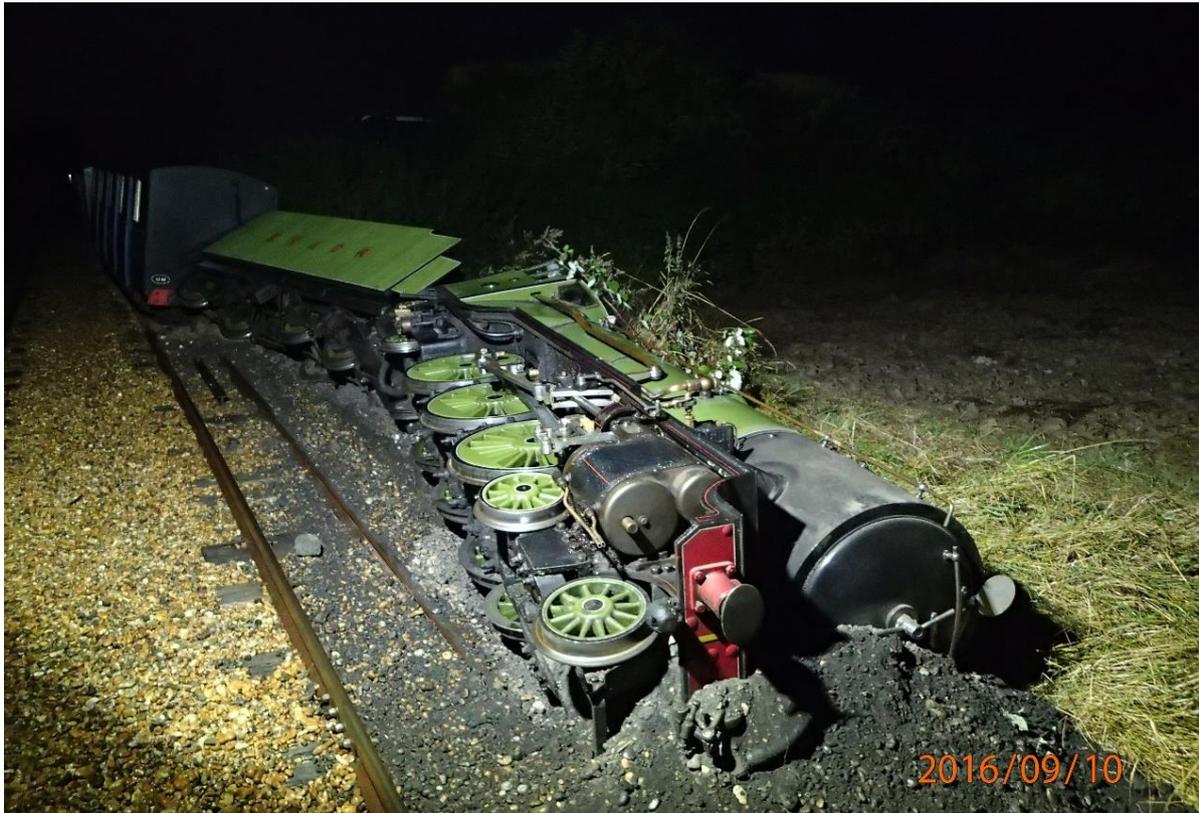
**Romney Hythe and Dymchurch locomotive Number 1 'Green Goddess' lying on its side after the accident**

The impact caused the steam engine and its tender to derail and tip onto their left-hand sides, coming to rest approximately 23 metres beyond the crossing. The first coach of the train was also derailed but remained upright. The front of the tractor was pushed sideways into the crossing gate and post.

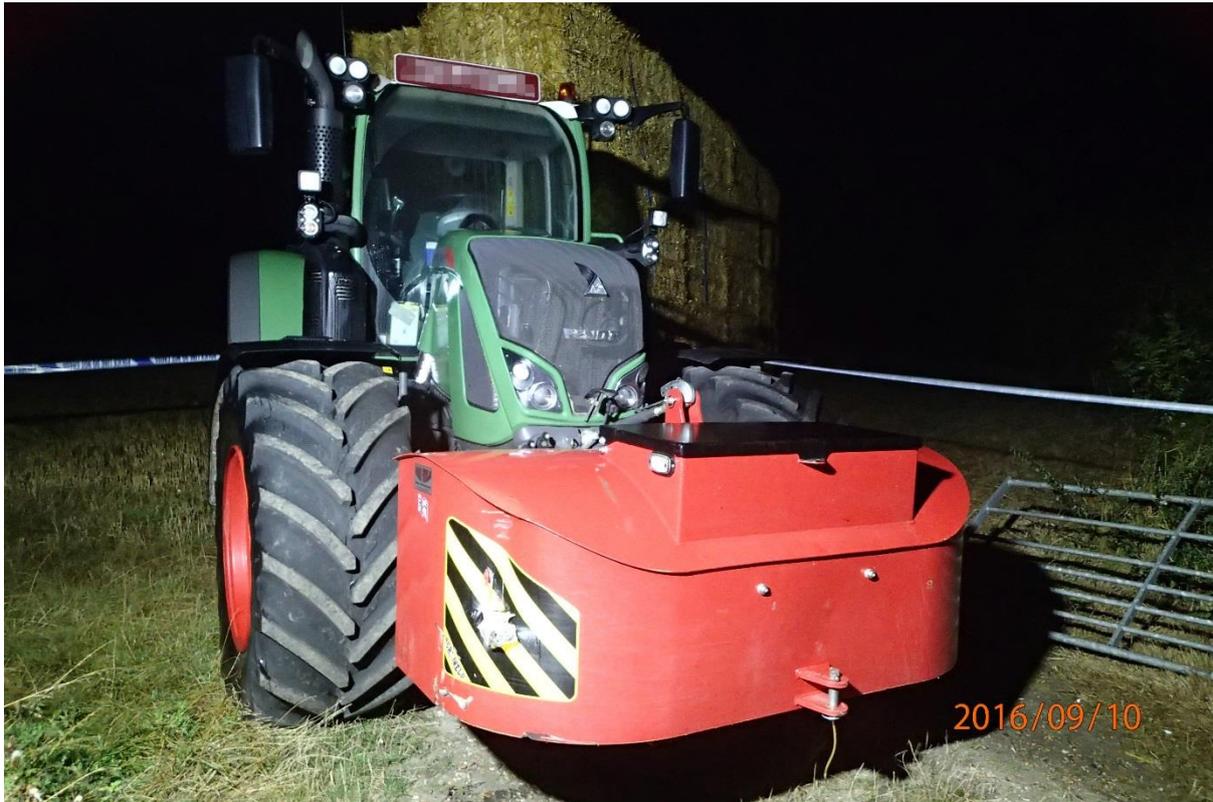
The train driver saw the tractor in the distance initially stationary, then moving towards the railway and then stationary again. As the train got closer, its driver became aware that the tractor was close to the railway and sounded the train's whistle. On hearing the whistle the tractor driver realised that he was probably too close to the line and began to engage reverse gear. About 50 metres from the crossing the train driver realised that the train would collide with the tractor and applied full braking to his train. Due to the time taken for the brakes to take full effect and the initial speed of the train, it was still travelling at an estimated 15 mph (24 km/h) when the front of the locomotive struck the front counter-weight on the tractor, which was overhanging the line. The tractor driver stated that he managed to engage reverse gear and was just starting to move when the train hit the counter-weight.

**The tractor involved in the accident. The train hit the red counter-weight attached to the front**

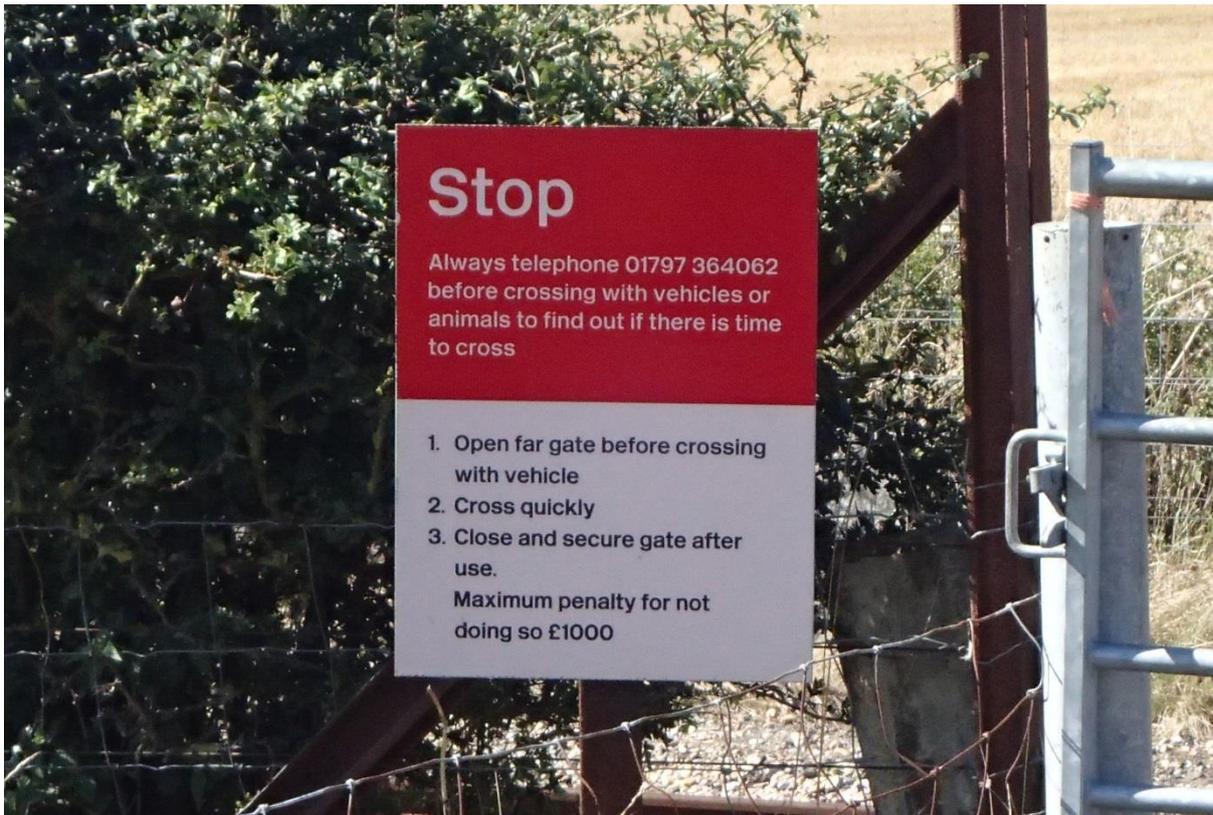
The tractor driver did not use the crossing in accordance with the instructions on the sign. He was not very familiar with this level crossing, having only used it for one day prior to the day of the accident. The tractor driver neither opened and closed the gates each time he crossed, nor telephoned the railway before using the crossing. Neither this driver nor any other farm worker had contacted the railway for permission to cross while harvesting was in progress during the week leading up to the accident.

**One of the signs displayed on either side of the crossing, which give users instructions on how to cross**

The RH&DR had not briefed the authorised user of this UWC in recent years and had no record of doing so earlier. The method described on the sign had not been briefed to the tractor driver by either his employer (a contractor working for the farm occupier), or by the farm occupier.

- briefing authorised users of user worked level crossings (UWC) about the correct method of use and the importance of them passing this information on to their employees and subcontractors
- considering the need for suitable risk mitigation when a crossing is in heavy use, for example during the harvest season
- implementing effective and practical risk mitigation when it is observed that level crossing gates have been left open.
