AAIB Bulletin

12/2016

Aircraft Type and Registration:	Embraer EMB-505 Phenom 300, HZ-IBN	
No & Type of Engines:	2 Pratt & Whitney Canada PW535E turbofan engines	
Year of Manufacture:	2010 (Serial no: 50500040)	
Date & Time (UTC):	31 July 2015 at 1408 hrs	
Location:	Blackbushe Airport, Surrey	
Type of Flight:	Private	
Persons on Board:	Crew - 1	Passengers - 3
Injuries:	Crew - 1 (Fatal)	Passengers - 3 (Fatal)
Nature of Damage:	Aircraft destroyed	
Commander's Licence:	Airline Transport Pilot's Licence	
Commander's Age:	57 years	
Commander's Flying Experience:	11,000 hours (of which 1,181 were on type) Last 90 days - 23 hours Last 28 days - 5 hours	
Information Source:	AAIB Field Investigation

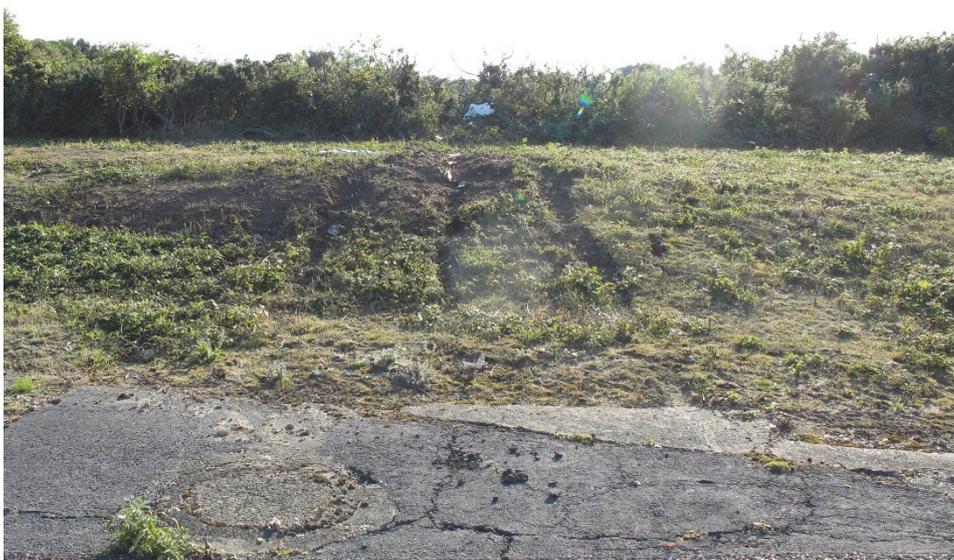
Figure 12

There were three tyre tracks in the earth bank at the end of the runway, formed by the two main wheels and the nosewheel, where the aircraft departed the runway (Figure 12). There were also two rubber tyre marks on the paved surface corresponding to where the main wheels departed the runway. These rubber tyre marks could be traced back to the point where the aircraft touched down (Figure 13). At touchdown the wheel spin-up causes rubber to be deposited on the runway surface causing the dark marks from each wheel shown in Figure 13. The marks showed that the left wheel touched down first, followed by the right wheel and then the nosewheel. The left wheel touched down 438 m from the end of the paved surface, and the right wheel 4.3 m closer. There were short breaks in the initial touchdown marks which were probably the result of the wheels skipping before they settle. The brakes would not yet have activated at this point.

Tyre tracks from the main wheels and nosewheel in the earth bank at the end of Runway 25

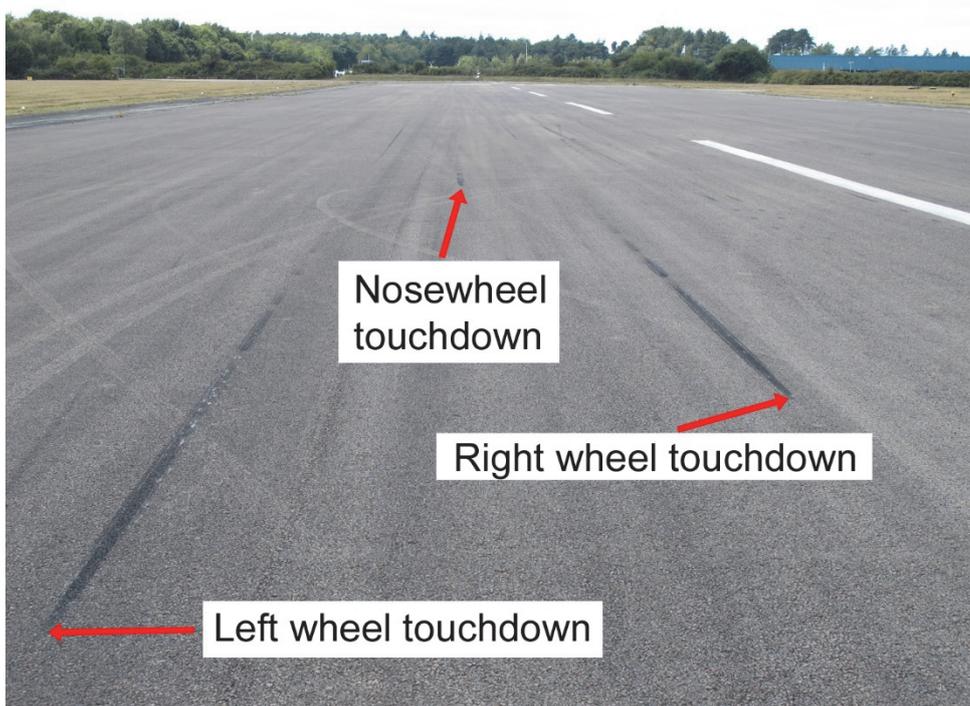
Figure 13

Touchdown tyre marks (looking in the direction of travel)

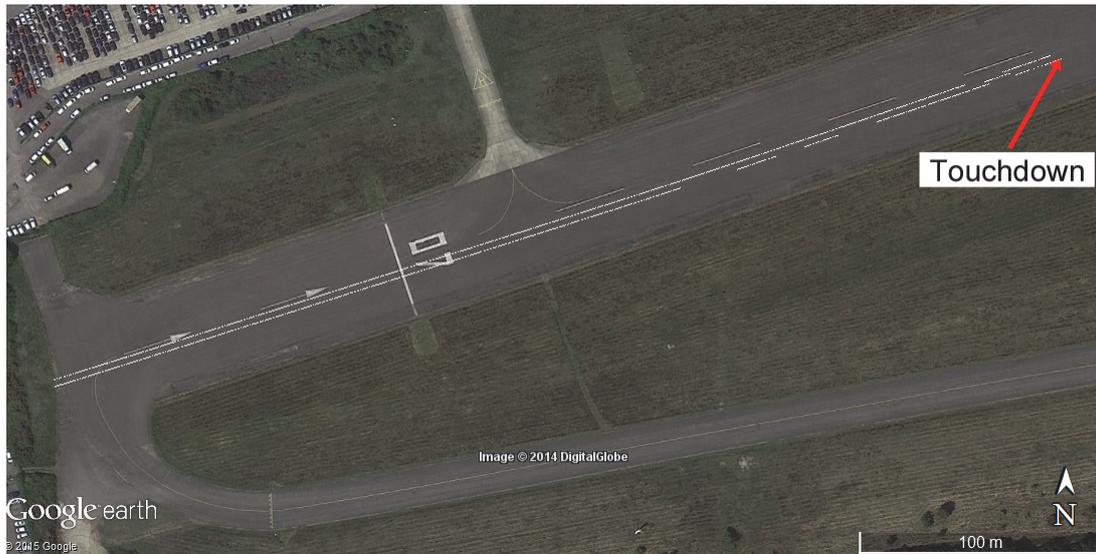
Figure 14

Tyre marks from touchdown to the end of the paved surface (white lines)
– GPS survey of marks overlaid on Google Earth image

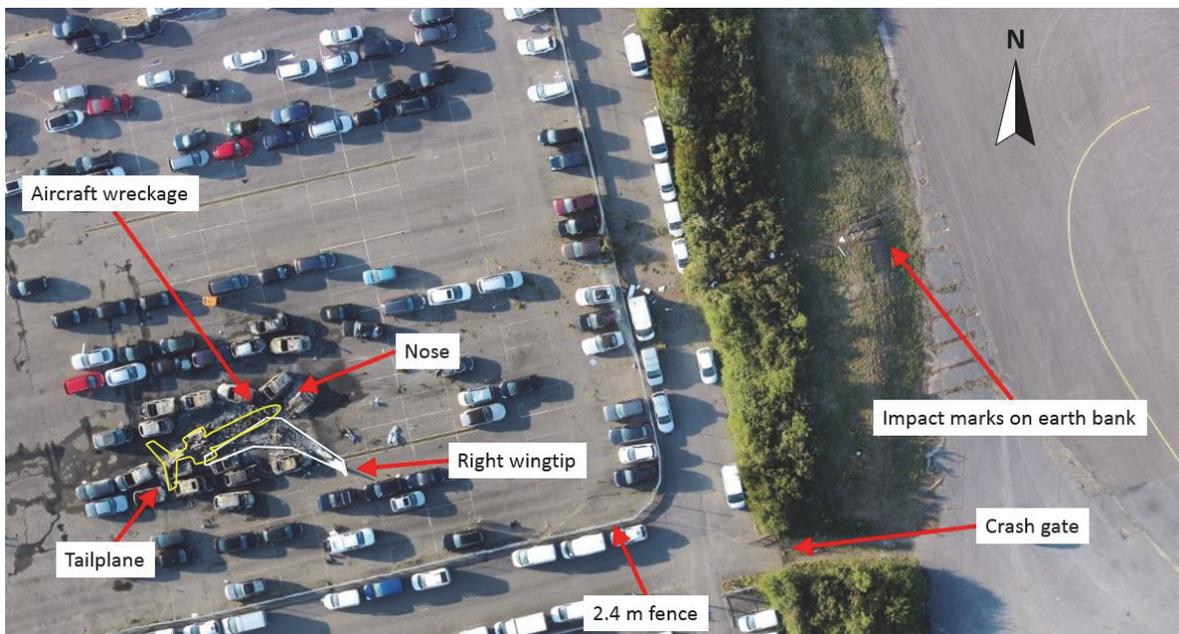
Figure 15

The aircraft departed the paved surface at the end of Runway 25 approximately 3 m to the left of the extended centreline. Ground impact marks indicated that it then collided with a one-metre high earth bank, causing the lower section of the nose landing gear and the nose gear doors to detach.

Overhead view of accident site, with outline showing wing and fuselage

CCTV footage of the car park was reviewed by the AAIB. It showed the aircraft touched down in the car park in an approximately 20° right wing low roll attitude, and a level pitch attitude. Within 0.1 seconds of touchdown, the entire wing was observed to separate from the fuselage, following which the fuselage rolled to the left through approximately 350°, before coming to rest laying on its right side, on a heading of 064°M and at a roll angle of about 30° to the horizontal. The fuselage was observed to be largely intact as it came to rest, on top of the detached wing. The wing was oriented on a heading of north (Figure 15).

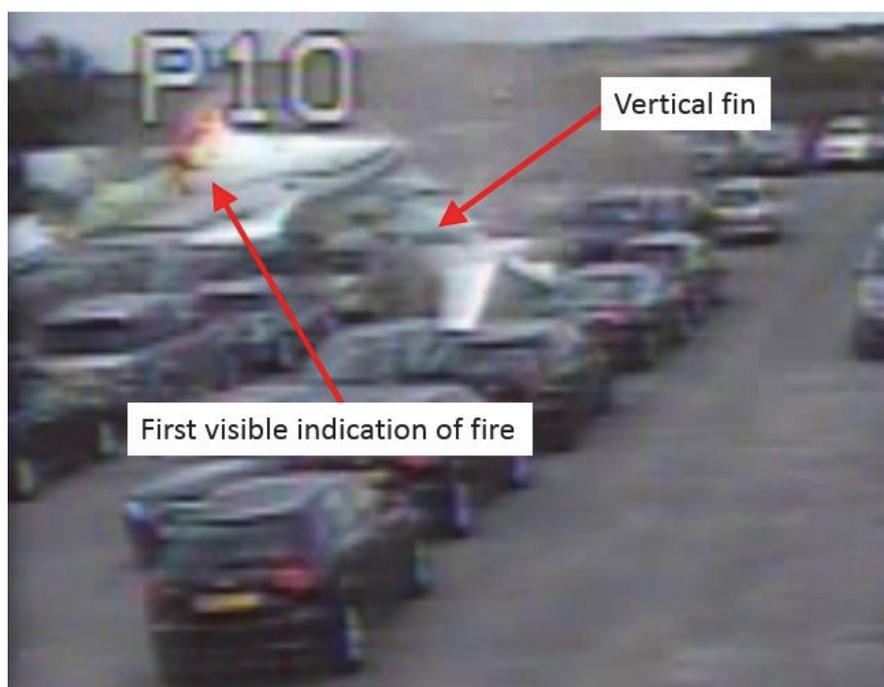
Figure 16

The first indications of fire visible on the CCTV footage occurred approximately 0.8 seconds after the aircraft's impact in the car park, as the fuselage was inverted following detachment of the wing (Figure 16). Visible flames were centred on the lower rear fuselage at the aft end of the fuselage belly fairing, immediately aft of where the wing was attached to the fuselage and close to the location of the aft main battery. The fire continued to burn with increasing intensity, consuming most of the aircraft.

CCTV image of aircraft approximately 0.8 seconds after touchdown in the car park (first visible indication of fire as the fuselage rolls through the inverted position)

The CCTV images showed that the fire ignited approximately 0.8 seconds after the detachment of the aircraft's wing assembly, with the initial seat of the fire located in the aft belly fairing, just behind where the wing had detached. The only significant fuel source in this area was fuel leaking from the severed wing-to-fuselage engine fuel supply fuel pipes, which contained fuel fed from the wing fuel tanks. The ignition source of the fire was not positively identified due to disruption of the aircraft in the accident and from the severity of the post-accident fire.

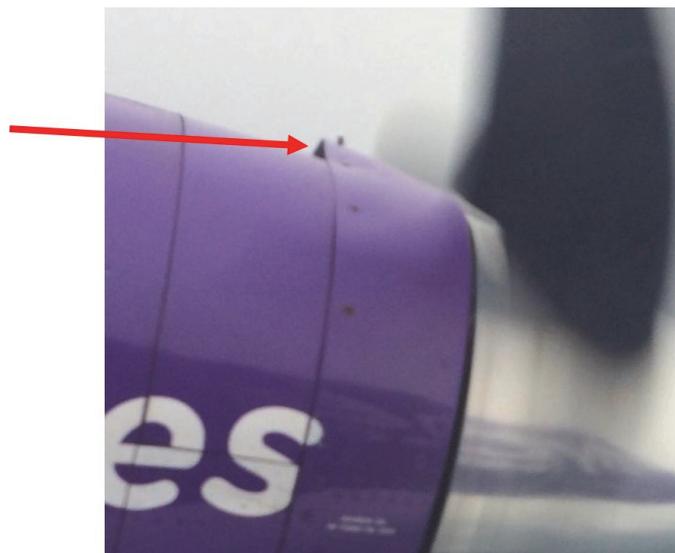
Figure 1

Picture taken in flight by a passenger showing the outboard section of the loose cowling

A section of the loose cowling was found to be worn on its forward face, and a small section of the cuff section of all four propeller blades had been damaged by contact with the cowling.

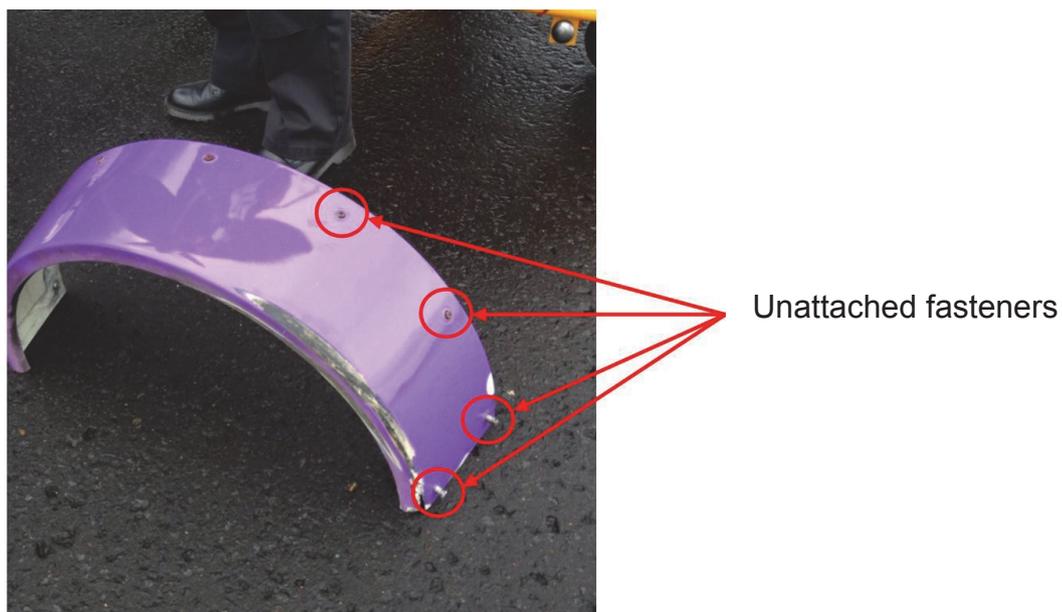
Figure 2

The operator determined that a member of engineering staff had been distracted during a maintenance task performed the previous day, and had not secured the cowling before dispatch. The unsecured latches (shown in Figure 2) were then not spotted by engineering staff during before-flight checks, or by the flight crew during the pre-flight external check.

Cowling removed with unattached fasteners highlighted

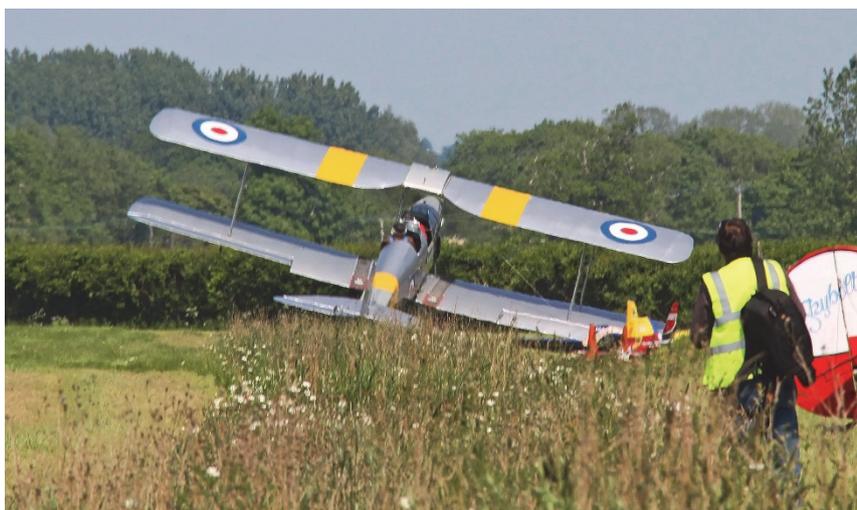
Figure 1

When the AAIB inspected the aircraft shortly after the accident the elevator trim was found to be in the fully aft position.

G-ANMY shortly before the accident
