# Rail Accident Report

## Occupied wheelchair contacting a passing train at Twyford station 7 April 2016

Report 01/2017  
January 2017

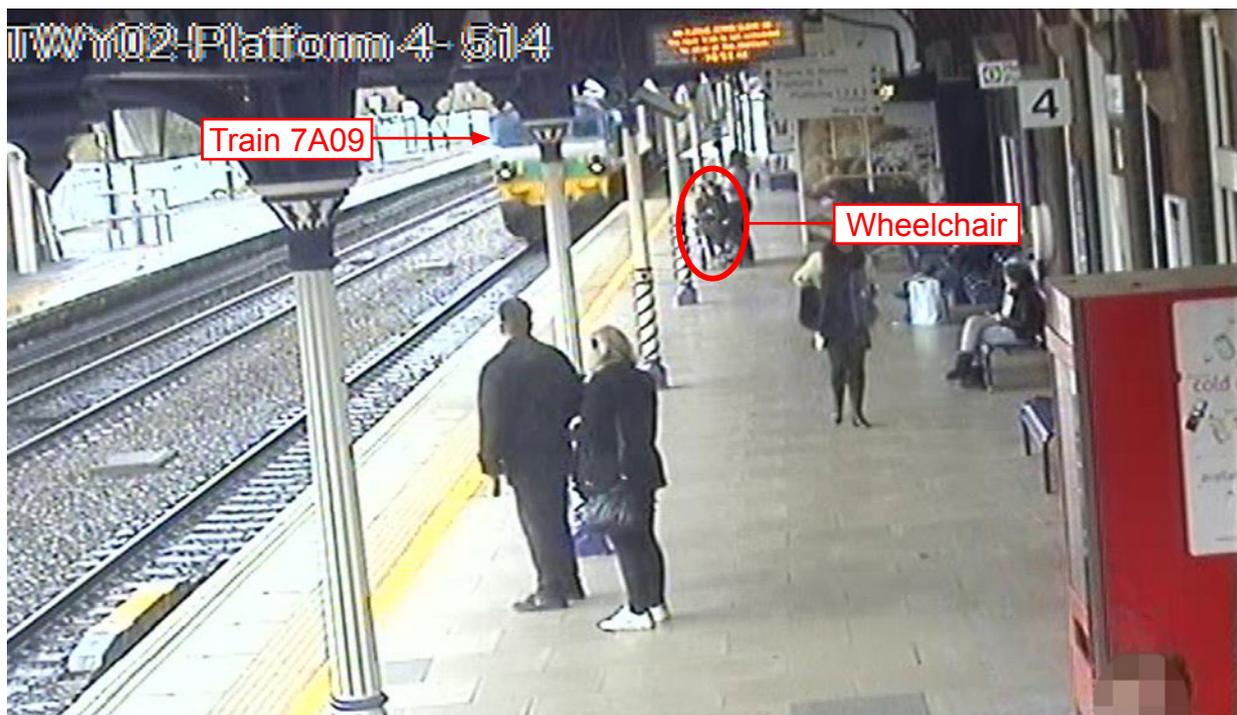
- 21 At 10:51:50 hrs, the locomotive of train 7A09 passed the wheelchair (figure 7). After approximately 13 seconds, the wheelchair began to move slowly, turning to the right and towards the train (figure 8). The initial movement occurred as the transition between the box wagons (wagons 1 to 16) and hopper wagons (wagons 17 to 44) passed the wheelchair.

Figure 7: CCTV image showing the locomotive of train 7A09 passing the wheelchair (courtesy of GWR)

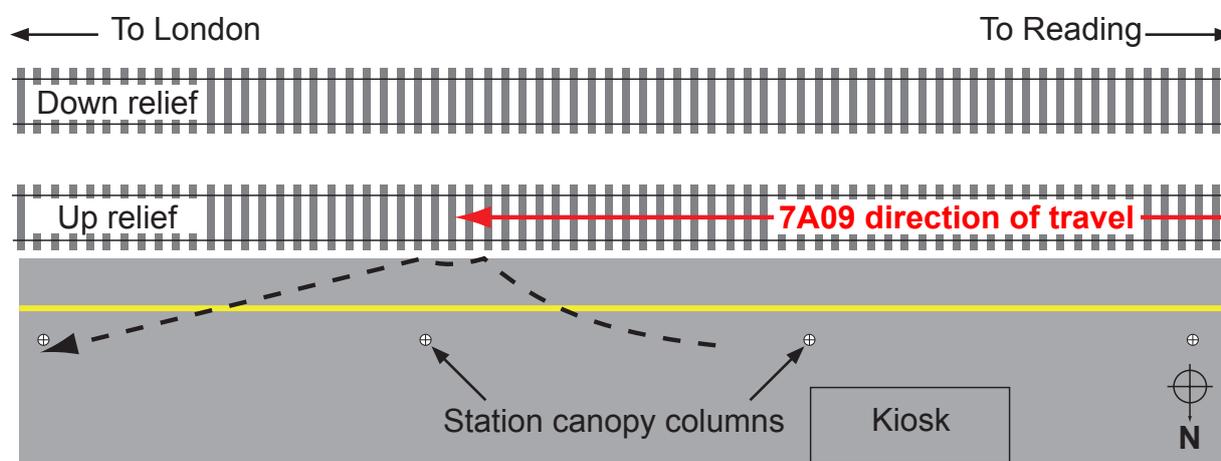
Figure 10: General path of the wheelchair along platform 4 (not to scale)

- With the wheelchair brakes in step 2, calculations undertaken by the University of Birmingham following testing (paragraph 44) showed that there are circumstances in which the force generated by the air flow would exceed the force generated by the wheelchair's brakes, setting the wheelchair into motion. CCTV showed that the wheelchair turned towards the right (paragraph 21) once it was in motion. This turn was probably caused by the differential braking effect of the right side brake being more effective than the left side brake (paragraph 47). The slight platform slope towards the railway (paragraph 7) would also have contributed to this curving motion.

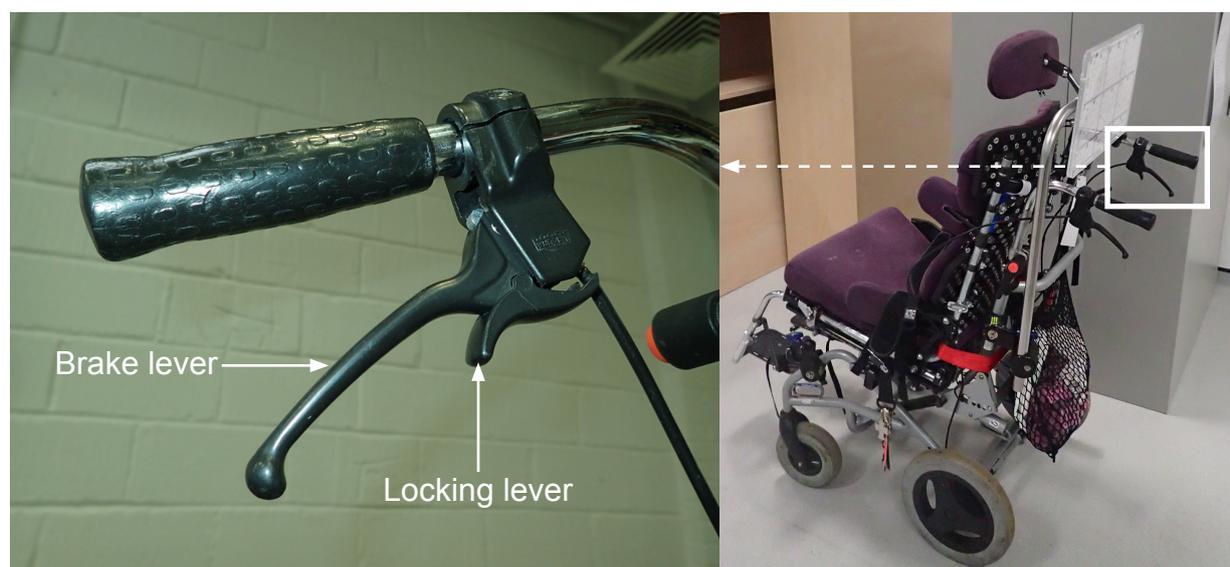
Figure 11: The wheelchair involved in the accident

- 30 The wheelchair involved was manufactured by Otto Bock Healthcare during 2010 and was the 'Discovery' model (figure 11). This design of wheelchair can only be propelled and braked by a carer; it cannot be operated by the user. The combined weight of the wheelchair and the girl at the time of the accident was approximately 90 kg.
- 31 The wheelchair is fitted with drum brakes operated by the carer using levers, one on each handle. There is one drum brake on each rear wheel controlled using a cable from the corresponding handle. The brakes operate independently of each other. A cam mechanism, operated by the cable (figure 12), causes brake pads to press outwards onto an annular inner surface within the wheel hub to apply the brake.

- 50 The RAIB arranged for Otto Bock Healthcare to examine the wheelchair. It noted that there was more wear on the left hand brake than the right. The effect of this wear would be that the right side brakes would have been more effective. Otto Bock Healthcare has advised the RAIB that the usual reason for a reduction in the effectiveness of the brakes on this type of wheelchair is stretch in the operating cables. It cannot be confirmed if the cables fitted to the wheelchair at the time of the accident had been subject to stretching since the original length of the cables fitted to the wheelchair is unknown<sup>9</sup>.

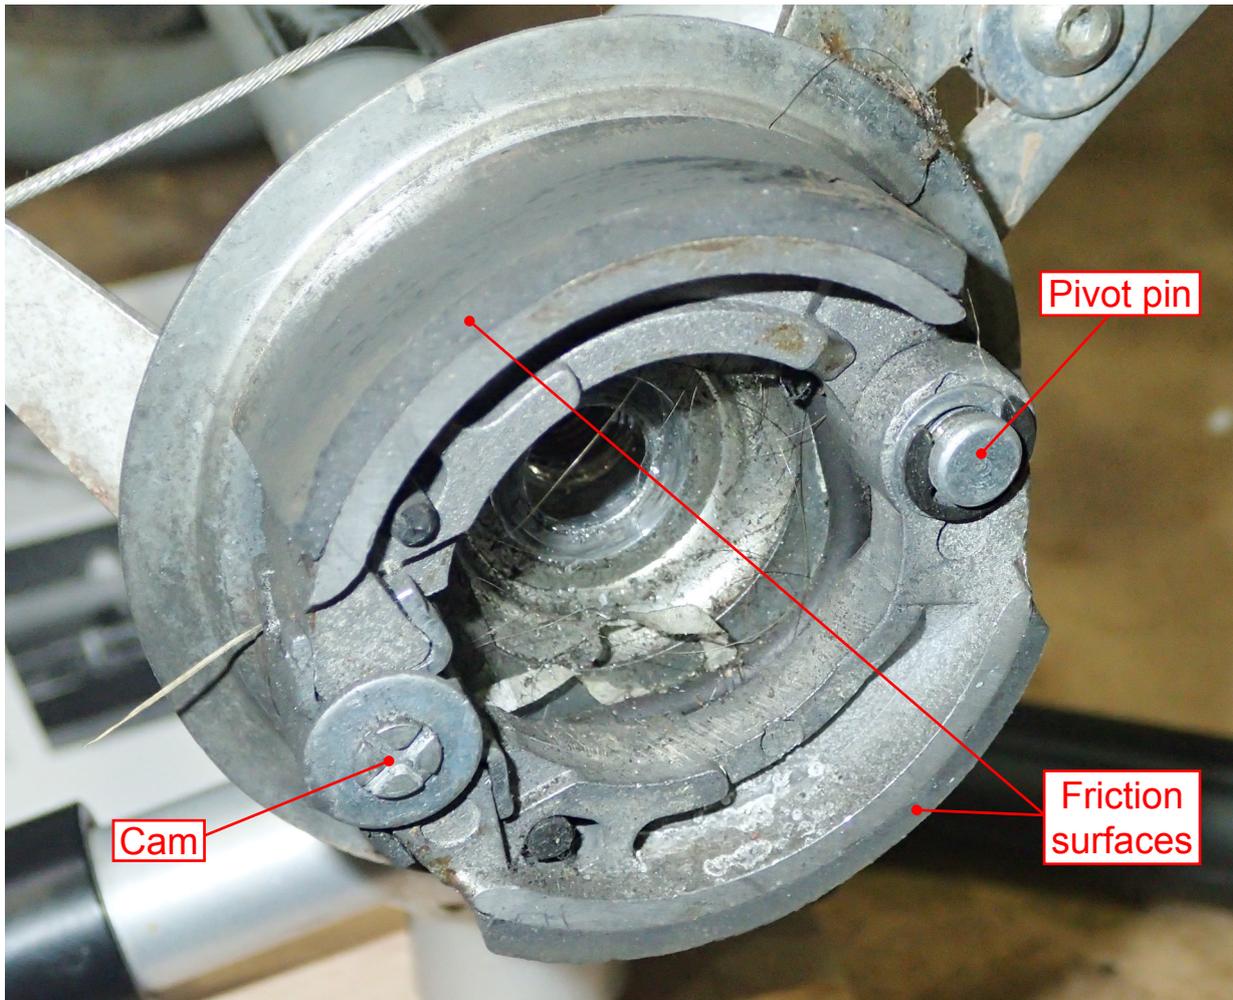
Figure 12: The wheelchair brake mechanism

- 32 Each brake lever has a separate smaller lever (figure 11) which allows the carer to lock the brakes into one of three steps, until released.
- 33 As part of its product acceptance process, this type of wheelchair was tested by the manufacturer in accordance with EN12183:1999 'Manually propelled wheelchairs – Requirements and test methods' and ISO7176 part 3 'Wheelchairs – Determination of the effectiveness of brakes' to check the adequacy of the brakes. A wheelchair was loaded with a test dummy and placed on an inclined surface. The total mass of chair and dummy was 131 kg. The brakes were applied with a maximum pull force on the handles of 72 Newtons (N). This force corresponds to step 2 on the brakes of the Discovery wheelchair design. The inclination on the surface is then increased until either the wheelchair starts to roll or it starts to slide. The greater the angle of inclination achieved, the stronger the brake. The minimum acceptable inclination is 7 degrees. The test report for the Discovery wheelchair design, dated August 2004, showed that it achieved a 10.7 degree inclination, equating to a brake force of 239 N.

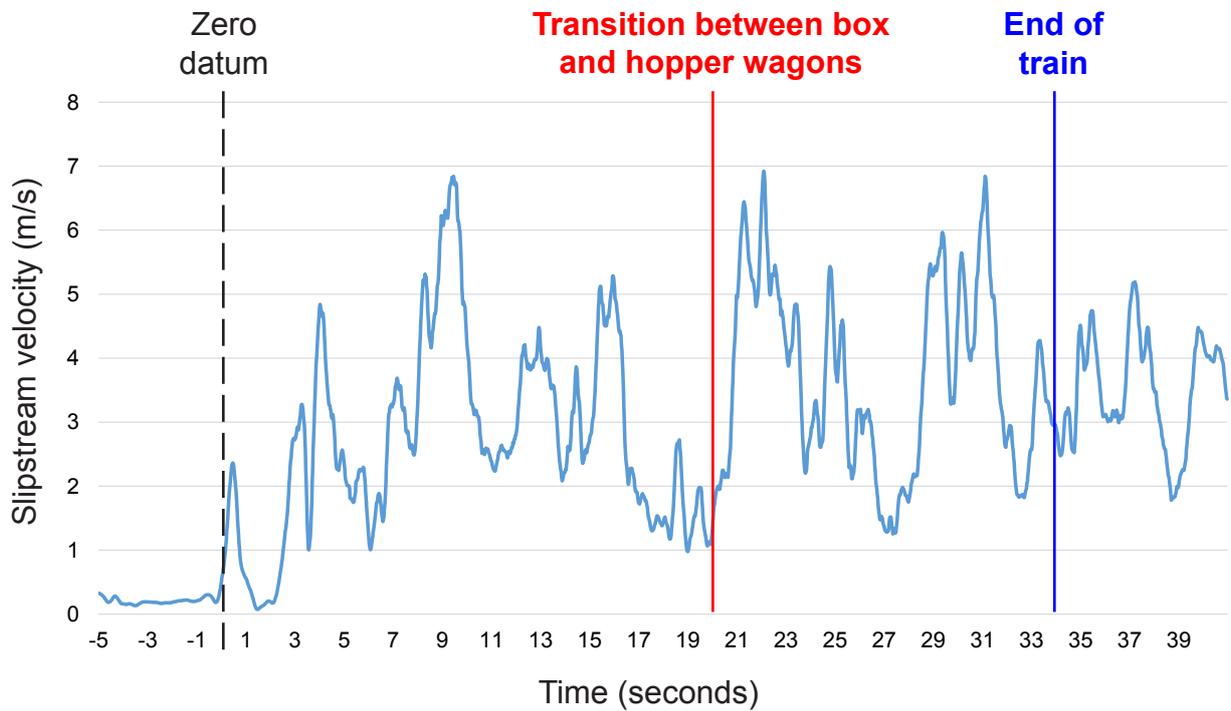
- 43 Measurements for the trains of a similar configuration to train 7A09 were analysed. Figure 14 shows the slipstream velocities measured by an anemometer when such a train passed through platform 2. It should be noted that there was significant variability in the anemometer measurements between trains and also between anemometers during the passage of a single train.

Figure 14: Typical measured slipstream velocity against time graph for the passage of a single train similar to 7A09. Data is taken from the passage of train 7A91 through Twyford station at 02:05 hrs on 9 August 2016.

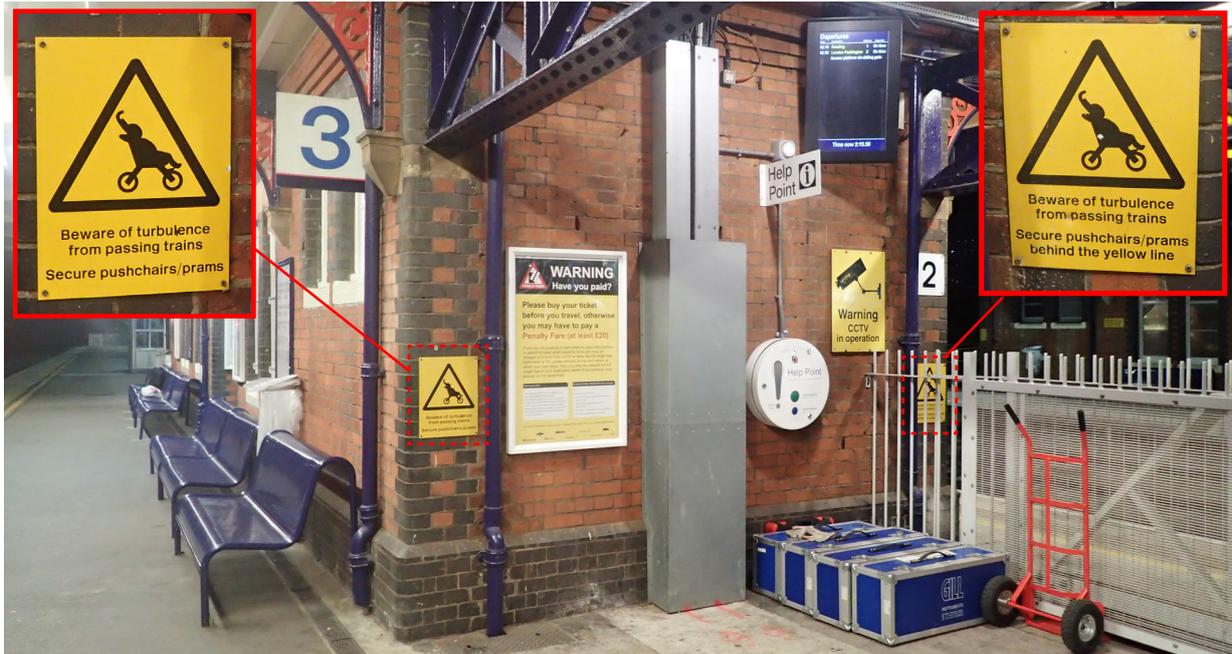
Figure 15: Warning signs on platforms 2 and 3

- 55 Yellow lines are painted on all the platforms at Twyford. Those on platform 4 are 1.2 metres from the edge of the platform. The wheelchair and the mother were well behind the yellow line (paragraph 20). These yellow lines are painted adjacent to the tactile strip near platform edges and serve to warn passengers that they are close to the platform edge. At platforms where passenger trains are permitted to pass through at greater than 100 mph (161 km/h) or freight trains at greater than 60mph (97 km/h), the yellow line must be located at 1.5 metres from the platform edge. The purpose of this is to reduce the exposure of station users to the effects of train slipstreams.
