# ***AAIB Bulletin***

***1/2017***

Published 12 January 2017

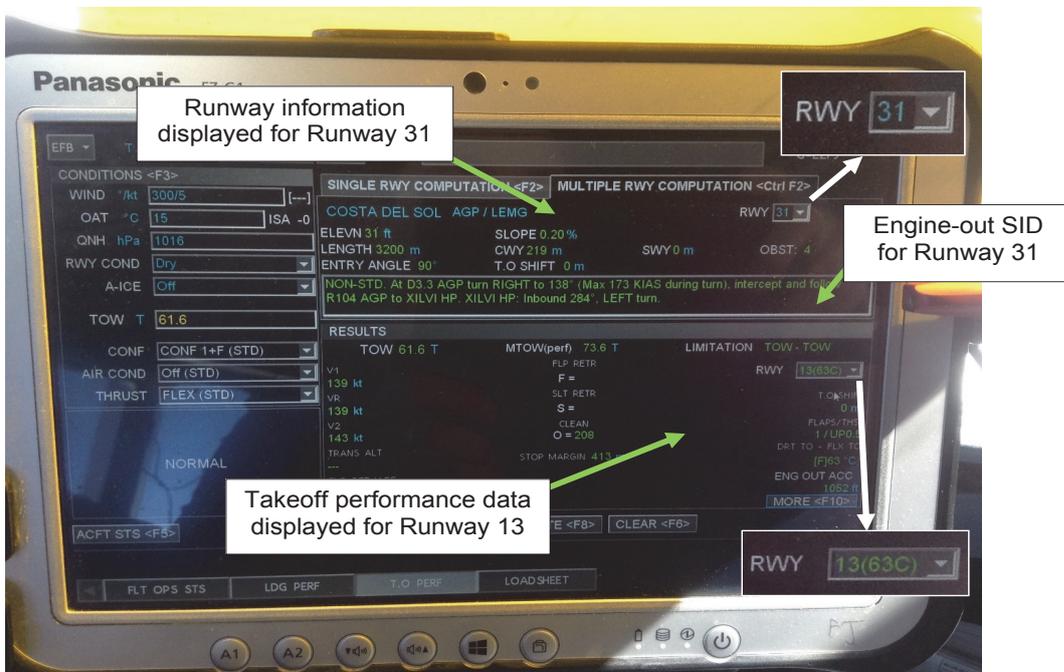
The sequence of events detailed by the flight crew suggested that the FlySmart software could display detailed information for one runway but with takeoff performance data for a different runway. Figure 3 shows a photo taken by the flight crew which confirmed this.

Photograph of EFB taken by G-EZFJ flight crew

The operator has disabled the MRC function and other affected operators have since been informed of this anomaly with a recommendation to disable the MRC function. The L6.x versions of the software do not exhibit this MRC function anomaly.

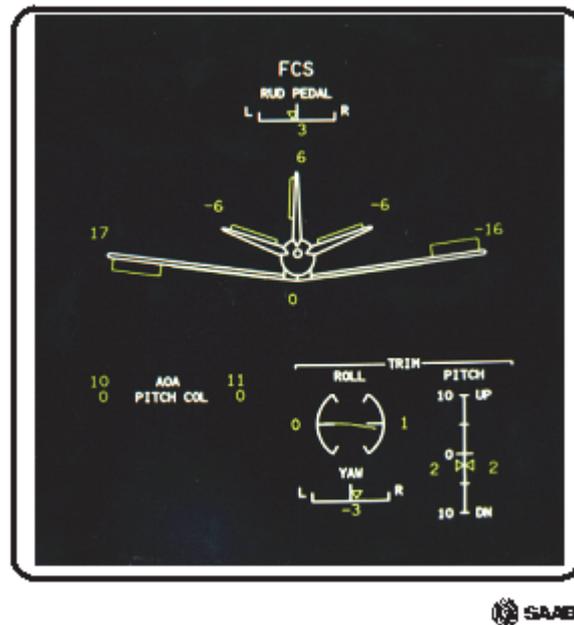
Figure 1

The PF decided to disconnect the autopilot, bracing the controls for the jolt he expected when doing so with an aileron mistrim. The jolt was more pronounced than usual and he had difficulty maintaining straight and level flight, finding that the aileron controls felt “sloppy” and unresponsive. He reduced airspeed to below 200 KIAS, and the PM viewed the Flight Control System (FCS) synoptic page on the Secondary EICAS Display (SED) (Figure 1). The pilots recalled that the FCS diagram indicated both of the aircraft’s ailerons were deflected upwards, with the left aileron up  $8^\circ$  and the right aileron up  $5^\circ$ , and that whilst they were looking at the display both aileron depictions briefly deflected upwards to  $17^\circ$ .

Example of FCS presentation on the SED Synoptic page

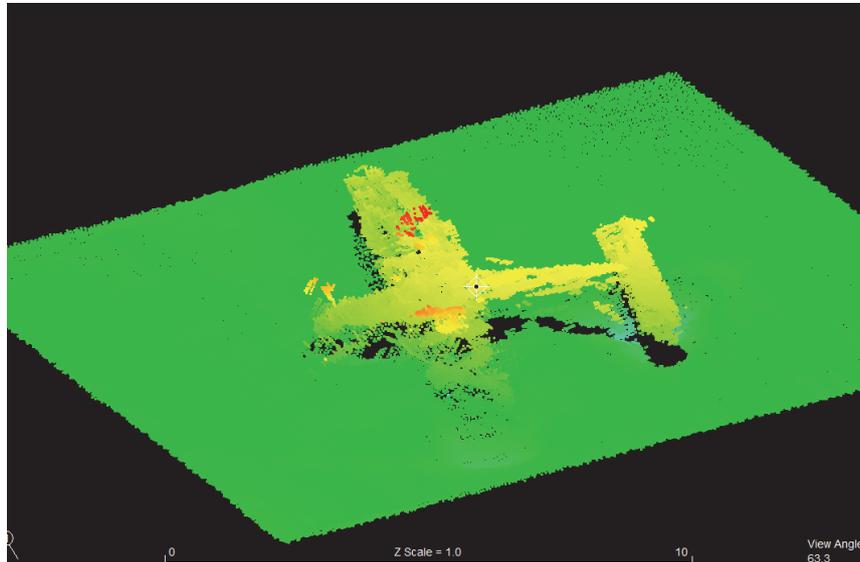
**Figure 4**

On 10 August 2016 a side-scan sonar equipped survey vessel, with SALMO and AAIB personnel on board, located the aircraft on the sea bed at a depth of between 5 m and 9 m, close to the marker buoy. Sonar imagery showed that the aircraft appeared to be intact and was inverted (Figure 4).

Sonar image of the aircraft

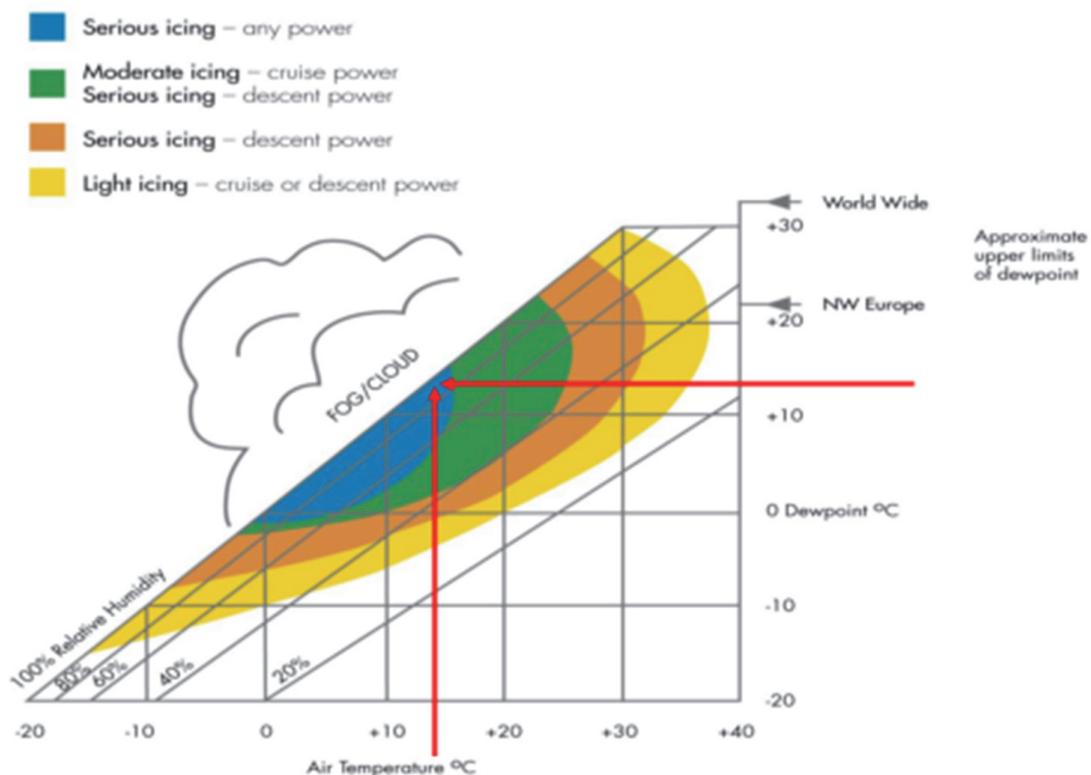
**Figure 5**  
Carburettor Icing

On the weekend of the accident, the southern part of the UK was subject to a moist south-westerly airflow. The temperature and dewpoint of this air mass was such that aircraft flying around 2,000 ft were operating in the area of the carburettor icing forecast graph where severe carburettor icing could occur at any power.

The carburettor icing chart, Figure 5, indicated that the aircraft was operating in conditions where carburettor icing would be expected at any engine power setting. Other events, both reported and anecdotal, from aircraft operating in the same weather system confirmed that carburettor icing may have been prevalent.

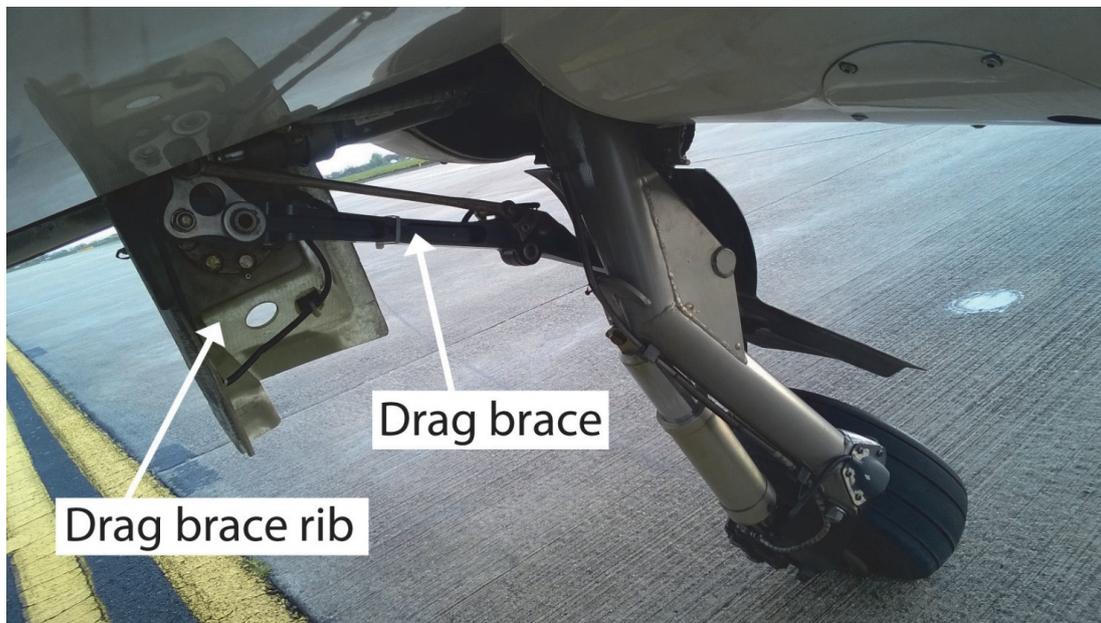
**Figure 1**

The composite drag brace rib, which secures the left main landing gear drag brace to the centre wing section, had detached (Figure 1), causing the left main landing gear leg to partially collapse. The aircraft manufacturer examined the aircraft and removed the failed rib for further detailed examination. They determined that the failure pattern was typical for an overload failure of the bonding between the composite rib and the composite centre wing section. They concluded that some damage had occurred during a previous hard sideslip landing and then the final failure occurred on the day of the accident.

View of left main landing gear leg (looking aft) showing detached drag brace rib

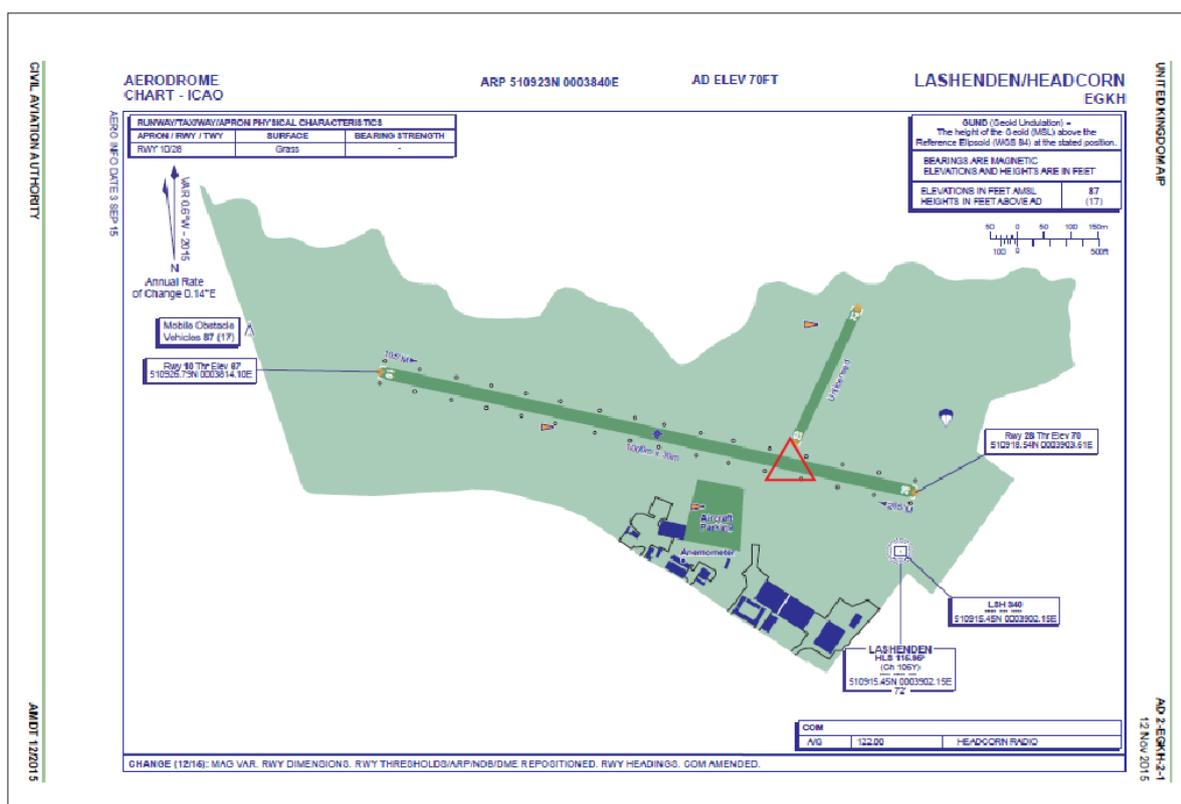
**Figure 1**

Lashenden/Headcorn Aerodrome  
 (red triangle indicates the location where contact between the two aircraft occurred)
