Report on the investigation of the collision

City of Rotterdam

Primula Seaways

3 December 2015

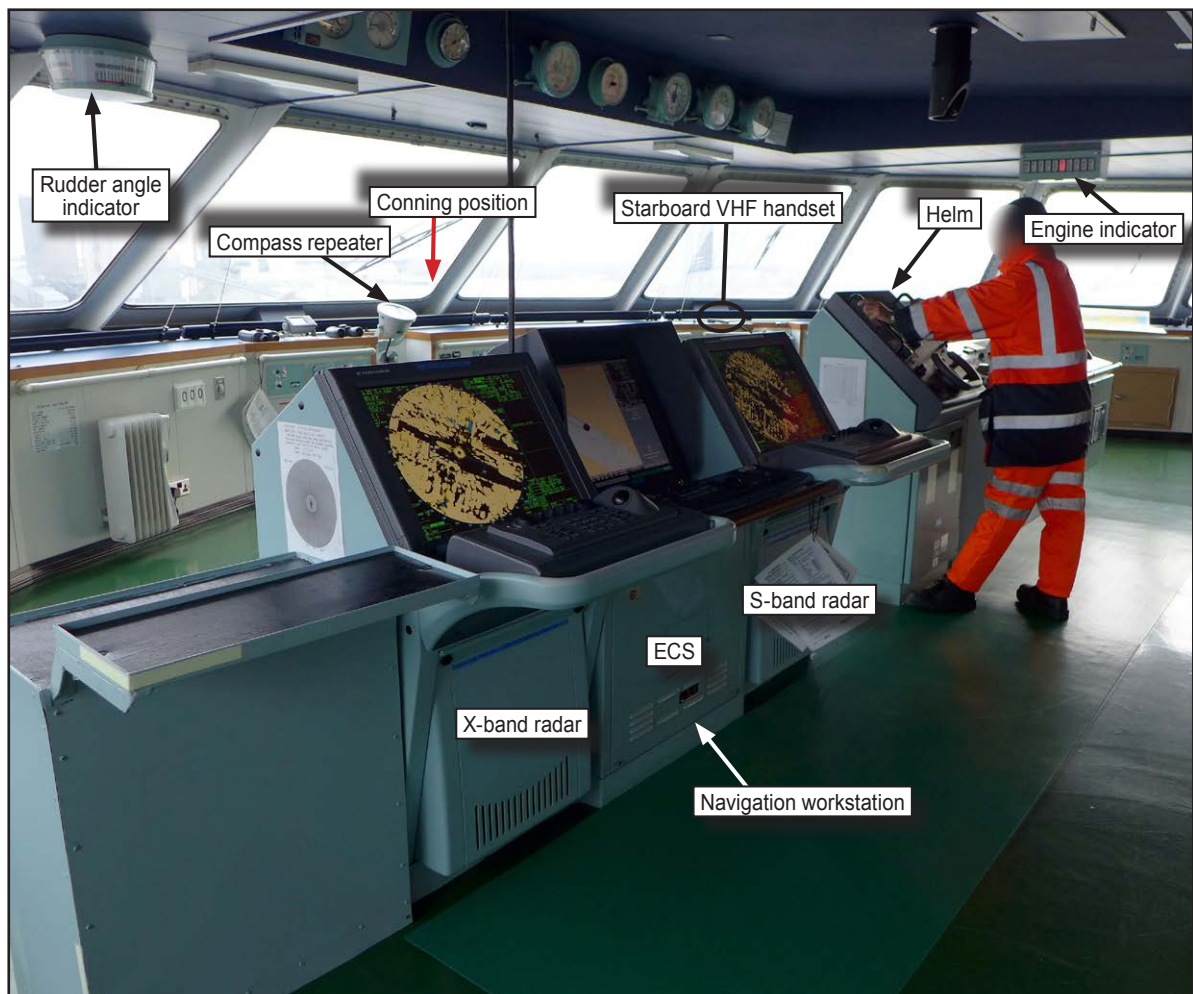
Figure 2: *City of Rotterdam* - bridge (from port side)

During the exchange, the master advised the pilot to stand at either the forward centreline conning station or behind the navigation workstation (**Figure 2**). He also pointed out to the pilot a length of cord on the centre window that indicated the vessel's centreline. The master and the pilot also discussed the potential effects of the wind. The vessel was high-sided and in ballast, and the wind was gusting up to 40 knots from the south-south-west. The pilot anticipated that the vessel would experience a high drift rate throughout its passage, but more so once passed Grimsby where it was more exposed and the effect of the tidal stream would be more pronounced.

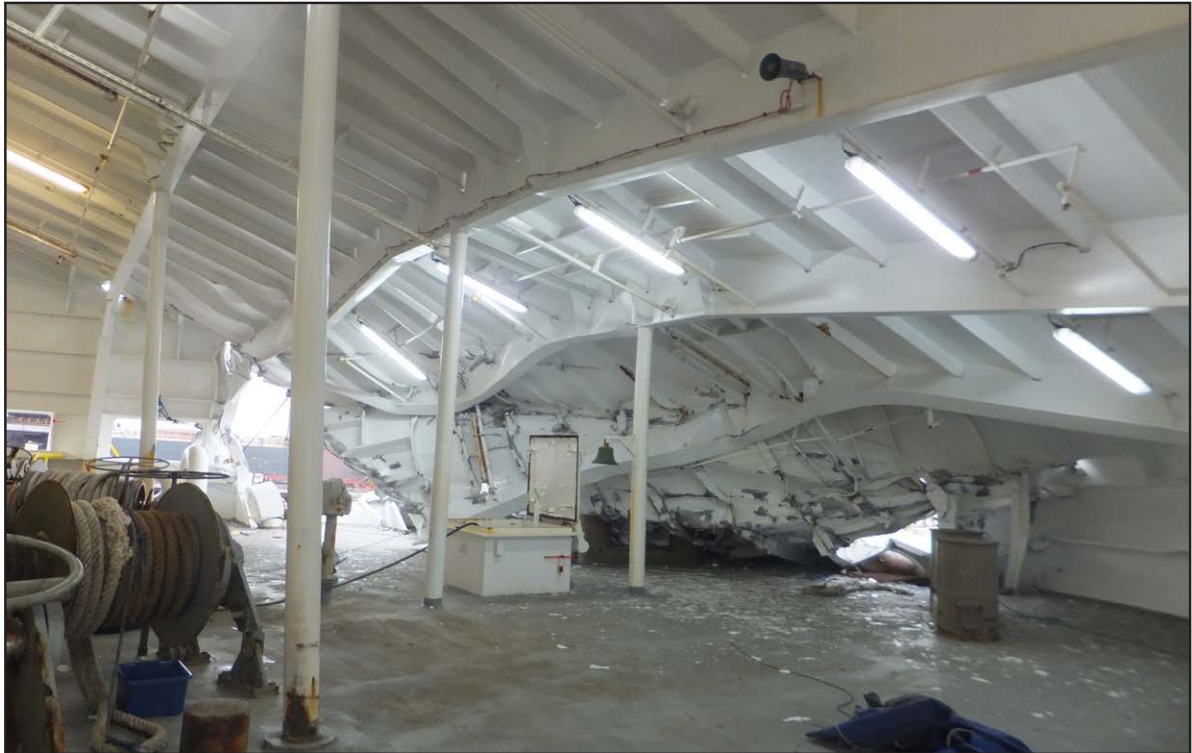
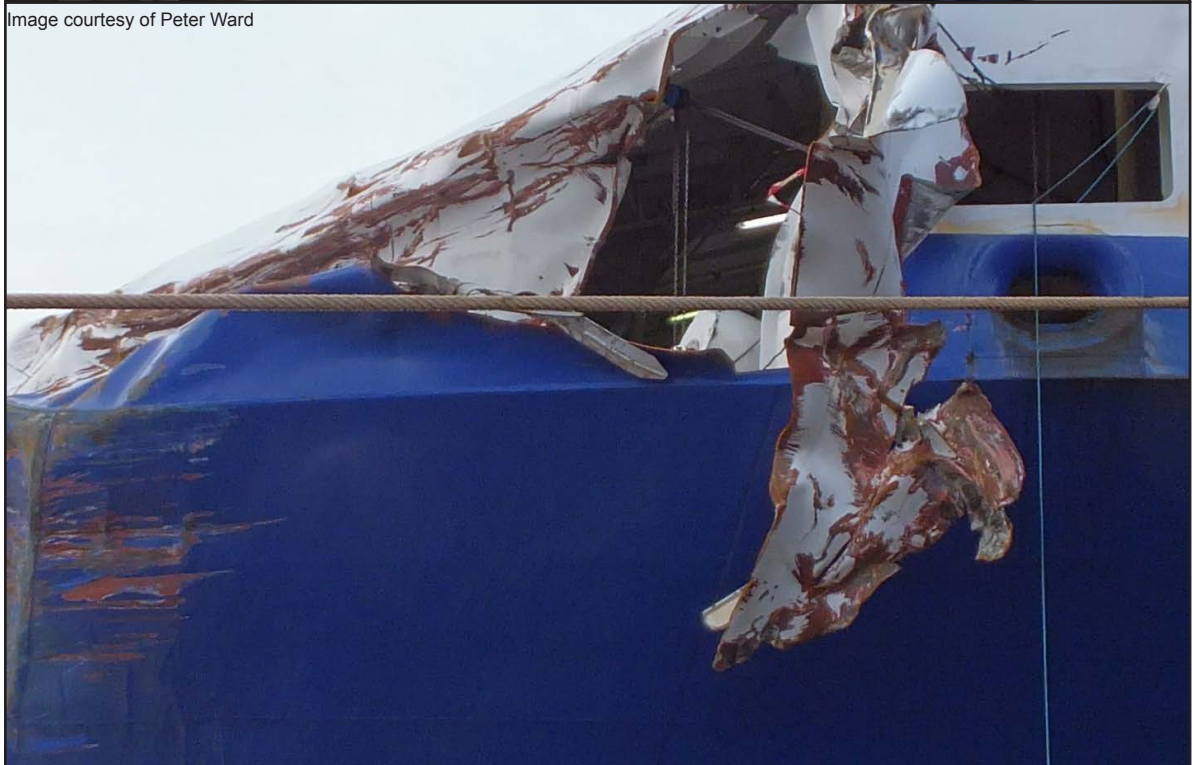
Figure 10: *Primula Seaways* damage

Primula Seaways suffered damage to its bow above the waterline (**Figure 10**). *City of Rotterdam's* bow was damaged in way of the forward mooring deck, the forward hydraulic room, and car decks 5 and 6 (**Figure 11**). The port side bilge keel and plating was also depressed and damaged, which resulted in water ingress to number 4 port ballast tank. The vessels were surveyed by classification society and Maritime and Coastguard Agency (MCA) surveyors. Following temporary repairs

in Immingham, both vessels proceeded to a ship repair yard on the River Tyne for permanent repair. The estimated cost of returning *Primula Seaways* to service was US\$3 million. *City of Rotterdam* spent 2 months in dry dock, but the cost of the vessel's repair was not disclosed.

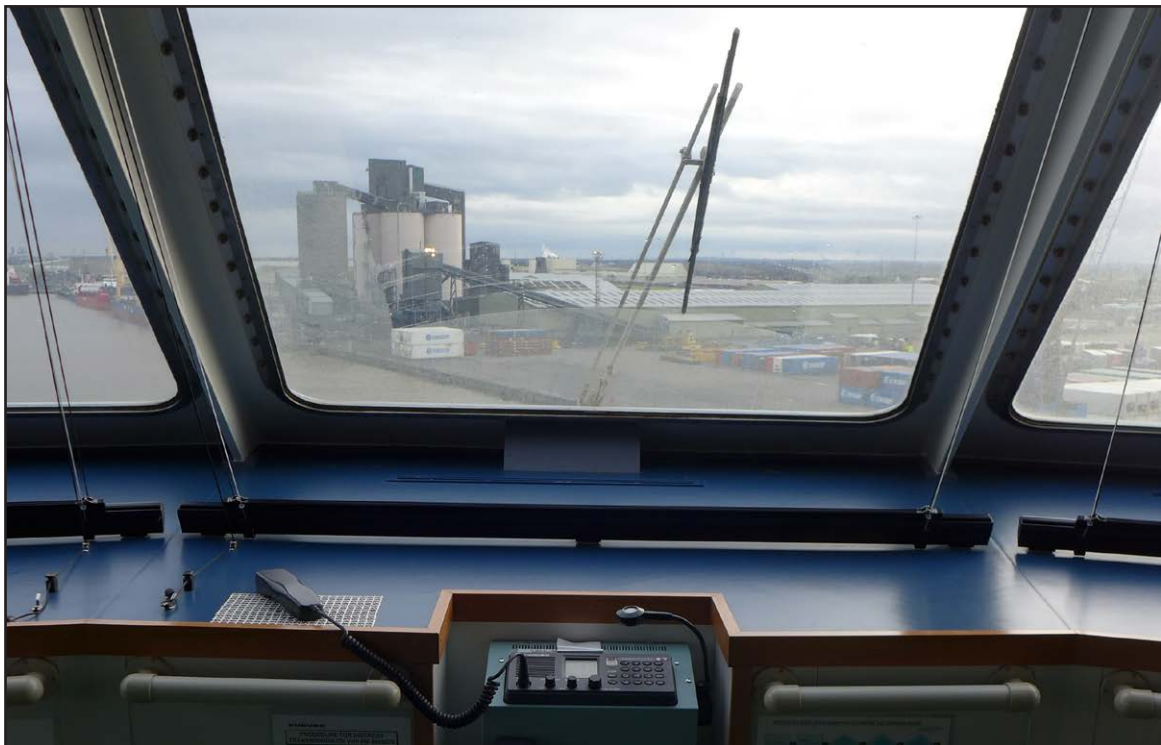
Figure 15: *City of Rotterdam* - same view, from off-axis window (starboard VHF)

Relative motion illusion deceives a viewer into thinking that the observed view is the direction of travel. In this case, the pilot was looking through the window above the starboard VHF radio, which was 33° off-axis from the centreline. As it was dark, the inward slope of the window removed all objects in the periphery, and there were no visual clues, such as a forward structure or bow tip, the illusion would have been compelling.

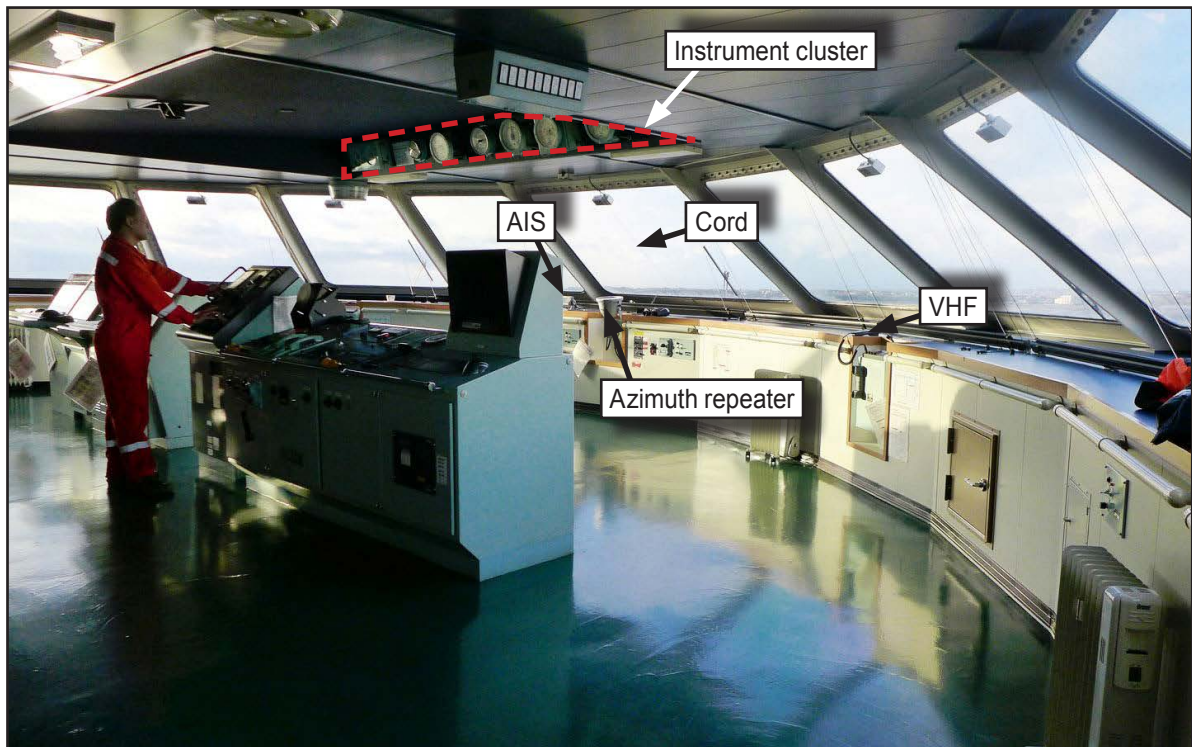
Figure 16: *City of Rotterdam* - bridge from starboard side

Recommendation 95) and it was possible to sight the azimuth repeater and the rudder angle indicator. However, the propulsion, wind and speed indicators on the deck head in front of the helmsman (**Figure 16**) were set back and were not readable as required by SOLAS V/19.2.5.4.

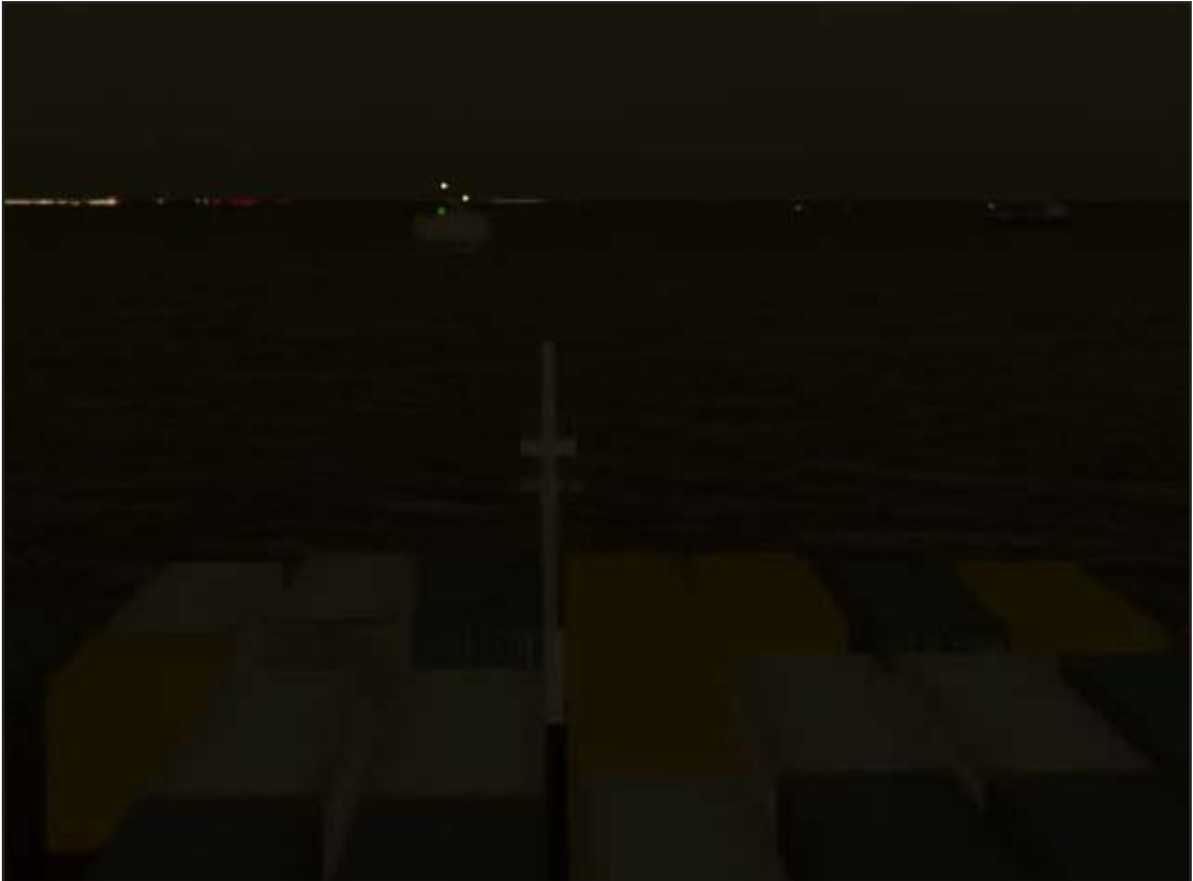
Figure 18: Simulated night-time view from *Primula Seaways* at 2038:25, *City of Rotterdam* is showing its two masthead lights and green sidelight

- When *Primula Seaways* started to reduce speed to 'half ahead' at 2038:25, *City of Rotterdam* was within 1nm (**Figure 18**). The car carrier's pilot had informed the ferry's master several times that he was manoeuvring to the south, yet there was no sign of the vessel doing so. From the simulations, it was evident that a course alteration to starboard would have caused the ferry to cross *City of Rotterdam*'s bow while an alteration to port would have exacerbated the close quarters situation that was developing if the car carrier did turn more to the south as the pilot had indicated.

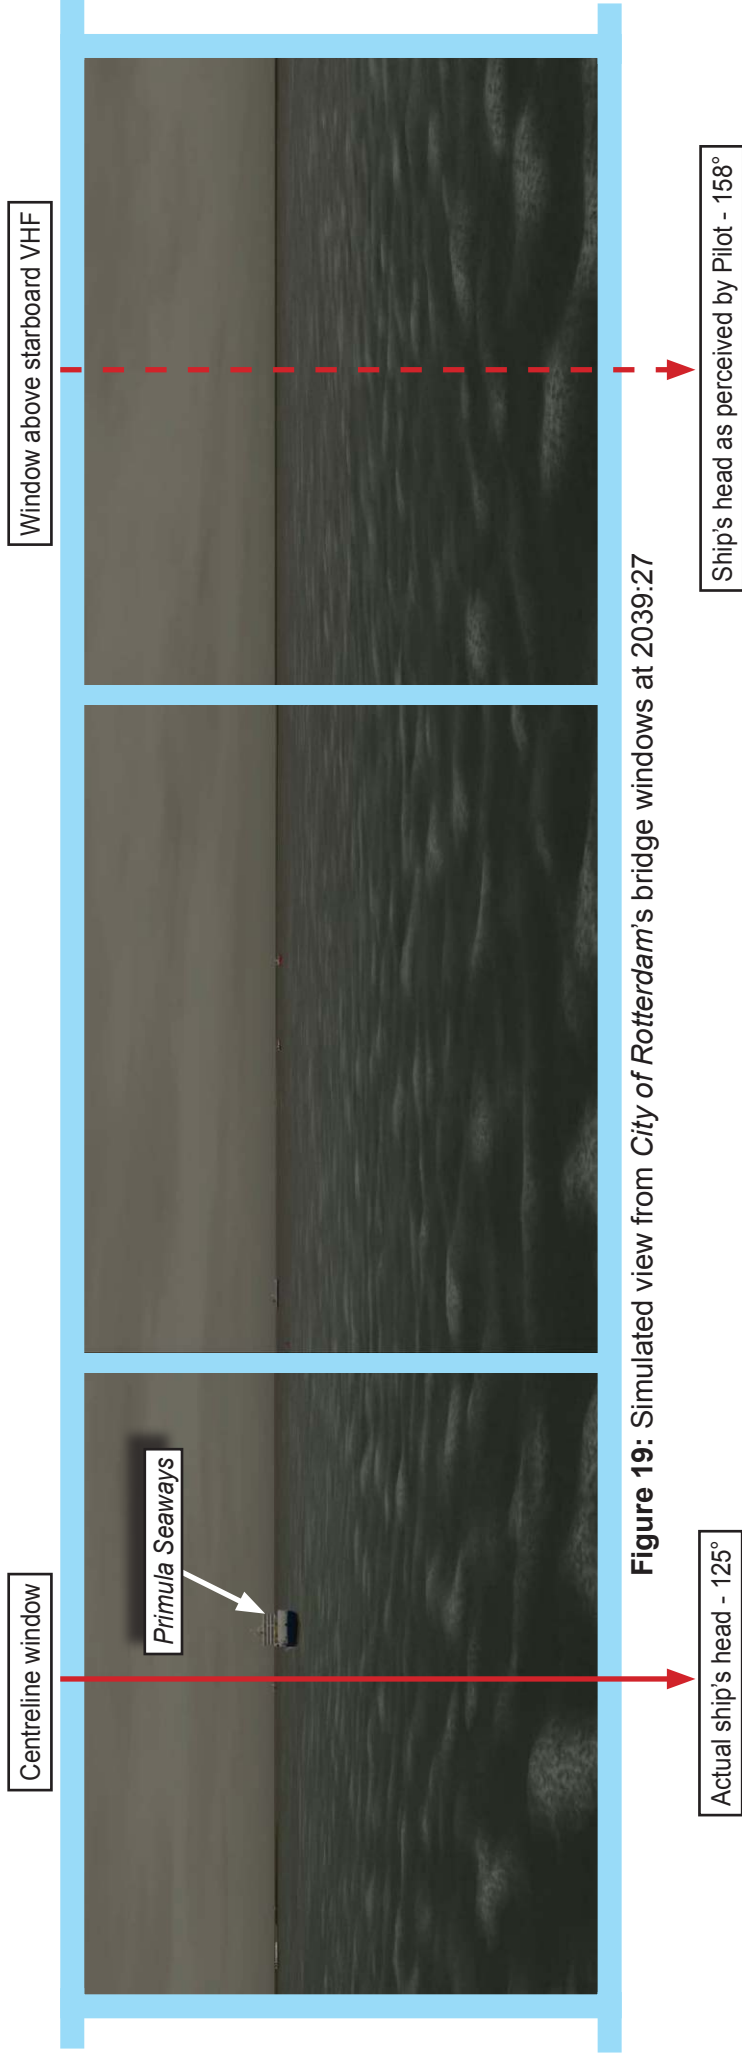
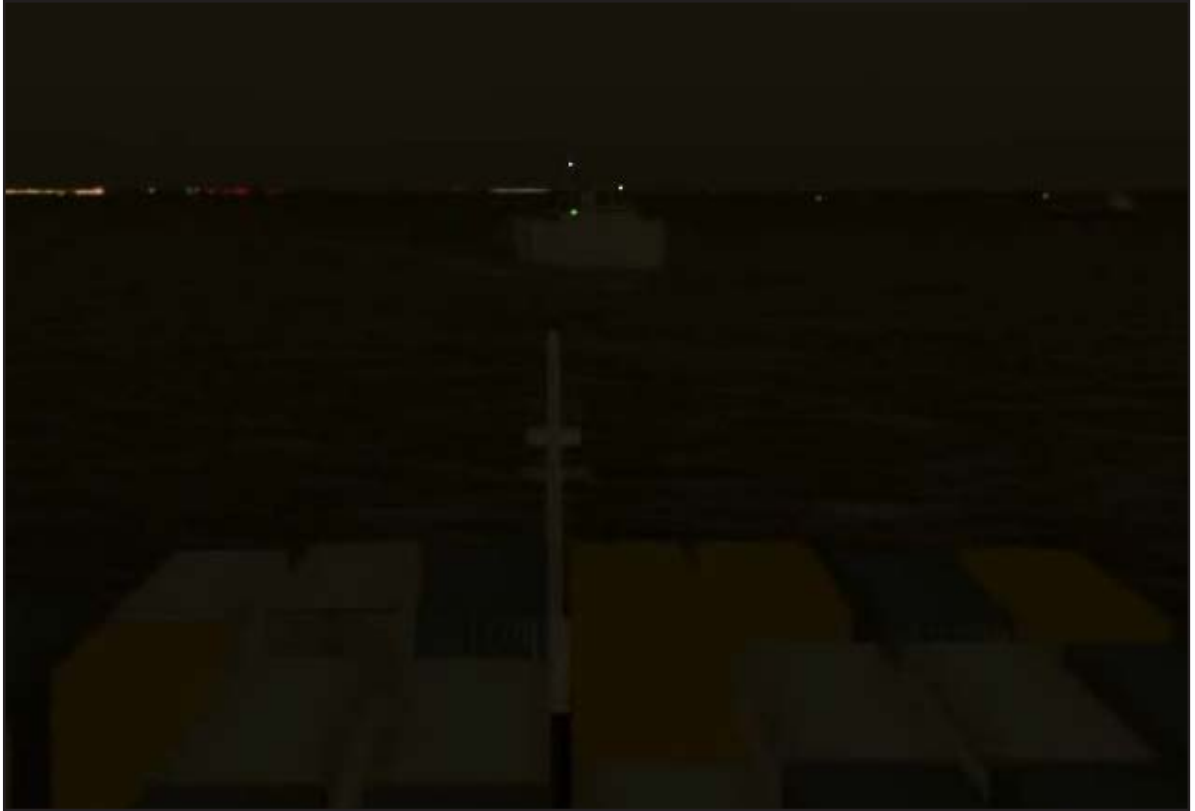
Figure 19: Simulated view from *City of Rotterdam's* bridge windows at 2039:27

Figures 19 and **20** show the respective simulated views from *City of Rotterdam* and *Primula Seaways* at 2039:27 when the ferry's engine was put to 'full astern' and full starboard helm was applied.

The simulations of the accident (paragraph 1.11) showed that, when the ferry's speed was reduced at 2038:25, a course alteration to starboard would have caused the ferry to cross *City of Rotterdam*'s bow while an alteration to port would have exacerbated the situation if the pilot manoeuvred the car carrier as stated (**Figures 8 and 18**). Doubt clearly existed and, as the vessels were only 1nm apart and closing at a speed of 28.5kts, a more substantial reduction in speed was warranted. By the time full starboard helm was applied and the engine was set to 'full astern' at 2039:37, the vessels' closing speed was still 26kts and they were only 0.5nm apart (**Figures 19 and 20**).
