Rail Accident Investigation Branch

Rail Accident Report

**Trains passed over washed out track at Baildon,
West Yorkshire
7 June 2016**

Report 03/2017
February 2017

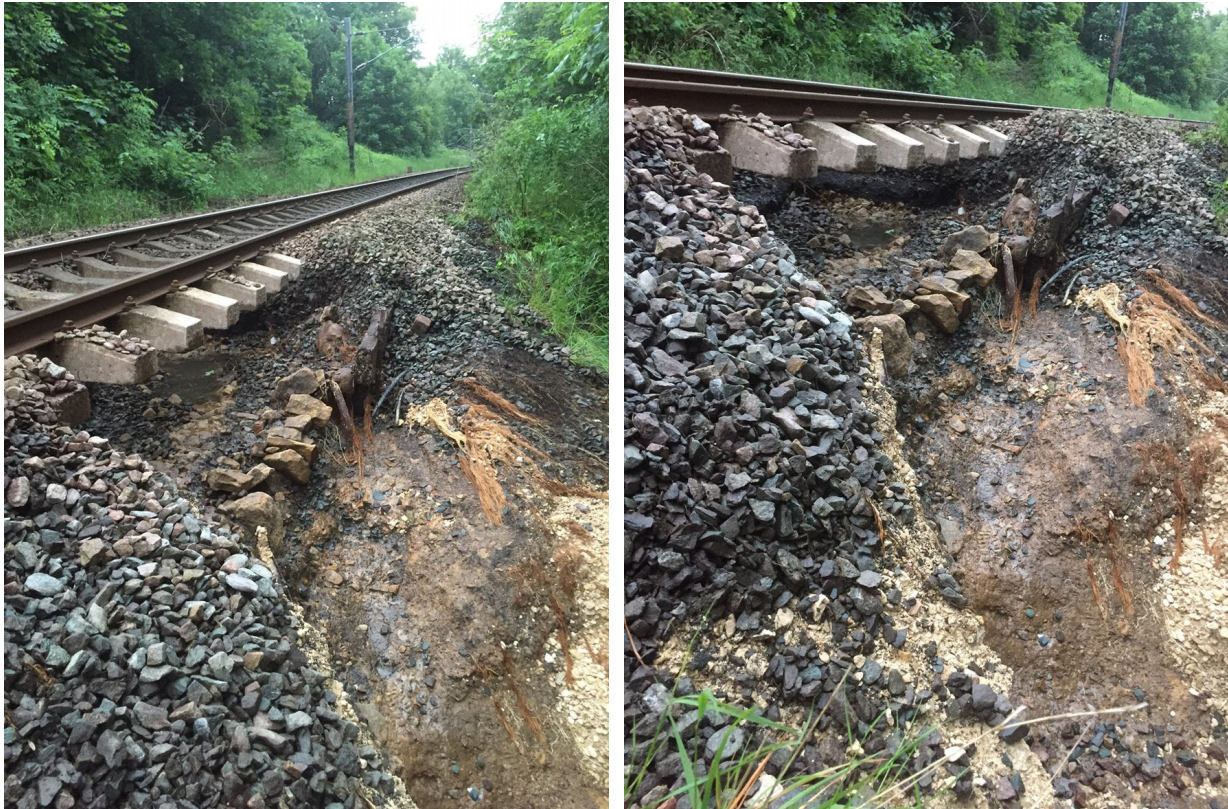
- 5 A member of Network Rail staff inspected the area that had been reported as flooded and concluded that it was safe to reopen the line. The washed out track, which was at a location 280 yards (250 metres) south of the inspected area, was not identified and the line was reopened. Another two passenger trains then passed over the washed out track. The driver of the second of these trains saw the damage as he approached it, applied the train's brakes and then reported that he had passed over it. The train was not derailed and nobody was injured, but the driver was badly shaken. The line was repaired and reopened to trains on 9 June 2016.

Figure 2: The washed out track and the embankment

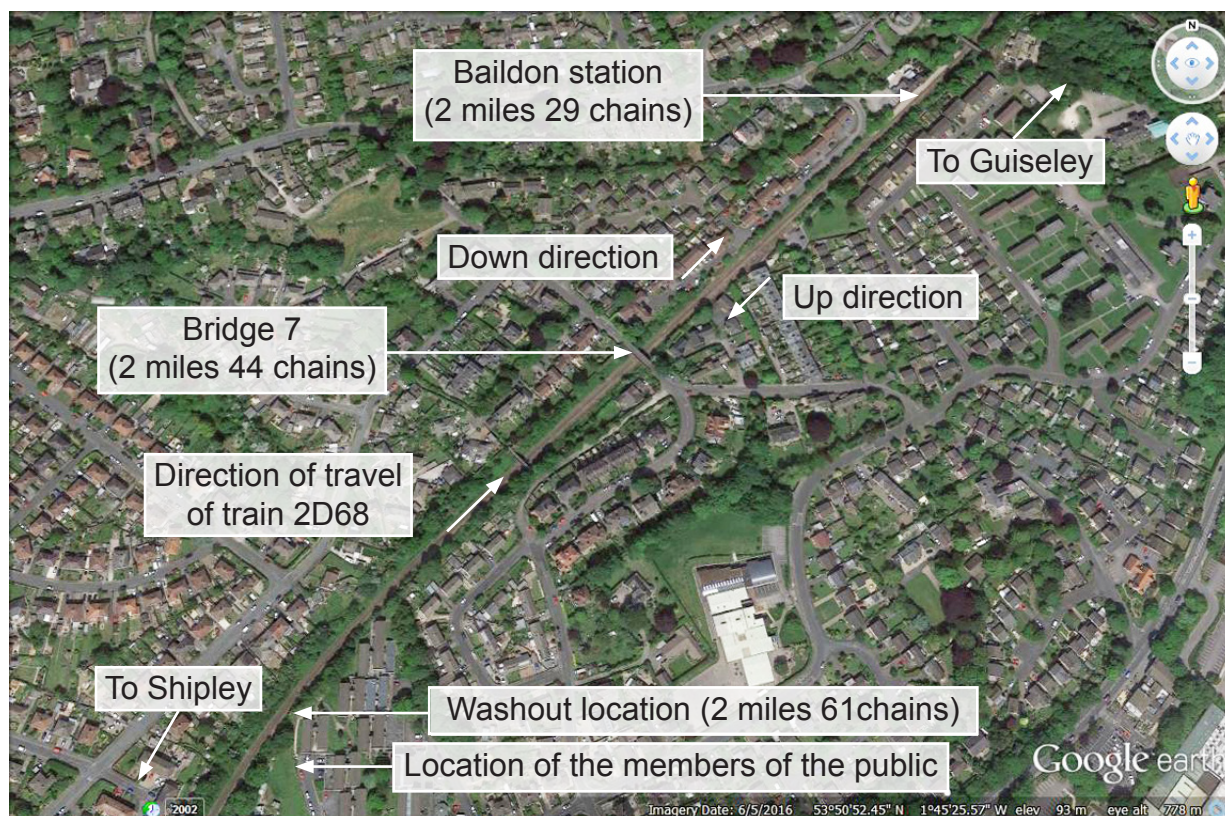
Figure 3: Location of the washed out track¹

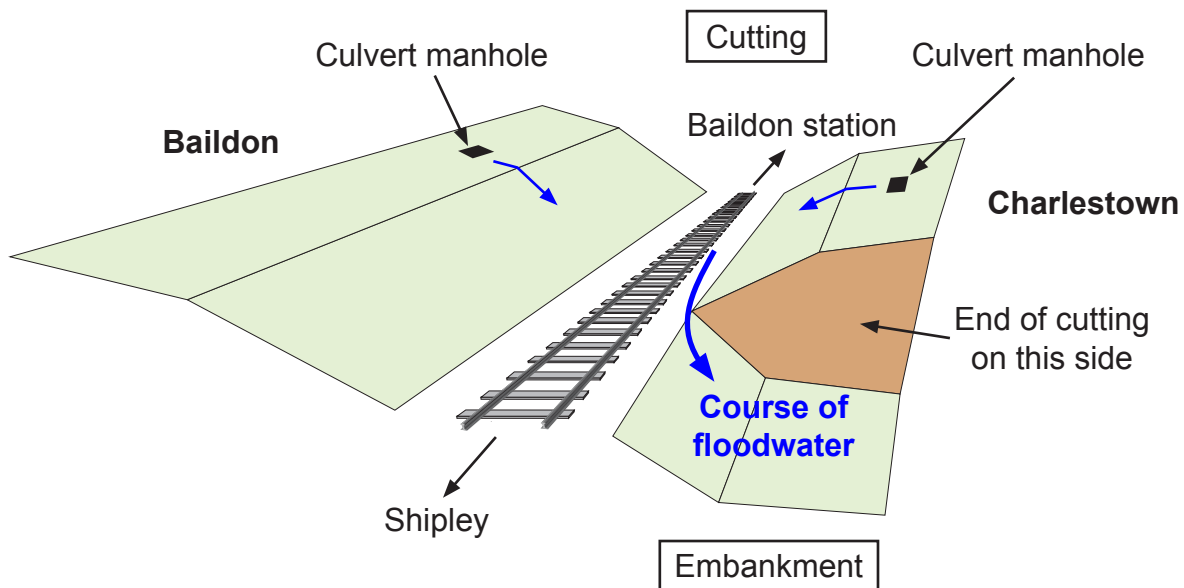
- 13 The section of affected track was constructed from rails mounted on concrete sleepers. These were supported by ballast on top of clay soil. This particular section is where a shallow cutting (running from Baildon station approximately 600 metres towards Shipley) ends and a single sided embankment begins (figure 4). The gradient of the line in the area of the washout was approximately 1 in 100 sloping down towards Shipley.
- 14 The signalling system on the single line is *track circuit block* with entry and exit signals at Dockfield Junction near Shipley and Esholt Junction near Guiseley. This is visible on the signaller's workstation as a single section 3.5 miles (5.6 km) long.

Figure 4: The cutting and the single sided embankment

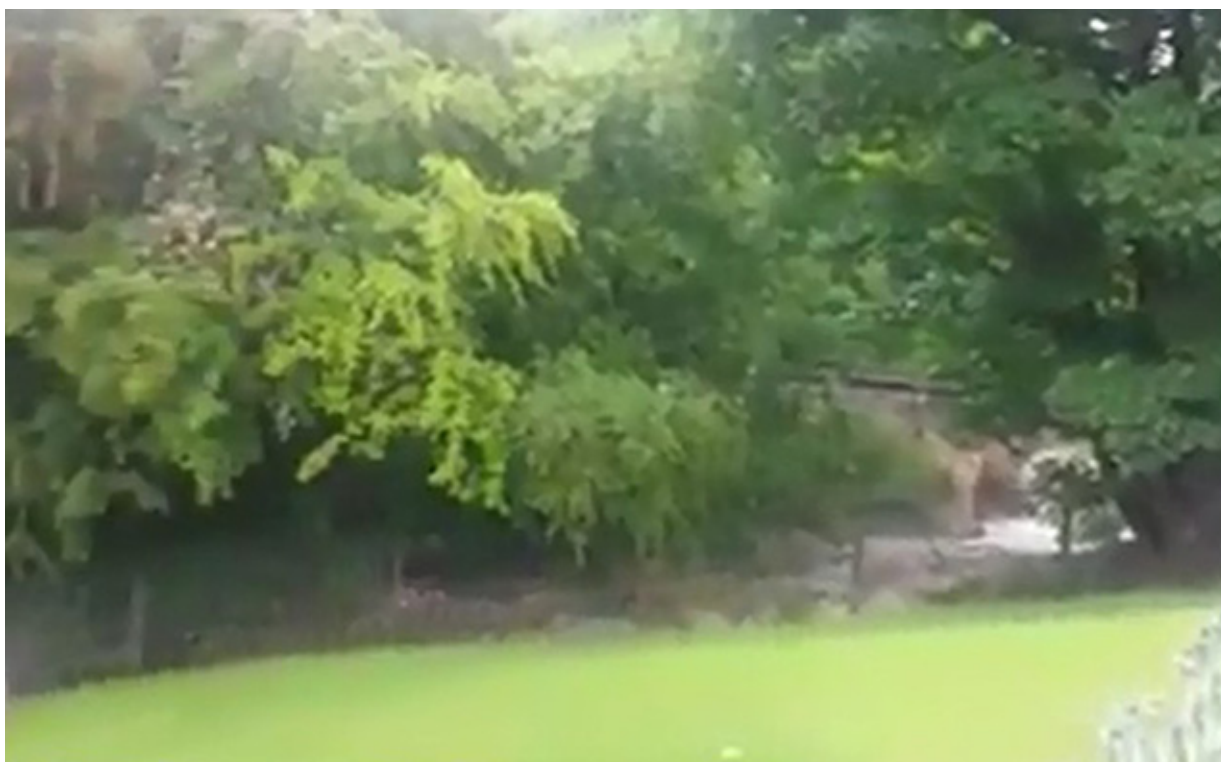
- 23 Between 16:00 and 16:30 hrs, several members of the public who lived close to the railway, about 600 metres south-west of Baildon railway station (in an area known as Charlestown), were observing flood water flowing down a railway embankment. It had been raining there between approximately 15:30 and 16:00 hrs, but at the time they were watching the flood water, and for the rest of the day, it remained dry. One of them captured video footage of the flood water on his mobile phone (figure 5).

Figure 5: Still image of the flood water and the washed out embankment taken from the video recorded by a member of the public

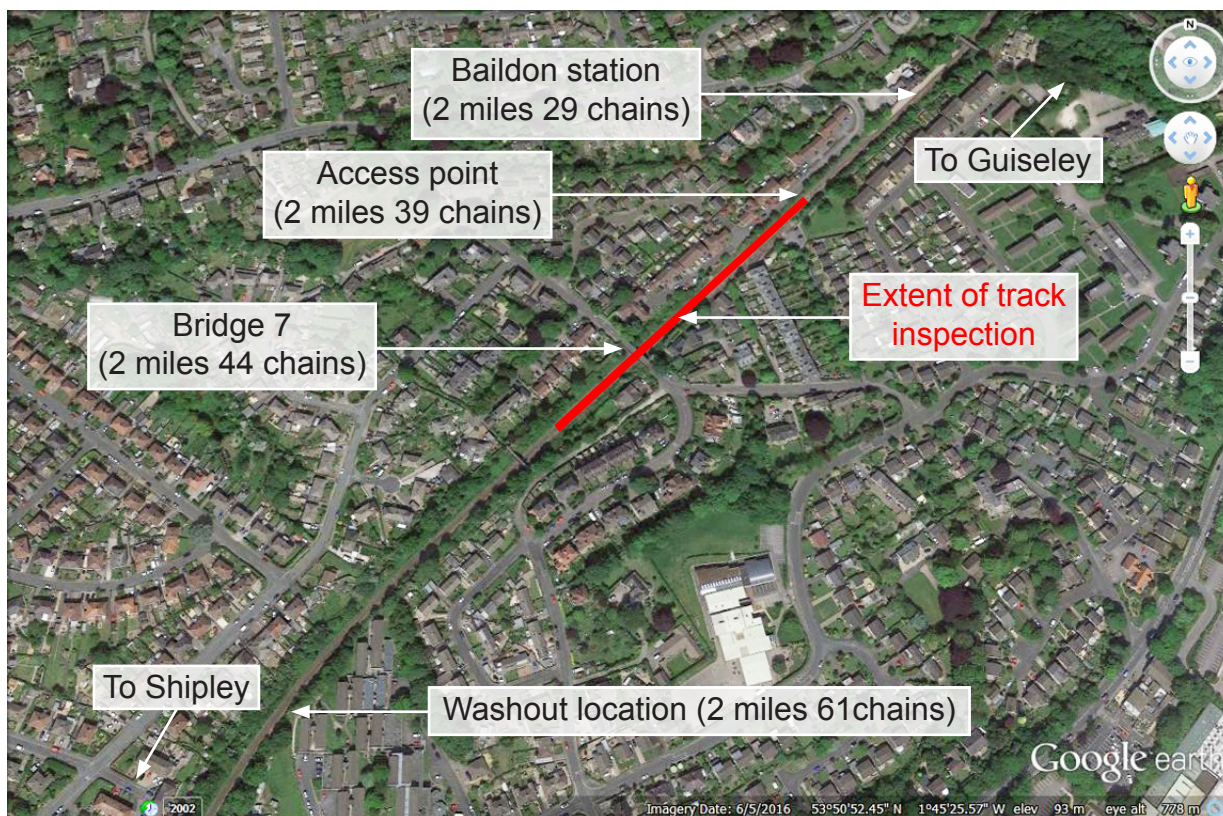
- 33 By 17:20 hrs the local track technician was on the track close to bridge 7 having accessed it via the access point near Baildon station. He reported to controller 2 that there was some water on the track but it was slow moving and below rail level. At 17:28 hrs, having walked 60 to 80 metres along the track beyond bridge 7 in a south-westerly direction (figure 6), he reported to controller 2 and the signaller that there was some water in both cesses and some in the *four foot*. He also reported that there was no sign of ballast disturbance and it was safe to reopen to trains at the maximum permissible speed of the line.

Figure 6: The location of the track that was inspected for flooding by the track technician²

- 71 The track technician was told that the flooding was the Shipley side of bridge 7 (paragraph 30). Although he walked to the south of bridge 7 and reported that there was water to the sides of the track (paragraph 33), the examination ended 280 yards (250 metres) north of the washed out embankment, so the damage was not identified.

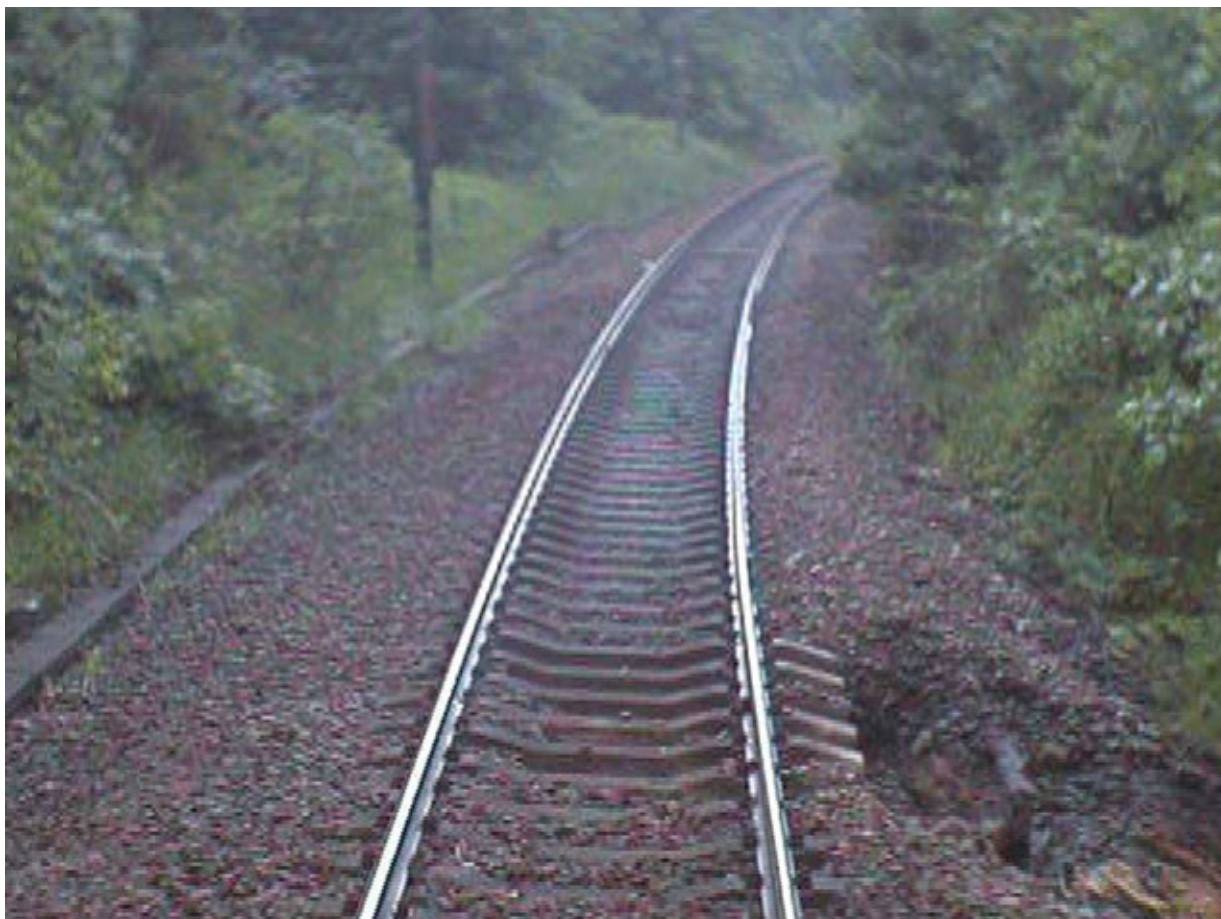
- 34 At 17:30 hrs the signaller reopened the line to traffic. The next train over the single line was train 2D72 which passed over the section of damaged track at 17:45 hrs. This train was travelling from Shipley towards Baildon in a north-easterly direction. Images taken from the forward facing closed-circuit television (FFCCTV) on this train clearly show that ballast was missing from the right-hand side of the track in the direction of travel (figure 7). However, the driver, who had been made aware of the previous flooding report by the signaller, did not see the washed out track. This was probably because, relative to the FFCCTV camera, he was further back and to the left-hand side of the cab. There was a structural pillar in the centre of the cab windscreen and foliage in front of the washed out section on the approach to the site along a right-hand curve, making visibility of the embankment difficult for drivers of trains travelling in the down direction³. Also the driver has stated that as he came around the curve he was concentrating on his approach to Baildon station which was his next station stop.

Figure 7: Still image of the track damage taken from the forward facing CCTV footage from train 2D72 (image courtesy of Northern Rail)

- 62 Images from the CCTV footage from the two trains which travelled over the damaged section at 17:45 hrs and 17:59 hrs following the reopening of the line (paragraph 34), show that the track had been washed out.

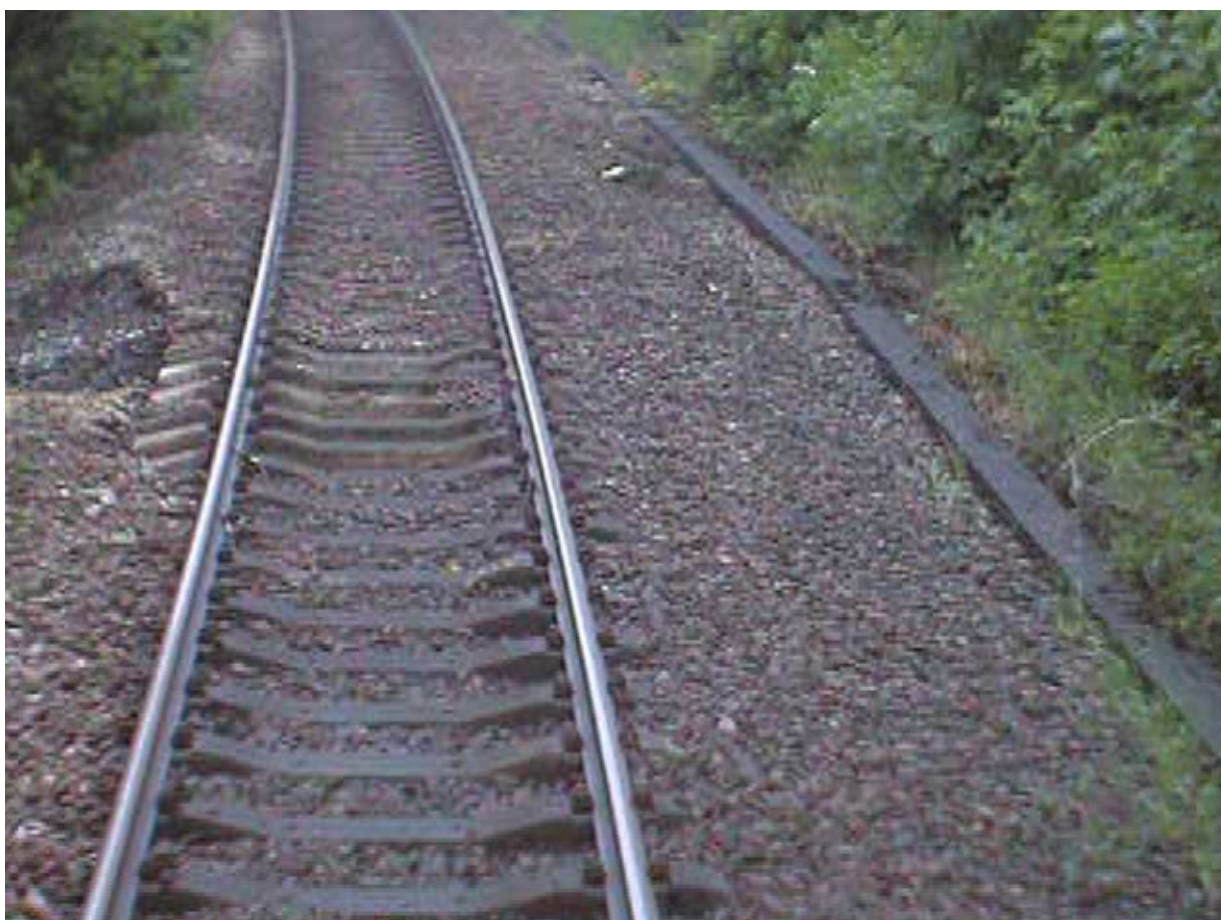
- 39 At 17:59 hrs, having departed Baildon station, the driver of train 2D73 saw the damaged track as he came around the left-hand curve of the track (figure 8). The train was travelling at approximately 38 mph (62 km/h) when it passed over the washed out section and the driver applied the brakes on the train and stopped at the next signal. He then contacted the signaller to report that he had just passed over a section of washed out track.

Figure 8: Still image of the track damage taken from the forward facing CCTV footage from train 2D73 (image courtesy of Northern Rail)

- 40 The signaller blocked the line a second time. The track technician and a track section manager (TSM) attended the site and noted that there were six unsupported sleepers with their ends hanging up to 1.25 metres above the washed out ground.

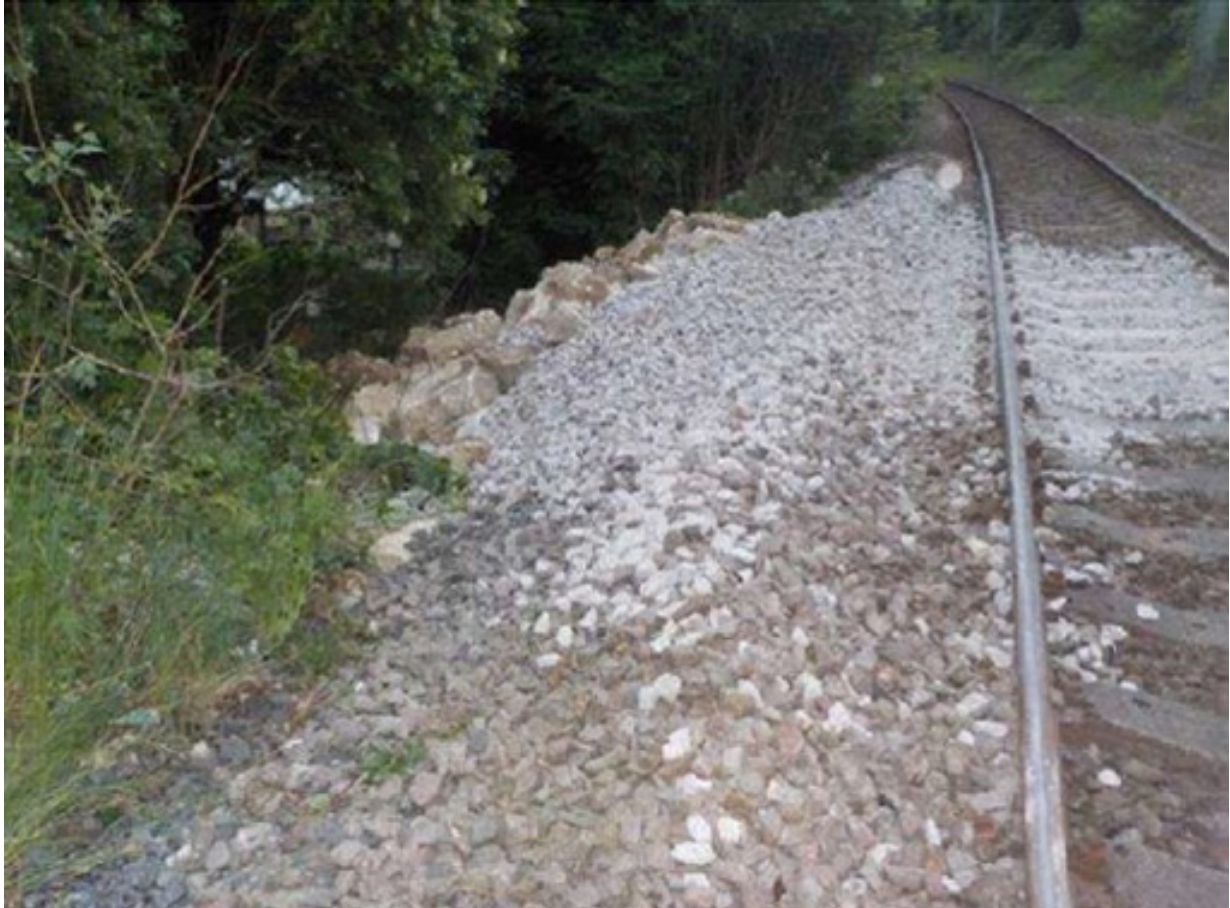
Figure 9: The rebuilt embankment following its repair

- 41 Following repairs to the embankment, the line was reopened to trains with a 20 mph (32 km/h) speed restriction at 23:45 hrs the following day. This included adding large boulders, weighing approximately 1 tonne each, to re-establish the embankment (figure 9). This section of track was opened at its maximum permissible speed at 07:07 hrs on 12 June 2016.

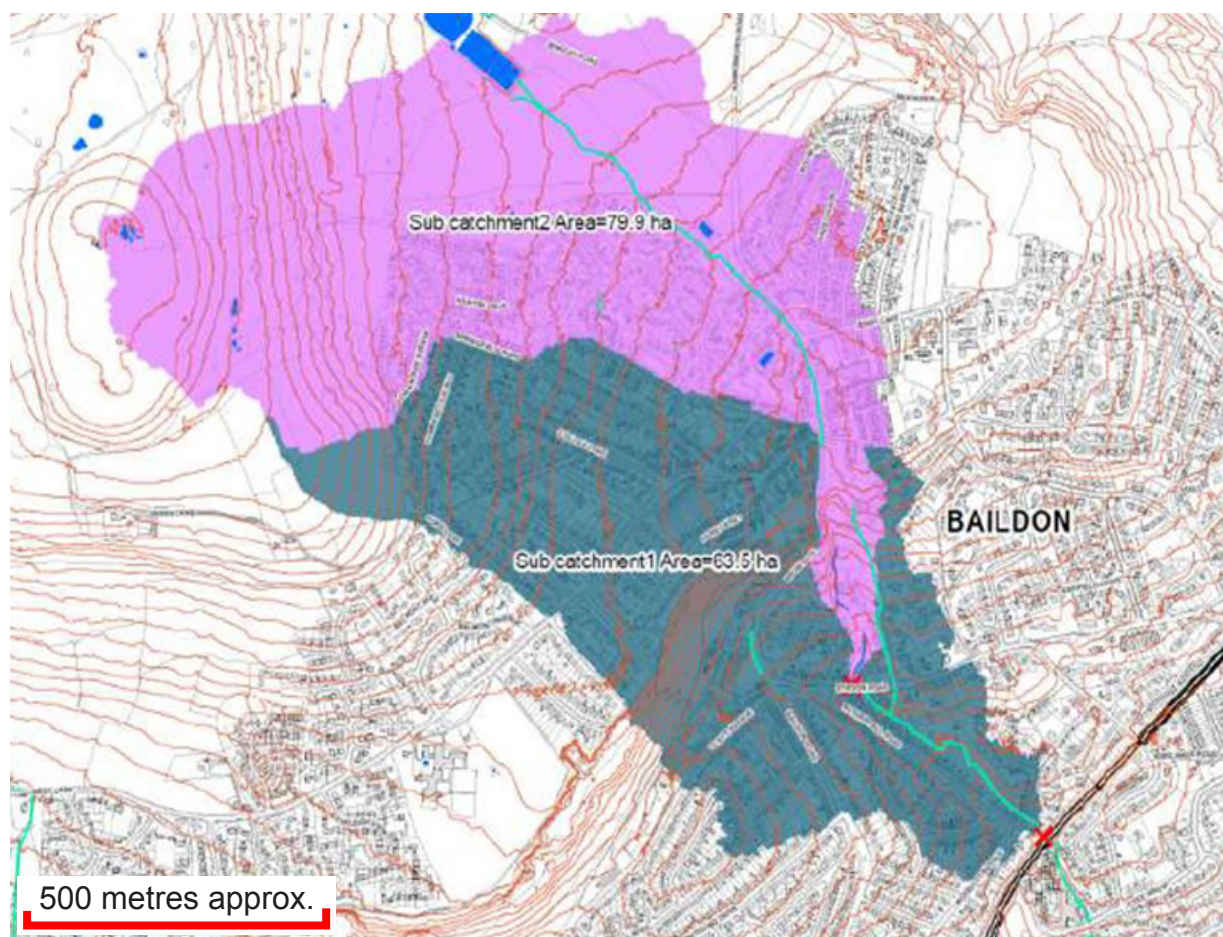
48 Figure 10 shows the Baildon rainfall catchment areas. A natural watercourse, known as the Barnsley Beck, is shown in blue. It runs from a former reservoir to the north-west of Baildon, under the town and to the south-east where it crosses under the railway line through a culvert known to the railway as structure GUE2/5. The difference in height between the land on the north-western edges of the catchment area and the culvert is around 180 metres.

Figure 10: The Baidon rainfall catchment areas (courtesy of Bradford Metropolitan District Council)

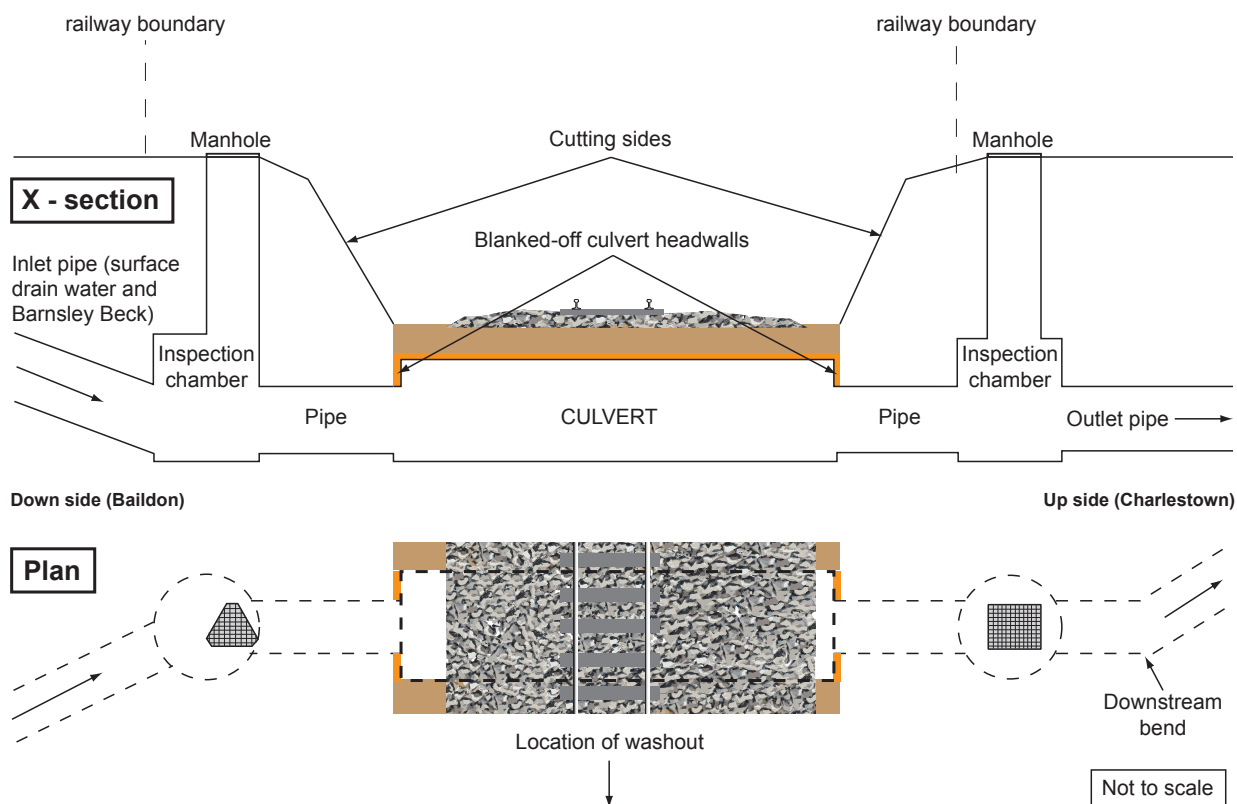
- 49 The culvert, which allows the railway to pass over the beck, was built when the railway was constructed in the 1870s. It consists of a brick barrel arch, which is approximately 1.1 metres high by 1.8 metres wide and passes under the railway approximately 100 metres north of the washed out embankment. Old maps of Baidon indicate that until the mid-1960s, sections of the beck were open and visible on both sides of the railway.

- 50 In 1966 an agreement was made between the British Railways Board and the then Baidon Urban District Council to connect drain pipes to the culvert. Inspection chambers were added at both ends of the culvert and then connected to it at its *headwalls* (figure 11). Records indicate that both the inlet and outlet, to and from the chambers, consist of circular concrete pipes with internal diameters of 36 inches (915 mm). The bore of these pipes reduced the overall cross sectional area of the drainage system, which affects the quantity of water that can be carried, to approximately one-third of that of the original culvert. It is also known that there is a change in direction of the downstream outlet which would tend to further restrict the flow.

Figure 11: The culvert and its connections to the drainage system

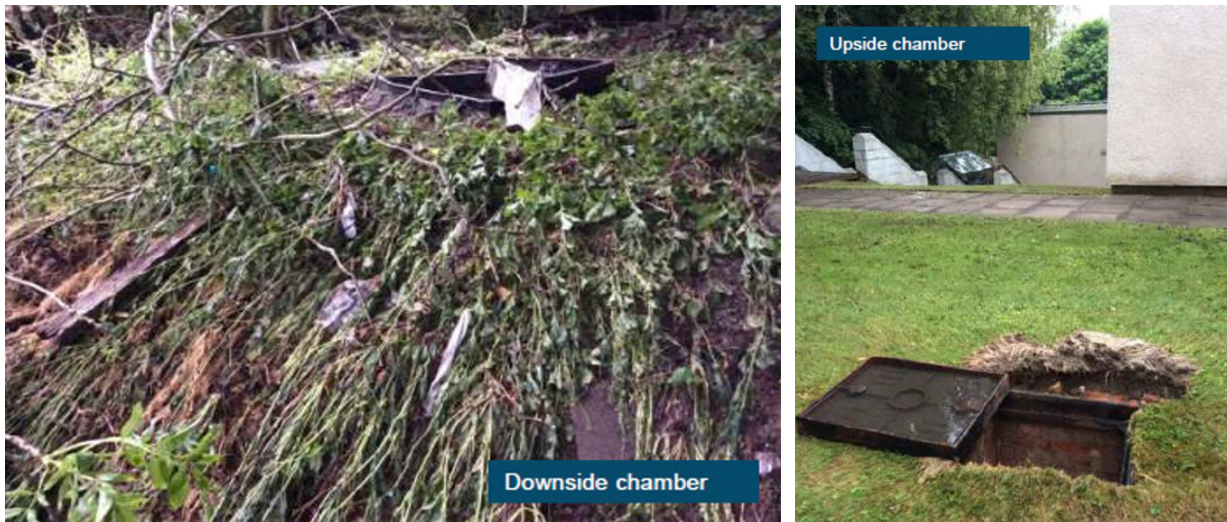
- 52 The track flooding in this incident was caused by water overflowing from the inspection chambers either side of the railway at each end of the culvert. This is supported by the evidence of the lifted manhole covers (figure 12). The water then flowed down the sides of the cutting and onto the track. This occurred because the drain system was unable to cope with the quantity of water that entered it during this flash flooding event.

Figure 12: The lifted manhole covers of the drain's inspection chambers

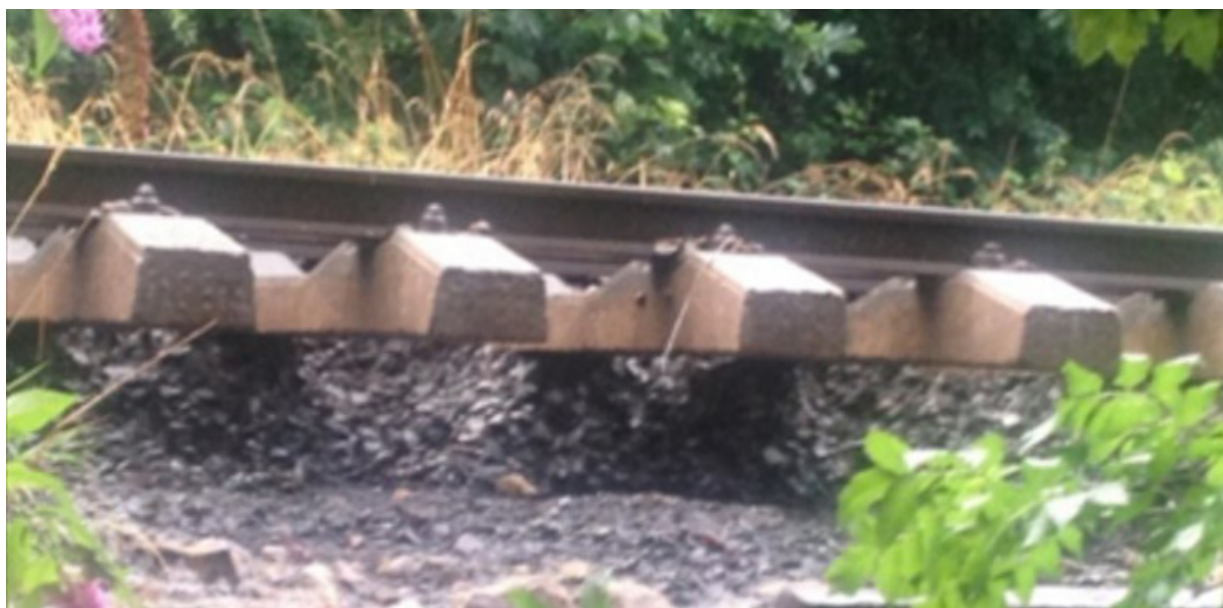
- 59 Following the washout of the track at the same location in 2012, the line was closed for about a day while repairs were made to the embankment (figure 13). The repairs following the washout in 2012 consisted of digging out the clay around the embankment and reinstating it with ballast. Network Rail has stated that it considered the repair to be a temporary solution to reinstate railway services, until a more permanent solution was found.
- 60 In addition to the two recommendations (paragraphs 54 and 58) Network Rail has stated that it was considering reconstructing the embankment at the site of the washout so that it could withstand the flow of flood water. This too was not progressed (paragraph 89).

Figure 13: The unsupported track section following the washout in 2012
