Charter train derailment near Southampton Eastern Docks, 5 November 2016

2. Summary of the accident

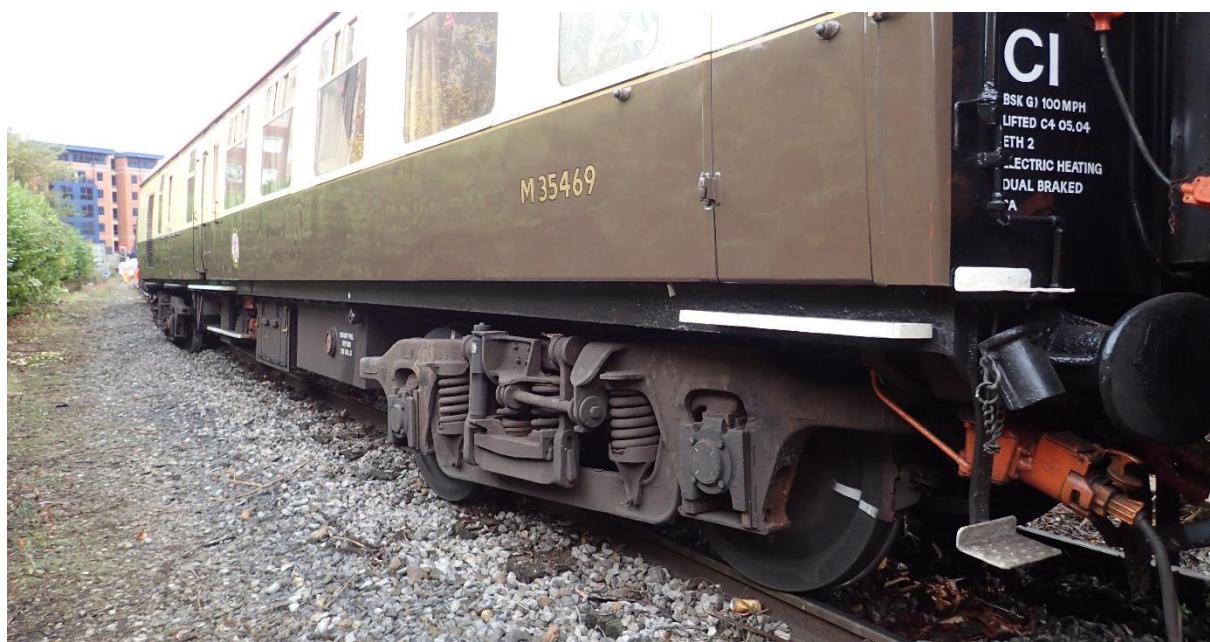
Leading coach derailed by three axles

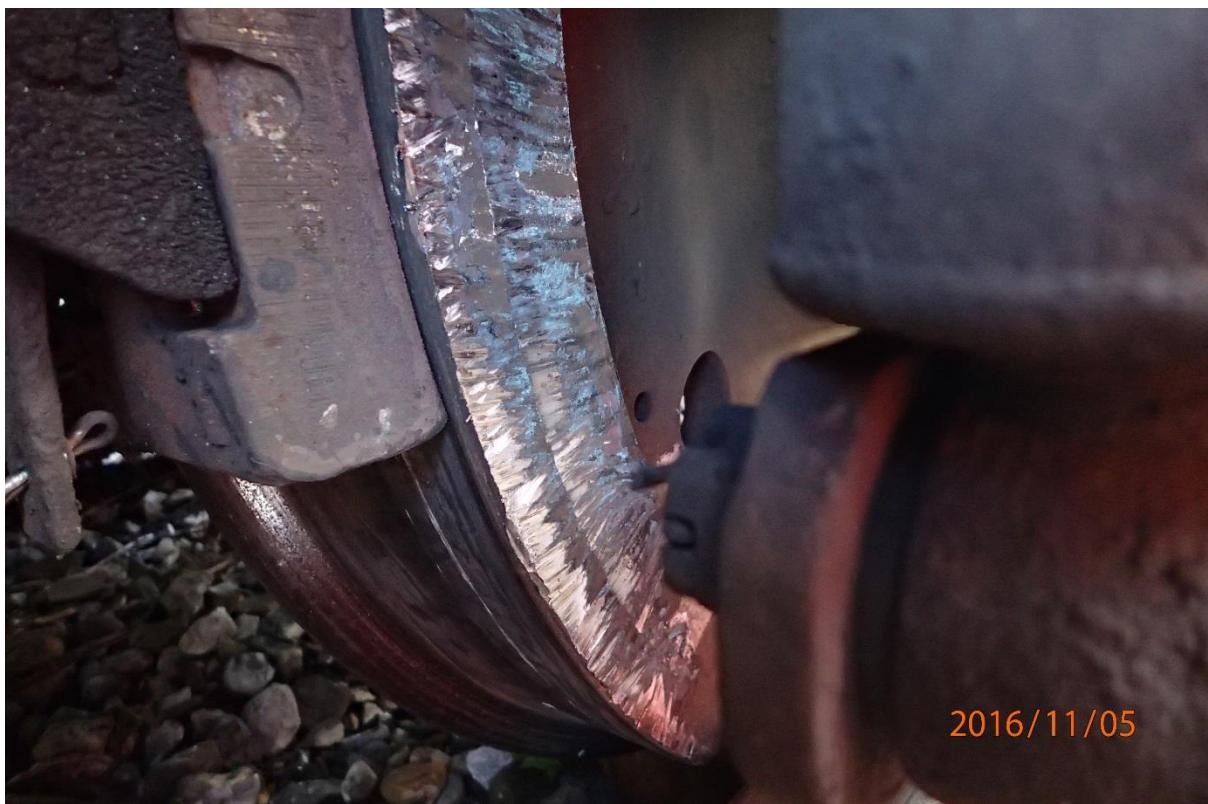
The train derailed on track which was wide to gauge (the RAIB measured the gauge at up to 51 mm wider than the nominal standard gauge of 1435 mm on site under loaded conditions). The derailed wheels dropped between the rails, and as the train moved forward, the gauge narrowed, forcing the left-hand wheels (in the direction of travel) up and over the left-hand rail. There was significant bruising on the outside (field) face of the right-hand wheels, showing that they had run pressed hard up against the rail for some distance. Many of the sleepers were badly damaged in the derailment, but several sleepers appeared to have been defective and the rail fastenings were worn.

Significant bruising on the field face of the right-hand derailed wheels
