AAIB Bulletin

4/2017

Published 13 April 2017

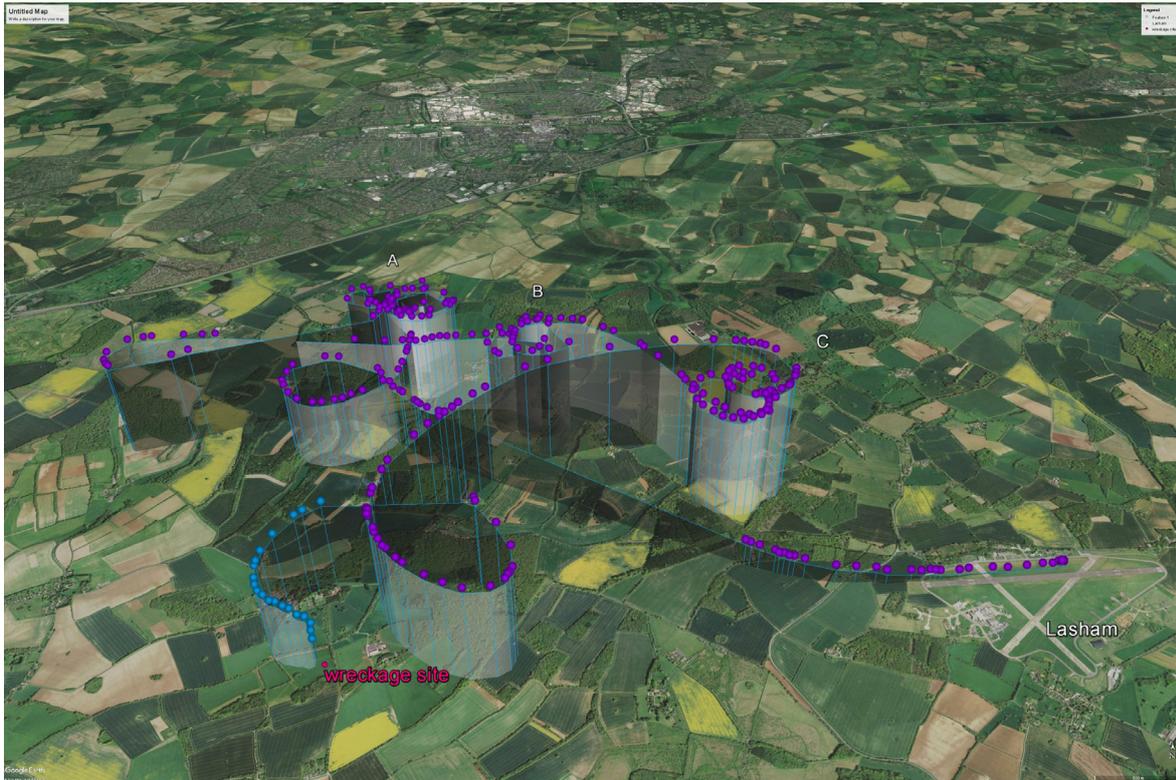
Figure 1

Flight track of G-VLCC with area of climbing marked at A, B & C and the last 35 seconds of recordings in light blue (Figure 3). The distribution of points varies as not all of the FLARM broadcasts were detected by the ground-receiver

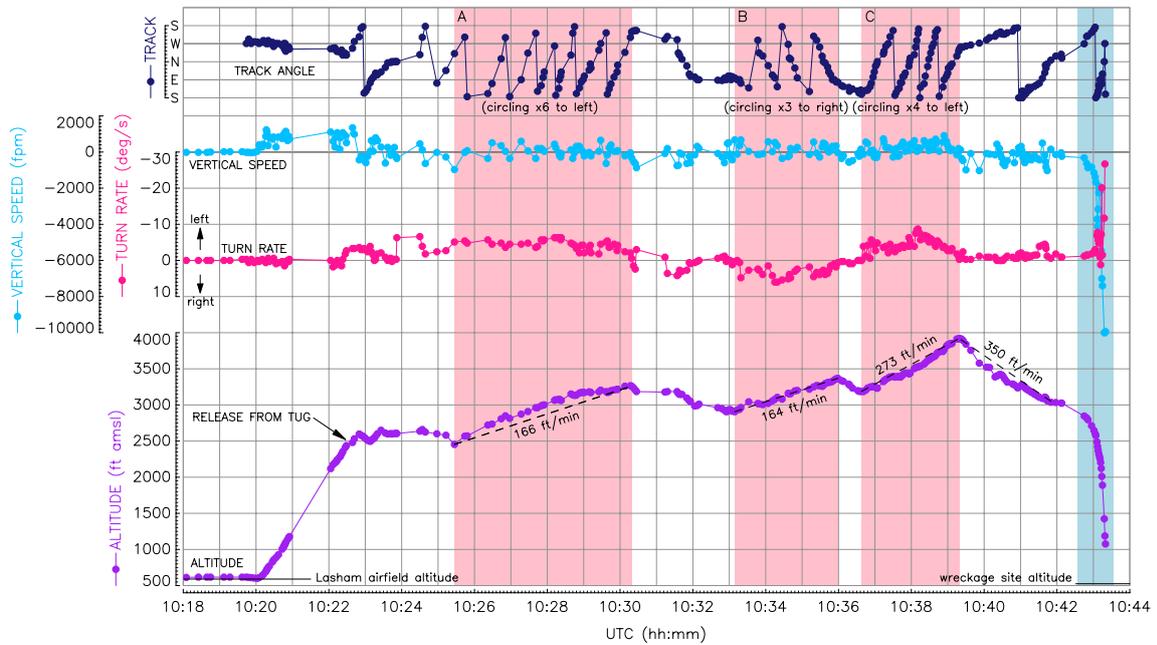
Figure 2

FLARM flight data with the last 35 seconds of recordings highlighted in light blue (Figure 3) – the highlighted areas in pink indicate when G-VLCC was climbing

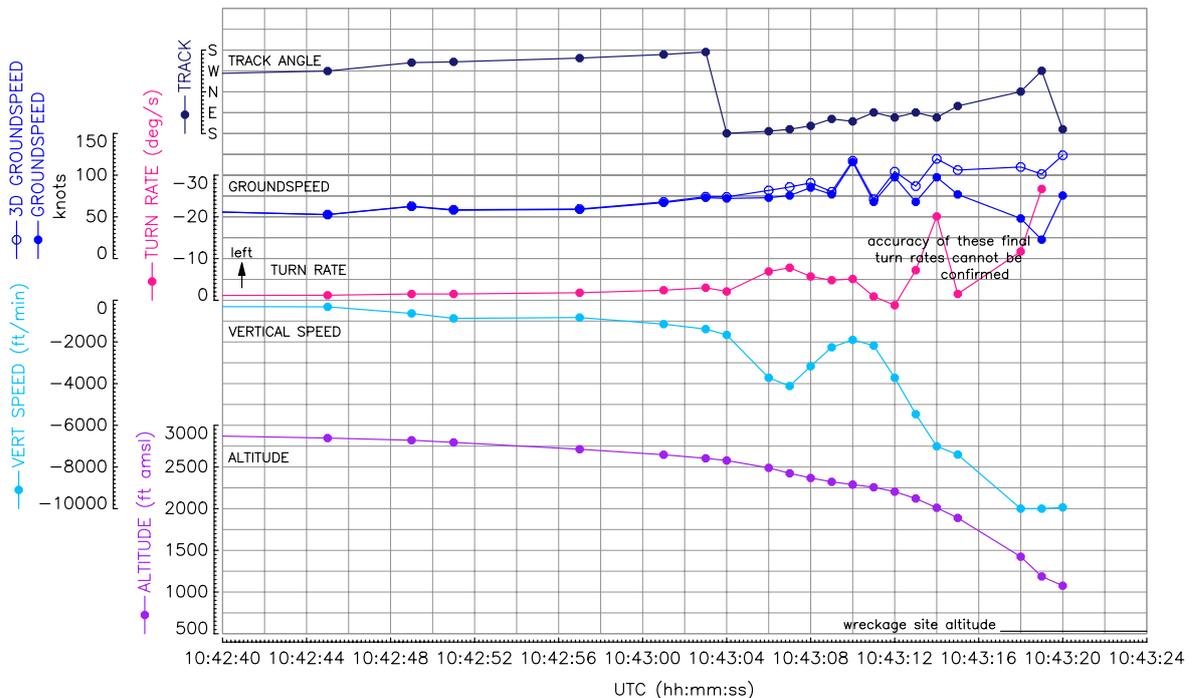
Figure 3 shows the FLARM flight data once contact was regained, with G-VLCC at 2,850 ft on a south-westerly track, gently descending and turning, through to the end of the recording 35 seconds later. Groundspeed (calculated from distance travelled and time taken between points) is also presented, together with a parameter labelled '3D' groundspeed that incorporates the component of vertical speed.

FLARM flight data – last 35 seconds of recordings

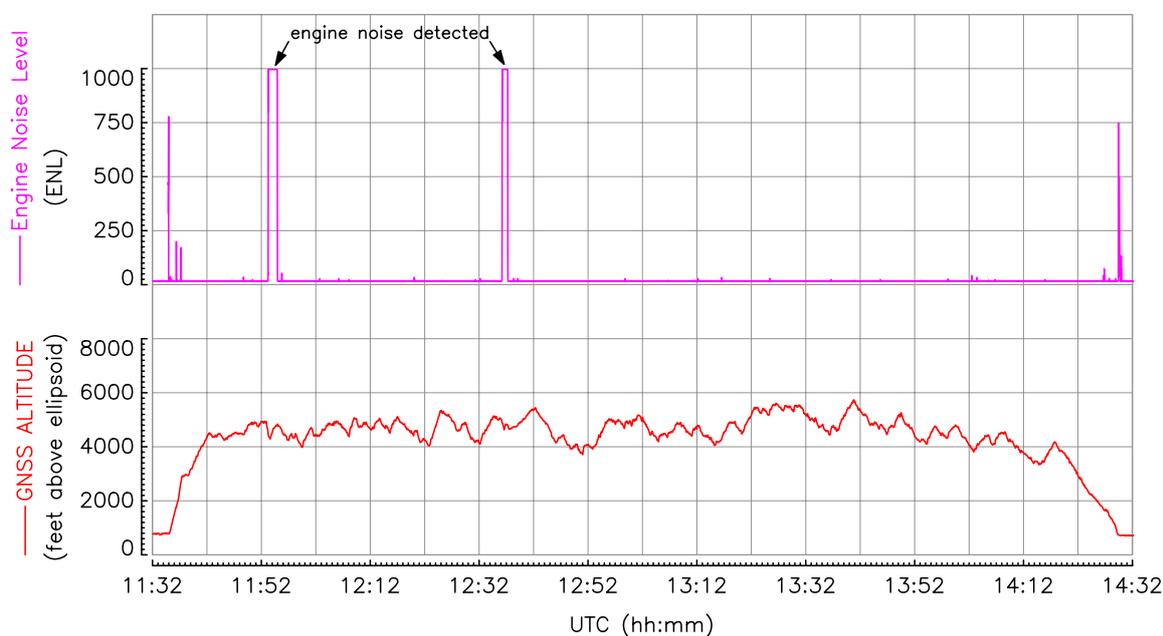
Figure 4

Data from flight on 11 April 2015 showing when noise from the engine may have been detected

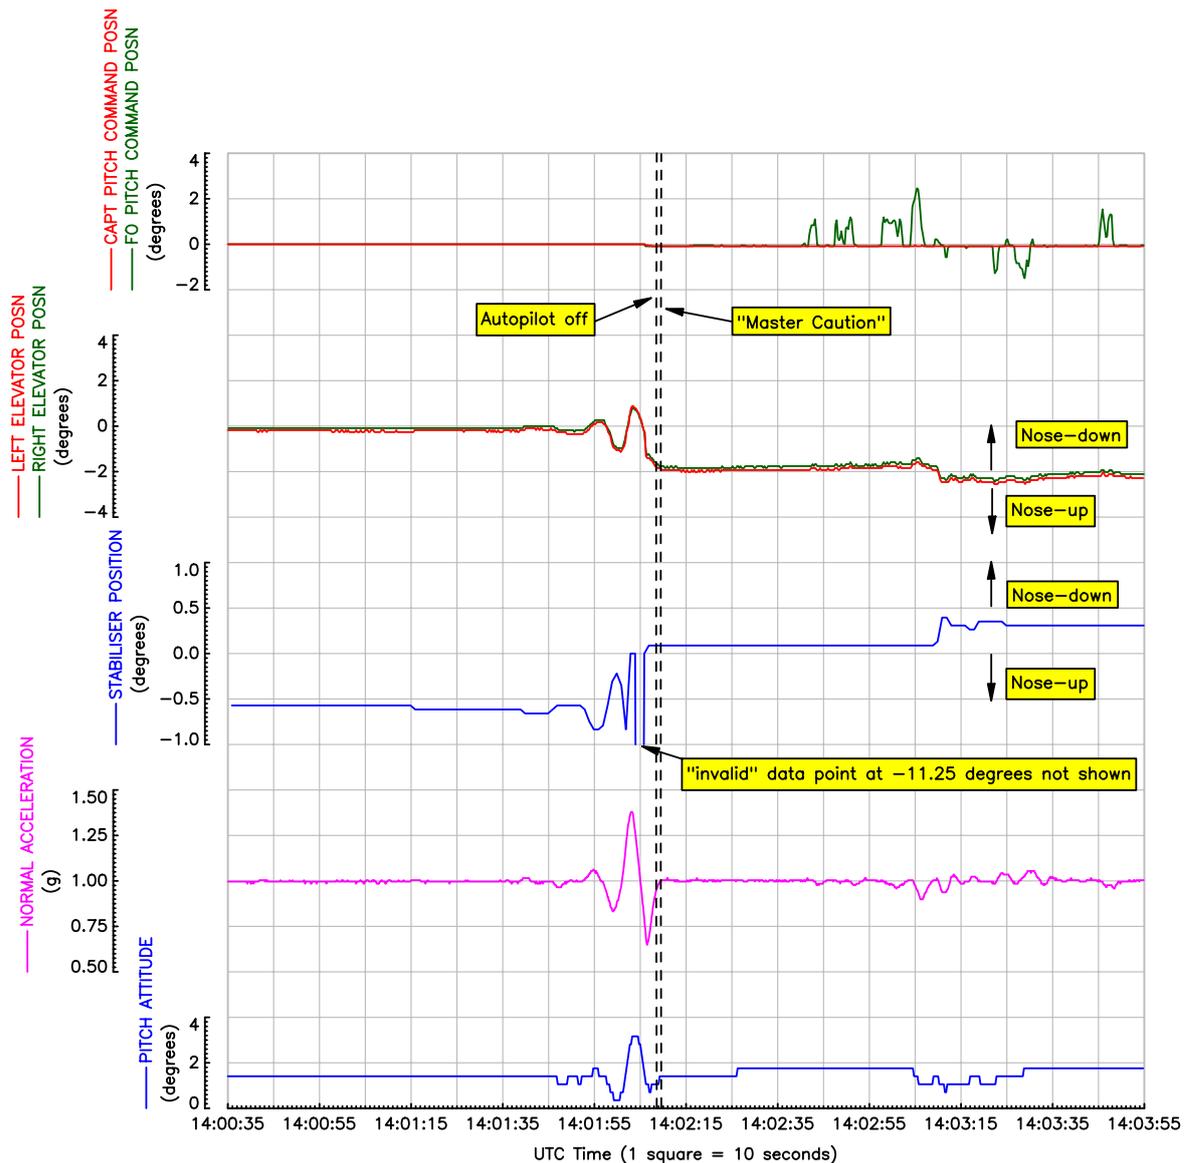
Figure 1

Salient FDR parameters at the time of the stabiliser malfunction

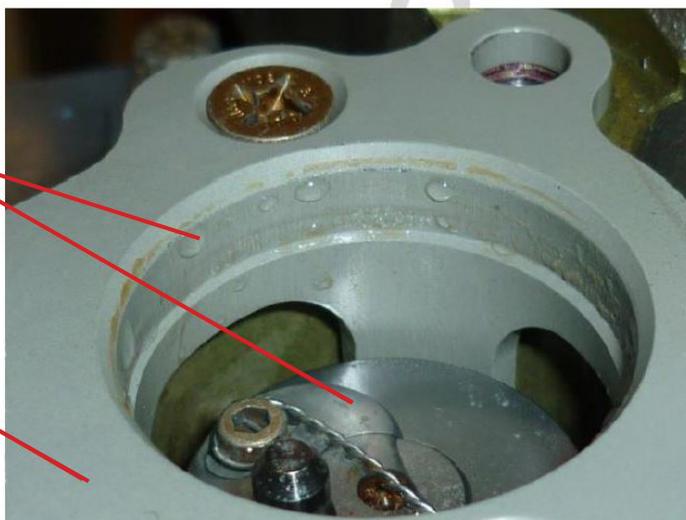
Figure 2

Water inside mini reduction gear liner/cavity

When the operator received confirmation from the THSA manufacturer that water ingress was the probable cause, the operator performed a detailed inspection of the area in which the THSA was installed on the incident aircraft. No signs of water, moisture or signs of previous wetting were identified in or around the area in which the THSA was fitted.

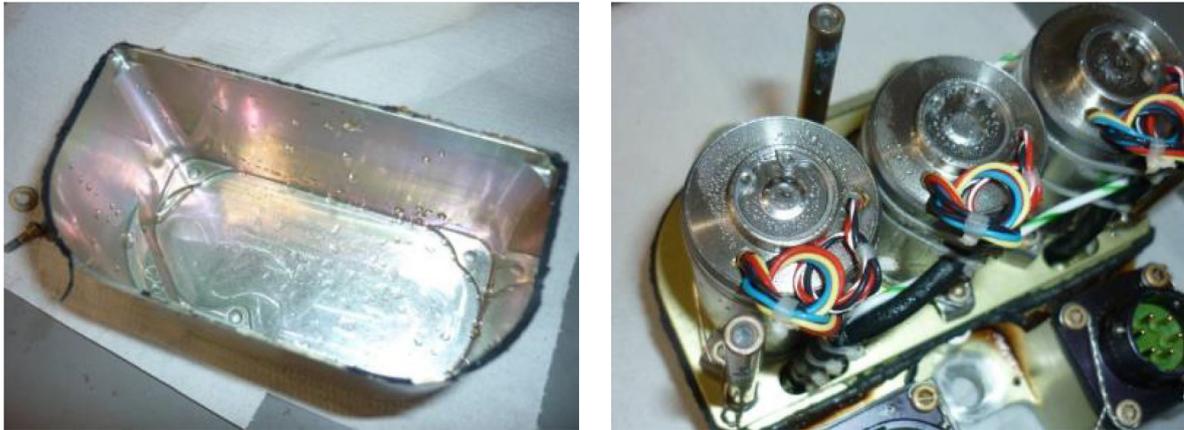
Figure 3

As a precaution, the COM transducer was removed from a similar age aircraft in the fleet and sent to the component manufacturer for analysis. The analysis included a pressure leak check of the case, electrical tests and visual inspections. None of these tests identified any issues with the sample unit and no signs of water were identified within the unit during inspection.

Water inside THSA COM transducer, cover (left) and internal RVDTs (right)

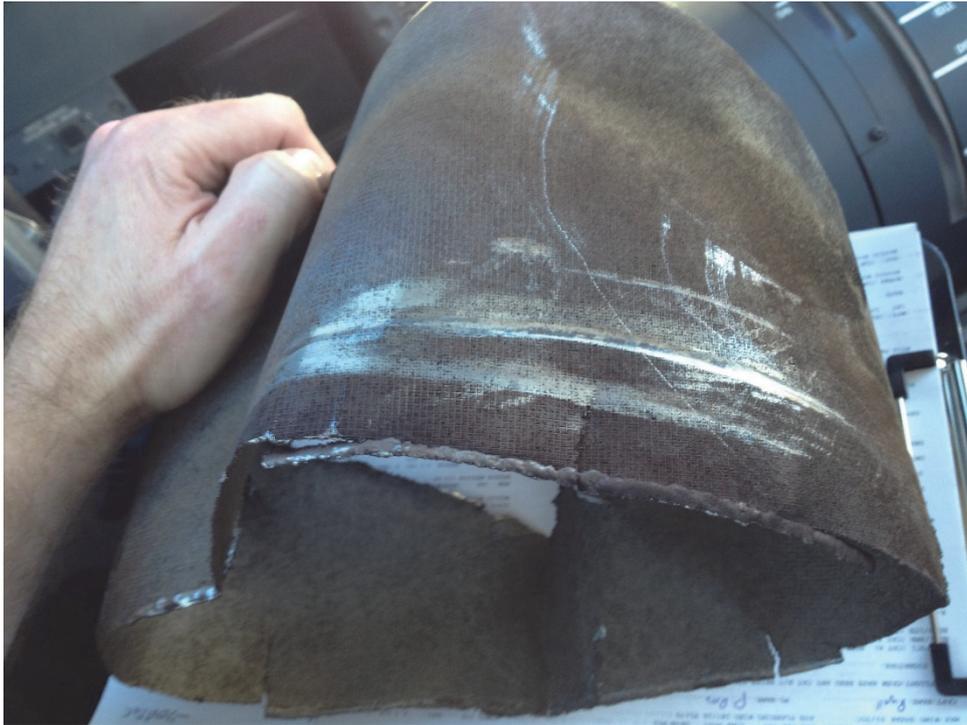
Figure 1

Debris item photographed by crew after discovery

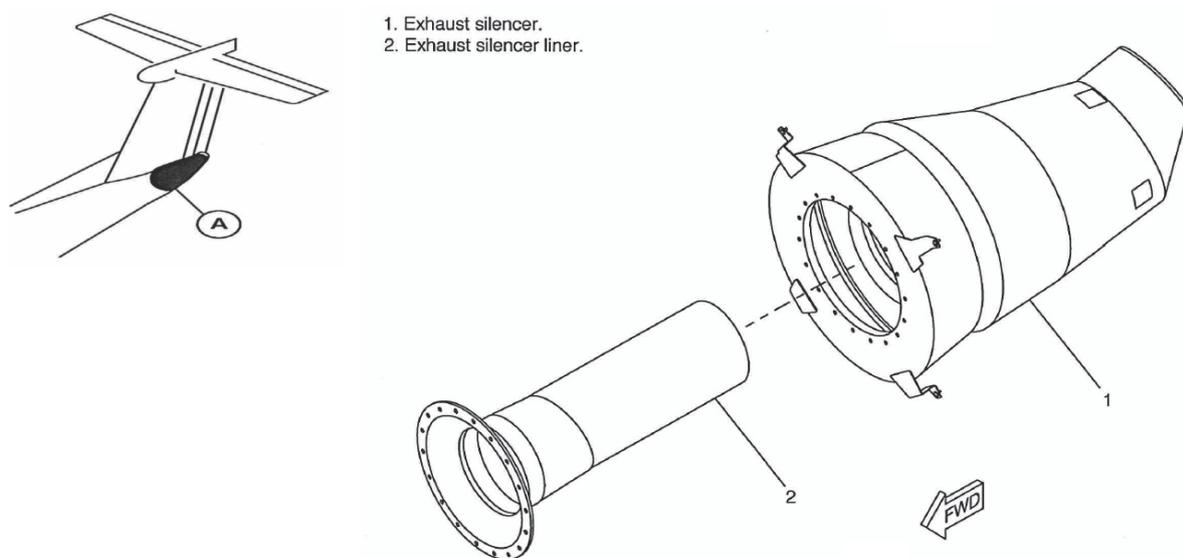
Figure 2

The APU is located within a bay in the tail cone on this aircraft type. An exhaust duct, fabricated from titanium, is installed within the aft section of the tail cone. Within this is a duct liner made from a fibre-metal acoustic material; it is elliptical in section, supported on frames within the duct and bolted to it at its forward end (Figure 2).

APU exhaust duct and liner

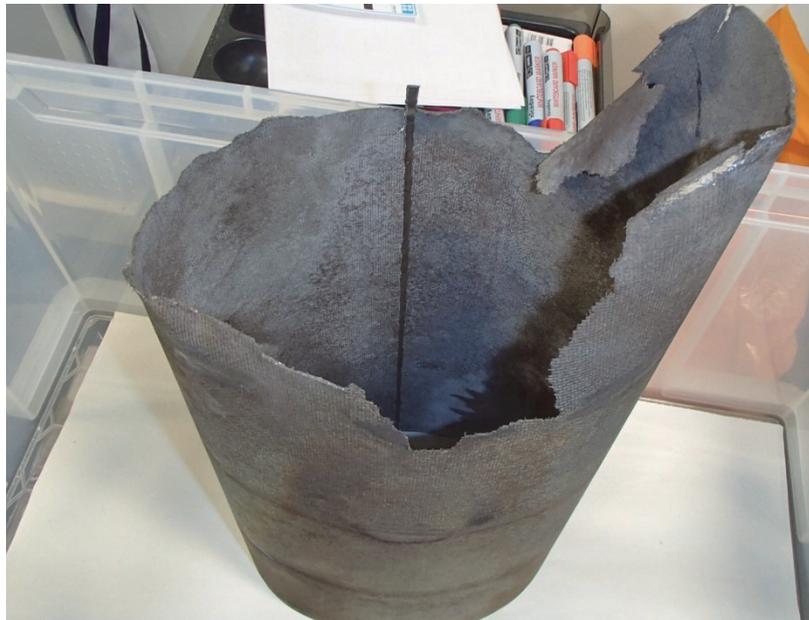
Figure 3

It was apparent that the front half of the liner had partially disintegrated and that the item discovered on the ground at Birmingham was a circumferential section from the front end, having separated both at the junction with the bolted ring and several inches aft. The portion of the liner that remained within the duct was removed, possibly causing some additional distortion (Figure 3).

Recovered part of the exhaust duct liner

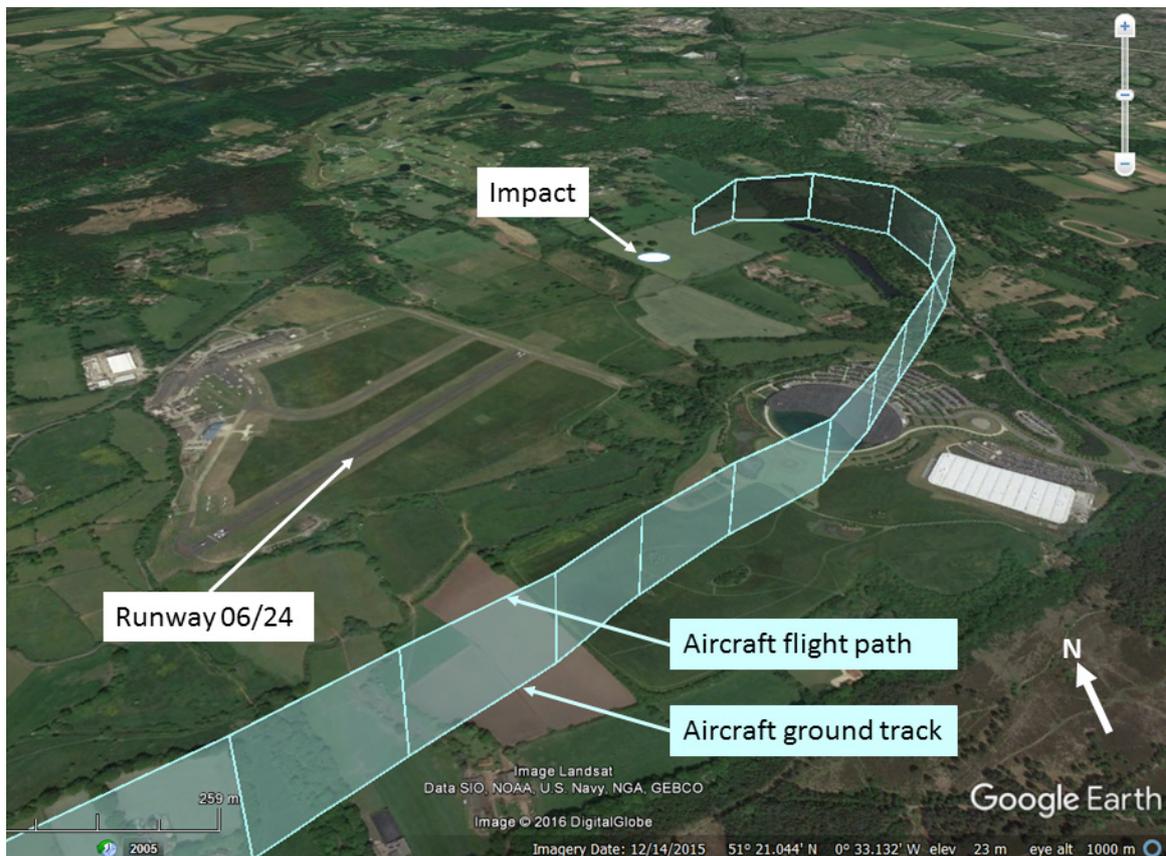
The aircraft was 650 m displaced from the runway threshold as it passed abeam it. It maintained approximately straight flight for a further 15 seconds before starting a left turn. There were a further 5 radar returns, at 4 second intervals. The first two returns showed a turn rate of approximately 5°/second for the first part of the turn, which doubled to about 10°/second in the second part of the turn and immediately before the accident.

Figure 1
Aircraft flight path (Heathrow radar data)

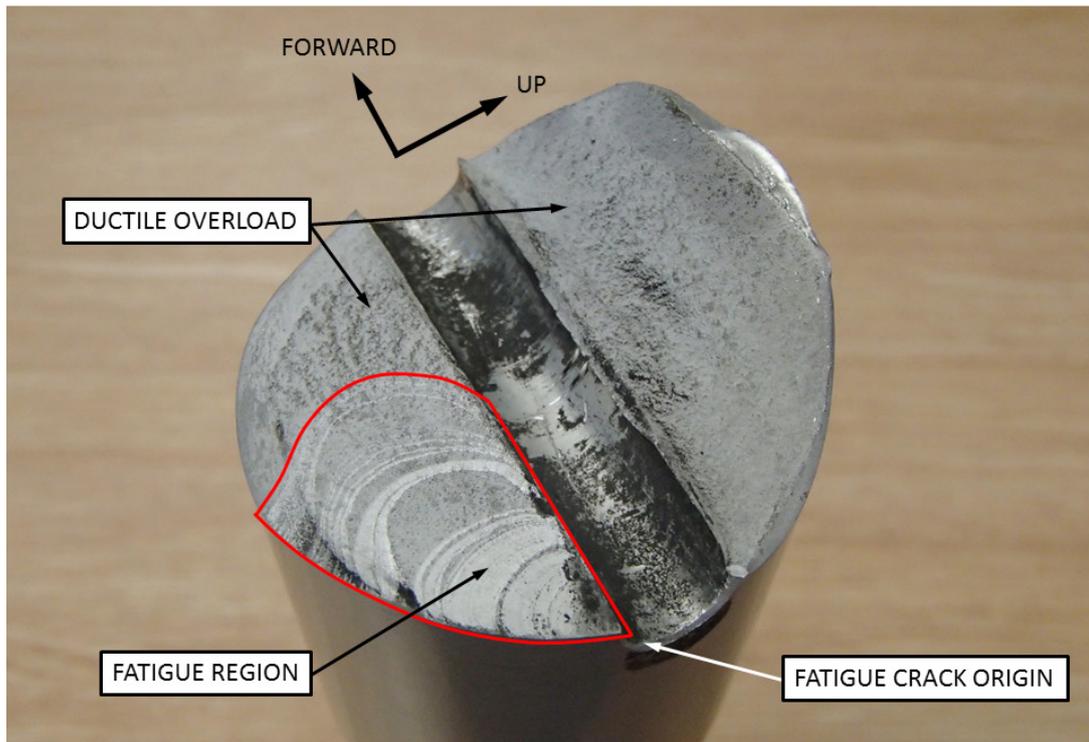
Figure 2

Fracture surface of upper part of the left main landing gear leg
