ACCIDENT TO WESSEX HAS MK 1 XS 880 ON 22 MAY 1975

REPORT ON INVESTIGATION INTO ACCIDENT TO WESSEX HAS MK1 XS 880
OF HMS ARK ROYAL SAR FLIGHT ON 22 MAY 1975

TECHNICAL INVESTIGATION INTO ACCIDENT TO WESSEX XS 880 OF HMS ARK ROYAL
SAR FLIGHT ON 22 MAY 1975 BY LT XXXXXXXXXXXX, AA1(AE), XXXXXXXXXXXX & AA1 (AE)
(XXXXXXXX)

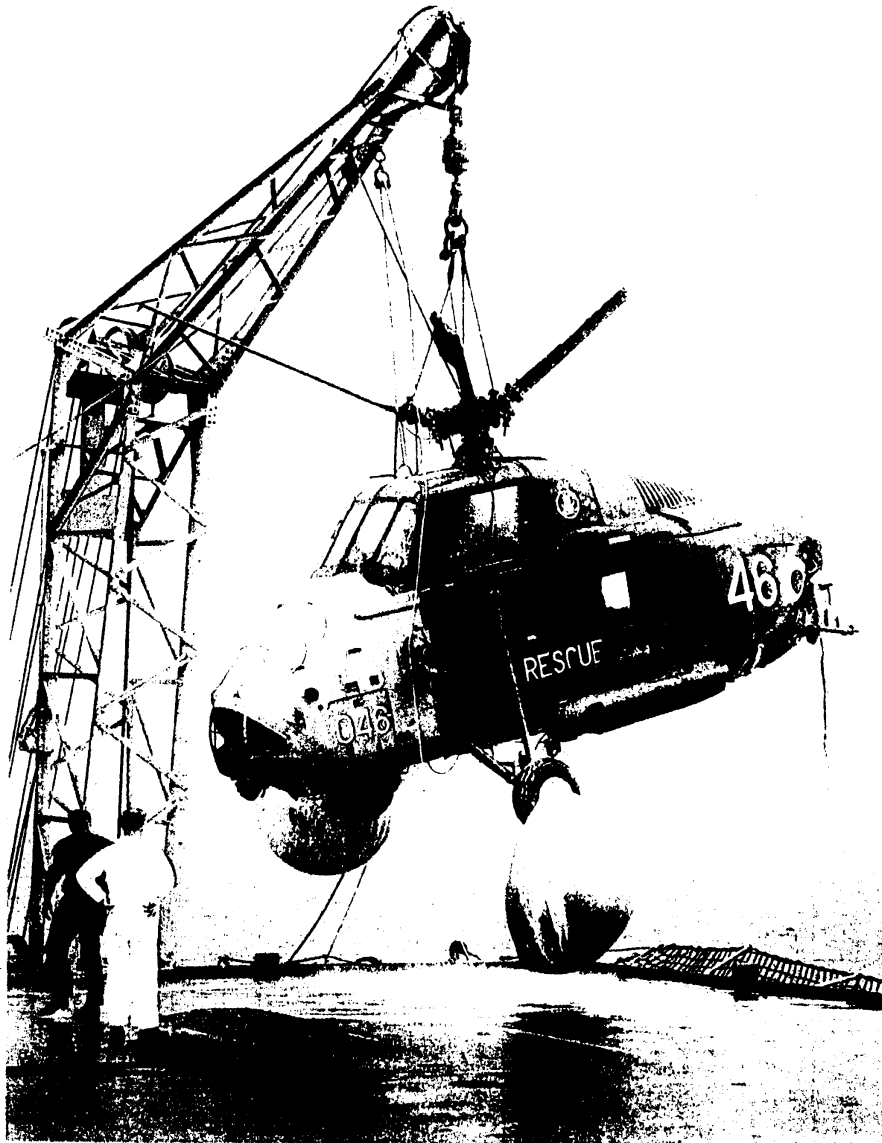
4. The aircraft was salvaged and lifted on board ARK ROYAL at 1200P, it having been immersed for $3\frac{3}{4}$ hours. On recovery it was noted that all aircraft fuselage structure aft of station 206 was missing, and that the four main rotor blades had broken off approximately 2 metres (6 feet) outboard of the main attachment points (PHOTO 1). As the aircraft fuel tanks were ruptured fuel samples were not taken, however, samples of fuel from the refuelling point last used by the aircraft and from the ship's tanks were taken and sent to NAML for analysis. The samples were later reported to be satisfactory (NAML's J2113/22.1 of 2 July 1975).

PHOTO 1 Condition of aircraft on recovery
