Passenger ferry *Uriah Heep* contact with Hythe Pier near Southampton, United Kingdom 13 May 2016

SUMMARY

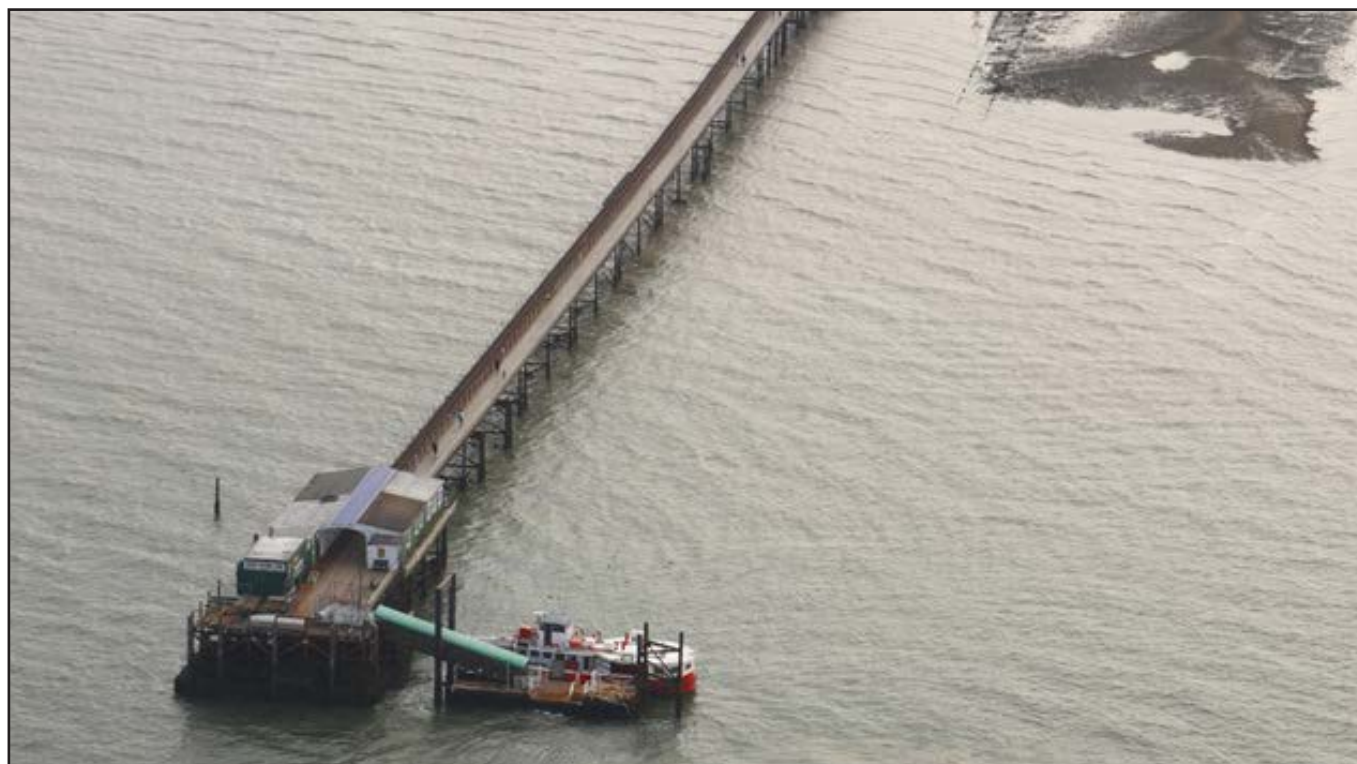
Figure 2: Arrangement of Hythe Pier showing *Hotspur IV* at the inner berth

Uriah Heep's normal berths on Hythe Pier and at Town Quay afforded little margin for error. Both were confined with limited options available in the event of an approach having to be aborted. In addition, the berth at Hythe Pier was exposed to the effects of the wind and the tidal stream. Further, even when the tide was ebbing, the easiest approach to the inner berth was down-tide. Although the ferry's water jet propulsion arguably made it more manoeuvrable than similar sized vessels fitted with a propeller and rudder, high engine speeds were required when manoeuvring to ensure that sufficient thrust was generated and that the response time of the deflector was minimised. At Hythe Pier, the ferry's susceptibility to rolling was also a consideration with respect to the speed of approach. In such circumstances, any loss of directional control or of 'ahead' or 'astern' drive had the potential to be difficult to correct in the limited sea room available.

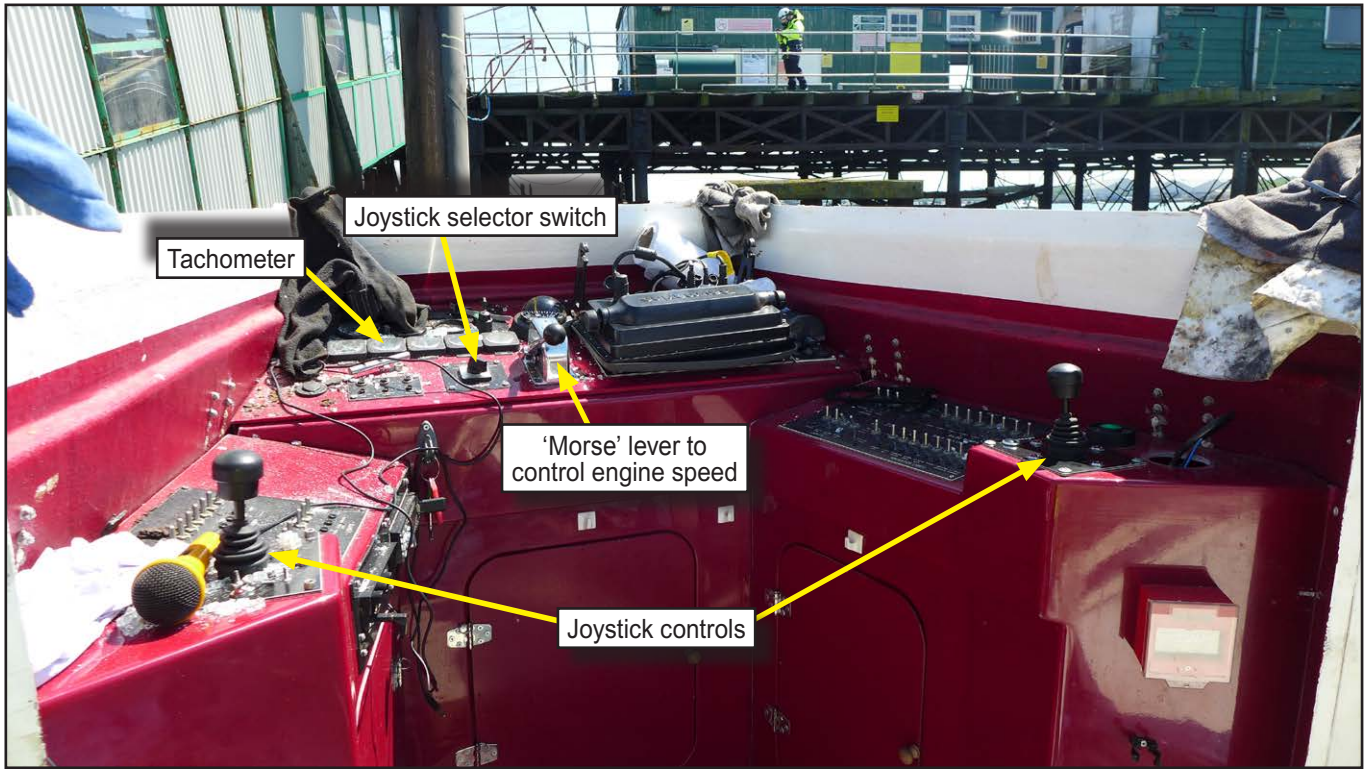
Figure 3: Wheelhouse console

Uriah Heep was fitted with a single water jet (**Figure 7**) powered by a 388kW diesel engine. The amount of thrust generated by the water jet was directly proportional to the speed of the impeller driven by the engine. Engine speed was regulated by a Morse control lever and indicated by a tachometer, both of which were sited on the wheelhouse's forward console (**Figure 3**). The minimum engine speed generally used when manoeuvring was approximately 1500rpm.

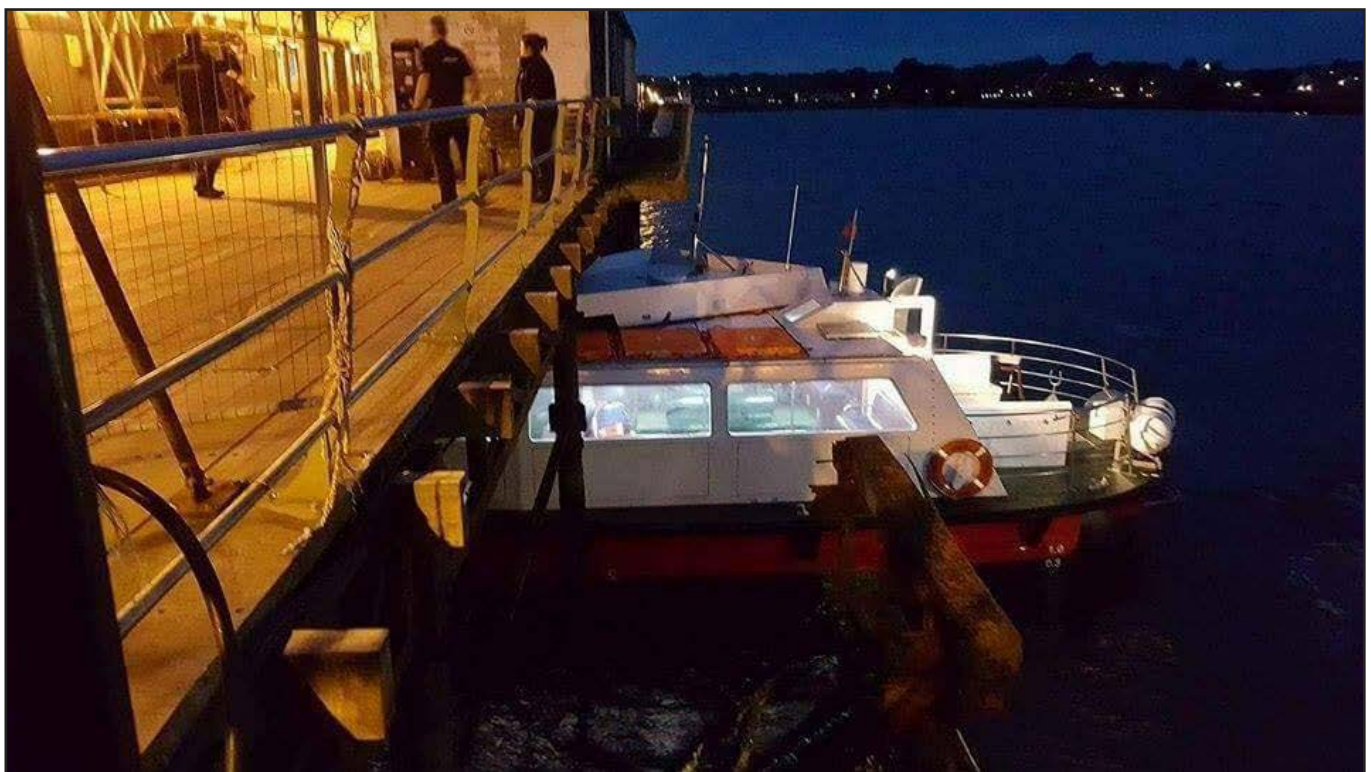
Figure 4: *Uriah Heep* under Hythe pier

Seconds later *Uriah Heep's* wheelhouse struck the underside of Hythe Pier. The impact shattered the wheelhouse's glass windows and pushed its roof and canopy on to the top of the passenger cabin. The ferry came to rest wedged under the pier (**Figure 4**). The mate checked the wellbeing of the passengers, none of whom were injured, and then helped the skipper, who had suffered minor cuts and abrasions and was crawling out from beneath the wheelhouse debris. He then told the deckhand to use a hand-held VHF radio to inform Southampton VTS of the accident. The mate also told the passengers to don lifejackets and to remain seated until assistance arrived.

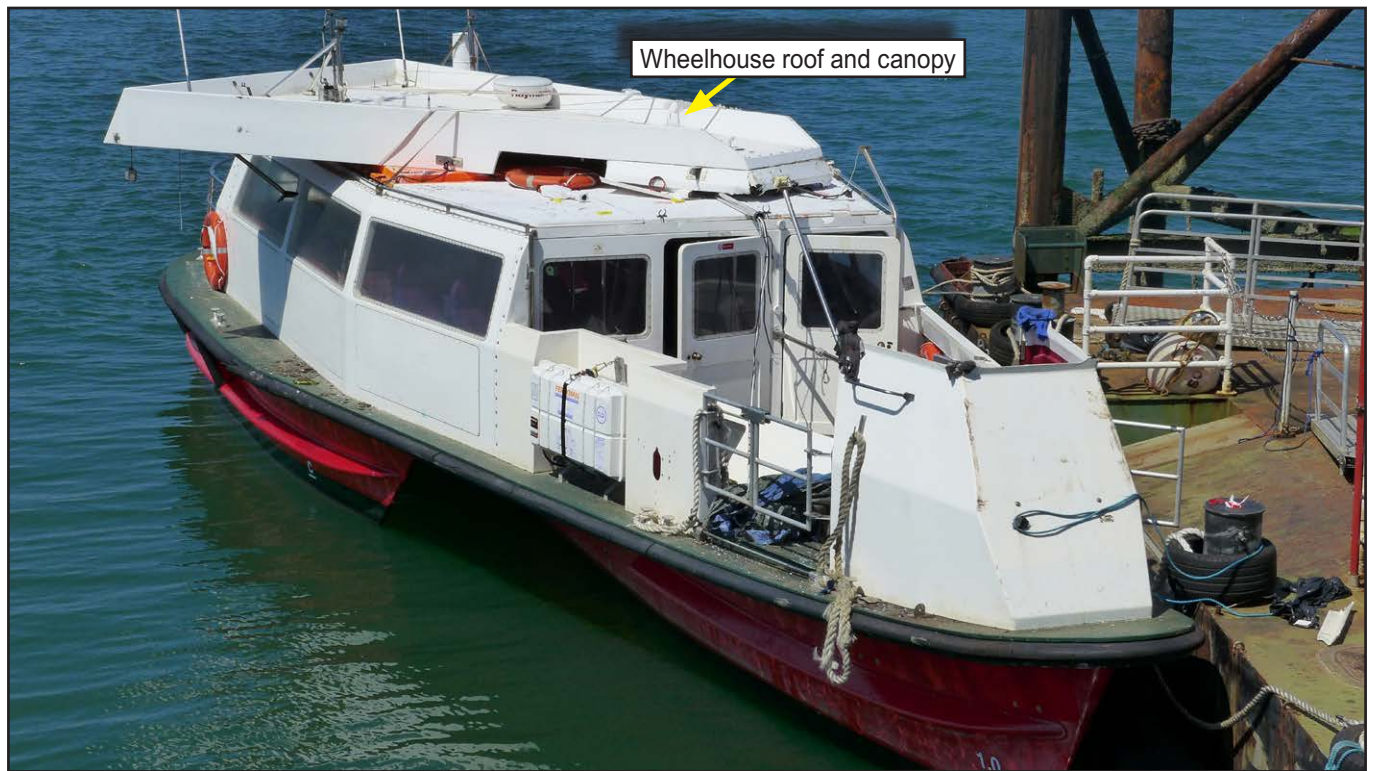
Figure 5: *Uriah Heep* showing damage

The port services launch, *Joker*, was first on the scene and was used to transfer the passengers and crew to the pontoon. *Uriah Heep*'s engine, which had been left running to provide lighting, was then stopped and the ferry was towed from under the pier and secured alongside the pontoon (Figure 5). It is reported that the position in which the starboard joystick control was found corresponded to a position that usually provided astern drive.

The **Maritime and Coastguard Agency** has withdrawn *Uriah Heep*'s passenger safety certificate and will take the findings of its own investigation into this accident into account should an application to certify the vessel as a passenger ship be received in the future. **White Horse Ferries Ltd** has sold the vessel.

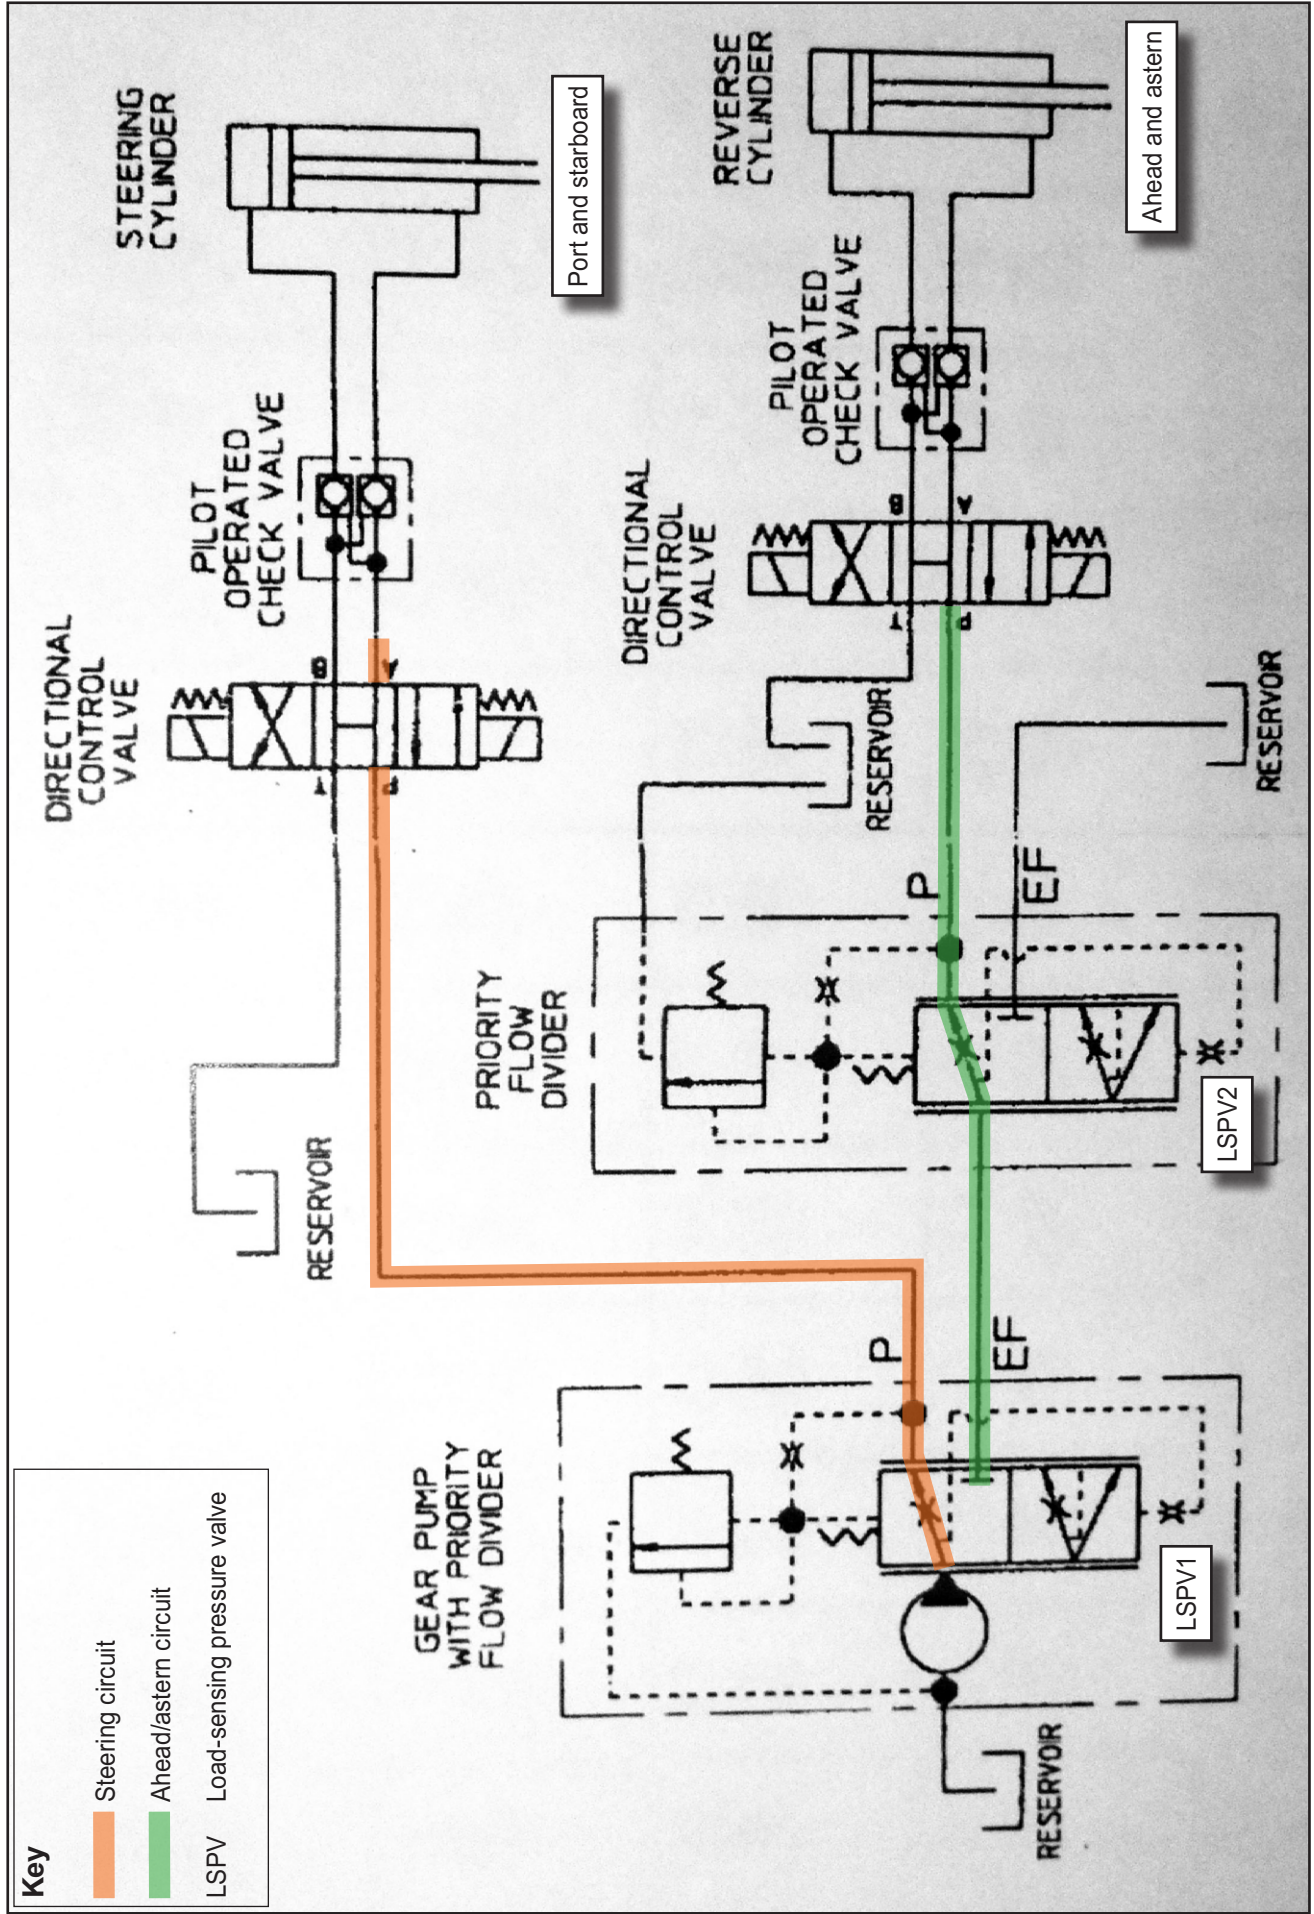
Figure 8: Hydraulic circuit diagram

The movement of the selected joystick in the wheelhouse was translated into electrical signals that acted, via an electronic logic controller, onto directional control valves that operated hydraulic rams connected to the water jet nozzle and the deflector (**Figure 8**). The hydraulic circuit included load-sensing valves that prioritised hydraulic power to the water jet nozzle over the deflector. The hydraulic pump had no back-up in the event of failure, and there was no means of moving the water jet nozzle or the deflector in the event of the total loss of hydraulic power.

Although *Uriah Heep* was equipped with two independent means of controlling its water jet propulsion from the wheelhouse, the mechanical rams that moved the water jet nozzle and the deflector were driven by the same hydraulic system. Consequently, the malfunction of a single hydraulic component had the potential to result in the prioritisation of nozzle movement over deflector movement or, worse, render both the water jet nozzle and the deflector inoperative.

In 1999, the failure of the deflector to operate was due to the malfunction of a load sensing valve within the hydraulic circuit. However, the technical investigations of the most recent occurrences have been inconclusive. Nonetheless, it is almost certain that the causes of the deflector failure on these occasions were again associated with the propulsion system's hydraulics.
