Rail Accident Report

Near miss between a train and a level crossing user at Dock Lane, Melton, Suffolk 14 June 2016

Report 08/2017
May 2017

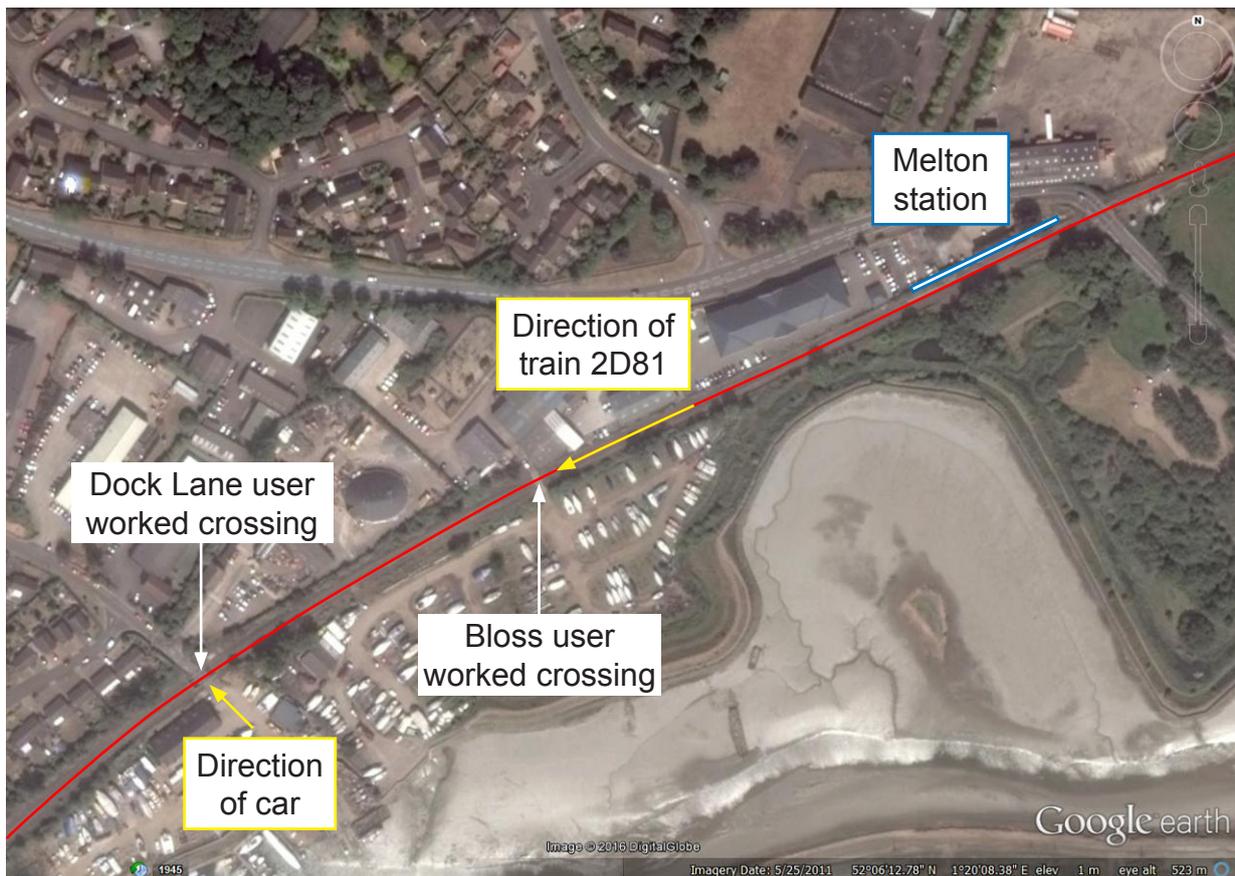
Figure 2: Detailed locations of crossings at Melton

- 45 The car passenger started to open the crossing gates after the car driver had used the telephone to contact the signaller and gained permission to cross (paragraph 25). This was in accordance with the instructions for using the crossing.
- 46 However, the signaller had given the car driver permission to cross the railway while an approaching train was leaving Melton station, which was only 280 metres from Dock Lane crossing. The signaller had just been told by another user at Bloss crossing that the train was at Melton station (figure 2 and paragraph 24).

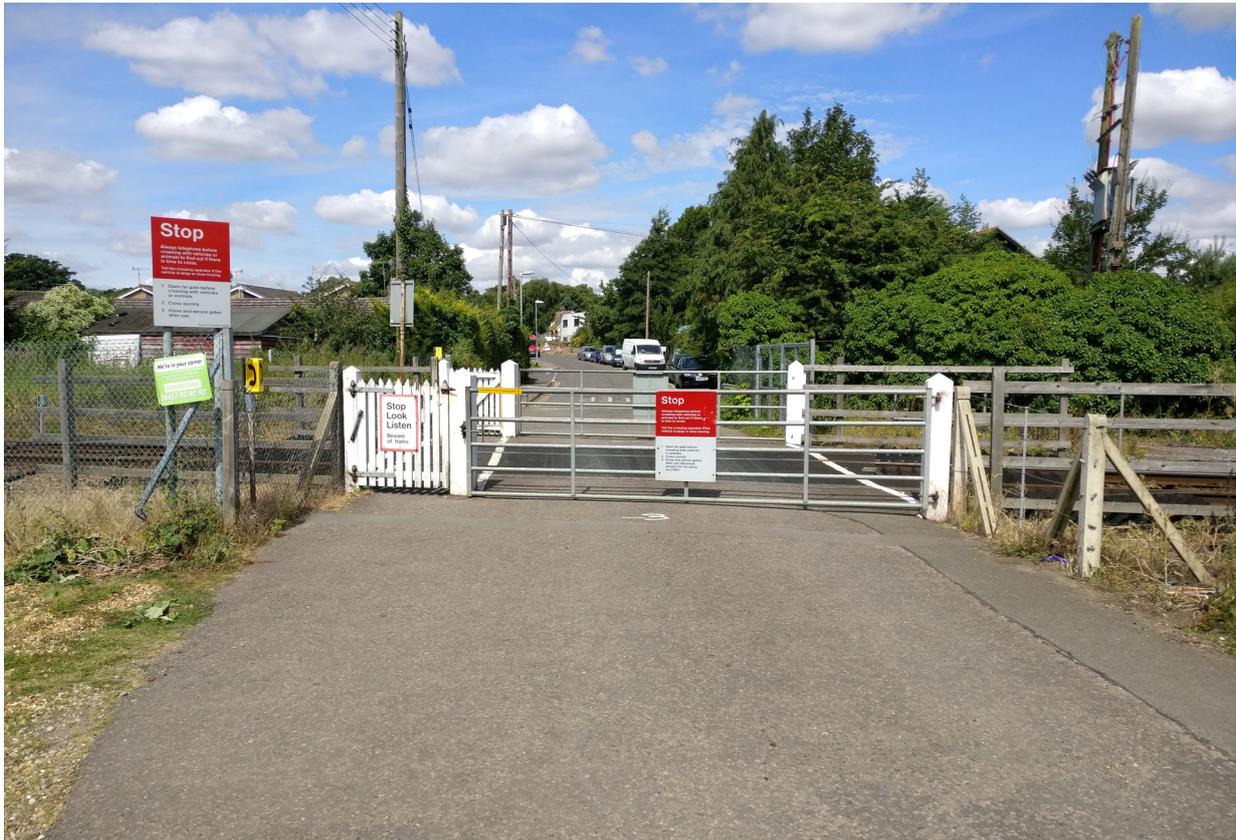
Figure 4: Dock Lane user worked crossing, viewed from river (east) side of railway

- 14 Dock Lane level crossing is classified as a user worked crossing with telephones (UWC-T) and is intended for use by road vehicles belonging to, or having business with, a defined set of authorised users. The operator of the boatyard that the vehicle occupants had been visiting, was an authorised user. The UWC-T is fitted with a metal vehicle gate on each side of the railway which the road user is required to open and close on foot. There is a parallel footpath crossing, provided with a wooden pedestrian wicket gate adjacent to each vehicle gate (figure 4).

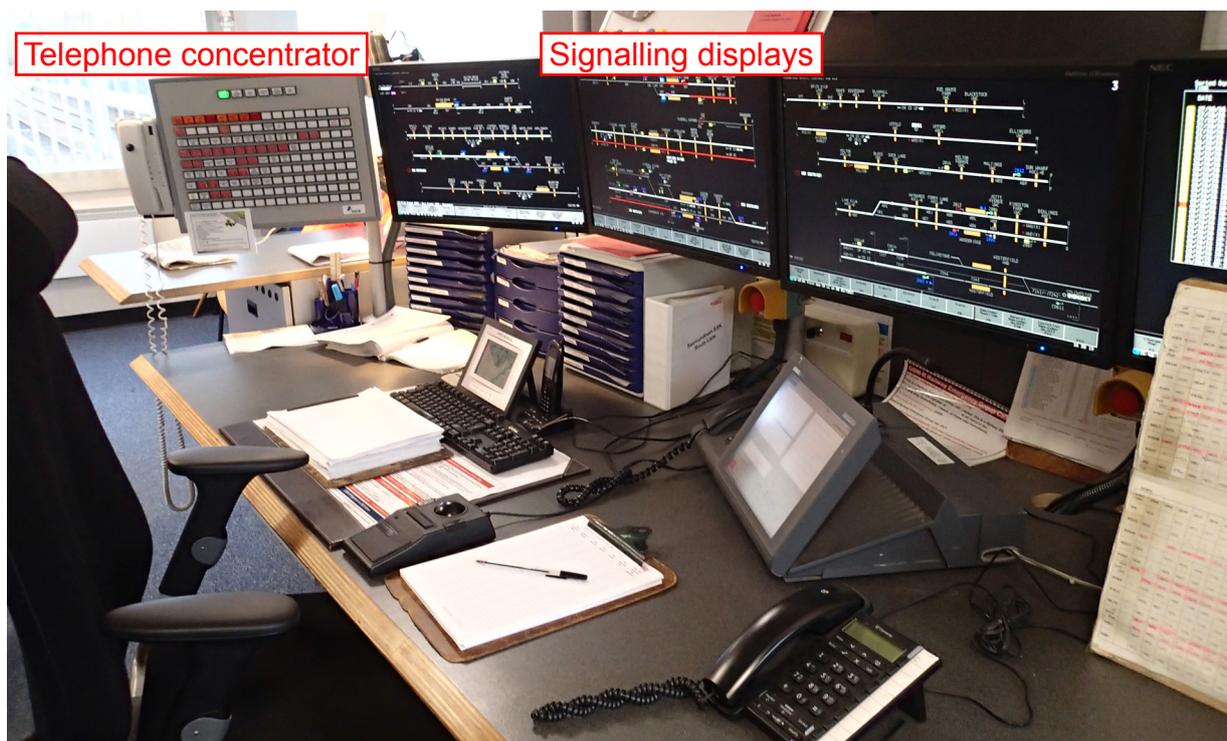
Figure 5: Saxmundham signal box

- 16 Saxmundham signal box controls trains on the line between Oulton Broad South, near Lowestoft, and Westerfield, near Ipswich, including those on the freight-only branch line to Sizewell. It has a bank of three display screens on which is displayed a schematic of the railway, showing signals, *track sections* and level crossings. A single signaller uses these screens to monitor the position of trains and to operate the signalling (figure 5). To the left of these screens is a *telephone concentrator* panel, which provides the signaller's interface with the telephones at all of the UWC-T crossings within the signal box's area. Each crossing has a combined button and lamp, which flashes when a user lifts the telephone to call the signaller. The signaller is able to answer the calls by pressing the appropriate button.
