AAIB Bulletin

5/2017

Published 11 May 2017

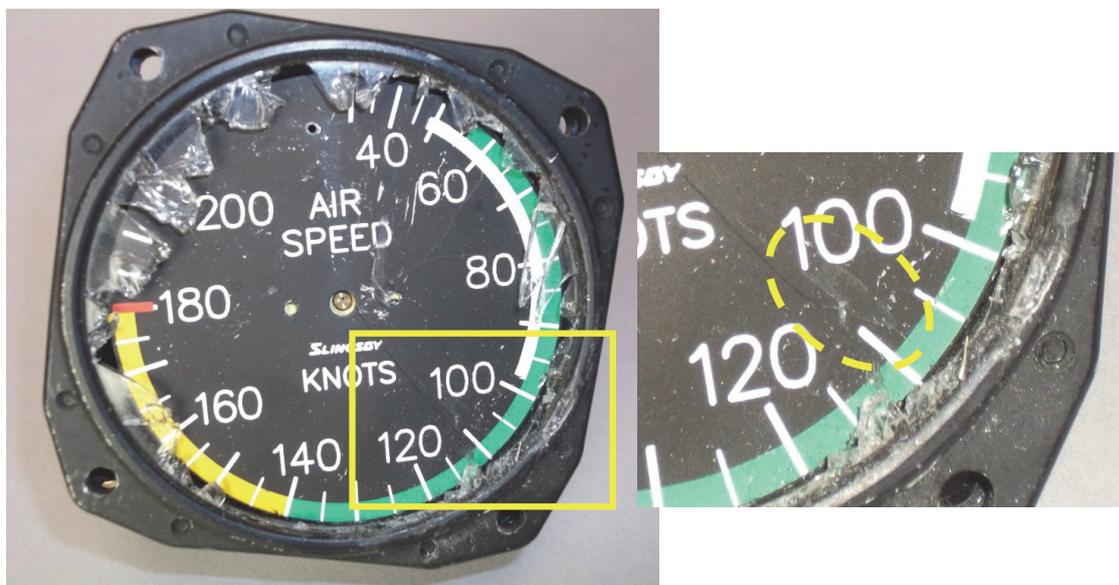
Figure 1

Needle strike on ASI face showing 108 kt

Testing could not be carried out on any of the primary instruments. The sub-scale setting on the altimeter of 1019 hPa was the QNH for the day and is likely to have been set by the pilot in preparation for the flight. The needle strike on the ASI shows an airspeed of around 108 kt at the impact, plausible considering the damage sustained by the aircraft.

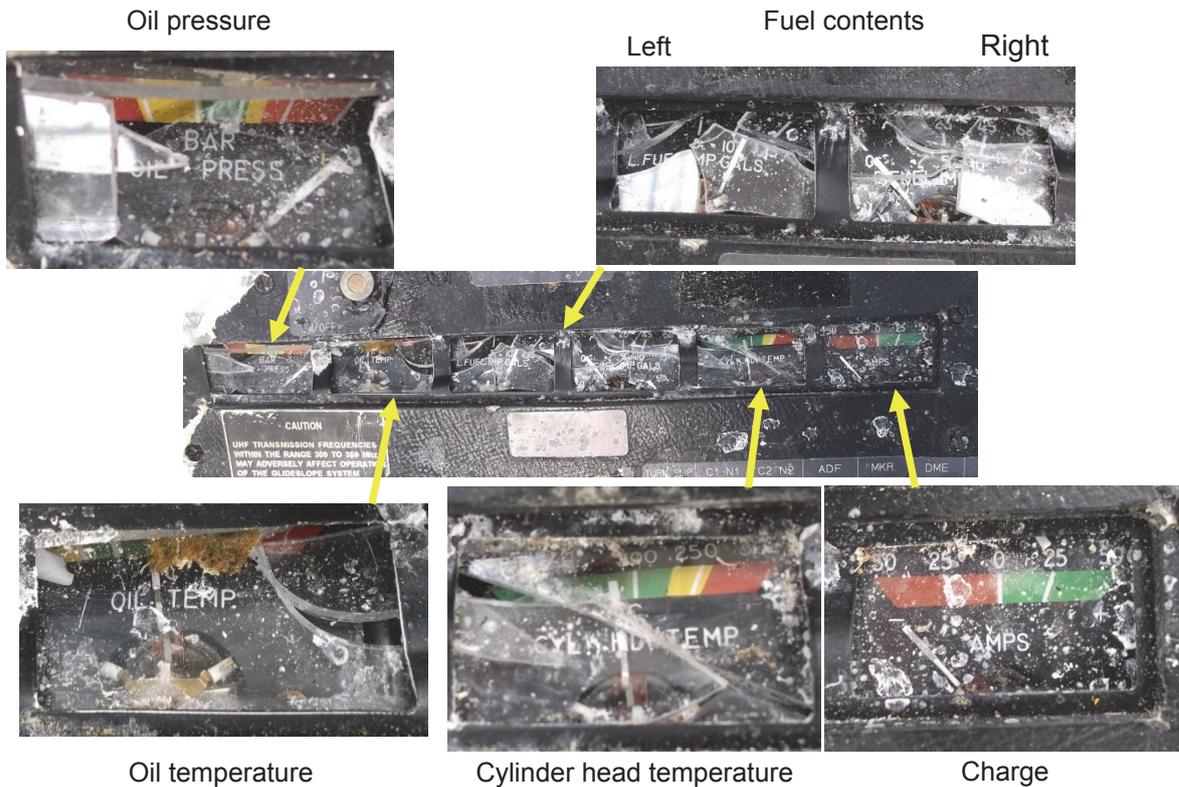
Figure 2
Engine and fuel gauges

Some of the engine instruments and one of the two fuel gauges needles appeared to have been trapped at, or close to, the position they were at the point of impact (Figure 2). In particular the engine oil temperature was indicating in the green sector, the cylinder head temperature at 180°C and the left fuel gauge was showing 12 imp gals. In contrast, less plausible were the oil pressure (at full deflection in the red sector), the right fuel gauge (showing zero) and the ammeter (at full deflection to the left).

The combined fuel and manifold pressure gauge was badly damaged, with no meaningful readings, and the position of the mixture, pitch and throttle controls at impact could not be determined. However, the mechanical rpm gauge, although damaged, showed a needle strike mark similar to that on the ASI, and its needle had bent and precisely matched the contour of a small area of distortion on the instrument face. The strike mark and the bend position indicated a reading of 1,150 rpm when the aircraft hit the ground.

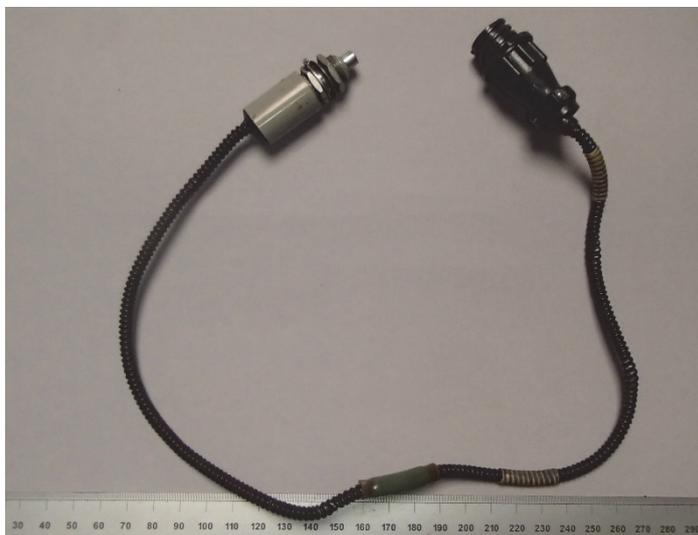
Following the second event, the nose gear downlock microswitch, Part Number TB2061032005, was removed from the aircraft and sent to the AAIB. Figure 1 shows the switch after removal.

Downlock microswitch and connector after removal from the aircraft

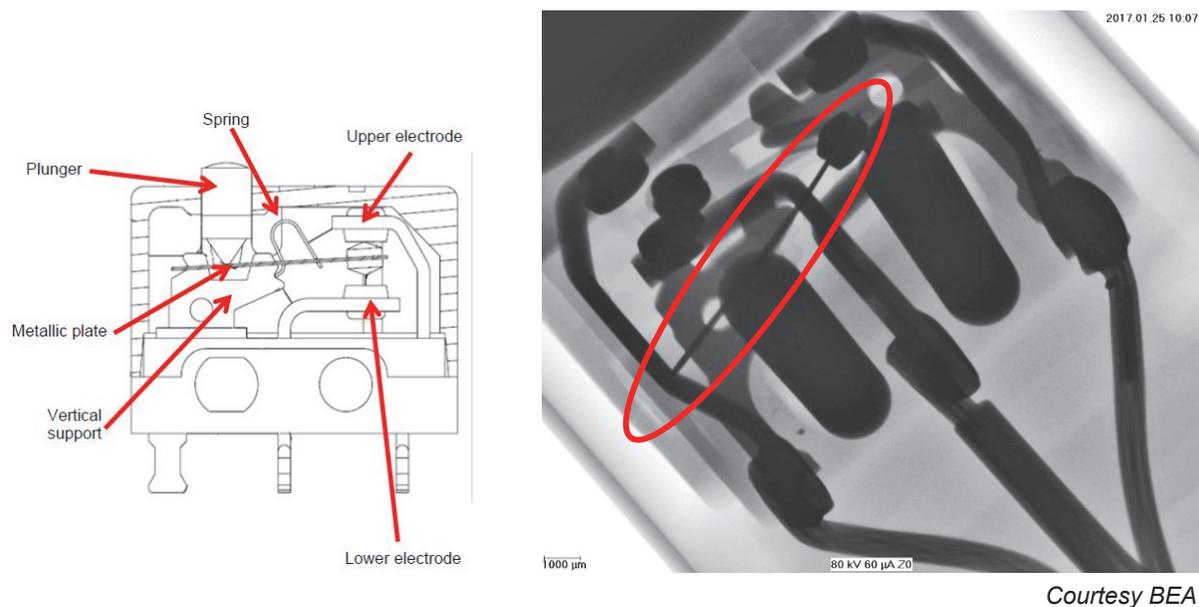
Figure 2

It was found that moving or tapping the switch would cause the metal plates to move relative to the surrounding components. Cutting the switch assembly open confirmed that the components of one of the microswitches were loose. In the other, the spring had become jammed under the plate. The aircraft manufacturer stated that they had not received any reports of similar failures and, having checked their stock of switch assemblies, confirmed that all of them functioned correctly. The manufacturer additionally stated that they considered that a possible reason for the internal components being found in this condition was the switch may have been subjected to a severe impact.

Cross section of assembly and (right) a sample X-Ray image.
The metal plate was loose

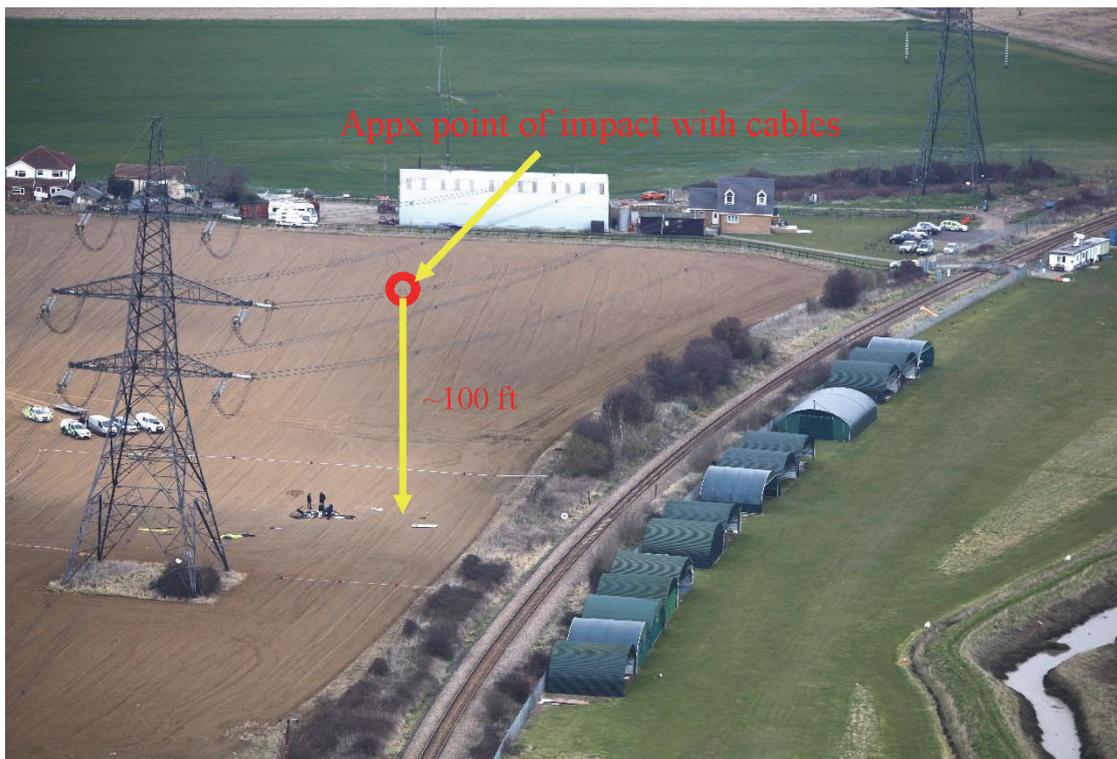
**Figure 1**

The aircraft had come to rest in a field adjacent to the northern edge of the airfield, beneath power cables carried on pylons running in a southwest-northeast direction (Figure 1).

View of accident site, looking along Runway 06

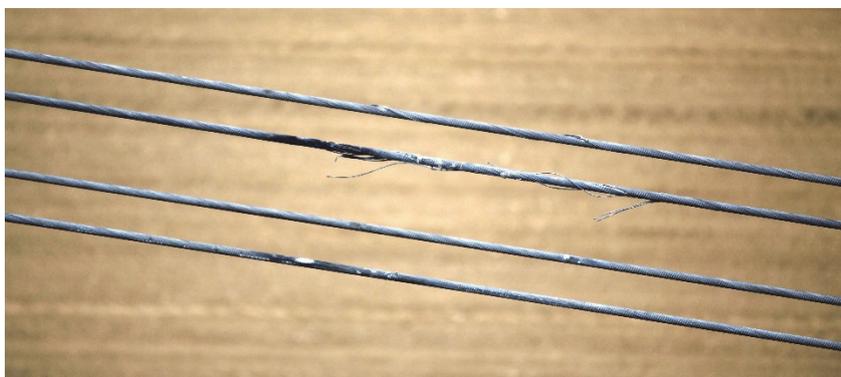
Figure 2

The aircraft had come to rest in an inverted attitude, with the nose pointing roughly parallel to the runway heading, ie 060°. The wreckage had burnt out, with the fire in the forward fuselage having been particularly intense. It was apparent that the right wing had separated close to the root as a result of striking the cable group mounted on the centre arm on the south side, approximately 100 ft above the ground. The right wing was found approximately 13 m from the main wreckage. The cables had not been severed, but had sustained damage in the form of broken cable strands (Figure 2).

Damage to power cables

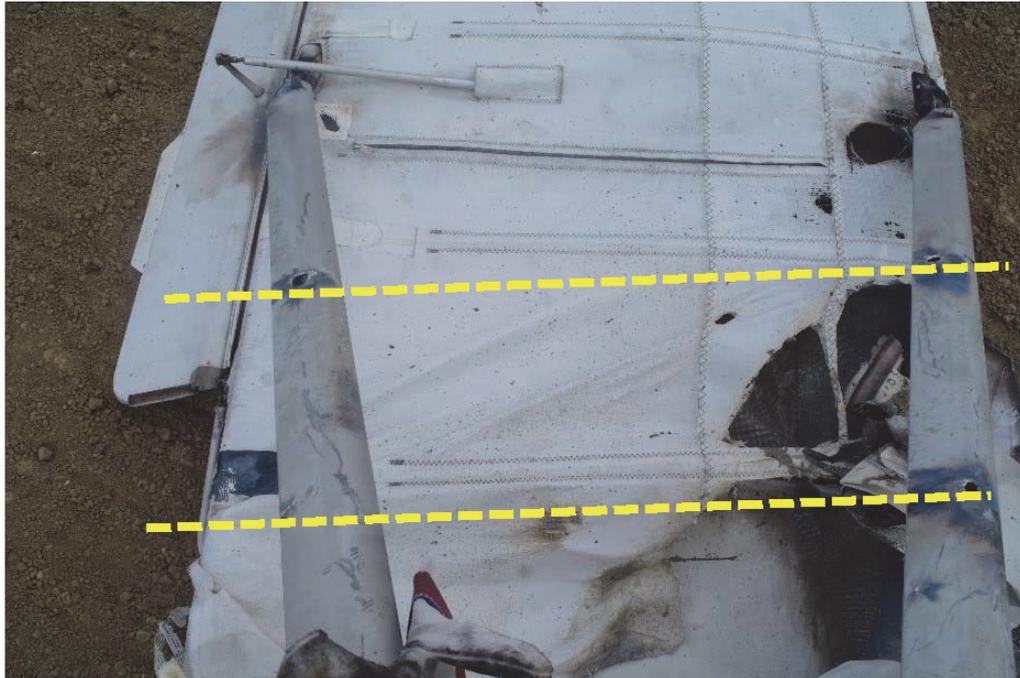
Figure 3

The cable group below the damaged ones exhibited some slight scuffing, possibly as a result of a brushing contact with the underside of the left wing; this showed evidence of light scuff marks on the wing struts, with several holes resulting from severe electrical discharges that had caused localised vaporising of the aluminium alloy. Similar features were observed on the structural members of both wings and on flying control components, with some of the flying control tubes having melted. The positions of the discharge damage on the wing struts was consistent with the spacing of the cables within the group (Figure 3).

Underside of right wing showing electrical discharge damage and possible cable contact positions

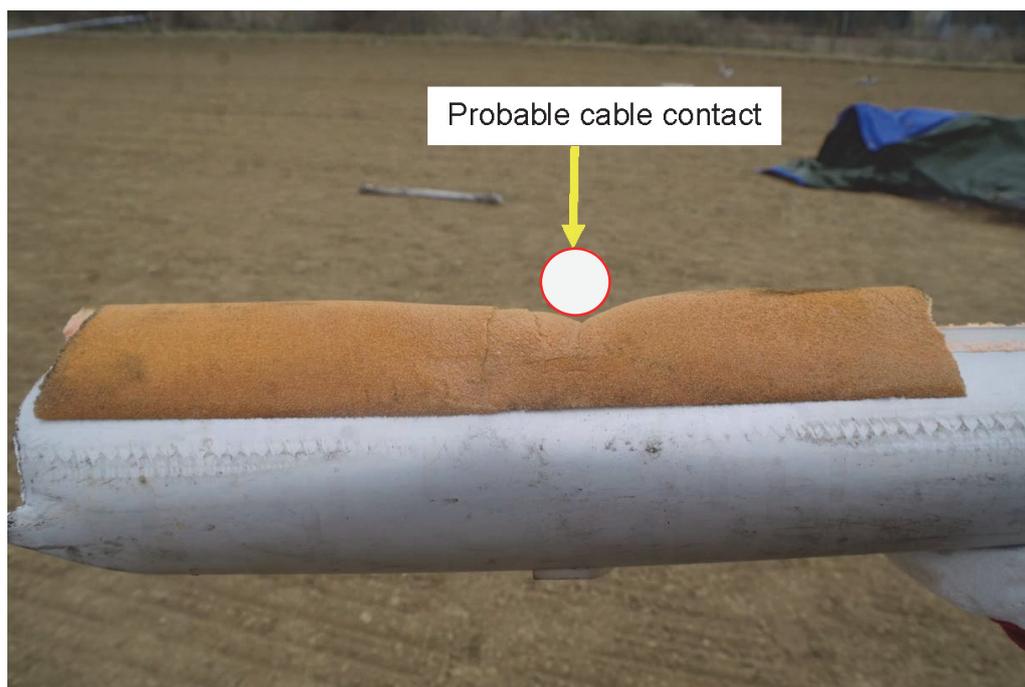
Figure 4

The right wing leading edge spar had been broken just inboard of its mid-span point, as a result of contacting the cables. A foam fillet had been bonded to the front face of the tube, giving an aerodynamic shape to the leading edge. An indentation was apparent in the foam, close to the spar fracture, which was consistent with being made by one of the cables (Figure 4). As can be seen, the cable would have been approximately vertical relative to the wing leading edge, suggesting the aircraft was in a near vertical nose-down attitude at the time.

Likely cable contact on the right wing leading edge spar

It was concluded, from the available evidence, that the right wing had struck the middle set of cables on the south side of the pylons whilst the aircraft was in a steep, probably vertical, nose-down attitude. It is likely that this caused a yaw to the right, bringing the left wing into light contact with the lowest set of cables, resulting in the phase-to-phase discharge that in turn produced the bright flash and explosion reported by witnesses.

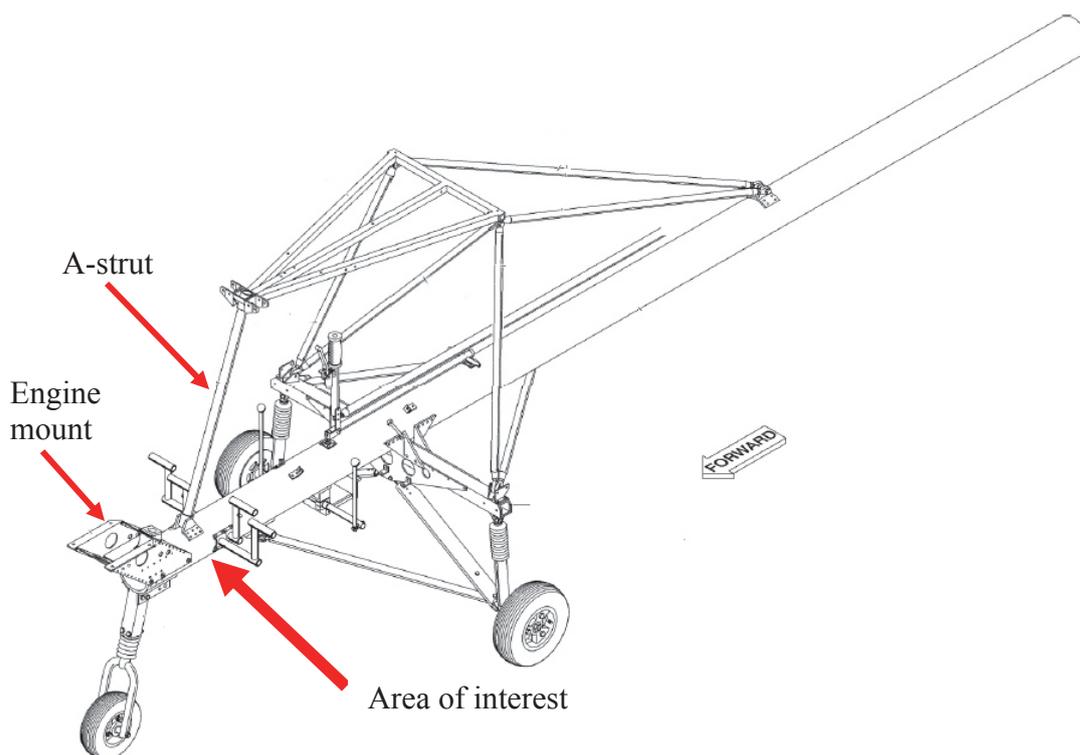
**Figure 5a**

View of fuselage structure

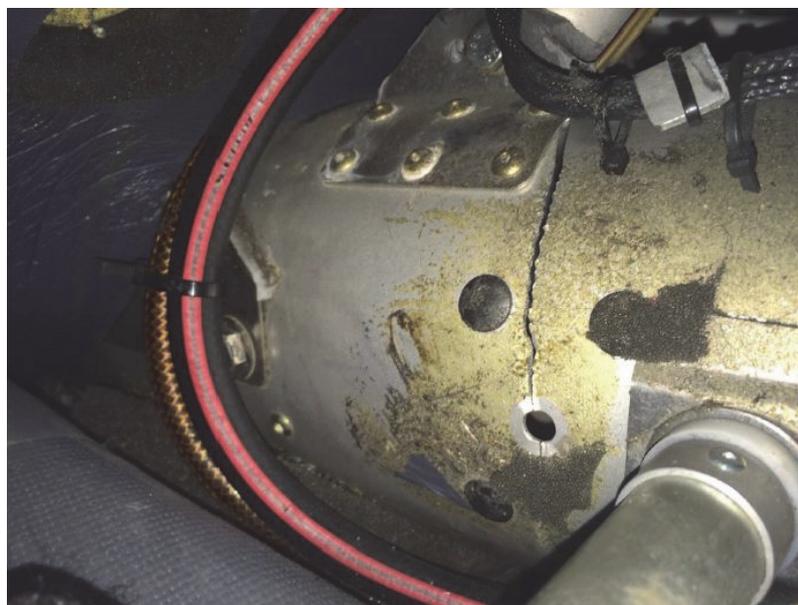
**Figure 5b**

Cracks have been found emanating from the corners of the upper cut-outs which, if allowed to propagate, would compromise the structural integrity of the engine mountings, the nose landing gear leg and the A-strut. An extreme example is shown in Figure 5b. As far as is known, no crack has progressed to complete failure. The LAA covered the topic in an article in the August 2016 issue of their '*Light Aviation*' magazine.

Example of crack emanating from rear cut-out, as shown in OSB 29

The cracking of the fuselage tube resulted in an Owner's Service Bulletin (OSB) 29, which was issued on 16 June 2016. The Bulletin became the subject of a Civil Aviation Authority (CAA) Emergency Mandatory Permit Directive (MPD), issued on 28 June 2016. It required an inspection for cracking of the front of the fuselage tube; the affected area is shown in Figure 5a. The engine is supported, via a pylon, on the front of the tube. In addition, there are two square cut-outs in the tube; the front one carries the nose landing gear and the rear forms the attachment of the A-strut.

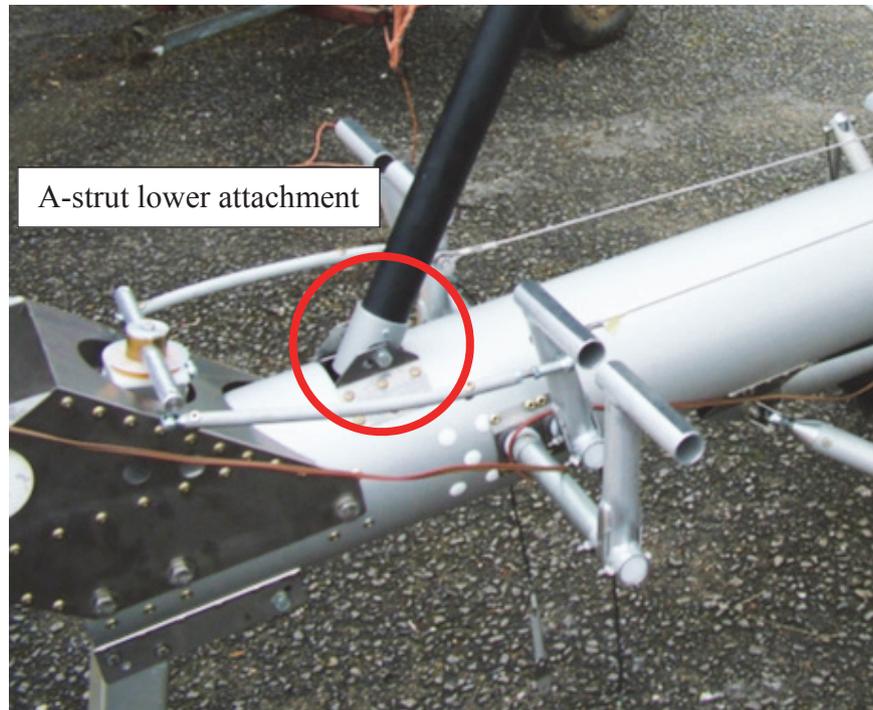
Figure 6a

the outer collar at the connection between the strut and the upper surface of the main fuselage tube (Figures 6a and 6b). The failure was concealed by the collar and the upper part of the strut had been retained in position only by a single locating rivet (ie a manufacturing aid) that located the collar on the strut. The crack had emanated from the bolt hole in the strut.

A-strut attachment to forward fuselage tube

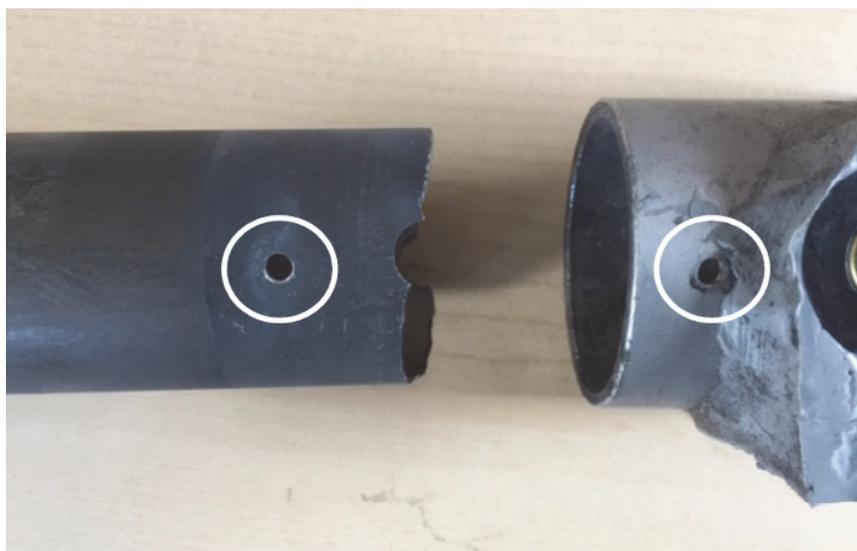
Figure 6b

Failed A-strut after removal of collar, showing rivet hole

The UK agent for the aircraft, in conjunction with the German manufacturer, issued OSB 31 on 30 November 2016, applicable to all C42 A and B model aircraft, although later B models featuring a different design were exempted. The Bulletin stated that it was believed that the failure was the result of excessive loads placed on the A-strut due to near failure of the main fuselage tube. One other similar case was known to have occurred on an aircraft known to have sustained landing gear damage. However, it was also considered that the failure may have been related to fatigue due to flexing of the A-strut, thus introducing the requirement for an inspection of potentially vulnerable aircraft.

The OSB requires any aircraft which have previously suffered damage that could have affected the A-strut, such as nose gear or accident damage, to be inspected by means of a borescope inserted into the strut from its lower end. However there was no requirement to inspect aircraft with no history of damage and which had flown less than 2,000 hours. Aircraft with more than 2,000 flying hours were recommended to be inspected at the next Annual or 100-hour Inspection, whichever occurred first.

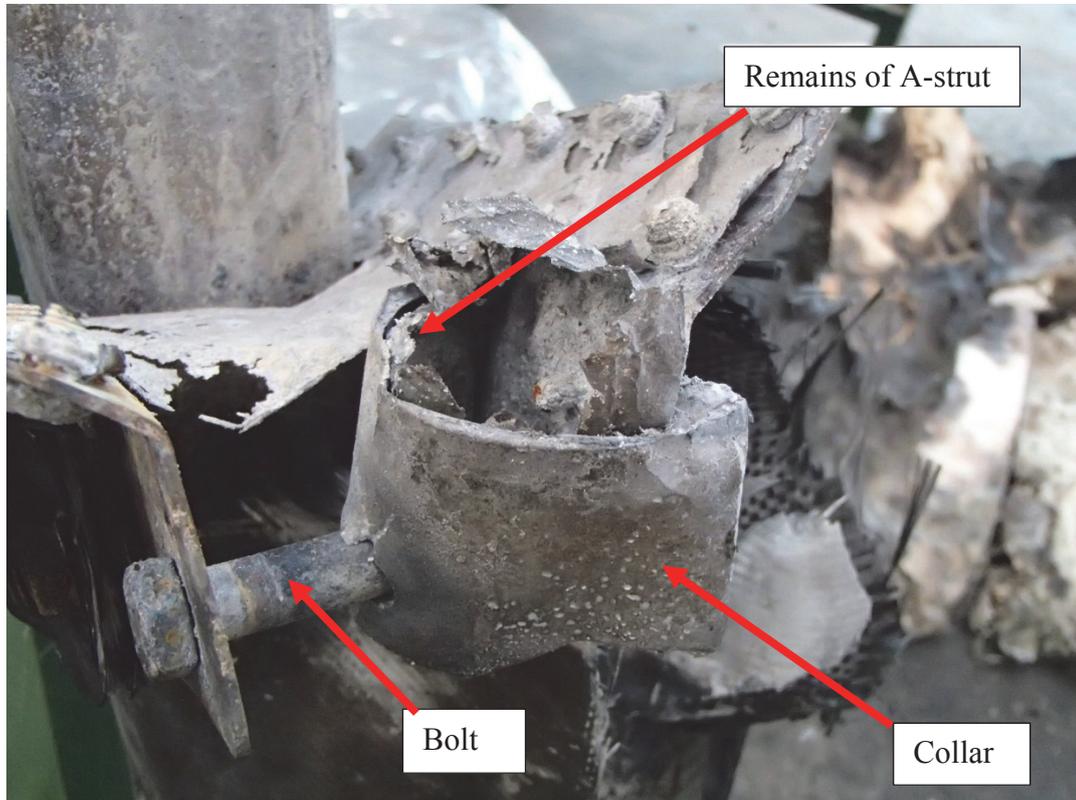
Figure 7
Lower attachment

The A-strut upper and lower attachments to the fuselage tube were made with steel brackets. These had survived the post-impact fire, whereas much of the surrounding aluminium material had not. Figures 7 and 8 show the remains of the lower and upper attachments. The lower attachment was similar to the upper in that both used collars and locating rivets (the rivet is not visible in the image of the lower attachment).

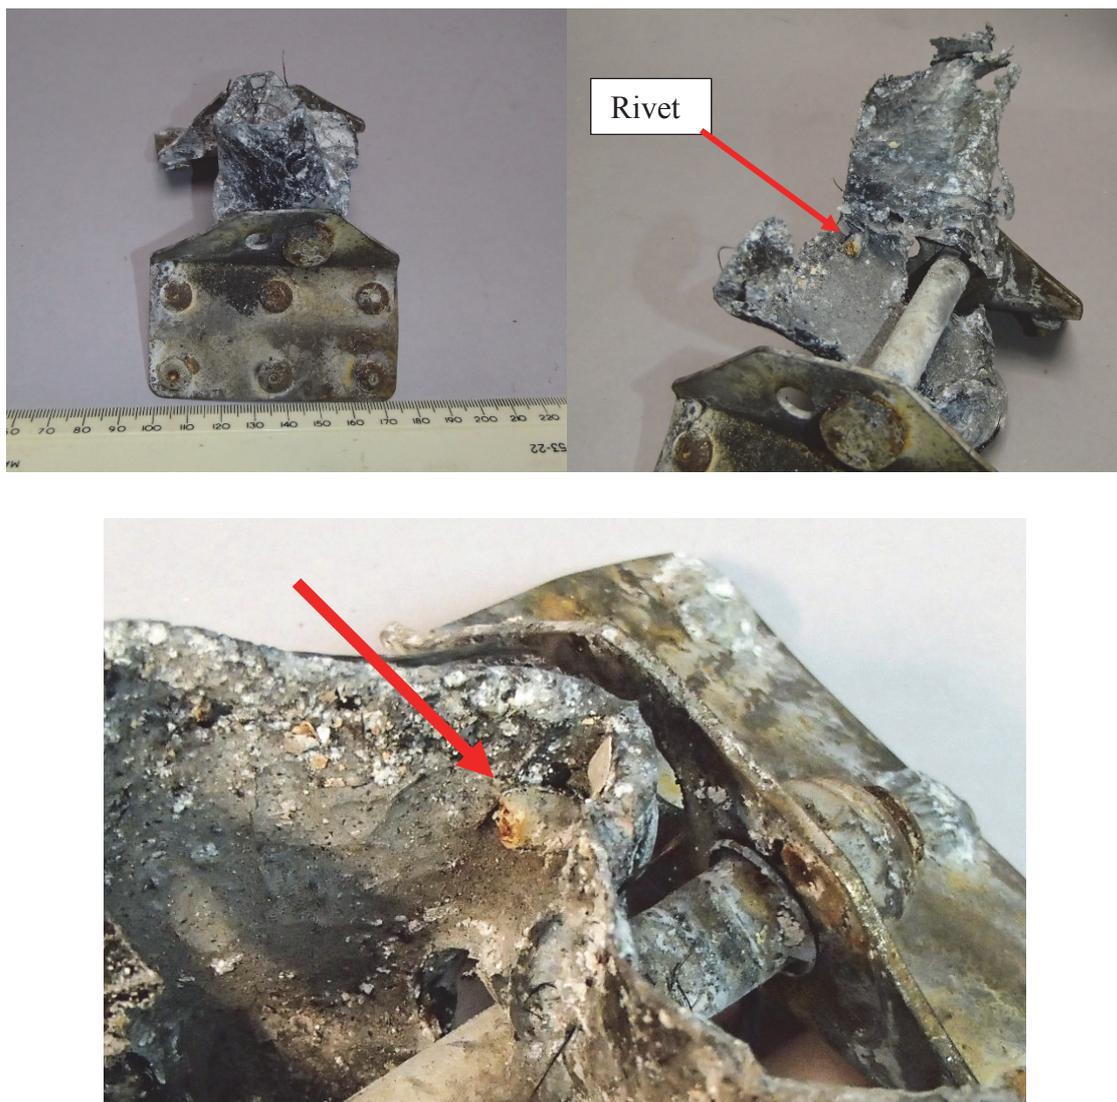
Figure 8

The remains of the collar on the upper attachment were fragile and part of it was peeled aside to reveal the locating rivet; this appeared intact. However there was no evidence of any part of the A-strut, unlike the lower attachment, where a section of the strut, together with the rivet was found positioned concentrically within the collar.

Remains of A-strut upper attachment and (lower view) rivet

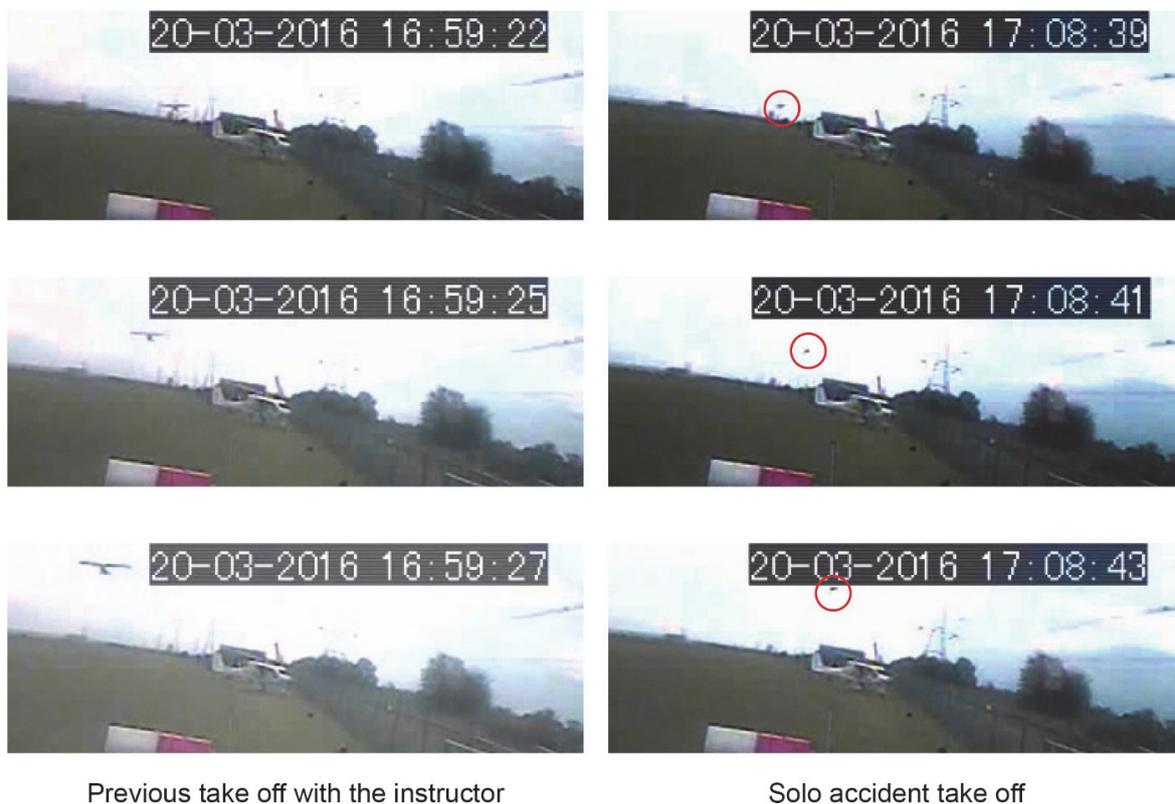
**Figure 9**

A video camera located on the clubhouse recorded both the takeoff with the instructor and the takeoff for the accident flight. Figure 9 shows three snapshots from each takeoff which illustrate differences in the respective flightpaths. The takeoff with the instructor was at a higher weight, but the aircraft tracked along the runway in a normal climb. On the accident takeoff the aircraft became airborne and climbed steeply, whilst drifting to the left (prior to dropping the left wing, descending and contacting the power lines).

Comparison of normal and accident takeoffs

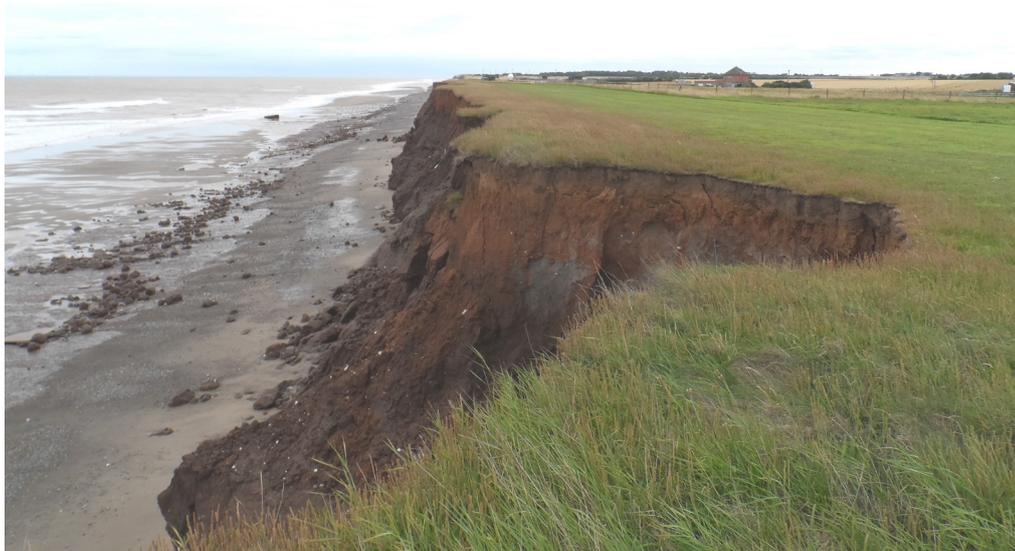
Figure 1

While landing on a cliff-top runway, the landing gear's right outrigger failed and the aircraft ran off the edge of the runway, over the cliff and into the sea. The failure of the aircraft's right outrigger was not explained. However, there was little margin for variation in landing track when using Runway 32, which was narrower than recommended by the CAA in CAP 793 because of coastal erosion (Figure 1).

Coastal erosion at Hollym Airfield

The airfield operator has informed publishers of various flight guides of the revised width of Runway 32 and warned about the cliffs on the east side of the airfield, for inclusion in their publications.

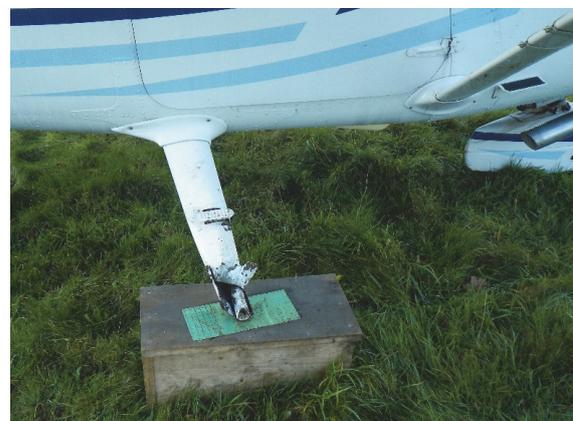
Figure 1

The pilot reported that the touchdown on the grass runway at White Waltham was smooth with little impact; however as the aircraft slowed to approximately 35 kt, there was a loud bang and the right side of the aircraft dropped. The aircraft turned to the right by approximately 120° before it came to a halt. On vacating the aircraft, the pilot noticed that the right main wheel assembly had detached from the landing gear leg (Figure 1).

Right main wheel assembly detached from its leg

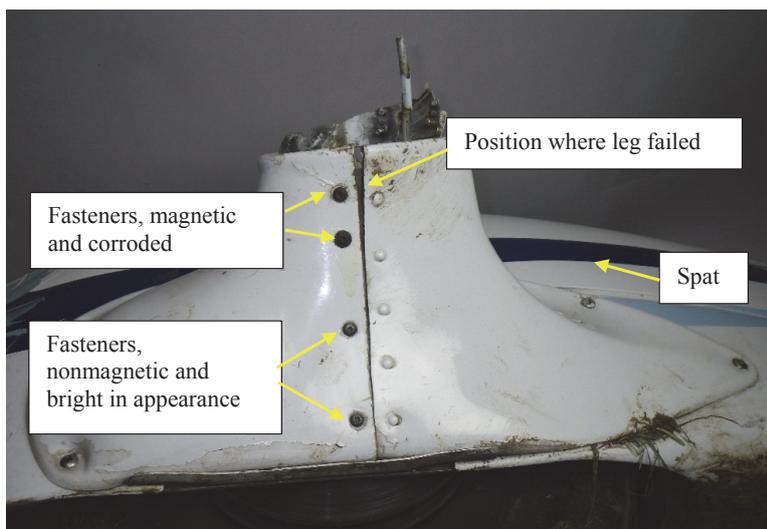
Figure 2

The right main landing gear leg failed adjacent to the top fastener in the aerodynamic fairing, which covers the lower part of the leg and is attached to the wheel spat (Figure 2). The screws in the fairing should all be identical; however the top two screws were found to be magnetic and heavily corroded, whereas the bottom two screws were non-magnetic and were bright in appearance. The screws were therefore made from different materials and varied in length by between 9 and 11 mm.

Fairing attached to right wheel spat

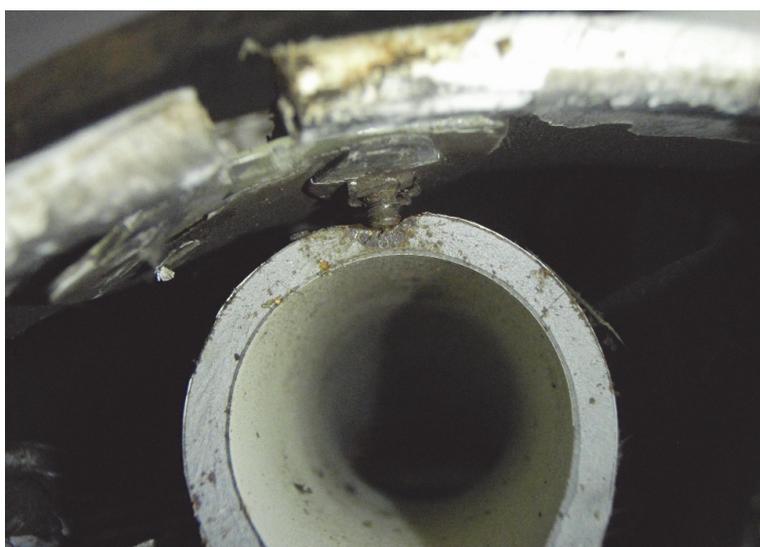
Figure 3

The top fastener had made contact with the leg and formed a dent approximately 6.8 mm in diameter and 1.6 mm deep (Figure 3). Spots of discoloration and surface damage indicated that the other three screws had also been in contact with the leg.

Top fastener in contact with the landing gear leg

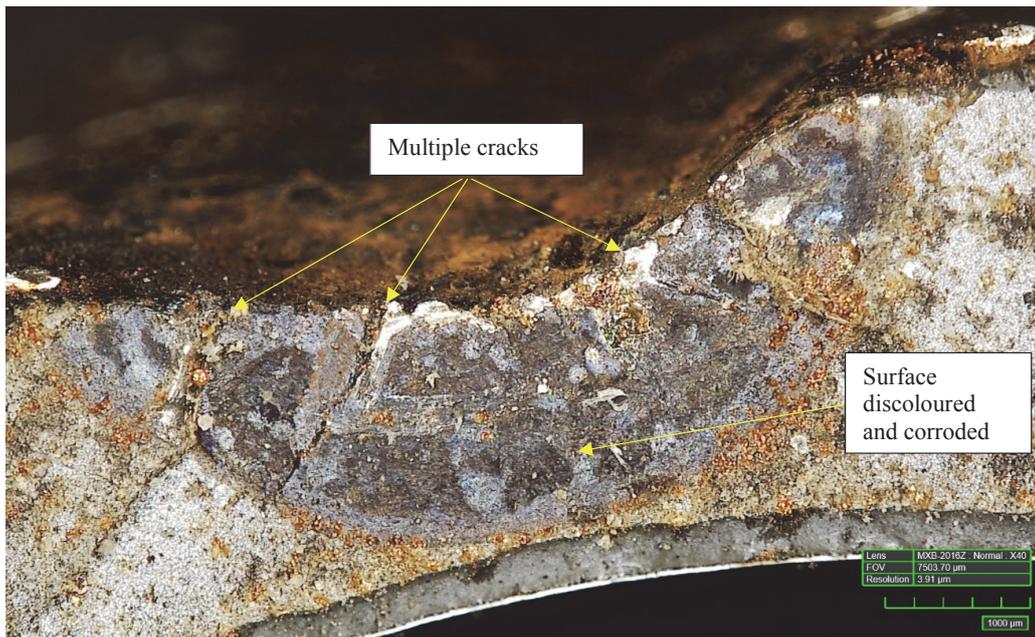
Figure 4

Examination of the fracture surface under a microscope revealed multiple cracks emanating from the dent, which had been caused by contact with the screw. The surface in the area of the dent was discoloured and corroded, and beachmarks extended from the centre of the dent to approximately 0.5 mm from the inner surface of the landing gear leg (Figure 4). The beachmarks were evidence of fatigue cracking and the corrosion and discolouration showed that the crack had grown over a period of time before it failed in overload. Due to the nature of the failure it was not possible to estimate the time period over which this occurred.

Multiple cracks and corroded surface
