Grounding of the passenger ferry *Royal Iris of the Mersey* River Mersey, UK 10 July 2016

SUMMARY

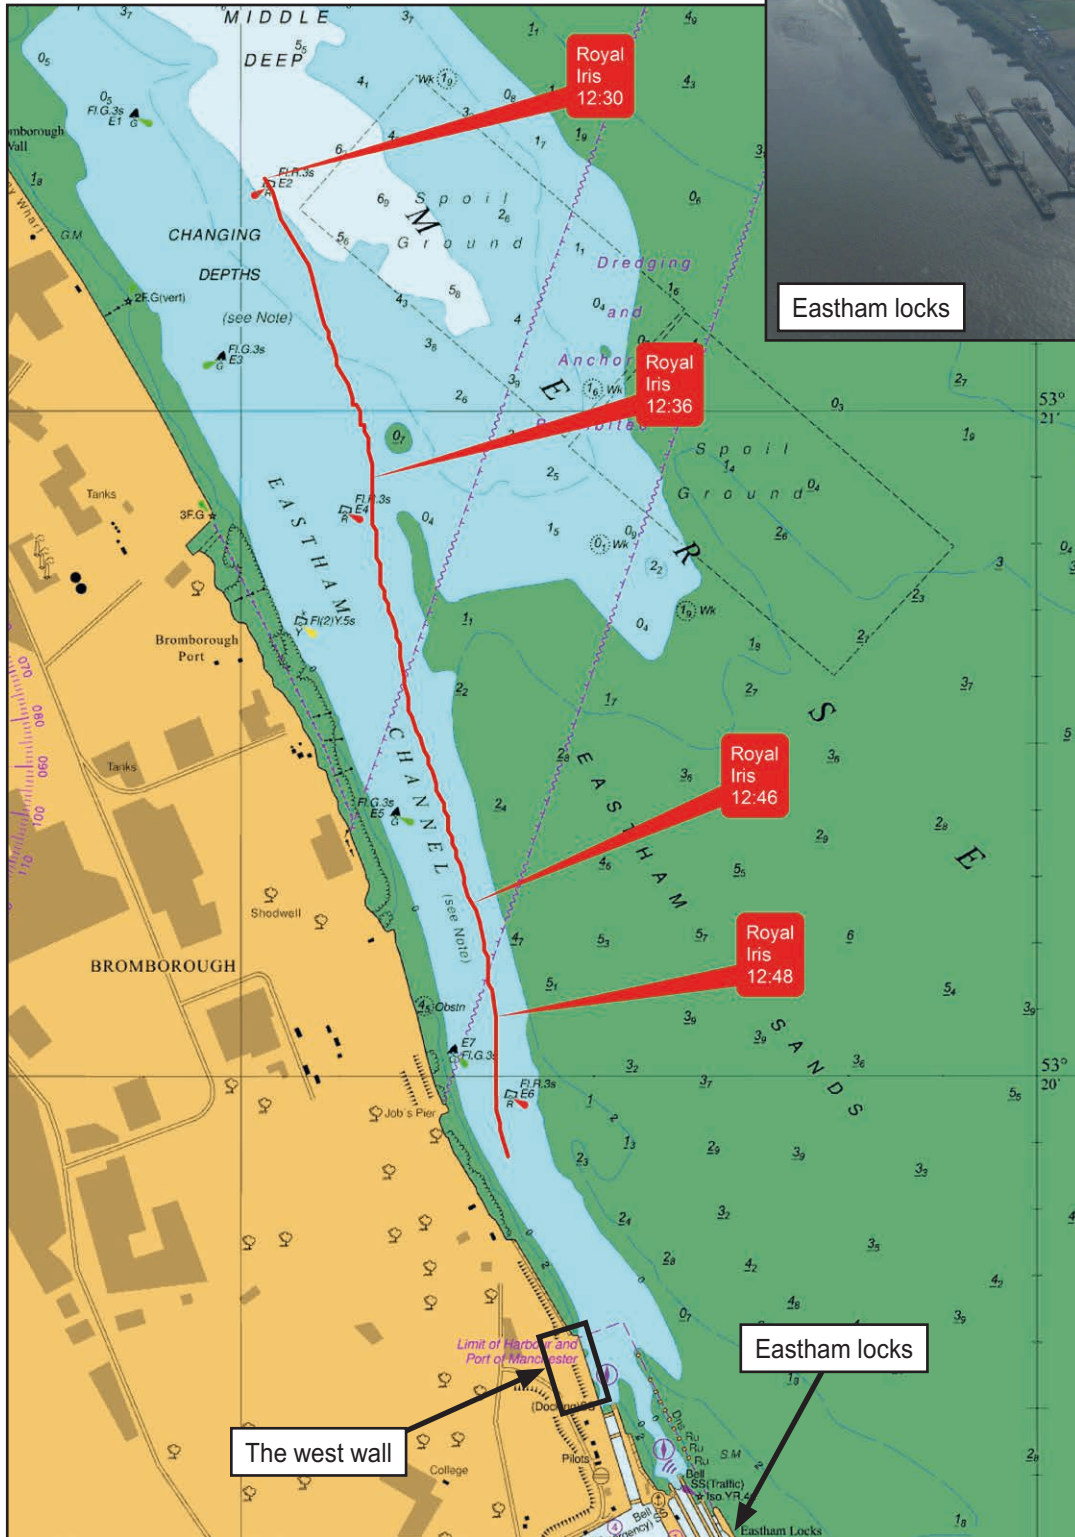
Figure 1: Royal Iris's passage through Eastham channel

At 1230¹ on 10 July 2016, the passenger ferry *Royal Iris* was on passage towards the Eastham Channel on the River Mersey (**Figure 1**). Nine crew and 66 passengers were on board the ferry, which was on a scheduled cruise of the Mersey and the Manchester Ship Canal. The master and the mate were on the bridge; the master had the con and stood on the starboard side of the bridge while the mate was on the helm on the centreline. Both were navigating solely by eye, although the depth sounder and radar were operating. The vessel's engineer was also on the bridge. *Royal Iris* was making good a course of 160° at a speed of 7.6kts². The scheduled time of arrival at Eastham locks³, at the entrance to the Manchester Ship Canal, was 1240.

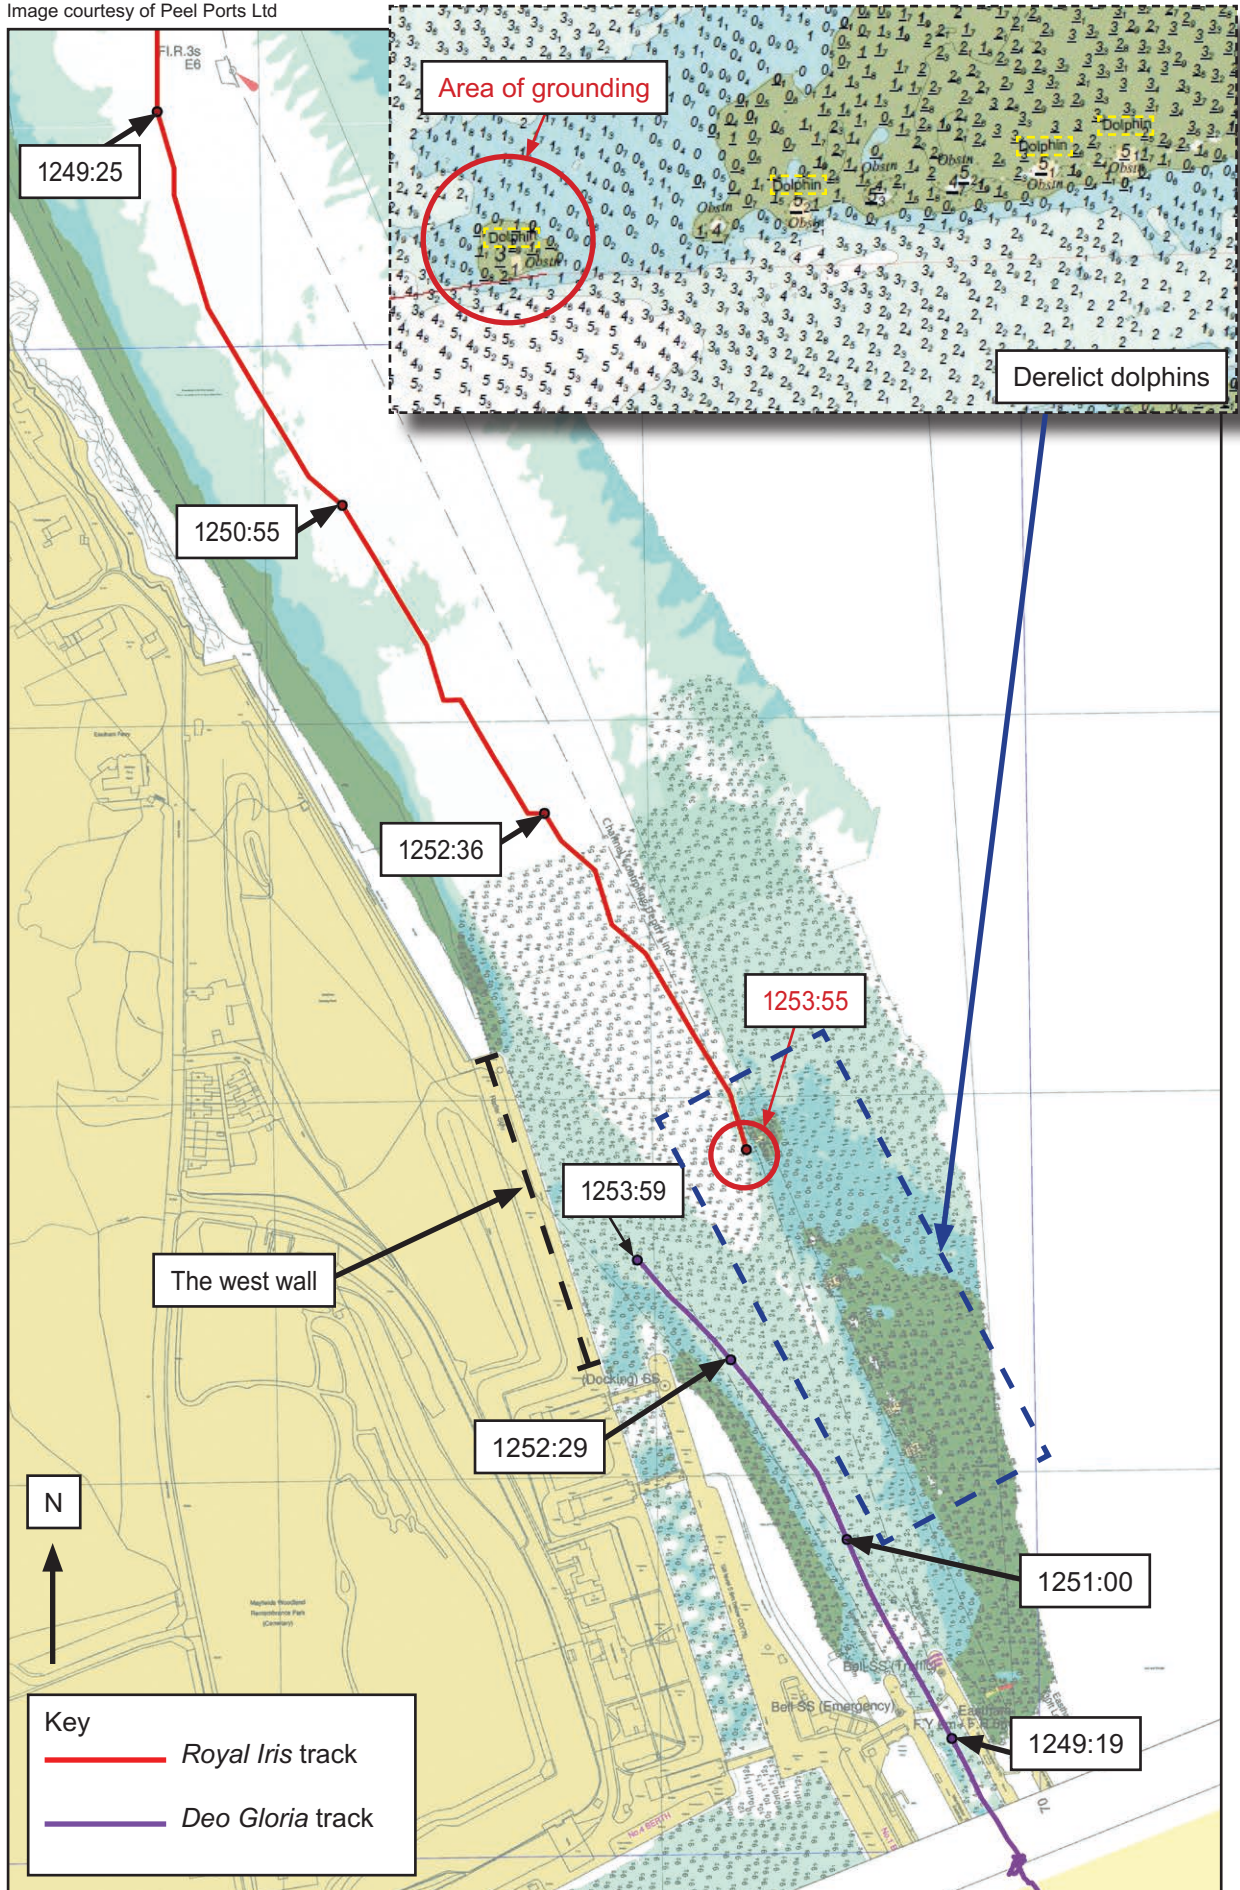
Figure 2: Plot of Royal Iris and Deo Gloria

Royal Iris passed the E6 buoy at 1249 at a speed of 6kts while *Deo Gloria* was leaving the lock. By 1251, the dredger was heading towards the west wall at the entrance to QEII lock at a speed of 3kts (**Figure 2**). The distance between the vessels was about 460m and *Royal Iris* was 560m from the lock entrance. The ferry's master briefed the mate to stay towards the edge of the eastern side of the channel and then to turn towards the lock entrance as soon as the dredger was sufficiently clear to the west to pass 'green to green'. Accordingly, the mate steered *Royal Iris* towards the eastern side of the channel (**Figure 3**).

Figure 2 shows that when *Royal Iris* unexpectedly heeled 5° to starboard and started to vibrate at 1254, the ferry's position was almost coincident with the submerged footings of the most northerly derelict dolphin on the eastern side of the approach to Eastham locks. The height of tide was 4.14m and the dolphin had a drying height of 3m. Consequently, the depth of the water over the dolphin was 1.14m, which was insufficient for *Royal Iris* to pass over with a 2.5m draught. The damage to the ferry's port propeller, shaft, stern seal, and rudder indicates that the ferry's stern swung onto the dolphin following the mate's use of starboard helm to turn the vessel toward the lock entrance.

However, because *Deo Gloria* had not departed from Eastham lock by the time *Royal Iris* passed E6 buoy and then the dredger moved slowly towards the west wall (**Figure 2**), the master had little option but to deviate from his usual approach toward the lock entrance. Instead of keeping close to the west bank after passing E6 buoy, the master told the mate to manoeuvre the ferry further to the east in order to allow the dredger to pass down its starboard side.

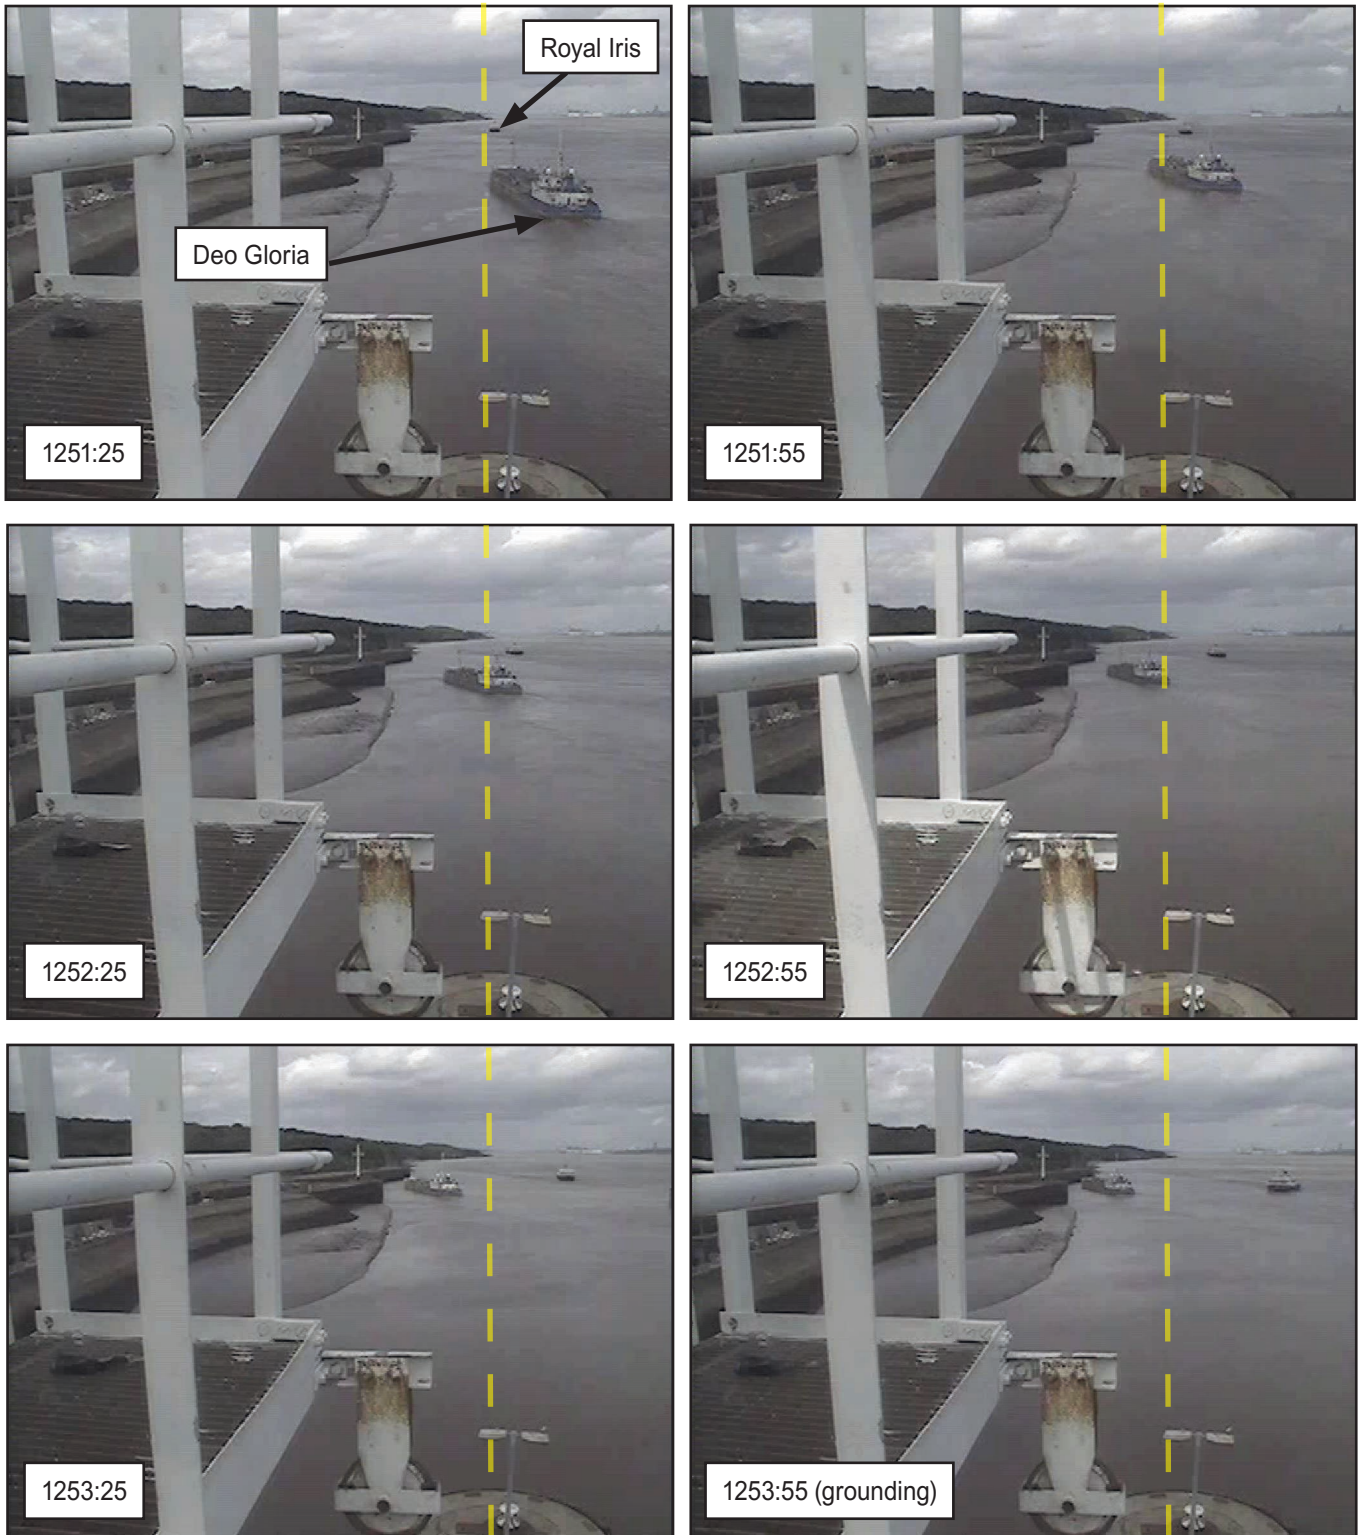
Figure 3: Movement of *Royal Iris* towards the eastern side of Eastham Channel (Yellow pecked line included to help illustrate *Royal Iris*'s drift across the channel)

Figure 3 shows the ferry's movement to the east during the 2.5 minutes before it grounded. Although the rate of movement might have been greater than intended due to the effect of the wind and tidal stream, the master and mate were not concerned about the ferry's position. Their priority was on closely monitoring their position relative to *Deo Gloria* so that the ferry could be manoeuvred towards the lock entrance as soon as possible.

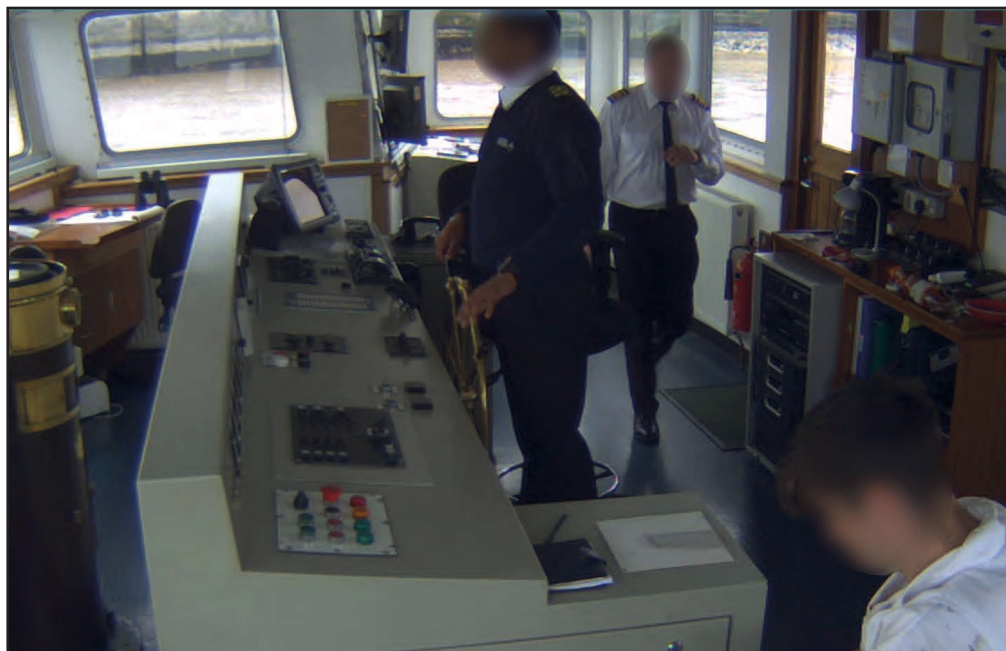
Figure 4: *Royal Iris* bridge at 1253

At about 1253, when *Deo Gloria* was sufficiently clear of *Royal Iris*'s starboard bow, the ferry's mate applied starboard helm to steer towards the lock entrance. As he did so, the master moved to the port bridge wing to assess the approach to the lock in relation to the east side of the lock (**Figure 4**). Seconds later, at 1254, the ferry suddenly heeled over about 5° to starboard. The vessel started to vibrate and both of its main engines stopped. *Royal Iris* had struck an underwater obstruction. The master was uncertain what the ferry had hit; he was aware that the ferry was on the eastern edge of the channel, but assessed that it was between 75m and 150m to the north of a line of derelict dolphins.

Royal Iris's master and mate were navigating solely by eye and the ferry possibly still appeared to be close to the west bank due to the height of tide (**Figure 4**), even seconds before the grounding. As the ferry also remained to the west of the line of the visible dolphins (**Figure 5**), *Royal Iris* would have appeared to have been in safe water. However, the margin for error was slim and the visual references were misleading. The master's assessment of the position of *Royal Iris's* grounding indicates that he was aware that the ferry had been on the eastern edge of the channel, but it also shows that he did not appreciate that it was so far to the south. His spatial awareness, and probably that of the mate, had reduced while monitoring *Deo Gloria*. Consequently, he was unaware of the proximity of the hidden danger posed by the submerged dolphin.

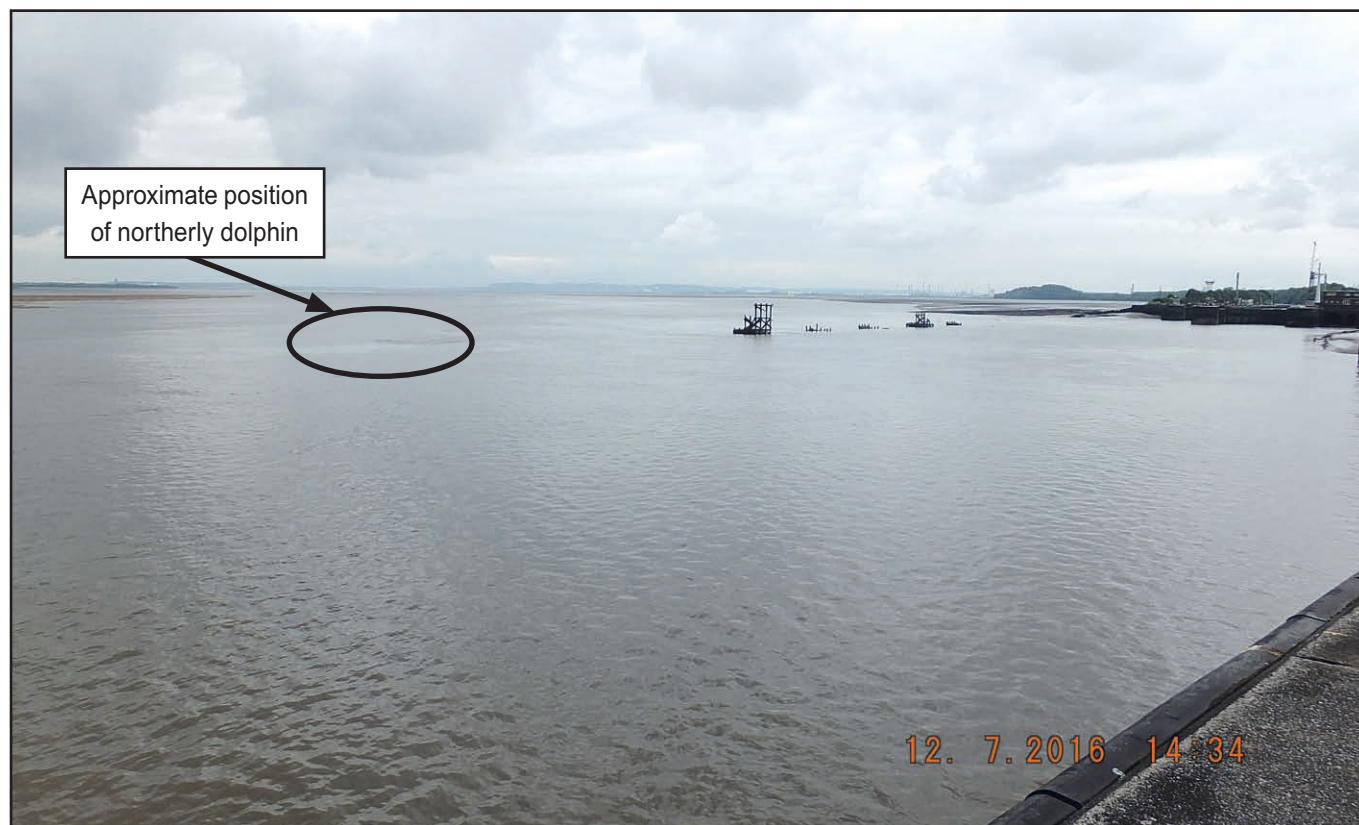
Figure 5: Derelict dolphins in the approach to Eastham locks (height of tide 4m)

Up to 10 derelict mooring dolphins were sited on the eastern side of the approach channel to Eastham locks (**Figure 2**). The drying heights of the dolphins varied between 3m and 5m⁶. The most northerly dolphin dried at 3m and was approximately 100m from the nearest adjacent dolphin to the south. The status of the dolphins when the height of tide is 4m is shown at **Figure 5**.

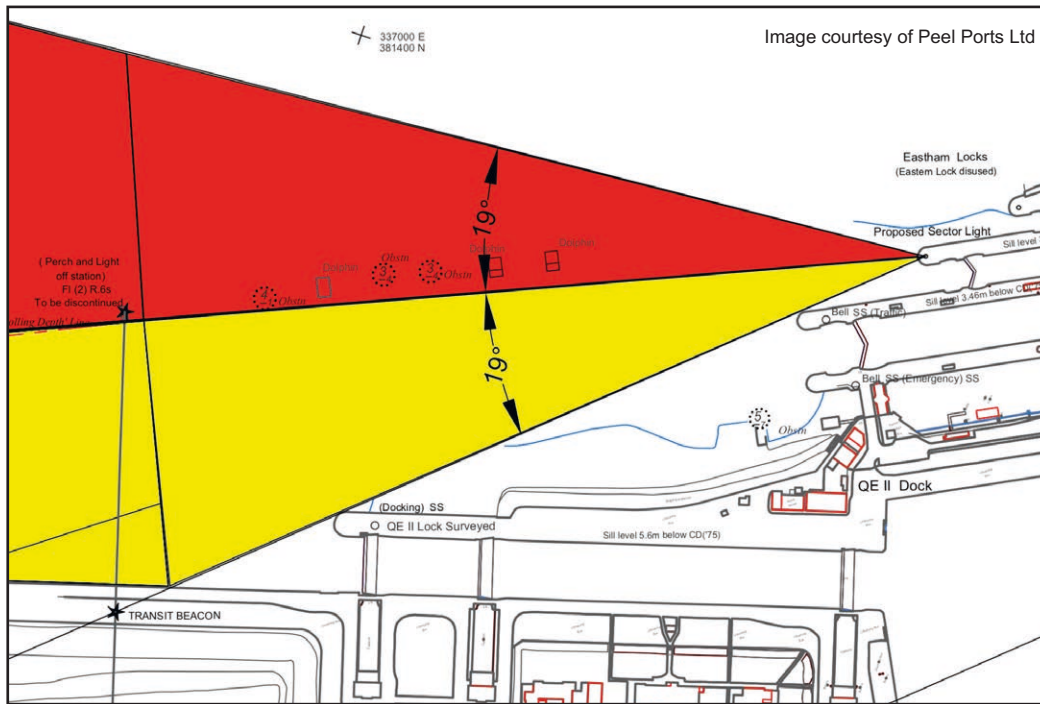
Figure 6: Sector light proposed by Peel Ports Ltd

In 2011, a light on the northerly dolphin was destroyed and was not replaced. Instead, with the approval of Trinity House¹⁰, Peel Ports installed a sector light by the locks to indicate the navigable channel¹¹ (**Figure 6**). Prior to the installation of the sector light, Peel Ports advised the United Kingdom Hydrographic Office (UKHO) and Trinity House that it had installed an ISO. YR.4s¹² 'transit' light as an interim measure. It did not

- Issued a local notice to mariners advising of the sector light at Eastham locks. It has also updated the UKHO and Trinity House on the light's status.
- Suspended the master's PEC for the area until his competency to navigate within the area has been re-assessed.
- Reviewed its aids to navigation database and its risk assessments concerning lock operations in the River Mersey and the Manchester Ship Canal.

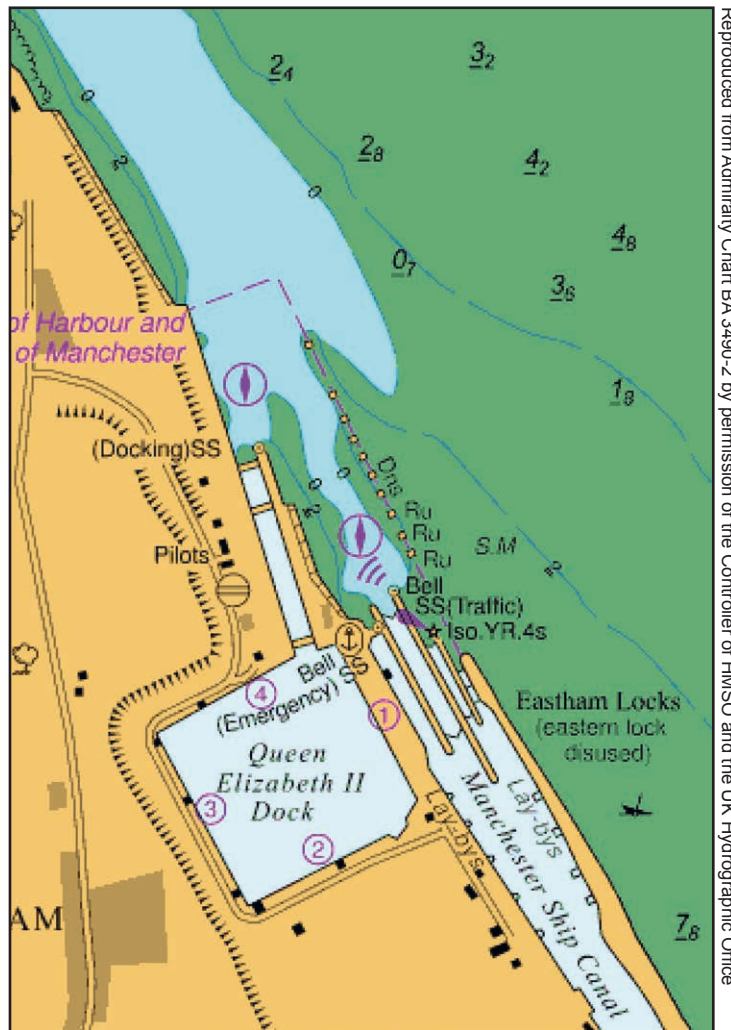
Figure 7: Extract of Admiralty chart 3490-2

In August 2012, the UKHO issued a New Edition of chart 3490-2, which covered the approaches to Eastham locks. The chart included the 'transit' light and indicated that all of the derelict dolphins remained visible above the water (**Figure 7**). A proposed draft of the new edition had been sent to Peel Ports for comment, but the port authority did not respond. Subsequently, by agreement, Peel Ports did not provide the UKHO with survey results for Eastham Channel unless there were significant depth changes when notification would be given via Peel Ports' Local Notices to Mariners.

The safe passage of a vessel to and from Eastham locks via Eastham Channel is reliant on accurate hydrographic information, particularly in view of the frequently changing depths due to siltation. Therefore, although the area was surveyed regularly, it is of concern that the changed status of the dolphins and the light on Eastham locks was not passed to the UKHO or to Trinity House. A consequence of this omission was that the information regarding these features was inaccurate on the new edition of Admiralty chart 3490 when it was released in 2012. All of the dolphins, which had evidently deteriorated over time, were shown to be permanently visible. In addition, the characteristics of the light on Eastham locks remained as ISO.YR.4s, which is not even a recognised combination.

However, although the UKHO chart's inaccuracies were potentially misleading and warrant correction, they did not contribute to this accident. *Royal Iris's* master had seen the most recent chart of the area produced on behalf of Peel Ports and he was aware of the status of the dolphins. He was also ignorant of the sector light on Eastham locks, therefore its misrepresentation had no consequence. Nonetheless, these inaccuracies highlight the importance of effective communications between port authorities

- Issued notices to mariners advising of the updated status of the derelict dolphins and the status of the navigation light at Eastham locks.
