Air Accidents Investigation Branch  
Farnborough House  
Berkshire Copse Road  
Aldershot  
Hants GU11 2HH

Published 8 June 2017

Airbus A319-131	G-EUPM	19-Oct-16	3
-----------------	--------	-----------	---

Westland Wasp HAS1	G-KAXT	23-Sep-16	18
--------------------	--------	-----------	----

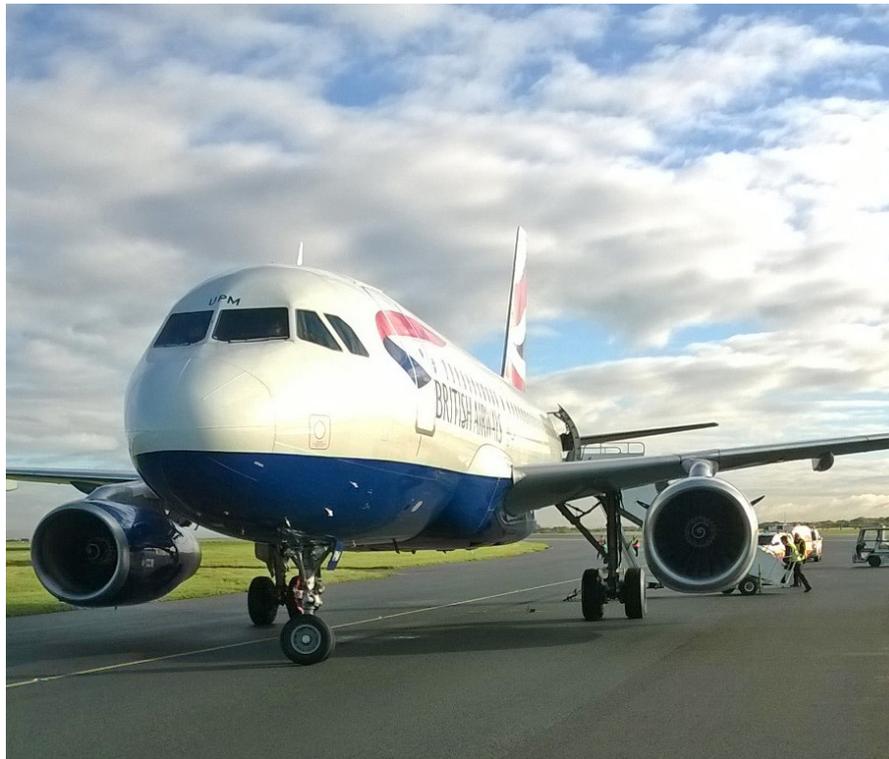
**Figure 1**

The aircraft stopped on Exit BD, 200 m from Runway 23R, with the nose slightly displaced to the left of the taxiway centreline (Figure 1). The upper and lower torque links of the nose landing gear (NLG) had separated and the nosewheels had rotated approximately 95° to the left, causing the aircraft to become immobilised. Tyre marks left on the taxiway surface showed that the nosewheels had rotated to the left following the release of the torque link apex pin.

G-EUPM position on Exit BD, prior to recovery

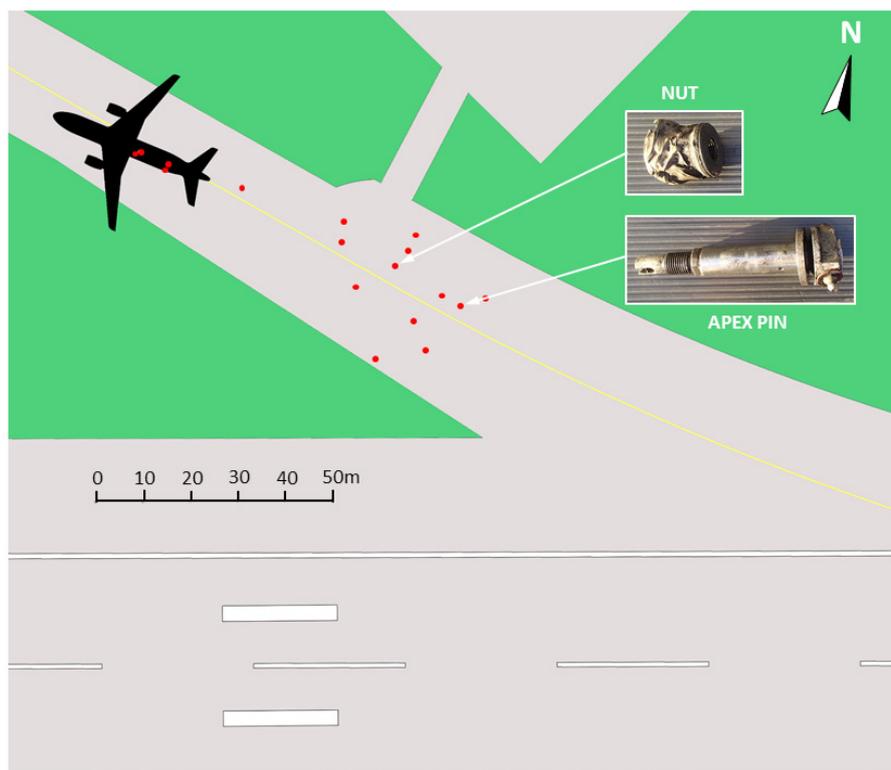
**Figure 2**

Debris shed from the nose landing gear was distributed on a 70 m path behind the aircraft. The debris included components from the torque link apex pin assembly, along with other parts of the nose landing gear that had been released due to contact with the upper torque link, which had been forced upwards by contact with the left nosewheel. The apex pin and nut were identified amongst the recovered debris (Figure 2). Despite a search of Exit BD and Runway 23R, no parts from the apex pin lock bolt assembly were found.

G-EUPM debris locations on Exit BD – red dots indicate recovered debris, including the apex pin and nut

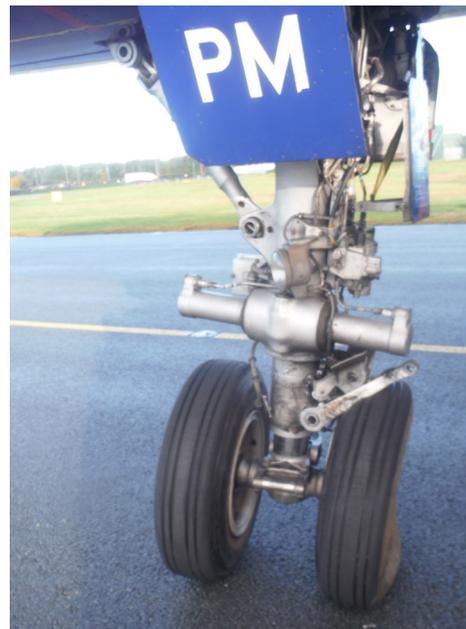
**Figure 6**

The NLG had rotated to approximately 95° to the left and the upper torque link had contacted the left nosewheel tyre, forcing the torque link upwards. The upward movement of the upper torque link caused it to fracture the NLG WOW detector enclosure and displaced the NLG WOW proximity detector target and sensor assemblies. The left WOW proximity detector had detached from its wiring harness due to its connector having pulled out of the proximity detector body. The subsequent open circuit condition of the left WOW proximity detector wiring harness was sensed by LGCIU 1, triggering the LGCIU 1 fault condition.

The left nosewheel tyre sustained abrasion damage to the inner sidewall but remained inflated, despite being heavily loaded due to the forward rake angle of the NLG (Figure 6). When the NLG was disassembled it was found that the nosewheel axle was bent, the barrel hinge pins were deformed and the rear steering cylinder had sustained an impact depression. The bottom edge of the NLG barrel sustained circumferential gouging damage<sup>4</sup> due to contact with the displaced NLG WOW proximity detector enclosure. The TPIS<sup>5</sup> wiring harness was severed at its attachment point on the upper torque link.

Displaced nose landing gear following release of the torque link apex pin

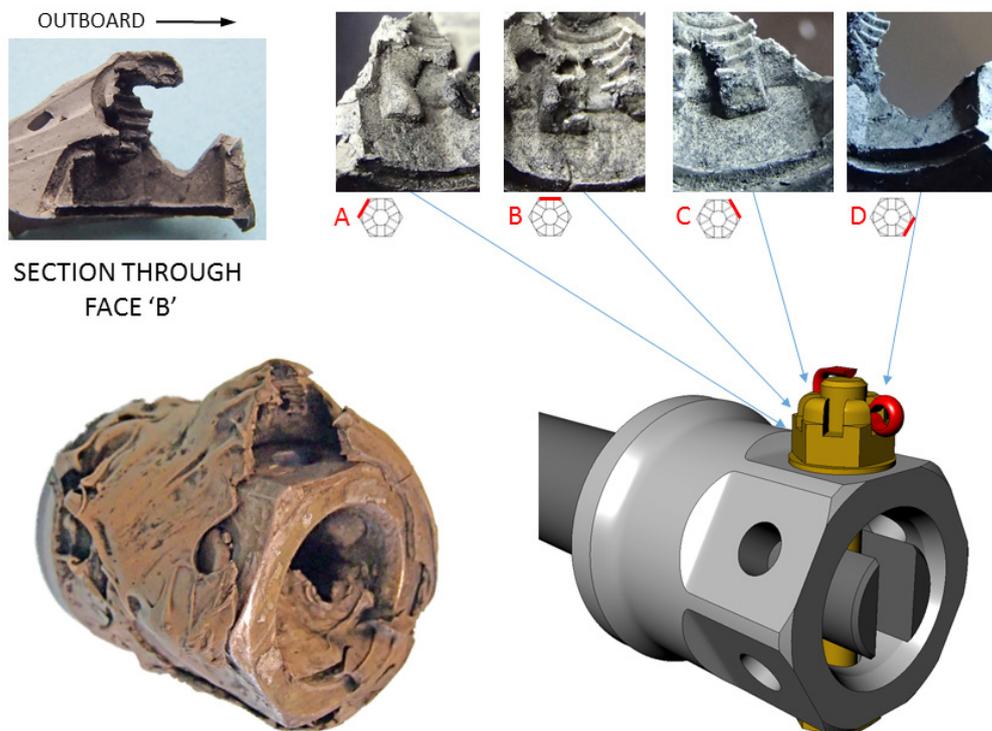
**Figure 7**

The apex pin, nut and associated washers and lockplate were recovered from Exit BD. The apex pin and nut were in good condition and did not exhibit any evidence of abnormal loading. The threads on the apex pin and nut were undamaged and when assembled, the nut freely screwed onto the pin without binding. The apex pin nut was covered in light grey cured sealant (Figure 7).

Witness marks in the sealant showed that the 3/16 inch diameter locking bolt, washer, castellated nut and cotter pin had been present when the sealant was applied, although these components were absent at the site. The sealant witness marks were examined by microscope at the AAIB (Figure 7).

Apex pin nut sealant witness marks

The sealant witness marks showed that the locking bolt had been assembled with a cotter pin prior to the application of the sealant, with the cotter pin oriented parallel to the locking bolt as per the AMM 'Second Procedure'. The head of the cotter pin had been pointing outboard as shown in the diagram in Figure 7. There was an area of missing sealant in the vicinity of the outboard edge of the castellated nut. The edges of this area of missing sealant were of a torn appearance, consistent with this area having detached from the main mass of sealant at some point after the sealant had been applied and cured.

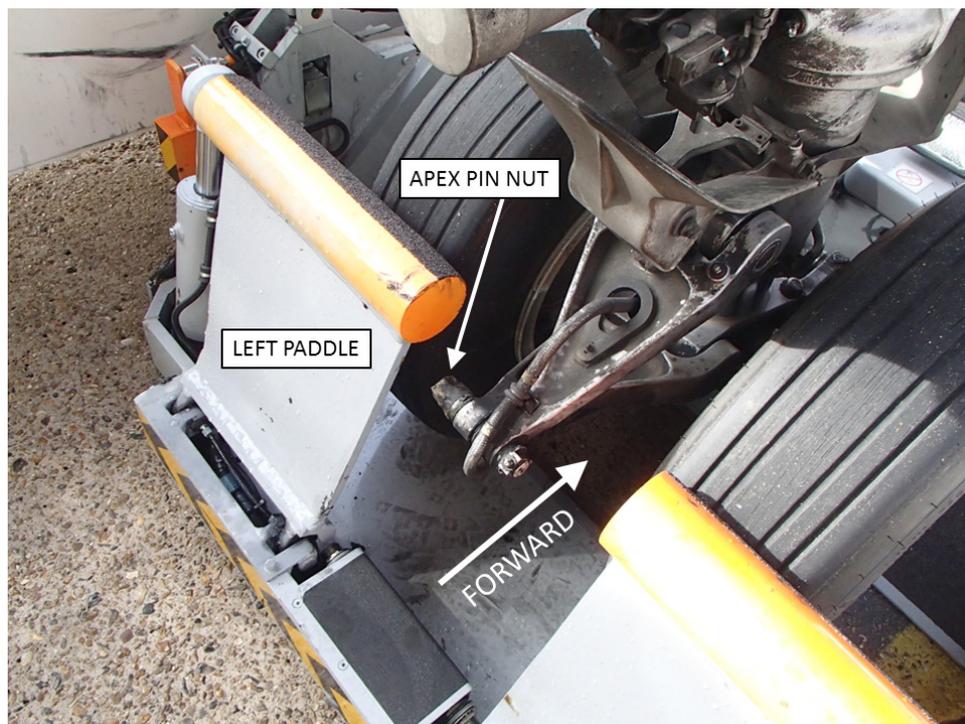
**Figure 8**

Previous cases of A320-series<sup>6</sup> NLG torque link separation have occurred in which the apex pin nut has detached due to overload rupture of the apex pin, following contact with a towbarless (TBL) tractor paddle. During towing and pushback operations, the left TBL tractor paddle is in close proximity to the apex pin nut and any significant lateral misalignment of the tractor to the aircraft can cause the left paddle to contact the apex pin nut. The contact can occur either when the tractor paddles rotate upwards to retain the nosewheels, or when the tractor rotates the nosewheels to steer the aircraft which imposes a side-load on the nosewheel tyres, causing tyre sidewall lateral deflection.

Apex pin nut and TBL tractor left paddle proximity

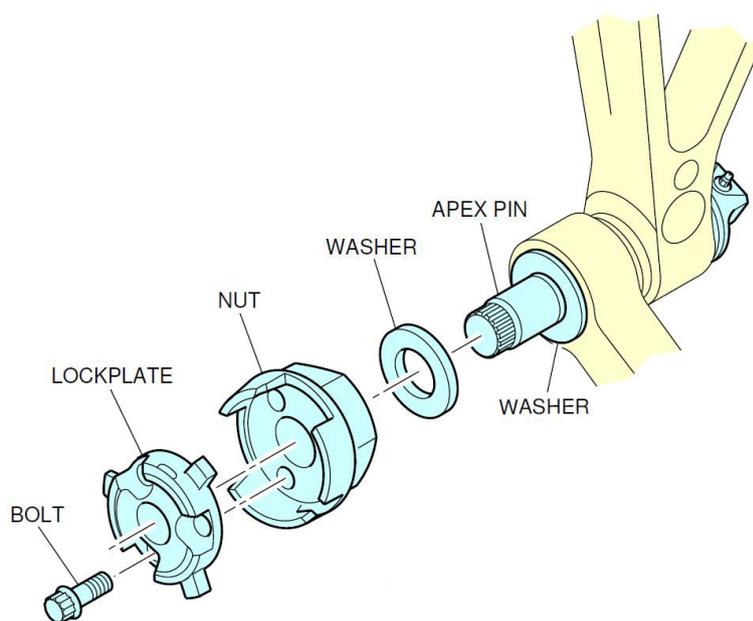
**Figure 9**

New design of NLG apex pin, nut and locking assembly introduced with SB A320-32-1400

In 2009, in response to in-service NLG apex pin fracture events, the aircraft manufacturer launched a redesign of the apex pin assembly. This activity resulted in a *'Technical Follow-up'* notice to operators, TFU 32.21.27.002, which described the in-service cases of NLG torque link separation following apex pin rupture due to TBL tractor contacts. This TFU also drew attention to Service Bulletin (SB) A320-32-1400, issued in June 2012, which introduced a new apex pin with a redesigned nut assembly, reducing the lateral projection of the apex pin nut by 7 mm. In addition to other improvements, the new design was *'developed to reduce the exposure to towbarless tractors'*, and was introduced as standard equipment on production A320-series aircraft at MSN 5154 (although, due to aircraft and parts sequencing during production, not every MSN immediately thereafter is to the post-modification standard). The aircraft manufacturer confirmed that approximately 2,400 in-service A320-series aircraft have been delivered with this modification embodied during production and none of these aircraft has experienced a torque link separation event. SB A320-32-1400 is available for retrofit to all A320-series aircraft.

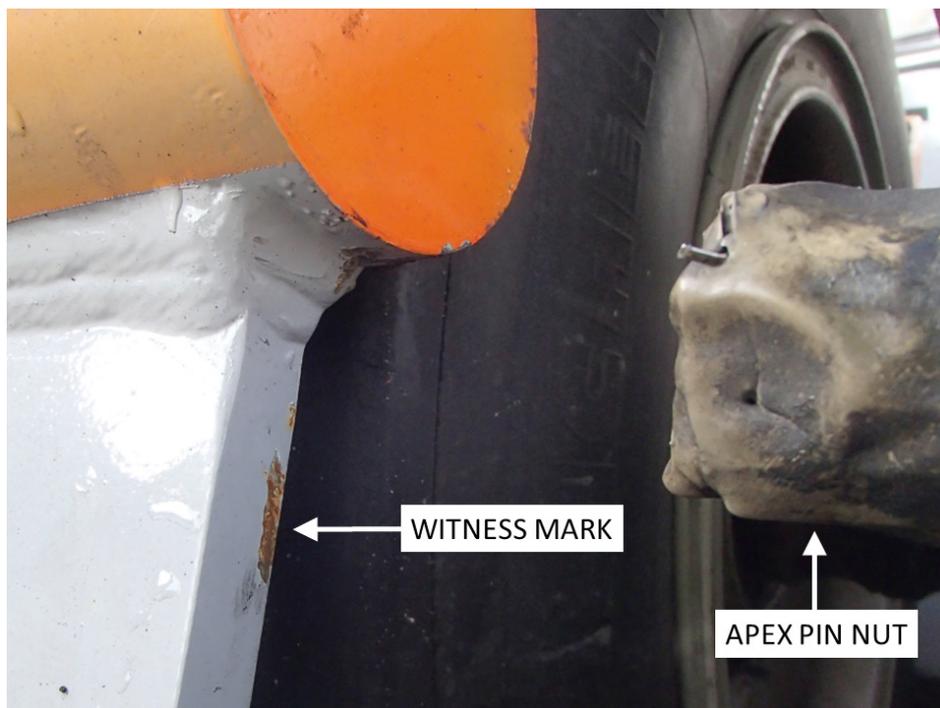
**Figure 10**

Inspection of the other 10 TBL tractors revealed witness marks on the left paddle inboard edges on eight of the units examined, Figure 10.

Example of a TBL tractor left paddle witness mark

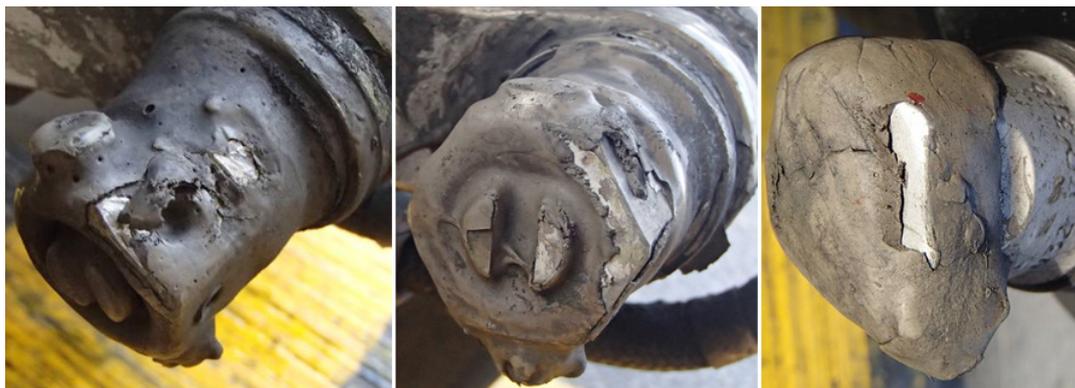
**Figure 11**

The AAIB carried out a survey of 34 A320-series aircraft, none of which had SB A320-32-1400 embodied, at Heathrow Airport as part of the G-EUPM investigation. Five of the aircraft surveyed had damaged sealant at the outboard end of the NLG apex pin nut, indicating possible TBL tractor left paddle contacts (Figure 11), although none of the aircraft surveyed had visible damage to components of the lock bolt assembly.

Apex pin nut sealant damage observed during AAIB survey

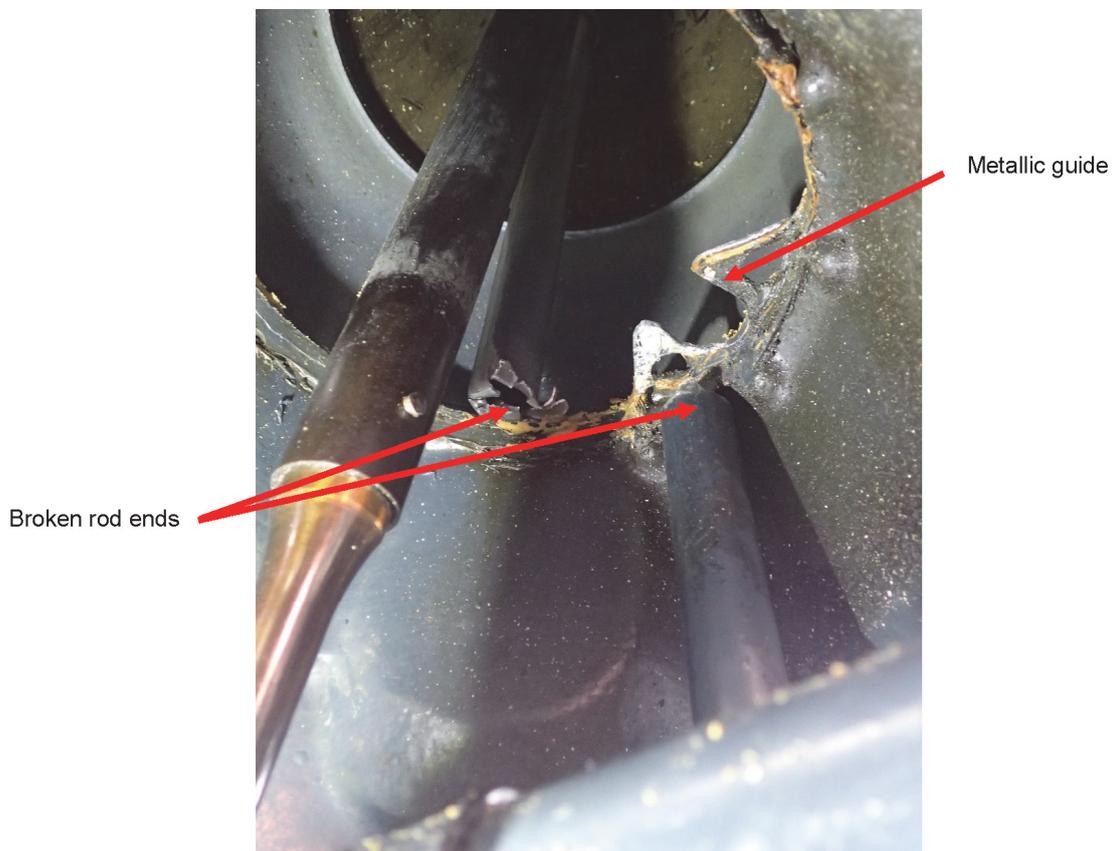
**Figure 2**

Examination, under the supervision of the AAIB, identified that the collective pitch control rod in the main rotor gearbox had broken. The failure occurred in an area where the rod passes through an aperture in a metallic 'guide' (Figure 2). By design, the rod should not touch the guide.

Broken collective pitch control rod

The circumferential fracture faces had been damaged by repeatedly impacting the surrounding structure and it was not possible to establish the initiating failure mechanism. Nevertheless, axial cracks extended approximately 30 mm away from the failure and the metallurgist identified features that were indicative of fatigue.

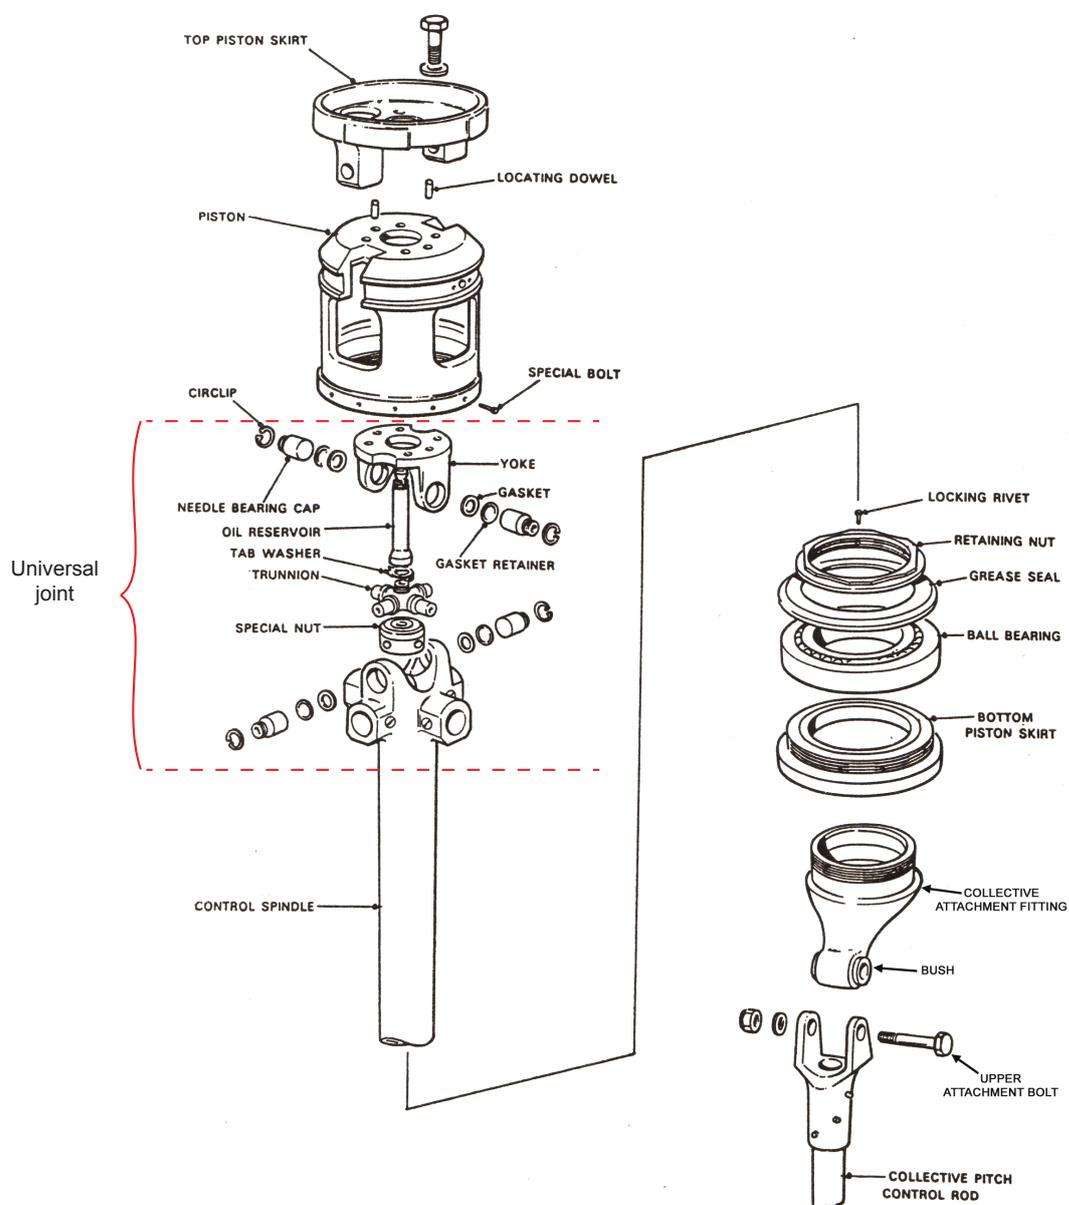
**Figure 3**  
Control hub assembly

The main rotor gearbox was removed and disassembled to access the control hub assembly and the upper section of the broken collective pitch control rod (Figure 3). All four spider arms showed evidence of unexpected wear due to repeated contact with the vertical slots in the main rotor drive shaft, which exhibited corresponding wear.

The joint between the collective pitch control rod and the collective attachment fitting exhibited excessive play. The bolt and bushes (both of which were cracked) were found to be outside the allowable wear limits. The excess play would allow lateral movement of the control rod resulting in contact with the metal guide.

Further examination of the control hub assembly identified corrosion on the universal joint and one of the 'ears' of the cyclic control spindle had broken, allowing the universal joint trunnion to become partially free. A cylindrical component found loose within the gearbox was identified to be the oil reservoir and an indentation on it had been made by contact with the adjacent piston skirt.

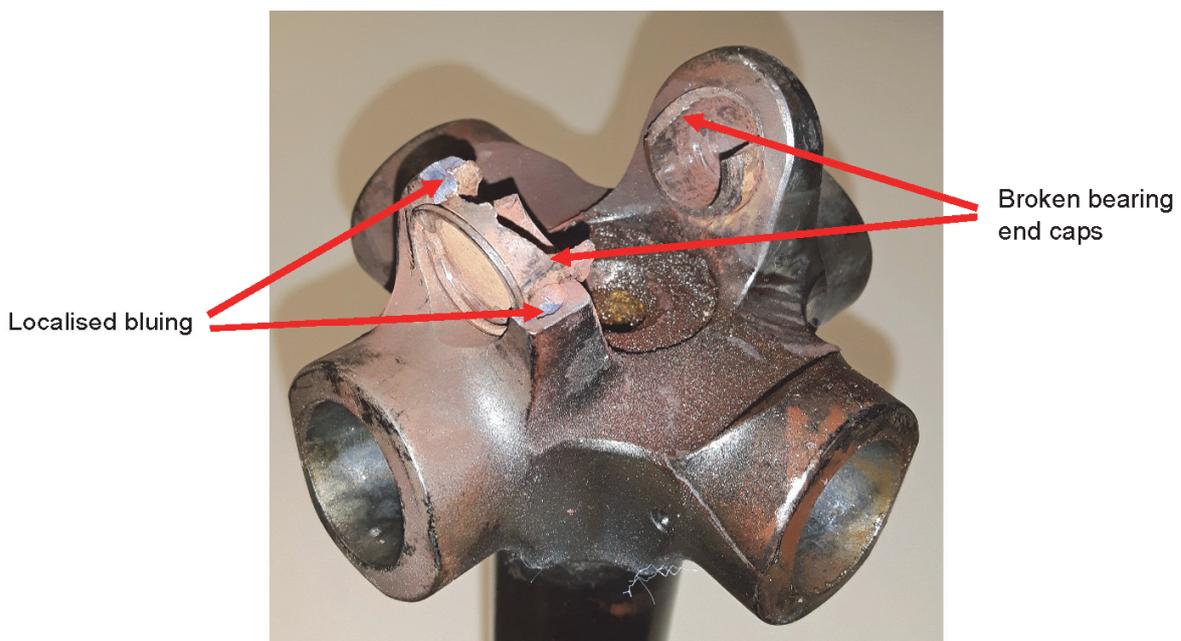
**Figure 4**

Corrosion deposits on the fracture faces of the broken control spindle ear indicated that the failure was not recent (Figure 4). Localised bluing of the material was indicative of an overheat condition. Both bearing caps were corroded and sections of their outer walls were missing; only four needles from the two needle bearing assemblies were identified.

Control spindle showing corrosion, broken ear and damaged end caps

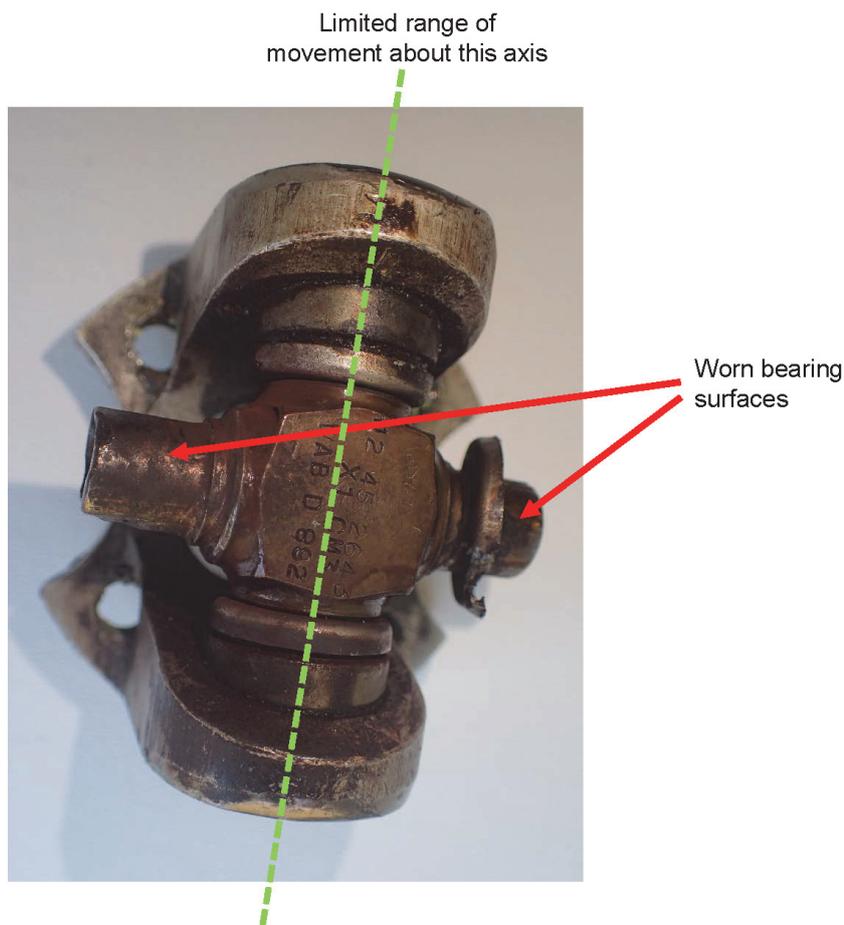
**Figure 5**

The exposed bearing surfaces of the trunnion showed extensive corrosion and wear (Figure 5). Attempts to move the trunnion about the axis that remained intact required undue force and the range of movement was restricted to approximately 10°. The evidence indicated that the universal joint had been operating with insufficient lubrication for a considerable period of time.

Corroded universal joint trunnion and worn bearing surfaces

The EMPD requires operators to perform a visual check of the condition of the universal joint and conduct periodic lubrication of the joint.

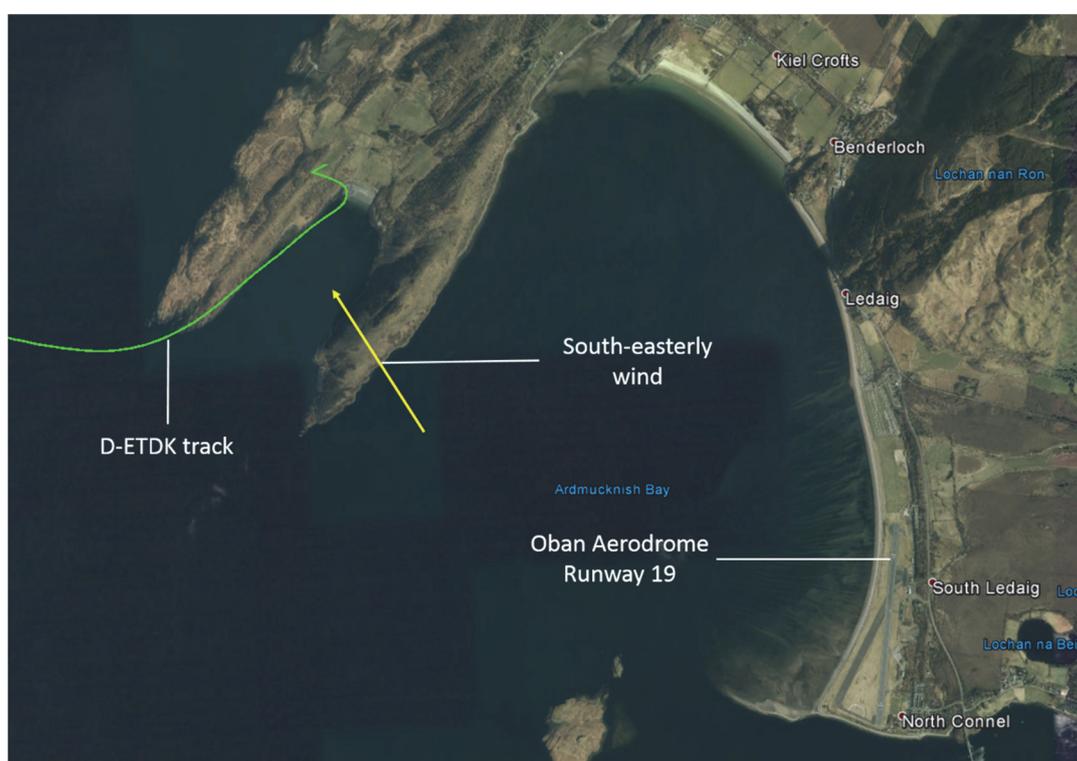
**Figure 2**

Final portion of the D-ETDK recorded track

D-ETDK struck the ground in an area of grassland adjacent to woods, on the headland to the northeast of Ardmucknish Bay, opposite Oban Airport (Figure 2). The initial impact created ground marks and removed sections of grass. A second large ground mark, preceded by several ‘slash’ marks, contained sections of broken propeller blades and parts of the engine cowl. Further sections of propeller blade were found some 20 m away. A wreckage trail of small structural items then extended on a bearing of approximately 324° toward the wreckage of the fuselage. The grass along the wreckage trail had been flattened and further ground marks where the grass had been removed were visible at various points. The fuselage was resting inverted, with the nose of the aircraft pointing back along the wreckage trail, but offset by some 40°. The ballistic recovery parachute was still attached to the aircraft and extended out in a direction of approximately 285°.

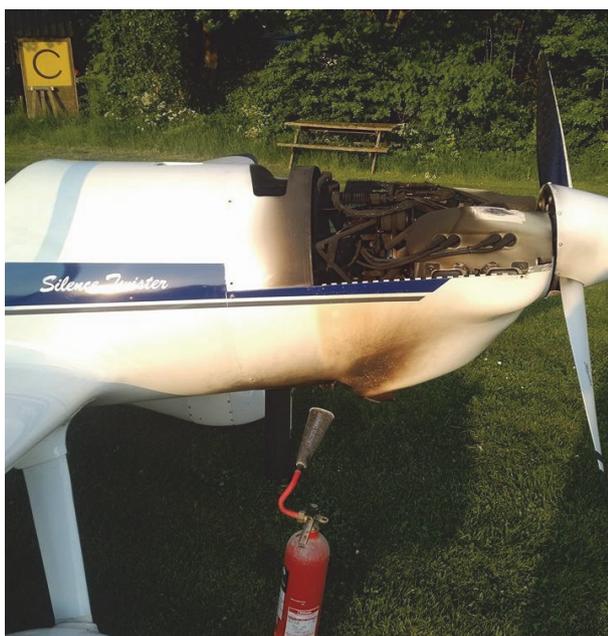
During an attempt to start the engine, and after about 5 seconds of cranking, smoke appeared above the engine cowling. The pilot turned off the fuel and fuel pump while continuing to crank. He then turned off the electrics and ran to a hangar to get a fire extinguisher. He returned to the aircraft about 20 seconds later and was able to extinguish the fire (Figure 1). The fault was traced to a sticking float inside the carburettor.

**Figure 1**  
G-TWSS after the fire was extinguished
