Rail Accident Report

**Partial collapse of a bridge onto open railway
lines at Barrow upon Soar, Leicestershire
1 August 2016**

Report 10/2017
June 2017

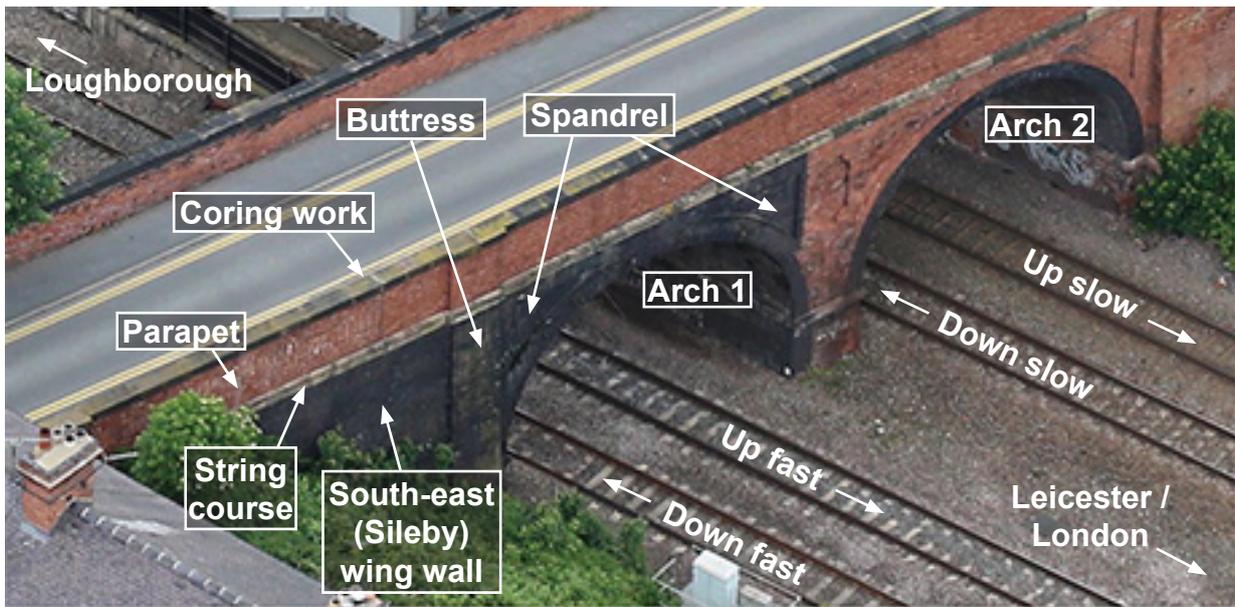
Figure 2: Location of incident and key features of Grove Lane bridge (image courtesy of Network Rail)

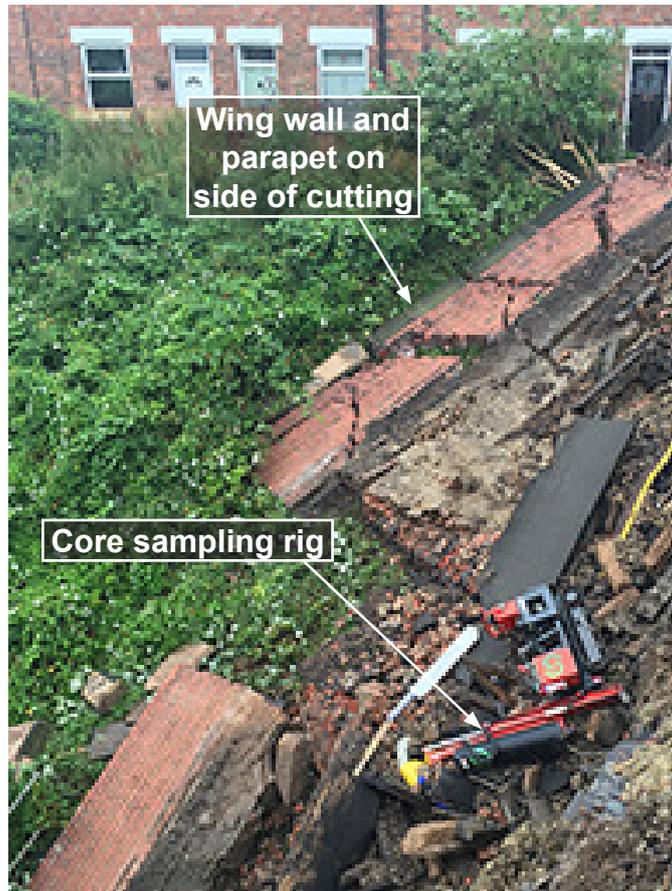
Figure 3: Masonry rubble post-incident (image courtesy of Network Rail)

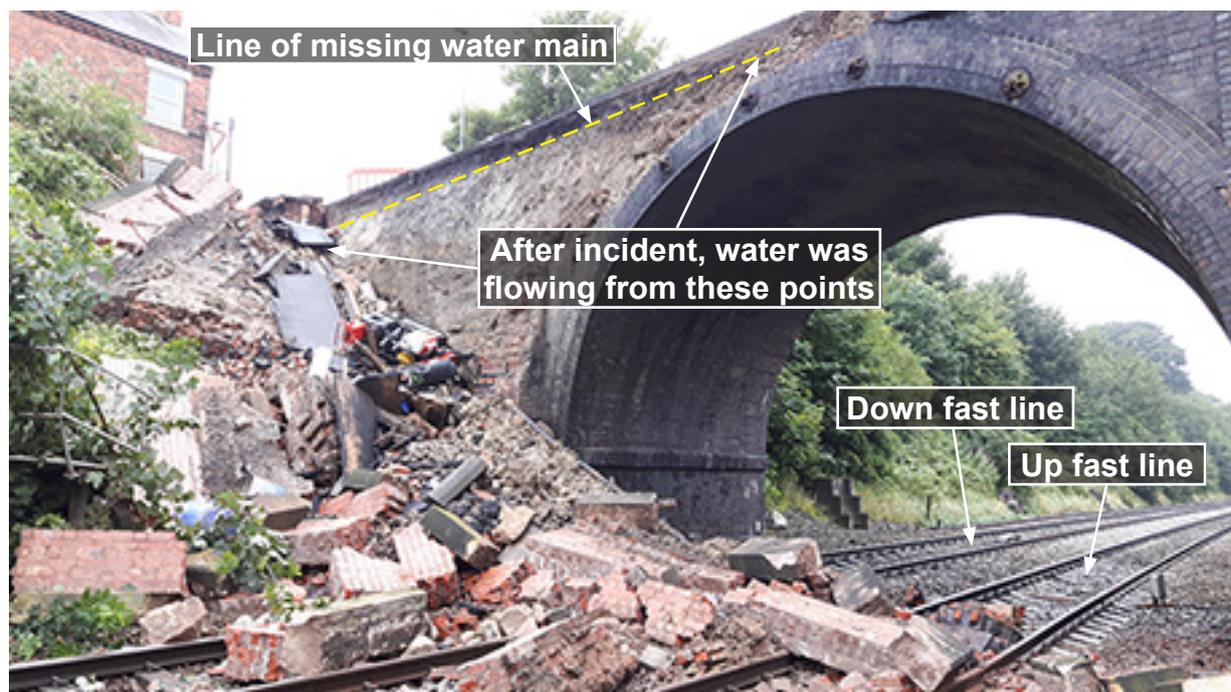
Figure 4: Extent of collapse and rubble obstructing the up and down fast lines

- 64 The strata exposed by the collapsed wing wall were analysed by Network Rail and found to be consistent with strata in the cutting face. The natural ground formation is largely Lias group³ mudstone clay with a layer of limestone about 300 mm thick, at approximately 2.6 metres below ground level. Above the limestone there was a layer of mudstone overlaid by clay-rich made ground about 1.5 metres deep. After the collapse the natural formation remained self-supporting with a near vertical stable face (figure 4).

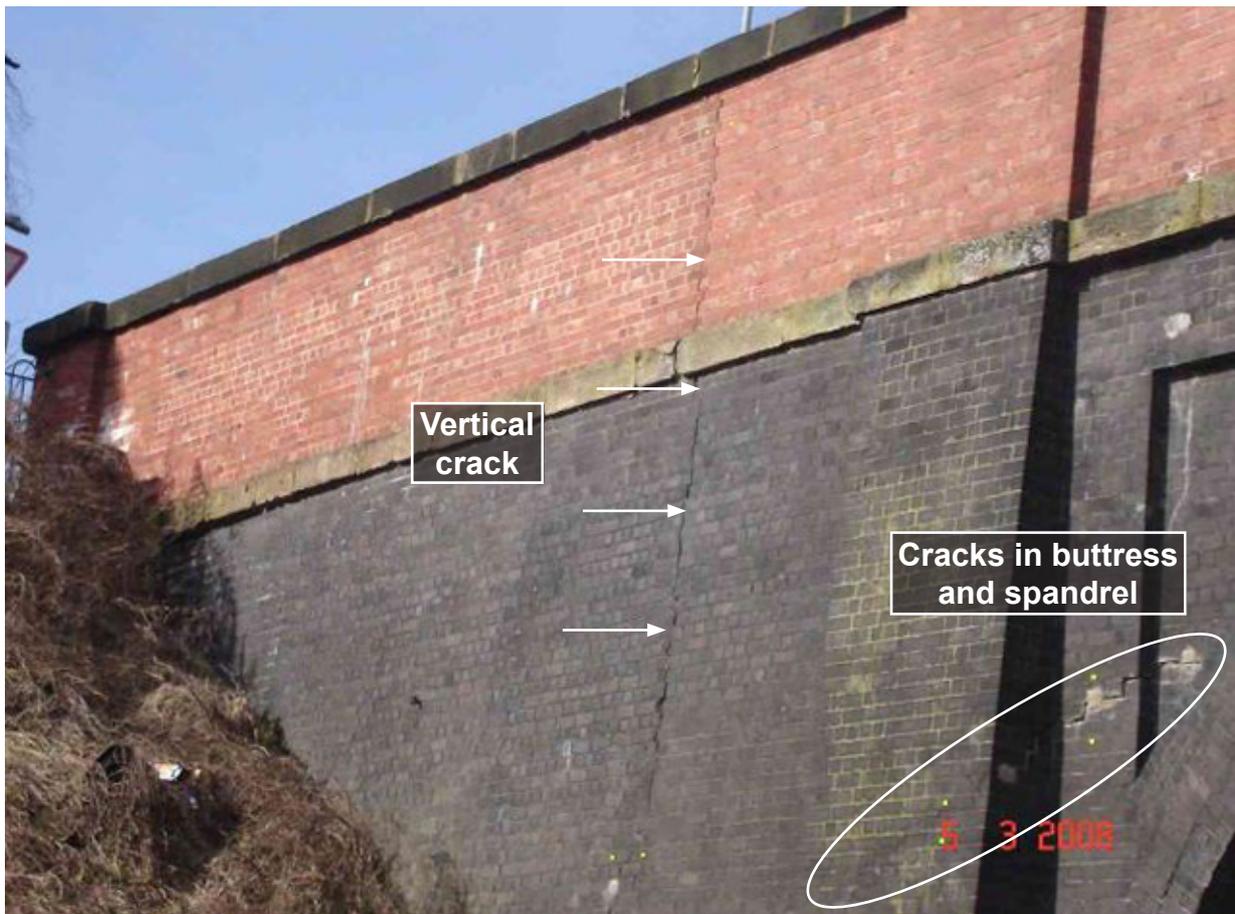
Figure 5: Vertical crack in Sibley wing wall and parapet (image courtesy of Network Rail)

- 70 The Sileby wing wall had a vertical crack extending its full height and continuing through the parapet (figure 5). It is not known when the full-height vertical crack first appeared in the wing wall; Network Rail's earliest record of the crack dated from a 1998 assessment report of the bridge's load capacity. This report also recorded a number of other cracks in the bridge masonry on both elevations.

- 71 The exact cause of these cracks is difficult to determine. The RAIB considers that the pattern is symptomatic of loading on the back of the spandrel and wing walls from the fill material and water ingress, combined with dynamic loading from the passage of road vehicles. The loading also appeared to be generating an outward tilt of the wing wall. The last additional monitoring report before the collapse recorded that the wall in the vicinity of the full-height vertical crack was leaning by almost two degrees towards the track.

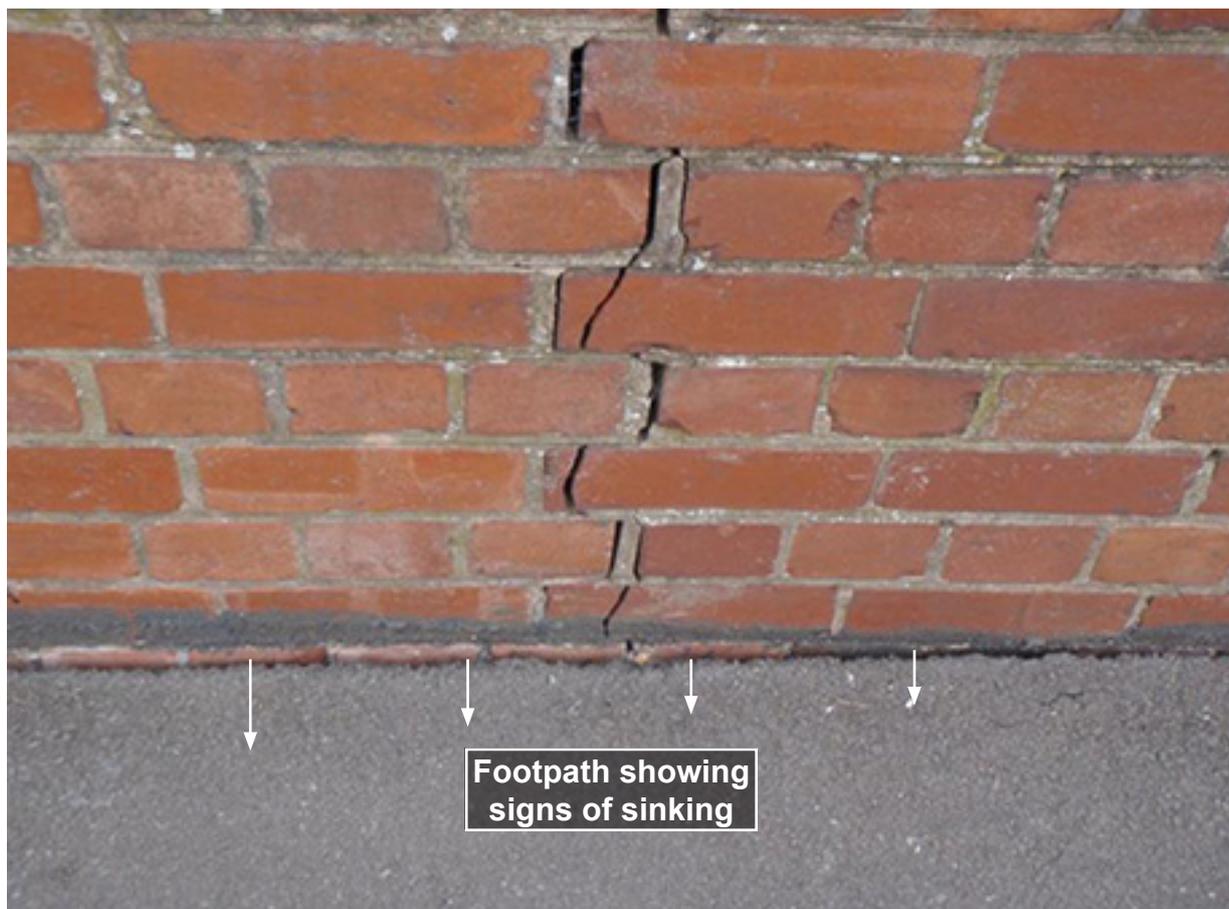
Figure 6a: September 2009 - first report of footpath sinking adjacent to the vertical crack (image courtesy of Network Rail)

- 85 In 2009, an examination report of the bridge by Network Rail's specialist contractor noted that the footpath was sinking slightly, close to the vertical crack (figure 6(a)).

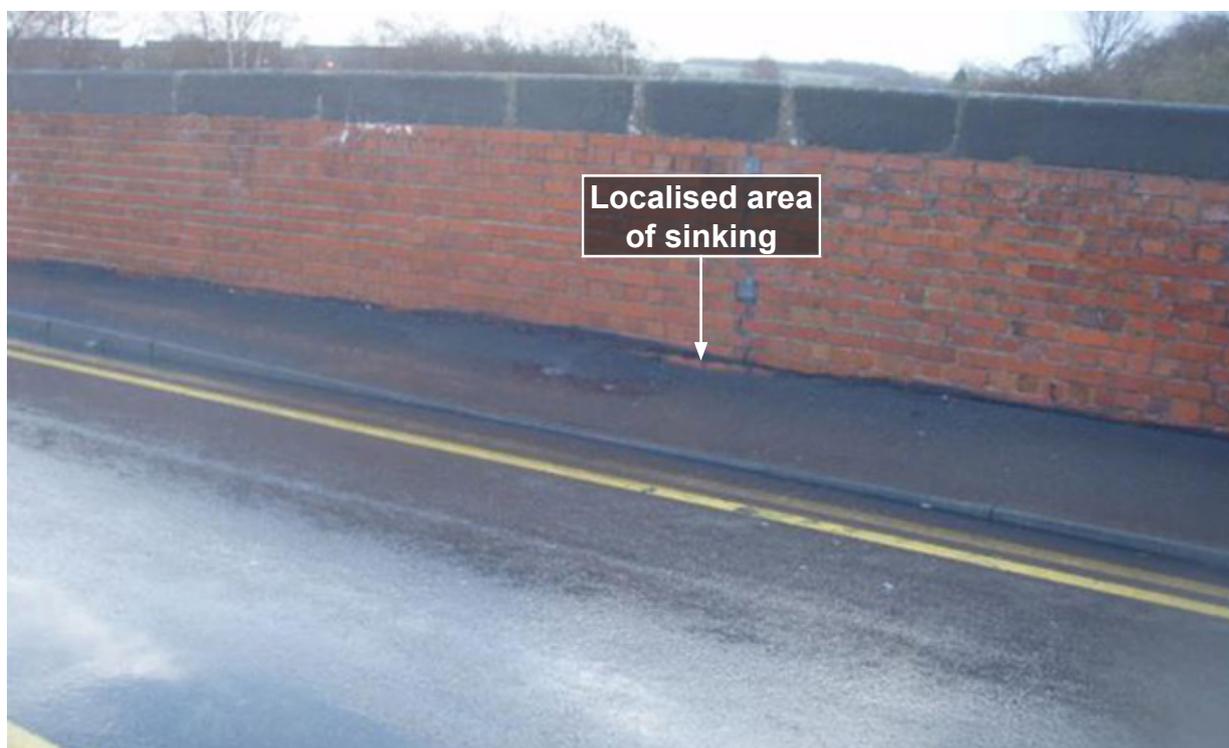
Figure 6b: January 2012 - subsidence continuing, with dips evident at both the parapet and the kerb (image courtesy of Network Rail)

- 86 By January 2012, and following a concern raised by a member of the public, it was found that the footpath had a dip of 100 mm adjacent to the vertical crack and a gap of up to 30 mm between the footpath and parapet (figure 6(b)). An excavation of the area of subsidence by a Network Rail contractor reportedly failed to find what was causing it and the area was made good. (Network Rail has no other records or photographs of the investigation.) The subsidence continued to occur (figure 6(c)) and in October 2014 a recommendation was made to Network Rail in an additional examination report that the subsidence be investigated again to discover the cause of the problem.

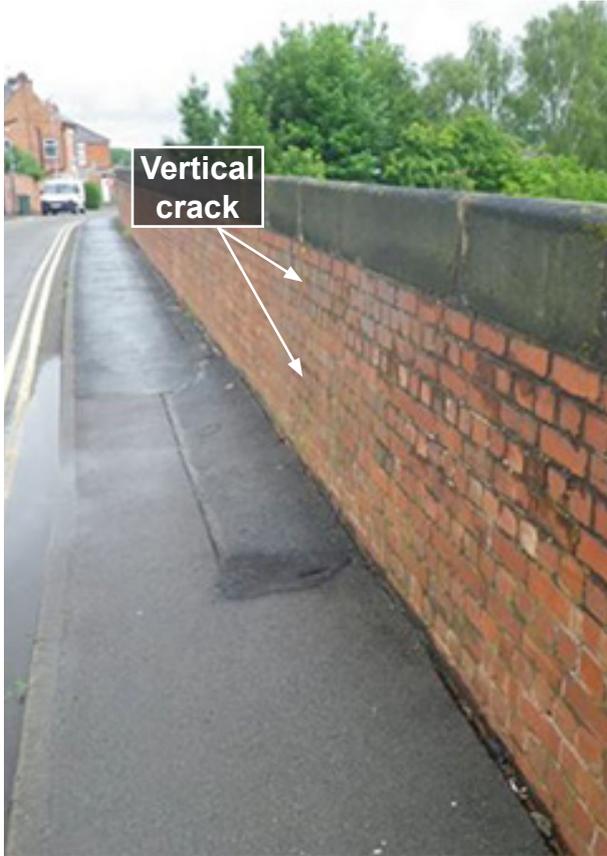
Figure 6c: June 2014 - the level of the footpath has been reinstated following the excavation in January 2012, but has continued to sink at the kerbside (image courtesy of Network Rail)

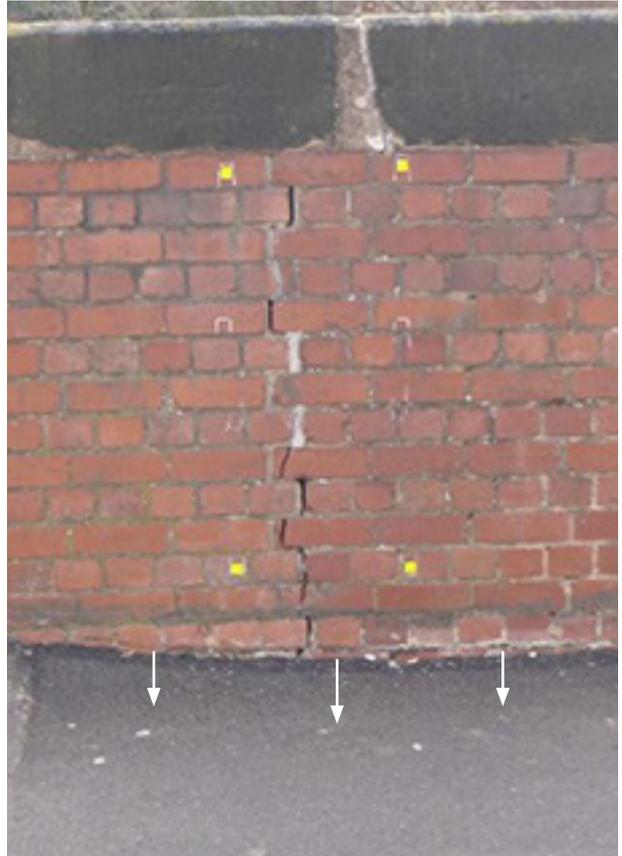
Figure 6d: March 2016 - the subsidence has recurred (image courtesy of Network Rail)

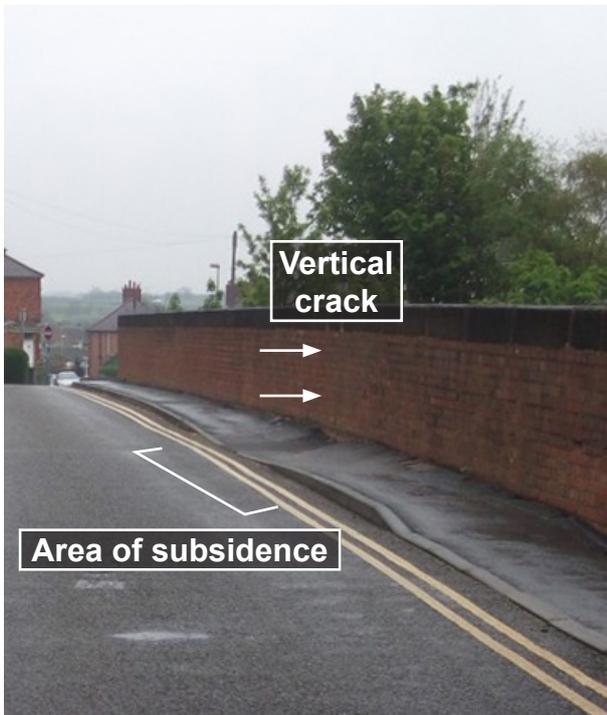
Figure 6e: May 2016 - area of subsidence in the footpath (image courtesy of Leicestershire County Council)

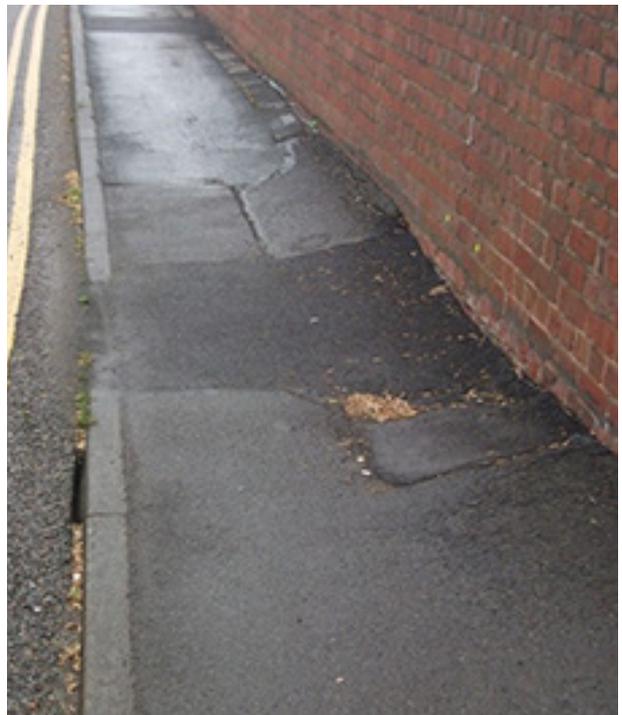
Figure 6f: May 2016 - close-up of area of subsidence (image courtesy of Leicestershire County Council)

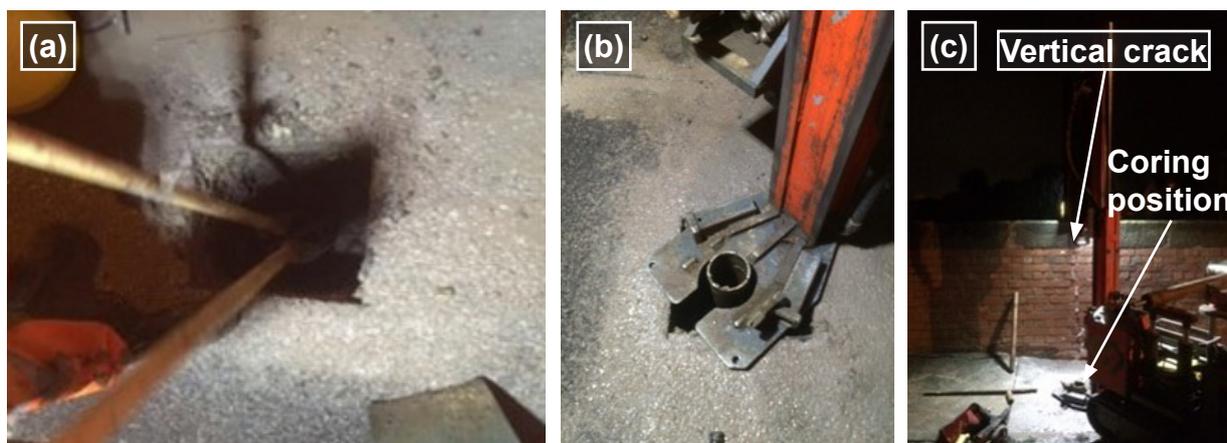
- 25 CML subsequently contracted with Central Alliance to undertake the core sampling works. However, CML was to provide the supervision, labour and equipment for identifying any underground services, breaking out the footpath and its reinstatement on completion.
- 26 On 1 August 2016, the CML supervisor and two operatives, and the Central Alliance sampling rig operator and assistant, arrived at Grove Lane bridge around 22:00 hrs. The supervisor stated that, after locating the area of work, he carried out a survey to locate any underground services using a cable avoidance tool and signal generator set (sometimes known as a 'CAT and Genny' (paragraph 106)). He then issued a 'permit to dig' for the digging of a trial hole in the footpath. The trial hole measured 300 mm by 300 mm by 800 mm deep and was reportedly centred 500 mm from the inside face of the parapet (figure 7).

Figure 7: Photographs from the day of the incident showing; (a) 300 x 300 mm trial hole being dug; (b) coring machine set over trial hole; and (c) proximity of coring to vertical crack in parapet (images courtesy of CML)

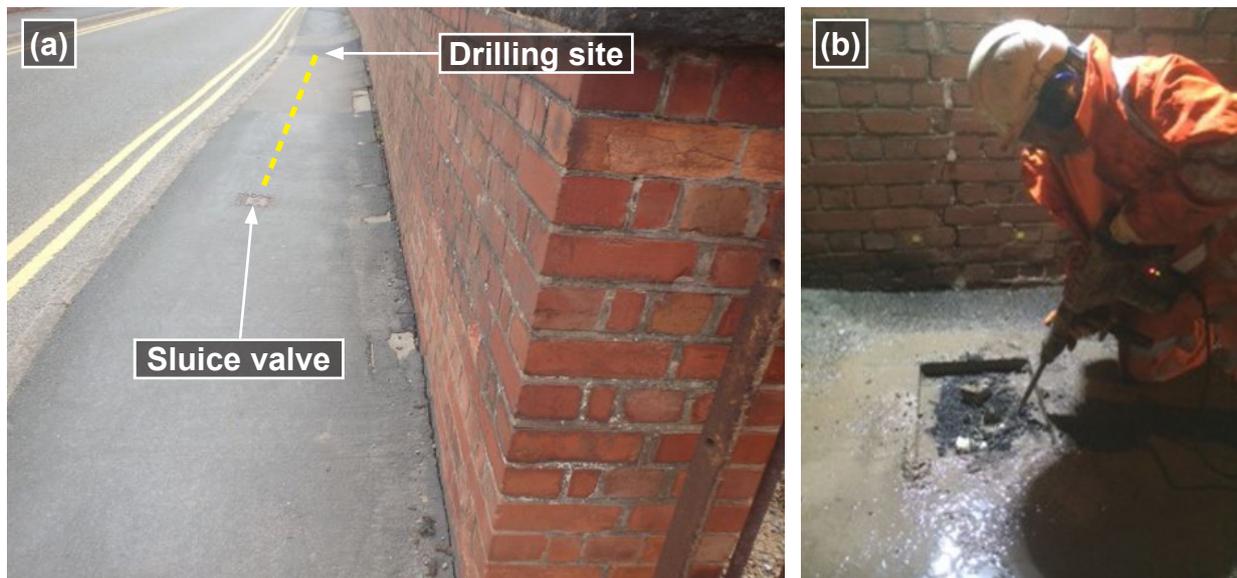
Figure 8: (a) trial hole site in relation to sluice valve (image courtesy of Network rail); and (b) trial hole on line of water main (image courtesy of CML)

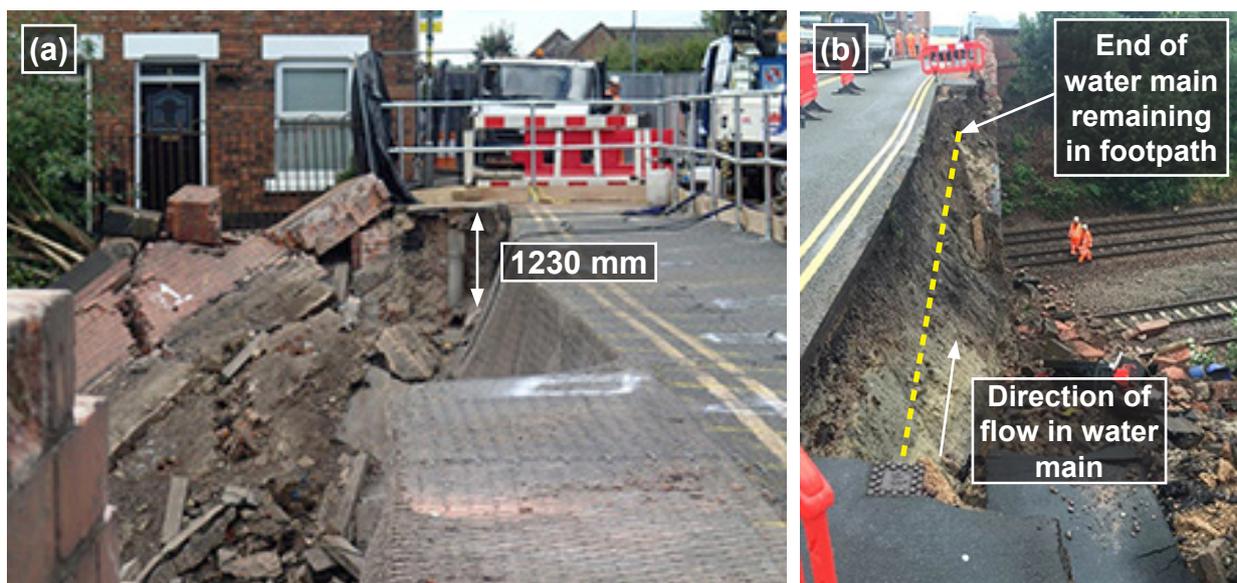
- 46 The bridge carried a 4" (102 mm) internal diameter (120 mm external diameter) cast iron water main, reported by STW to be around 70 or 80 years old, with a service life of over 100 years. The water main had an inner cement-mortar lining, which was thicker at the bottom of the pipe, indicating that it had been applied in situ and had slumped before setting. STW had no record of when the lining was applied.
- 47 The water main ran under the footpath adjacent to the Sileby wing wall. It was fitted with a sluice valve, accessed via a manhole in the footpath, approximately 2.6 metres from the end of the Sileby parapet and around 7.5 metres from the area of subsidence (figure 8(a)). The water main (to the top of the pipe) was 1230 mm below ground level at the sluice valve (figure 9(a)).

Figure 9: (a) exposed sluice valve and depth of water main; and (b) alignment of water main in footpath (image courtesy of Network Rail)

- 48 The water main was considered by STW to be a high pressure main. It was rated for a pressure of at least 10 bar³ and at the time of the incident the pressure in the main was reported by STW to be around 7 bar. The direction of water flow is shown in figure 9(b).

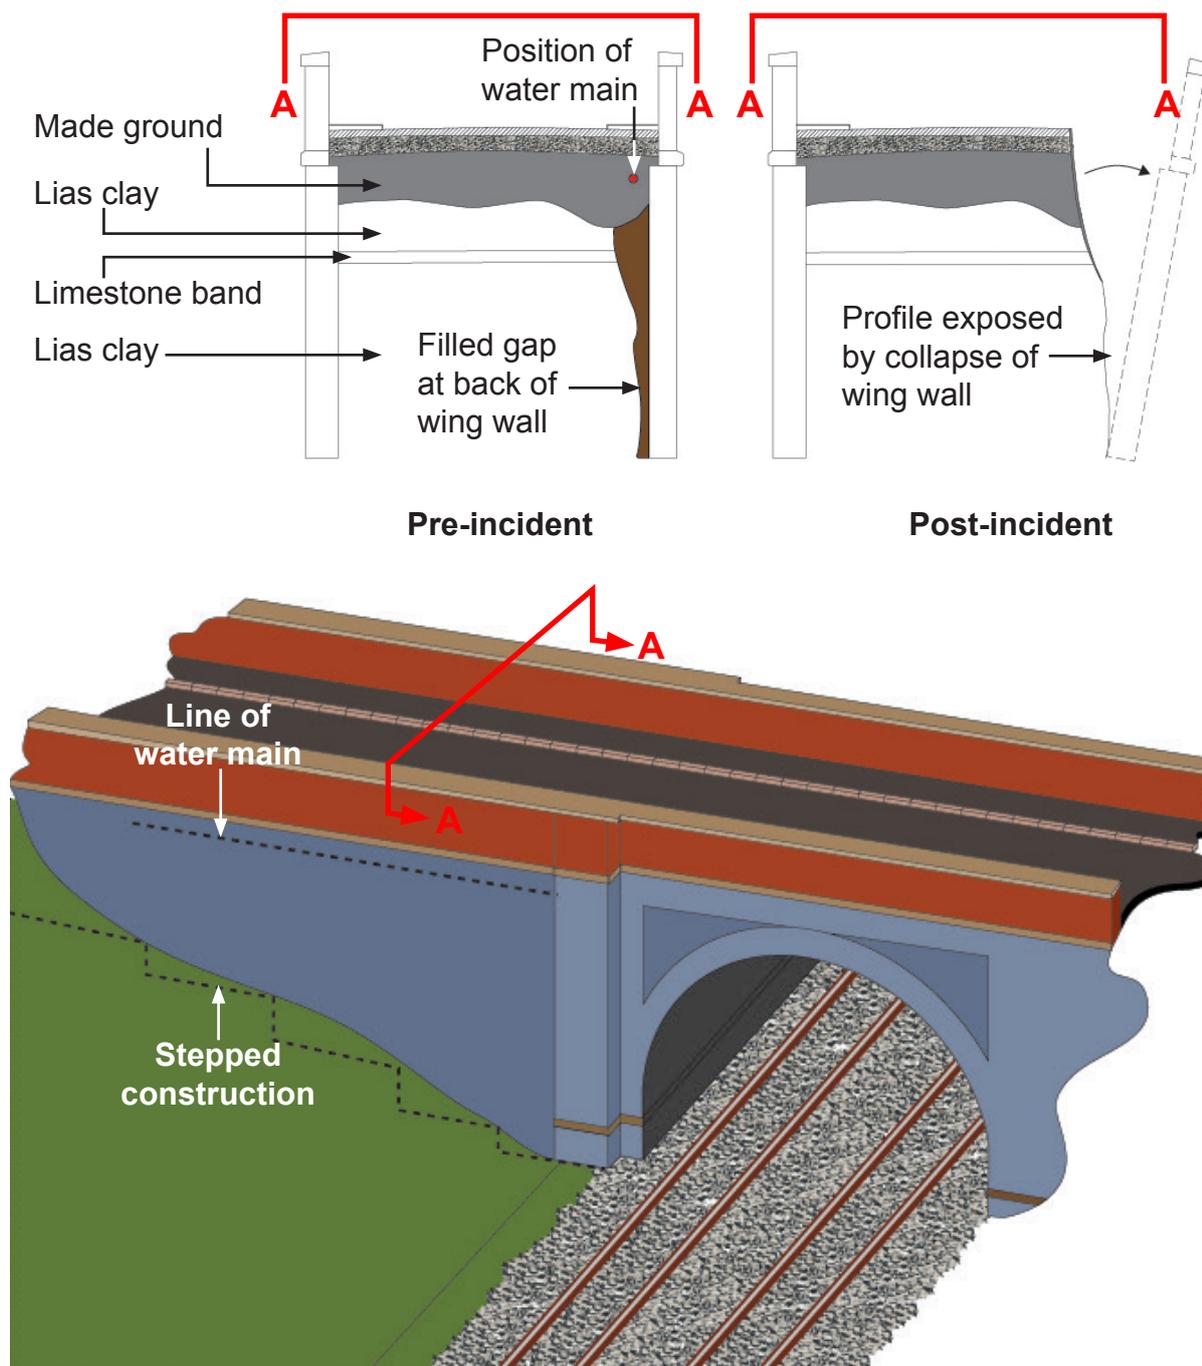
- 65 The investigation found that the Sileby wing wall was built as a free-standing wall, to 'face' the projecting formation. It was built as a stepped structure into the slope of the cutting and had little or no foundation (figure 10).

Figure 10: Schematic diagram showing section through bridge in area of collapse

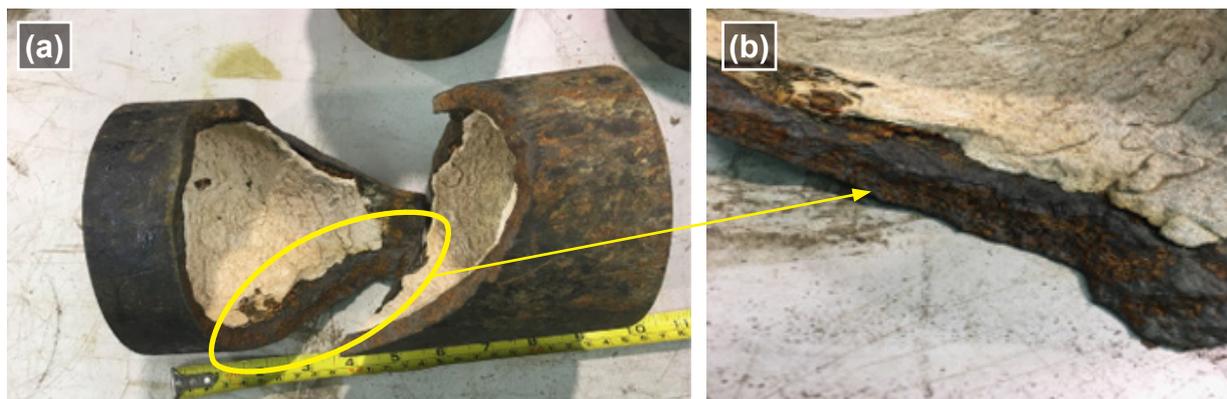
- 74 Examination of the water pipes, carried out by RAIB's forensic specialist, found that a section of water main under the area of subsidence in the footpath had corroded through the full thickness of the pipe wall. This combined with other evidence summarised below indicates that the pipe was probably leaking (figure 11).
- 75 The RAIB's forensic specialist reported that the tapered sides to the corrosion indicated that it had started on the inside of the pipe, possibly because of a defect in the lining at this location, and progressed through the pipe.
- 76 At the site of the leak there was also evidence of pitting on the outside of the pipe from oxygenated wet corrosion, suggesting that water had collected under the pipe.

Figure 11: (a) fractured ends of the two mating lengths of water main and area of corrosion. Note that some of the pipework is missing; and (b) close up of area of corrosion (images courtesy of SureScreen Scientifics)

- 77 The corrosion mechanism (known as graphitic corrosion⁵) is of a type that forms a labyrinth of small channels, through which water can pass and emerge as a slow leak. In the experience of the RAIB's forensic specialist, cast iron high pressure water pipes with corrosion of this type can survive without catastrophic failure for many years. This is because the remaining metal in the pipe retains some strength to hold the pipe together. The RAIB's forensic specialist estimated that the pipe had been leaking for approximately five years and possibly longer.

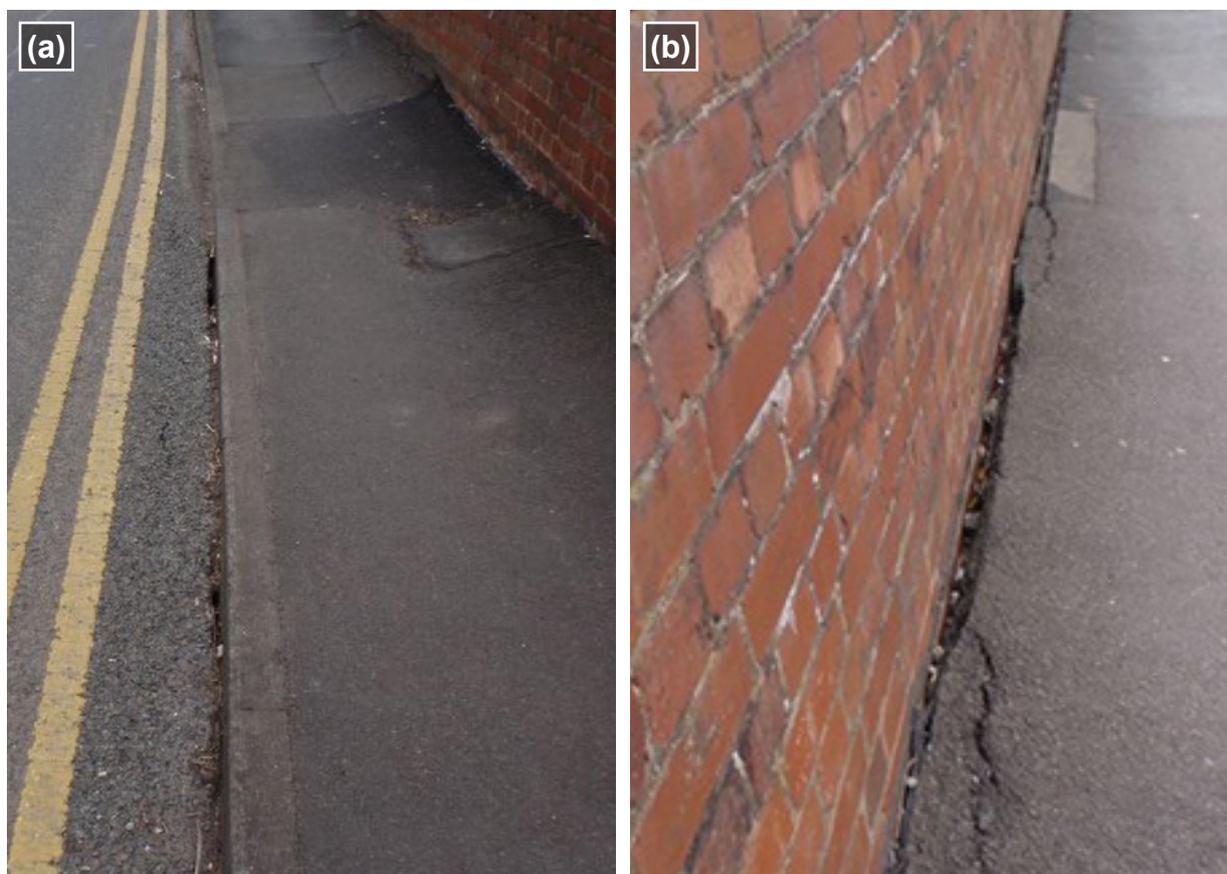
- 82 The footpath was sinking and there was relative movement between the kerb and the road and also between the footpath and the parapet, creating gaps through which water could ingress. The last additional examination of the bridge before the collapse, carried out in March 2016, recorded that the gap between the kerb and the road measured up to 30 mm wide by 500 mm long and varied from 100 to 200 mm deep (figure 12(a)). The gap between the footpath and parapet was typically between 5 mm and 50 mm wide with a maximum depth of 70 mm (figure 12(b)).

Figure 12: (a) March 2016 - void at kerbside; (b) May 2012 - gap opened up between footpath and parapet (images courtesy of Network Rail)
