Service Inquiry

Yak-52 G-YAKB

8 Jul 16

SERVICE INQUIRY INVESTIGATION INTO ACCIDENT INVOLVING Yak-52 G-YAKB on 8 Jul 16.

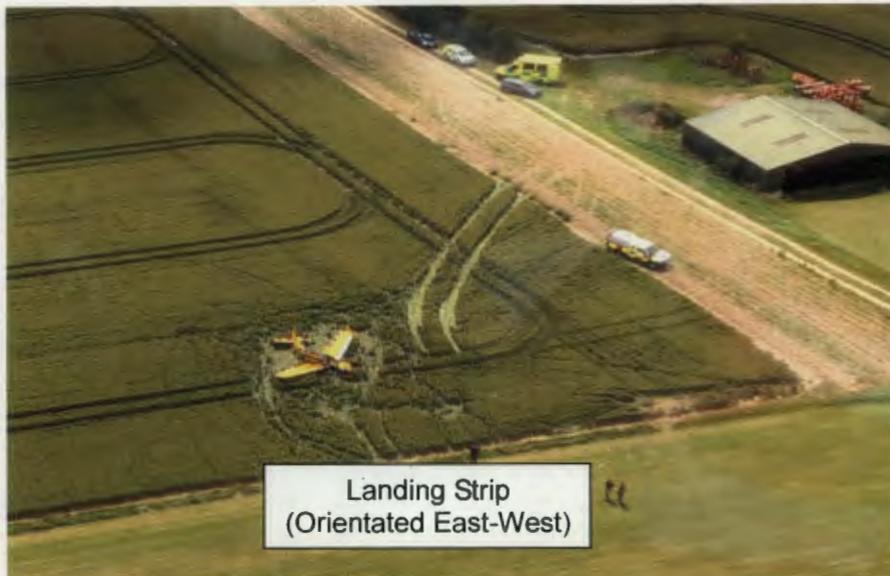
the south western edge of a landing strip orientated east/west, approximately 800m to the south west of the last radar contact. Four distinct witness marks indicated the initial impact point of the aircraft and subsequent movement. The aircraft had impacted the ground left wing first travelling downwind in an easterly direction, rotated onto its nose and subsequently came to rest facing in a northerly direction amidst, and partially concealed by, standing crops. The surrounding crops at the fourth impact point were mostly undamaged and indicated a near vertical arrival at the final resting point. During the accident sequence the FSP was thrown from the aircraft. The crash was contained within approximately 33 metres. The aircraft fuselage, wings and tail-plane were intact; the engine, although co-located with the remainder of the wreckage, was almost completely detached.

Figure 1.3.4. Crash Site from approximately 600 ft, Looking in Southerly Direction.

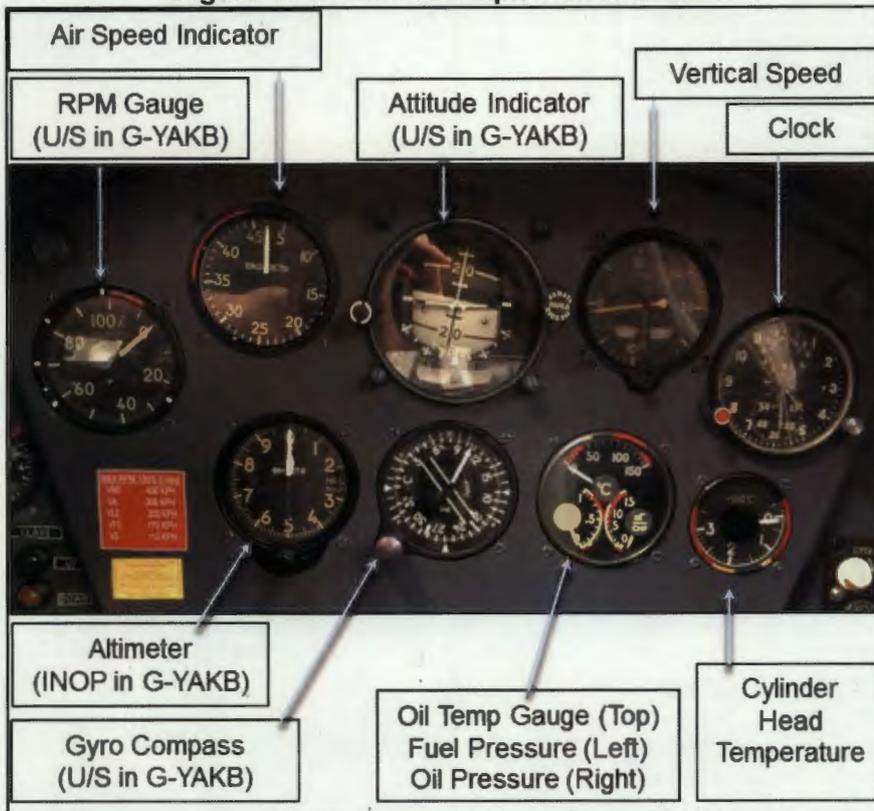
Figure 1.4.3 Rear Cockpit Instruments

1.4.83 The rear seat altimeter in G-YAKB was inoperative and placarded⁴¹ 'INOP'. The inoperative state of the altimeter was recorded in the aircraft logbook. The Panel were not told that the inoperative state of the rear altimeter was briefed to the ETPS students and no ETPS FTE student interviewed noticed that the altimeter was unserviceable or that it was placarded. The altimeter was not physically inoperative but had failed an accuracy test.

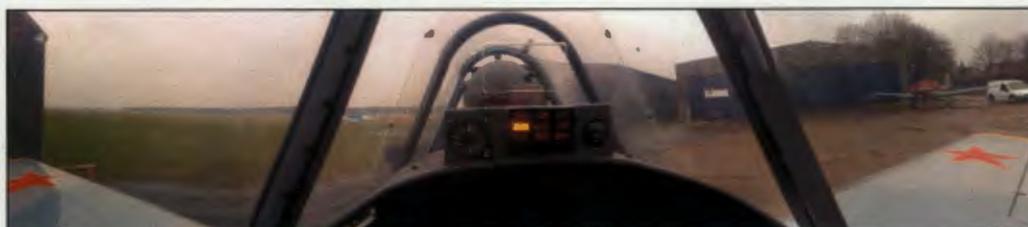
Figure 1.4.5. Yak-52 Rear cockpit Field of View (FOV) forward (180° panoramic). Note with FSP in place forward visibility is reduced, hangar in front obscured and side view obscured by straight wings; the remainder of forward FOV is unaffected.

1.4.109. One purpose of the PIC, as Safety Pilot, was the mitigation of the risk posed by potential emergencies. Reduced rear cockpit visibility is not abnormal in tandem aircraft. Reduced cockpit visibility does not present an issue unless it precludes the pilot from completing a task. In this case the task that the PIC reported that he planned to delegate was a key part of emergency handling. The PIC's plan was not relayed to supervisors; therefore, the risk that it posed was not identified or assessed.

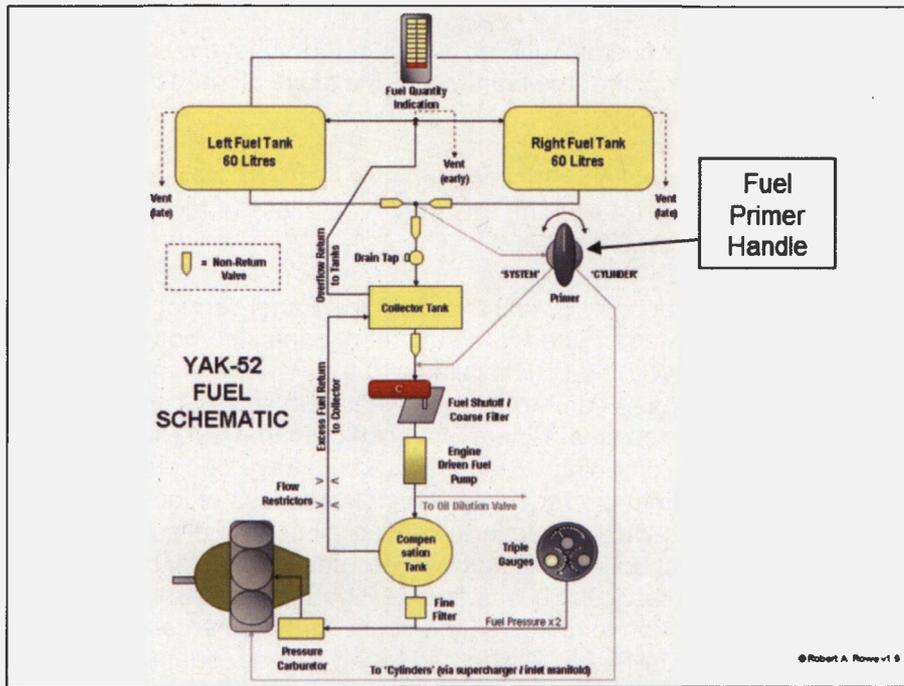
⁶³ AAIB investigations determined that the Engine Driven Fuel Pump was serviceable.

Figure 1.4.7 Yak-52 Fuel System⁶⁴

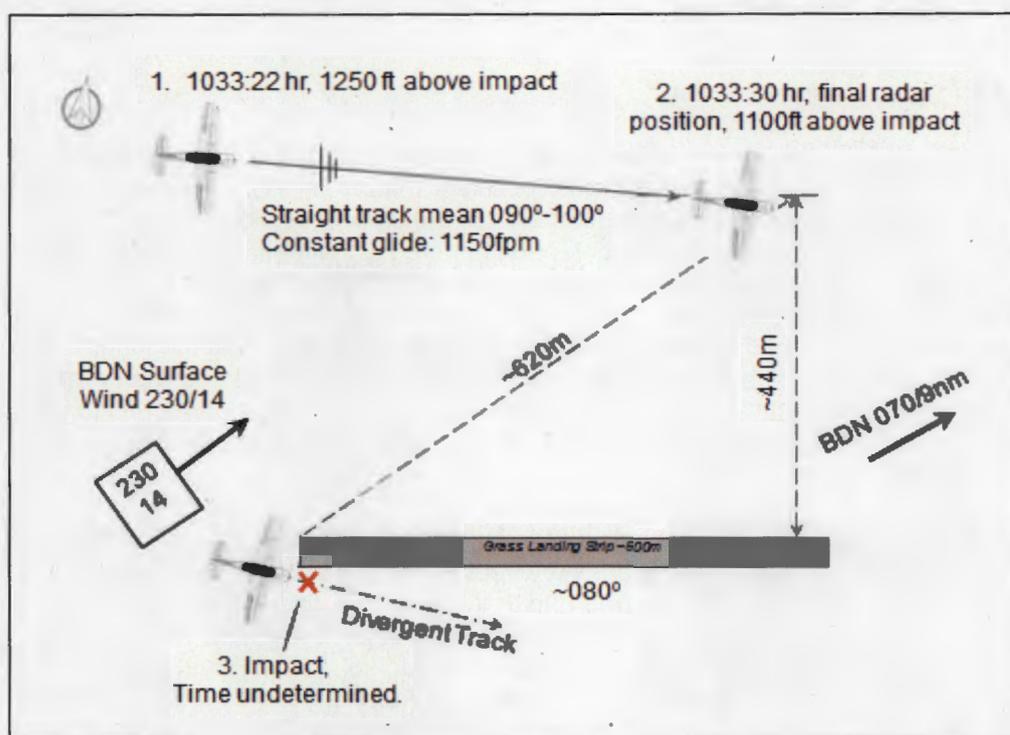
Figure 1.4.11 Plan View of Last Stages of Flight of G-YAKB, the Grass Landing Strip and the Point of Crash Site

1.4.184. The final radar position did not represent the last possible moment for a turn into wind to be achieved; however, it was close to the last point from where it was practical to execute a turn into wind and establish a safe final approach into a selected field. On balance of probability the relative position of the impact point from the final radar position is most likely to be due to a turn into wind to Forced Land. The accident crew waited until close to the last practical moment before turning into wind for the Forced Landing.

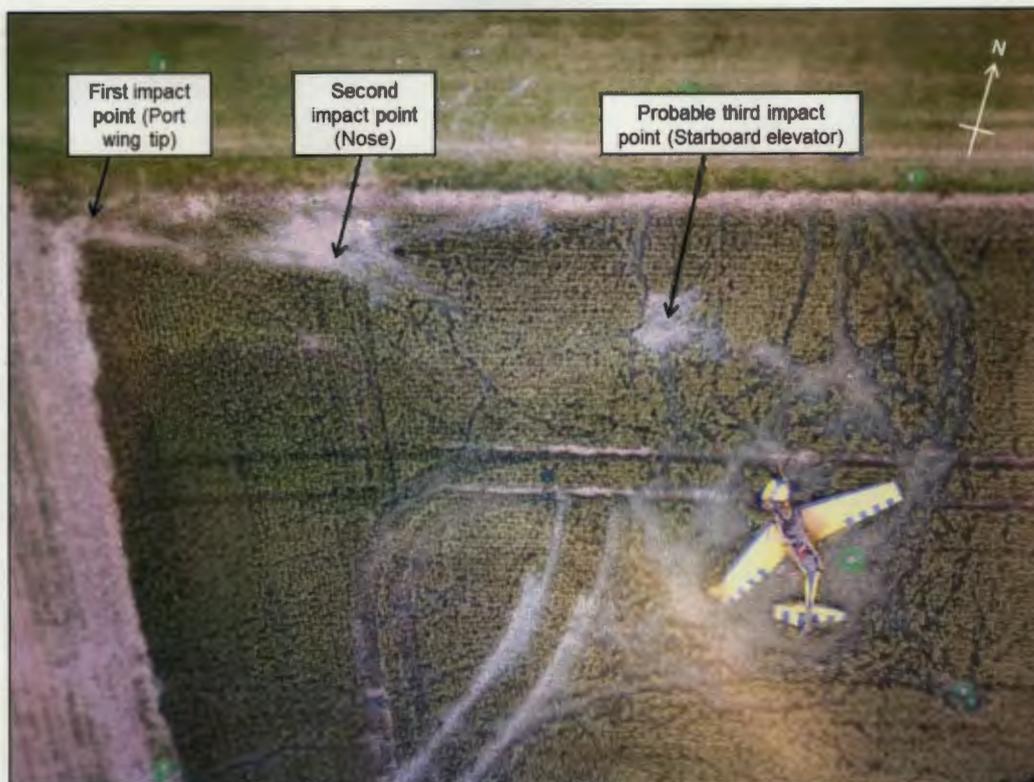
Figure 1.4.12 Aerial View of Crash Site Showing Impact Points

1.4.190. G-YAKB would have experienced a wind component of approximately 9 kts or 4.6 m/s along the impact axis. Had G-YAKB been at the published glide speed this would have resulted in an impact at approximately 50 m/s horizontally and 6.5 m/s vertically. Notwithstanding the earth at the crash site being dry, the crash site was compact and the single witness mark indicated that there had been both a low horizontal and vertical component of the velocity at impact. The damage to the propeller indicated low speed at impact; however, the Stall Warner light being extinguished indicated that the aircraft may have still been in controlled flight at impact. It was not possible to determine the height the aircraft achieved between impacts other than it is likely that the aircraft rose vertically between impacts in such a way as to leave the crop undamaged. The impact axis indicated that the aircraft approached from the West. It was not possible to determine the aircraft's energy at impact or decelerations experienced in the crash sequence without a modern functioning Air Data Recorder⁷²; therefore, it was not possible to deduce whether the aircraft impacted the ground in wing borne flight or that the aircraft stalled from low altitude. It is possible that a stall that occurred in a number of attitudes could have led to the left wing impacting first. Although the aircraft was travelling in an Easterly direction at impact it was not possible to deduce the aircraft's flight path between last radar position and impact. As the impacts were made by an aircraft that was translating and rotating in both the horizontal and vertical planes it is not possible to precisely determine the aircraft velocity immediately prior to impact. The Panel could not be certain why the Forced Landing failed as it was not possible to determine whether the aircraft was stalled at impact or whether anyone was controlling the aircraft.

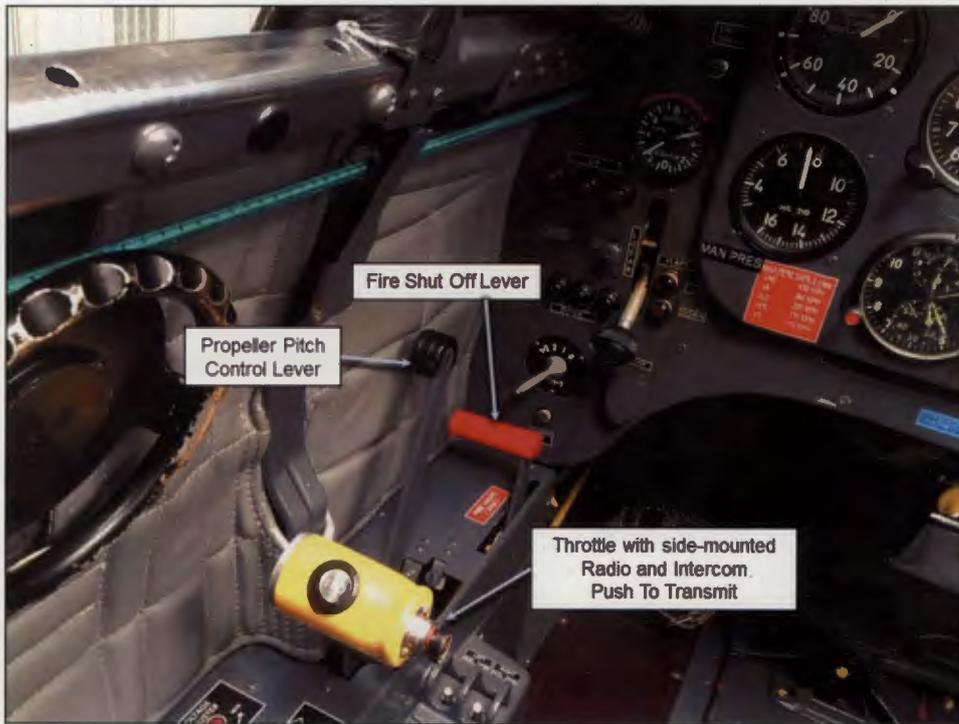
Figure 1.4.13. Yak-52 Front Seat Cockpit Engine Control Levers similar to that in G-YAKB. (Note: The Fire Shut Off Lever was black in G-YAKB.)

1.4.196. Whilst the activation of the FSOV would have produced the loss of thrust reported by the PIC the Panel was unable to conclude when the FSOL was moved and therefore could not conclude whether the position of the FSOL had any bearing on the accident.

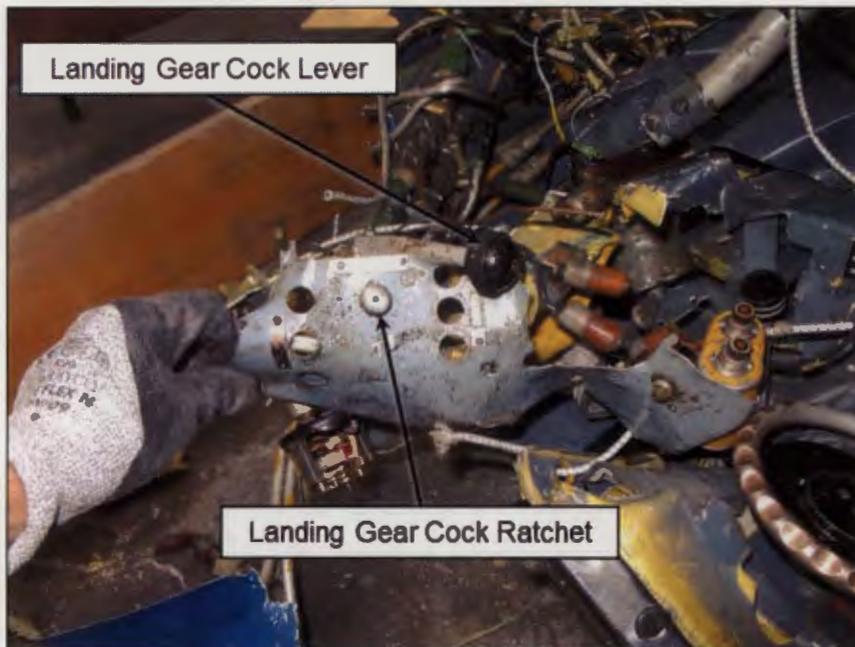
Figure 1.4.15 G-YAKB Front Cockpit Landing Gear Cock Lever in post-accident position. (Source: AAIB.)

1.4.198. The dent made by the LGCL in the surrounding metalwork indicates that it had been in the down position at impact. Yak-52 expert opinion is that the nose gear leg was probably unlocked at the time of impact and that significant damage to both the undercarriage and wing would have occurred had the main gear legs been locked down at impact. There was no evidence of such damage. It is highly unlikely that the LGCR and LGCL could move to the final positions on impact. Given the unlocked status of the starboard and nose wheel legs it is most likely that the FSP selected the LGCL to down and that constituent parts had unlocked but were not locked down prior to impact. This indicates that the selection was made in the last 15 sec of flight. With no further evidence available to the Panel it is impossible to conclude why the LGCL was found in the extended position.

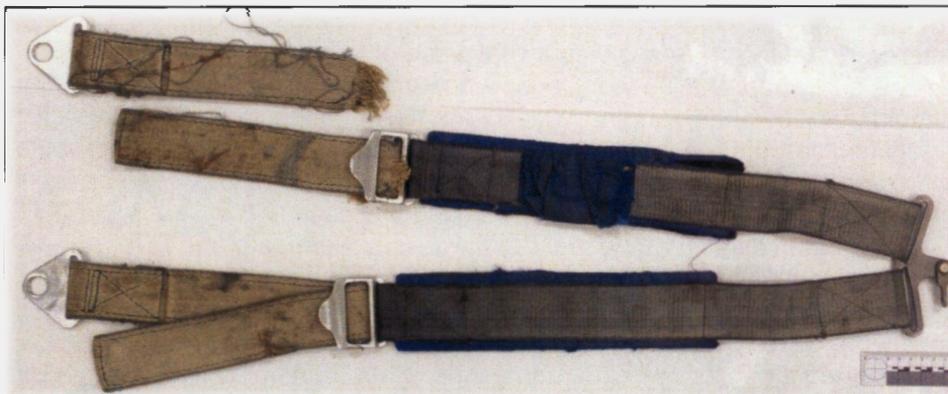
d. Originally the harness would have been made of natural fibre surrounding nylon. Some of the straps had been replaced. Synthetic sections had been used to replace natural sections. There was no record of when this activity had been carried out.

Figure 1.4.16 The Front Seat Shoulder Straps from G-YAKB

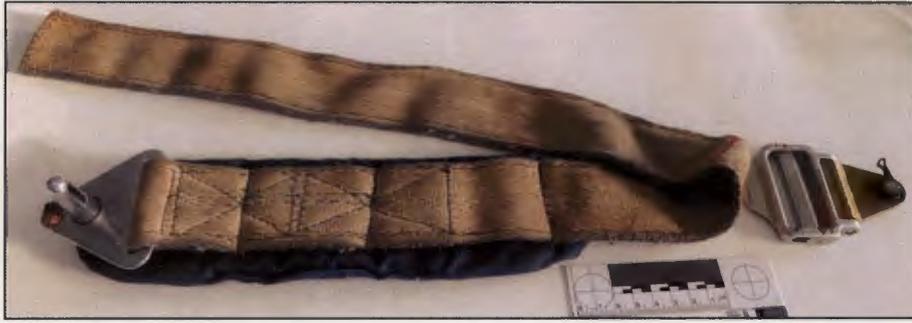
e. The fixed parts of the shoulder straps, above the adjustment buckle, and negative-G straps were made of synthetic fibre. The adjustable sections of the shoulder straps, below the adjustment buckle, and the lap straps were made of natural fibre.

Figure 1.4.17 A Front Seat Lap Strap from G-YAKB

f. The Yak manufacturer, Aerostar, does not know what the original design strength was for the harnesses. Stress test of 2 harness sections from G-YAKB, in comparison to a replacement harness section, resulted in the straps failing at 17% and 21% of the failure load of the replacement item. The Panel noted that the tested straps would have received significant loads in the crash sequence, which may have affected the post-crash tests. Aerostar use a 20 year life for the harness based on aircraft life being 20 years; G-YAKB was 24 years old.
