# Near miss at Ascot, Berkshire, 7 April 2017

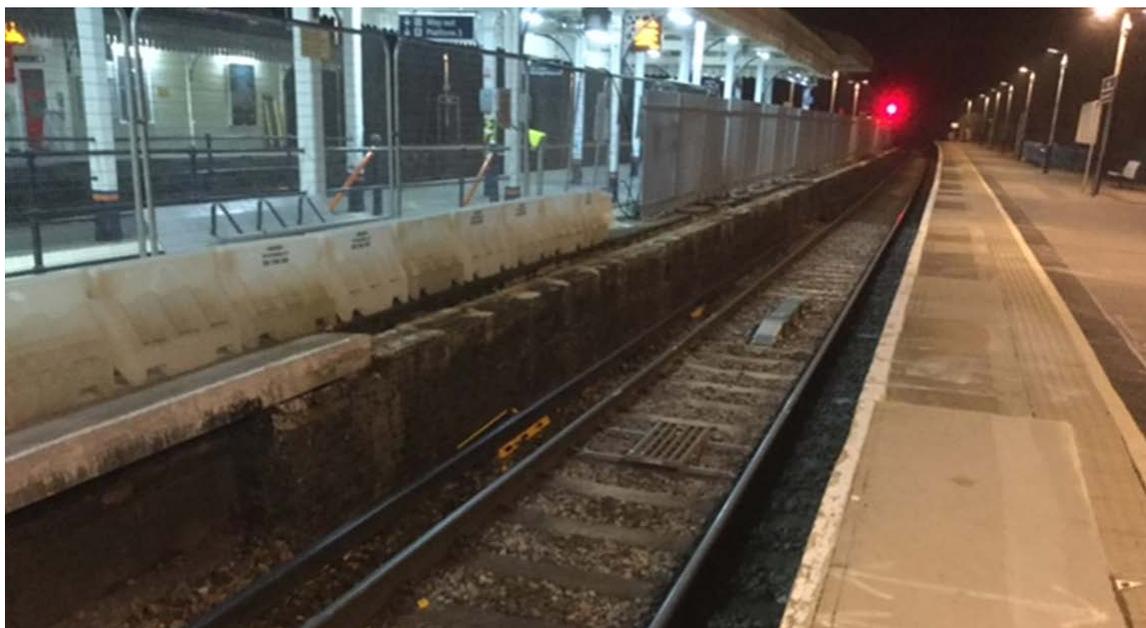
Platform 1 at Ascot station, where the work was taking place (courtesy Network Rail)

The track workers were standing on the up line at platform 1 as the train approached; the 01:11 hrs Reading to Staines empty stock movement was travelling at close to the maximum permitted speed of 70 mph (113 km/h). The train approached after the controller of site safety (COSS) had fitted insulating shrouds over the conductor rail and climbed back onto the platform, and prior to the two track workers starting work on the adjacent platform edge; there is a platform face on each side of the track at this location. The driver of the train saw the track workers as he approached Ascot station. He immediately sounded the horn and applied the emergency brake. This reduced the speed of the train from 67 to 43 mph (108 to 69 km/h) in the 9 seconds it took to reach the workers. One of the track workers saw the headlight of the approaching train and they both climbed onto the platform 2 to 3 seconds before the train passed. The train came to a stop with its rear portion still in the platform. The driver reported to the signaller that a near miss had taken place.

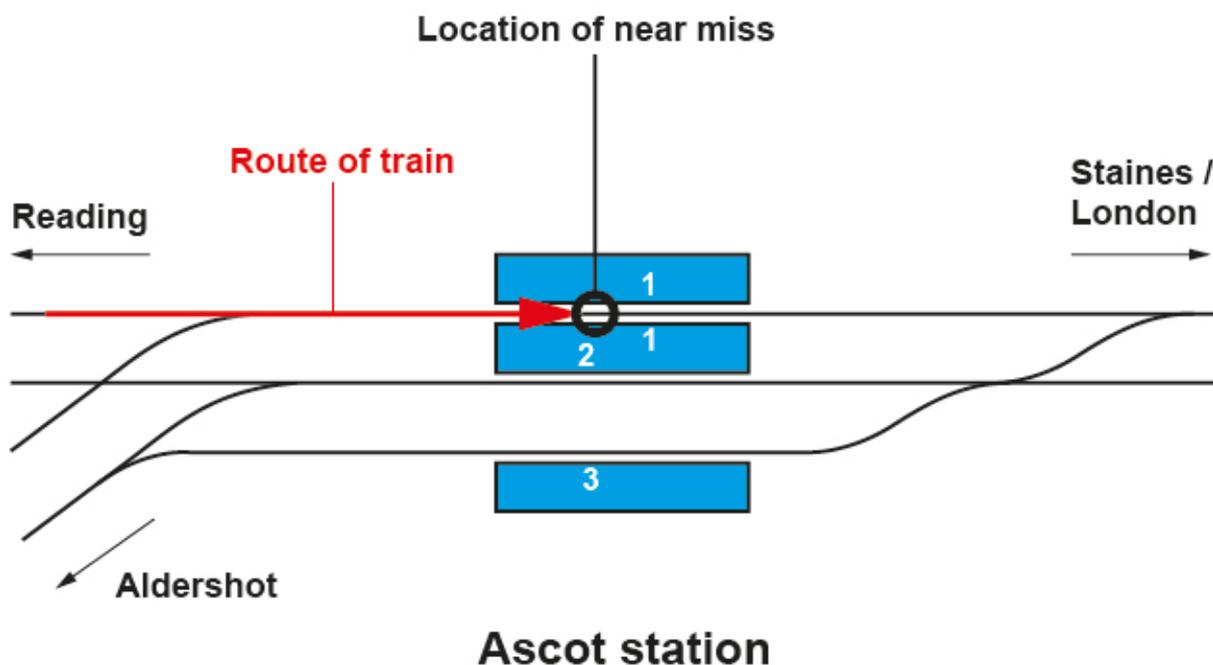
Schematic diagram of track layout at Ascot
