## SAFETY FLYER TO THE FISHING INDUSTRY

Fishing vessel *Sea Harvester* (N822), serious injury to a deckhand,  
3 August 2016

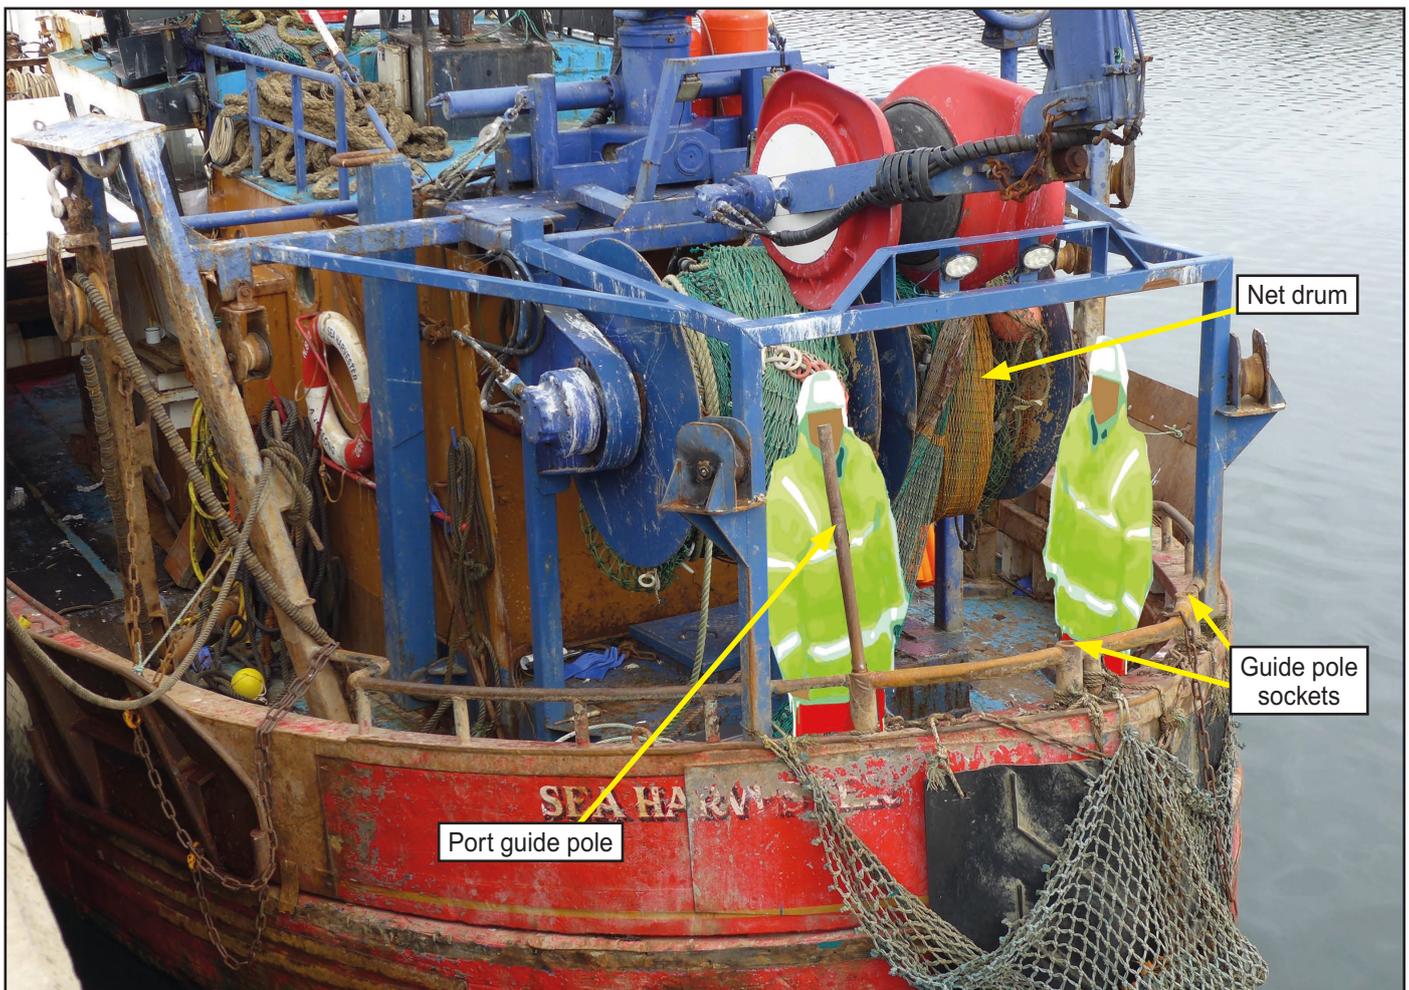
On 3 August 2016, the 19m twin rig trawler *Sea Harvester* came 'fast' on a seabed obstruction while trawling for prawns in the Firth of Clyde, Scotland. During the attempt to retrieve the snagged fishing gear onto the net drum, the tension in one of the bridles, in conjunction with the vessel's motion in the moderate seas, bent a guiding-on pole on the stern bulwarks (**Figure 1**) and forced it from its socket. The pole struck a deckhand on the side of his head and knocked him unconscious. The deckhand was transferred to hospital by helicopter. He suffered serious, life-changing injuries (**Figure 2**) and will require medical care for the foreseeable future.

**Figure 1:** Aft deck area showing approximate positions of deckhands

2. Knowing where to stand on working decks with limited space is a significant factor in staying safe. Ropes and wires can part, while blocks and winches and other deck equipment can fail. The forces involved and the energy released when this happens can be phenomenal. It doesn't happen very often, but when it does it is frequently without warning.

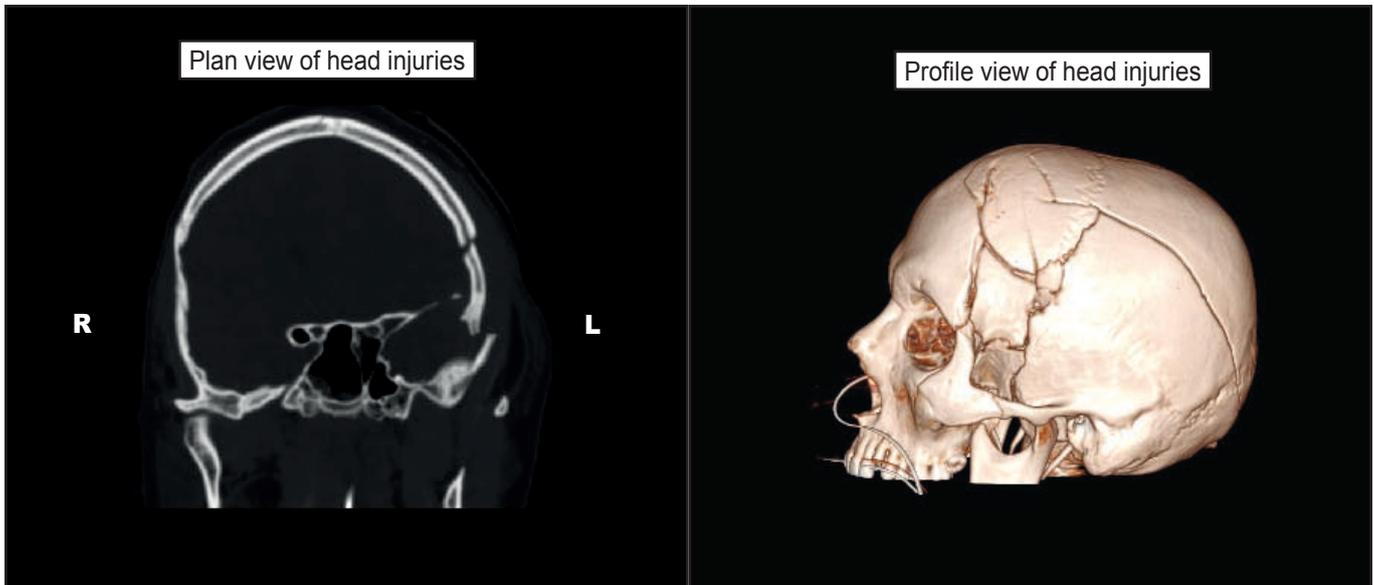
**Figure 2:** Casualty's injuries

3. Safety helmets are not routinely worn by fishermen, even when shooting or hauling. However, the risks of head injuries from wires or ropes under tension and overhead loads are no less than in other industries in which safety helmets must be worn. In this case, the degree of protection that would have been afforded had the deckhand worn a helmet is uncertain. Nonetheless, some protection, no matter how limited, could have reduced the severity of the life-changing injuries he sustained.
