NAVIGATION RISK ASSESSMENT - OYSTER TRESTLE FORESHORE DEPLOYMENT, WHITSTABLE, KENT

Report Number: 17UK1322
Issue: 01
Date: 15 June 2017

MARITIME AND COASTGUARD AGENCY

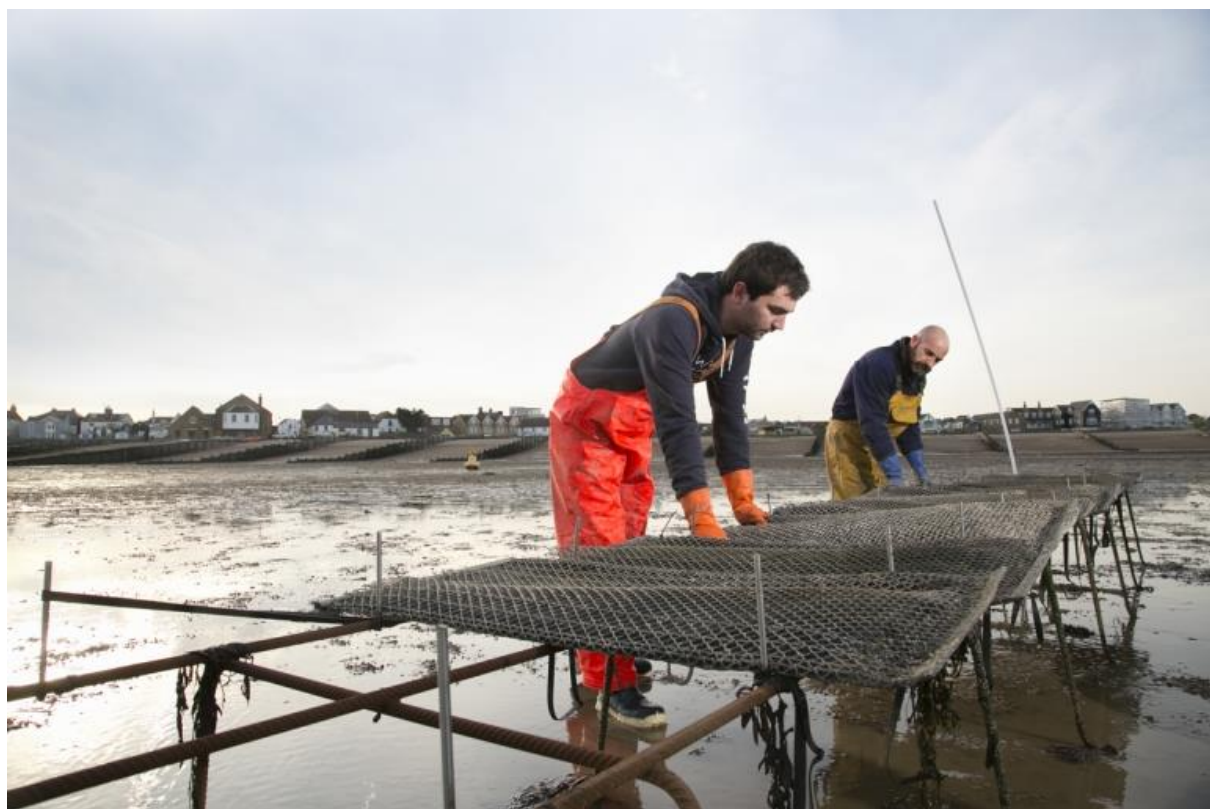
Figure 3 Whitstable oyster trestle - Source WOFC

WOFC imports pre-fabricated trestles from France to a specified design. **Figure 3** shows a trestle in situ on the foreshore at Whitstable. They are 0.75m in height and approximately 1m long and 0.5m wide. They are made of steel re-bar construction and trestles are linked together and arranged in rows. The trestles are not anchored to the foreshore as they are of a considerable weight and this prevents them moving due to waves and currents. Due to early experience with bags moving in strong north easterly conditions, vertical steel rods, extending approximately 0.2m above the trestle surface are specified by WOFC at construction in order to retain the mesh bags in situ with rubber banding and strapping (**Figure 3**).

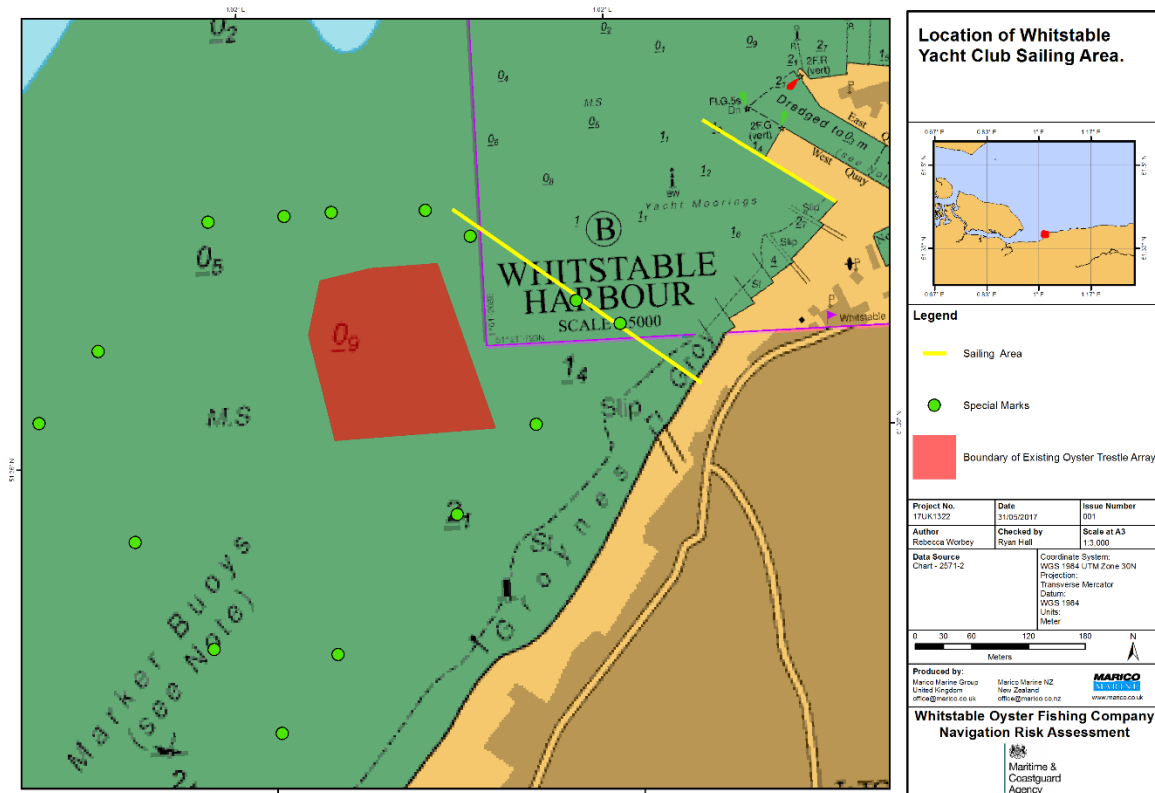
Figure 5 Whitstable Yacht Club Sailing Area

Whitstable Yacht Club (WYC) is based 100m from the West Quay of Whitstable harbour. The club has an active membership of approximately 600 and is also a Royal Yachting Association (RYA) Training Centre. The yacht club is home to approximately 200 sailing dinghies and catamarans (stored ashore) and there are no moored yachts or vessels. At present, and following trestle placement, ailing vessels are launched from the foreshore and WYC slipway at all states of tide and sail within the corridor area bounded by the harbour wall and the trestles or proceed through this area to more open water. This is shown in **Figure 5**.

This sailing area has been reduced in size due to the trestles being placed on the foreshore. Prior to their placement, the yacht club utilised the entire foreshore length and area, with school groups maintaining a sailing line close to and along the foreshore. The new sailing area has resulted in activities now having to take place in a more condensed area or proceed further offshore.

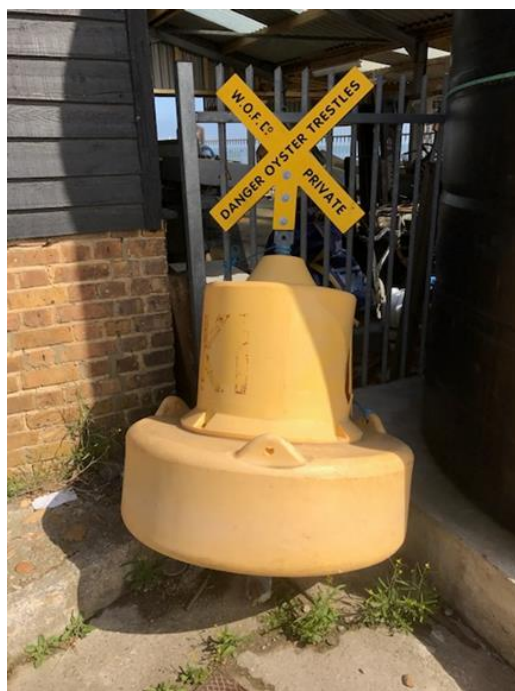
Figure 9 WOFC Special mark

Unlit special marks have been placed around the trestle array, as shown in **Figure 9** and **Figure 2**. The marks are spread some distance apart and located such that they don't fully represent the extent or proximity of the trestle array or the direction in which the trestles are laid relative to the special mark.

As the marks are widely and variously spread there is therefore an unclear visual barrier to those utilising the water space.

It is recommended that buoyage layout is modified to locations as shown in **Figure 10** (reflecting the current trestle location) and in a broadly repeating pattern. The special marks could also be re aligned to allow for more sailing space in the area (opening the angle towards the foreshore) and to reduce the risk of collision due to congestion. This buoyage would also clearly mark the relative location of the trestles and allow those navigating in the area, especially the RNLI if required to carry out a search and rescue, to identify the hazard more readily.

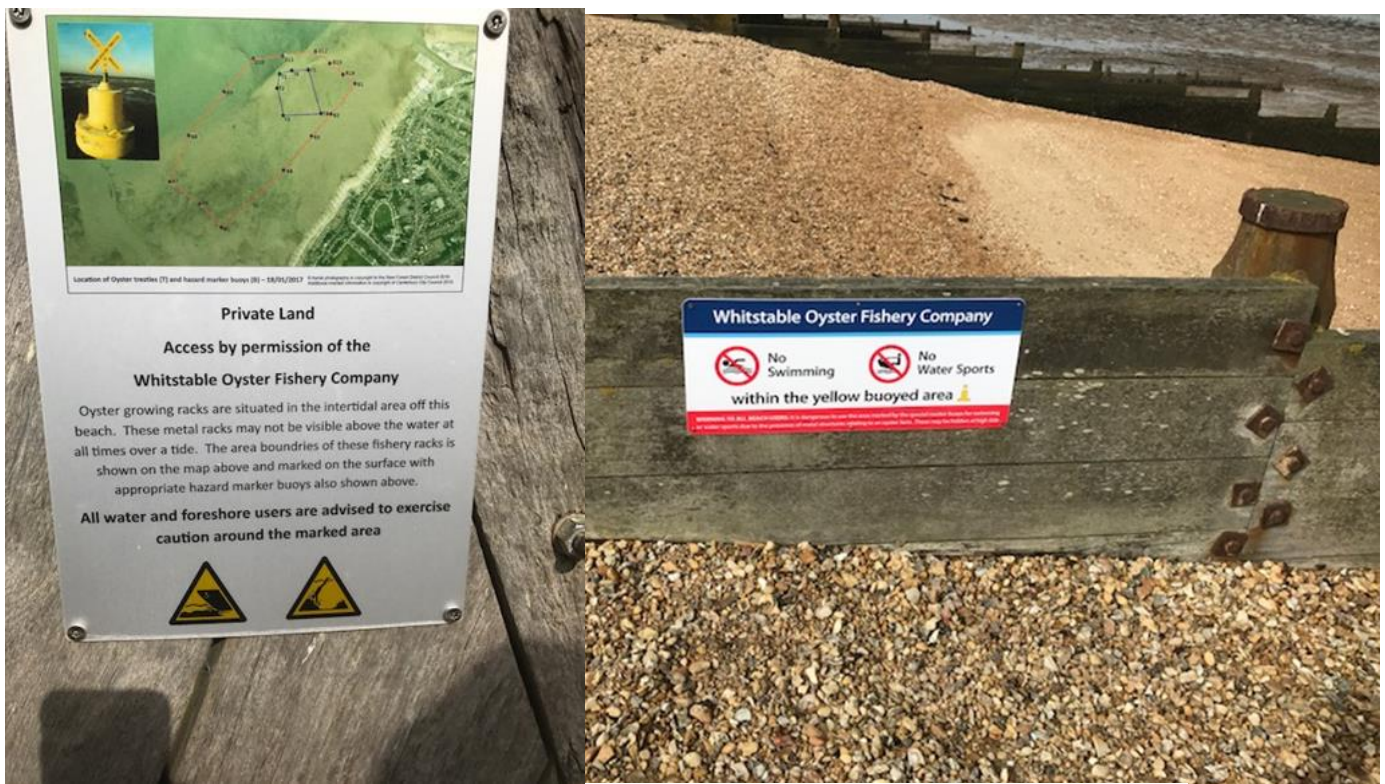
Figure 11 WOFC Signage

By informing local users of the trestle hazard the frequency of occurrence may reduce. WOFC have installed signs on the foreshore at Whitstable and these are sited on all groynes and public notice boards. Examples of the signage in place is shown at **Figure 11**.

WOFC is recommended to write to WYC, and other known water space users to inform them of the hazard. Additional signage could also be utilised to inform water space users of the hazard in local clubs, restaurants and other public amenities.

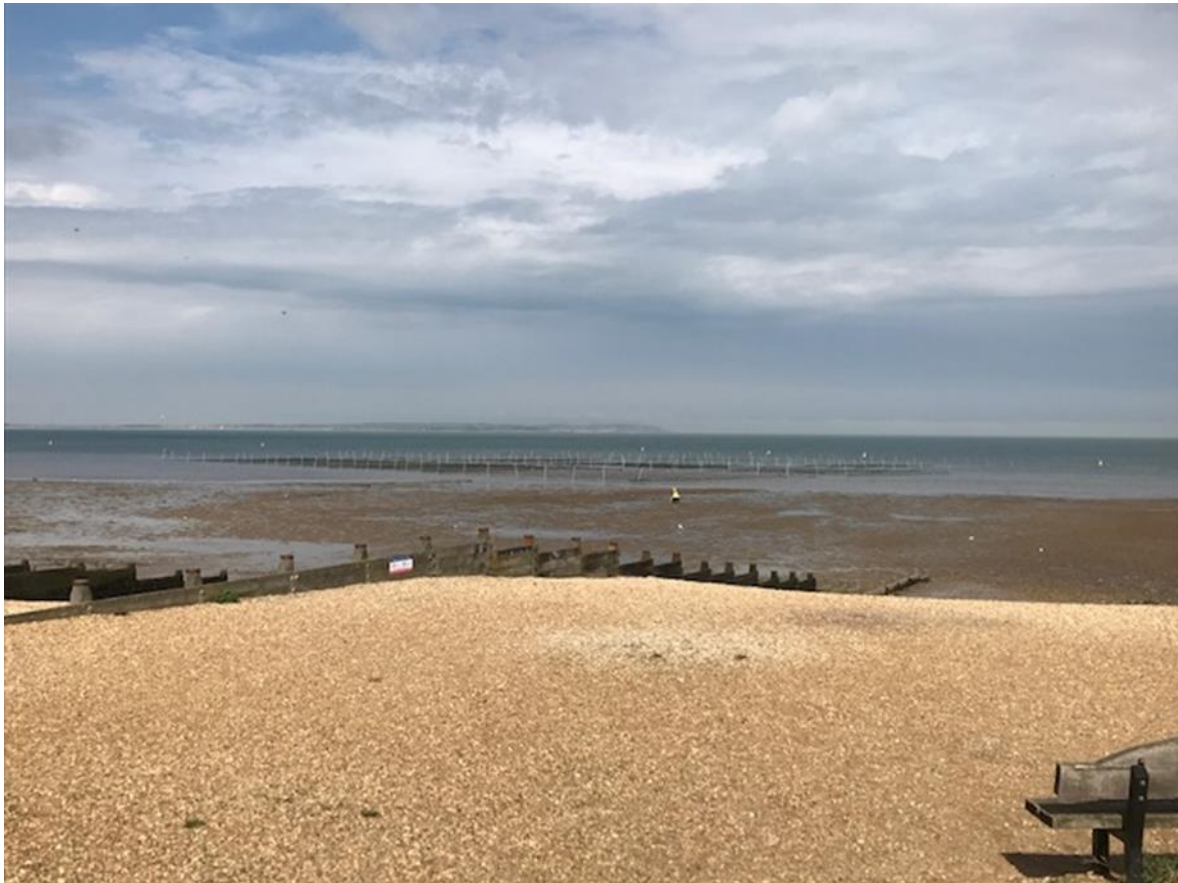
Figure 12 WOFC withies

The trestle array is currently well marked by withy navigation markers (vertical sticks) which are placed at the corner of each trestle block as shown in **Figure 12**. The withies are submerged at high tide and therefore not always visible. It is recommended that WOFC increase the height of these withies such that they are visible at all states of tide.
