BRE Global Client Report

BS 8414-1:2015 + A1:2017 test referred to as DCLG test 1.

Prepared for: DCLG
Date: 27th July 2017 (Issue 1.0)
12th September 2017 (Issue 1.2)
Report Number: B137611-1037 (DCLG test 1) **Issue: 1.2**

Prepared for:
Department for Communities and Local
Government
2 Marsham Street
London
SW1P 4DF

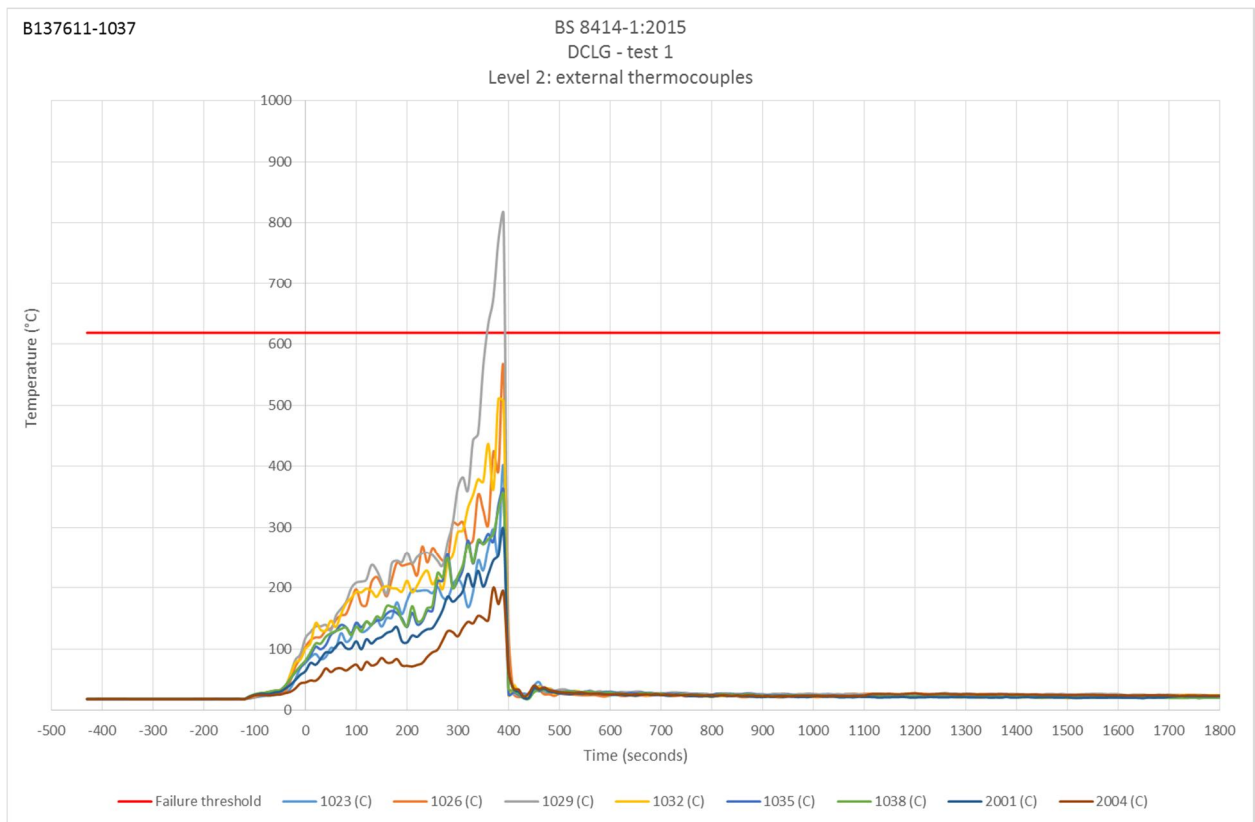
Figure 18. Level 2 external thermocouples.

In addition, *Figure 18* shows that the level 2 external thermocouples would have failed to meet the external fire spread criterion if classification had been possible as a measured temperature exceeded a 600°C temperature rise above T_s , for a minimum of 30s, within 15mins from test start time (t_s) at time 360s (6mins after t_s).

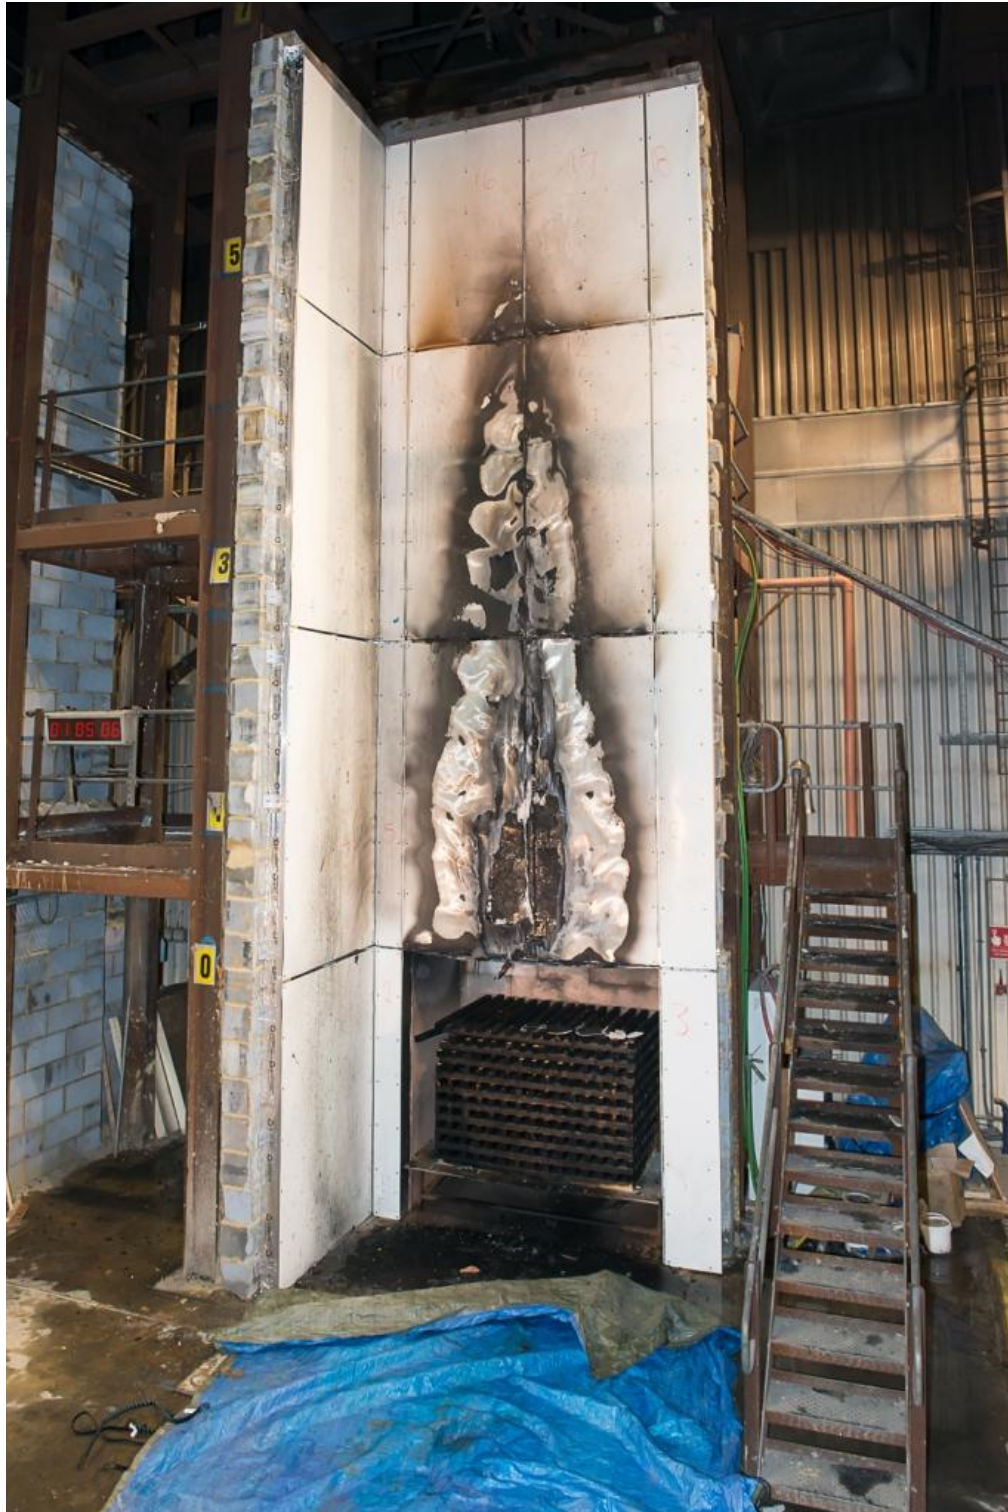
Figure 21. Full height photograph of system soon after test termination.

The surface finish of the panel was burnt away revealing a shiny metallic surface in a 300mm-wide strip adjacent to the consumed areas of the ACM panel which increased to approximately 1000mm at the tip of the flame impingement zone. Adjacent to the 'metallic' strip, a strip of dark discolouration, approximately 100mm-wide, which increased to approximately 1000mm at the tip of the flame impingement zone, extended to a height of 5000mm above the combustion chamber – see *Figure 21*.

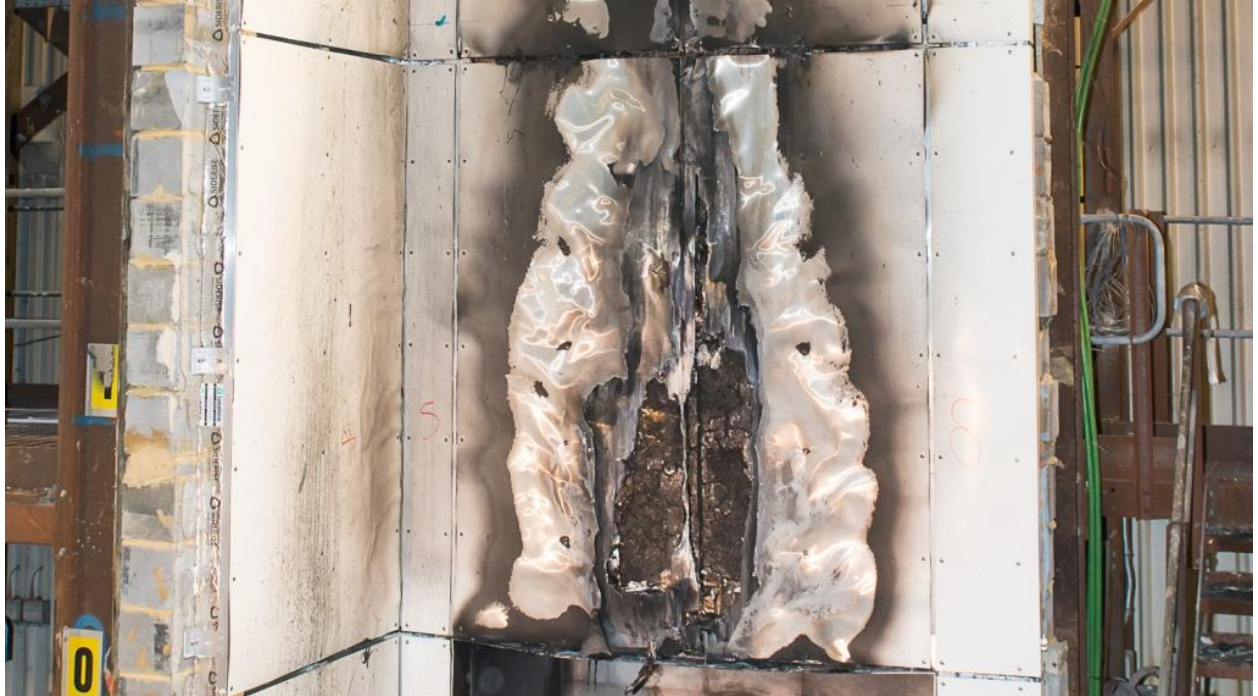
Figure 22. First row ACM panels (directly above combustion chamber).

Complete consumption of the ACM panel occurred in a 500mm-wide channel along the centre line of the combustion chamber up to a height of approximately 1000mm which narrowed to approximately 100mm at the top of the first panel exposing a total area of insulation of approximately 0.75m² - see *Figure 22*. At the base of the second row of panels (2300mm above the top of the combustion chamber), there was less consumption of the panels. A central 400mm-wide x 800mm-high section was damaged with approximately 0.05m² of the outer skin of the ACM panel melted exposing the core material – see *Figure 22*.

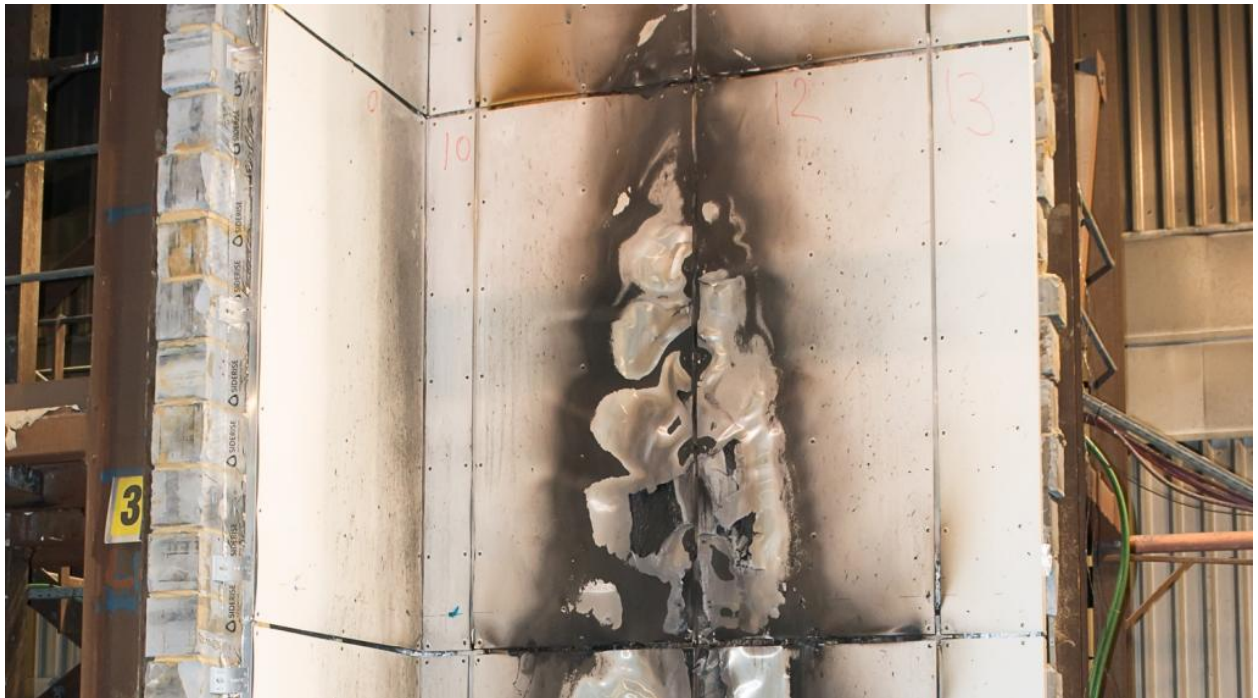
Figure 23. Second row ACM panels (approximately 2300mm-4600mm above combustion chamber).

Figures 22&23 show the main damage areas spanned the majority of the combustion chamber opening (2000mm-width) tapering to a point 5000mm above. The extent of the damage increased from black discolouration at the edges of the damage zone to complete consumption of sections of the ACM panels, rail substructure and some charring of the insulation at the centre of the main wall – see *Figures 21-32*. Slight distortion of the ACM panel on the wing wall, immediately above the combustion chamber was the only external damage on this face of the cladding - see *Figures 21-25*.

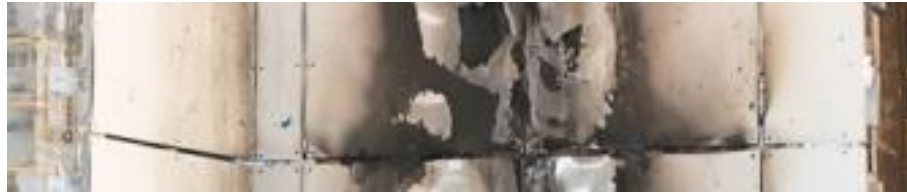
Smaller areas of discolouration spanned the full-width at the base of the second and, to a lesser extent, third row panels where flaming had spread laterally – see *Figures 24&25*.

Figure 24. Zoomed view of discolouration on base of second row panels.

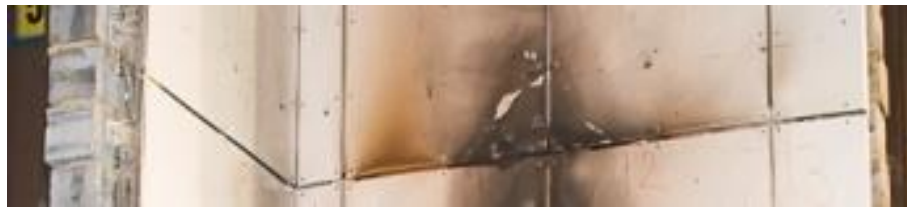
Figure 25. Zoomed of discolouration on base of third row panels.

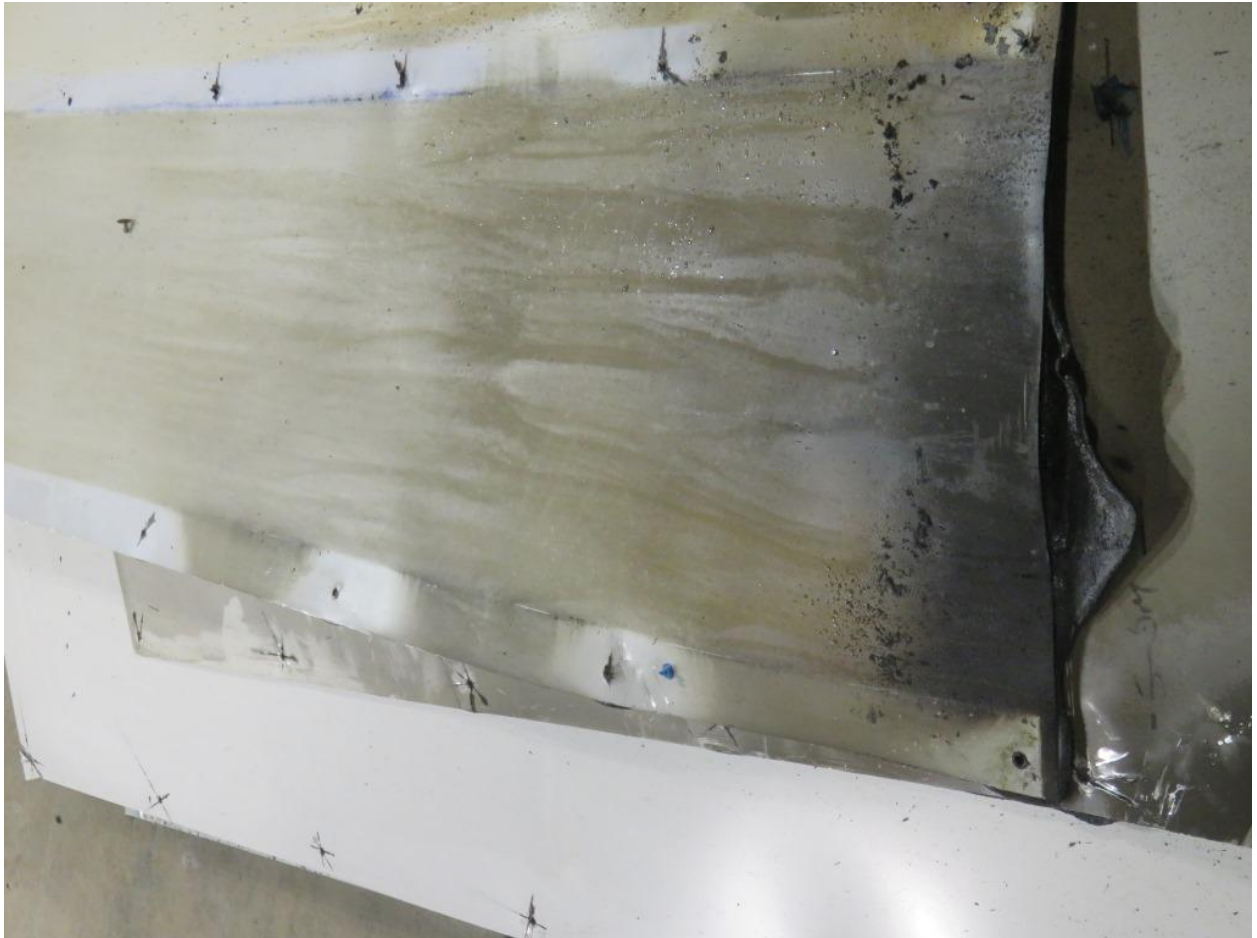
It was observed that there was no PE 'filler' material between the aluminium sheets on the remaining ACM panels directly above the combustion chamber - significant melting had been observed during the test. Some residual solidified material was observed at the base of the panels in the top row (5000mm above the top of the combustion chamber) – see *Figure 26*.

Figure 26. Rear side of panel 3C (approximately 4600mm above the top of the combustion chamber) showing re-solidified PE core material.

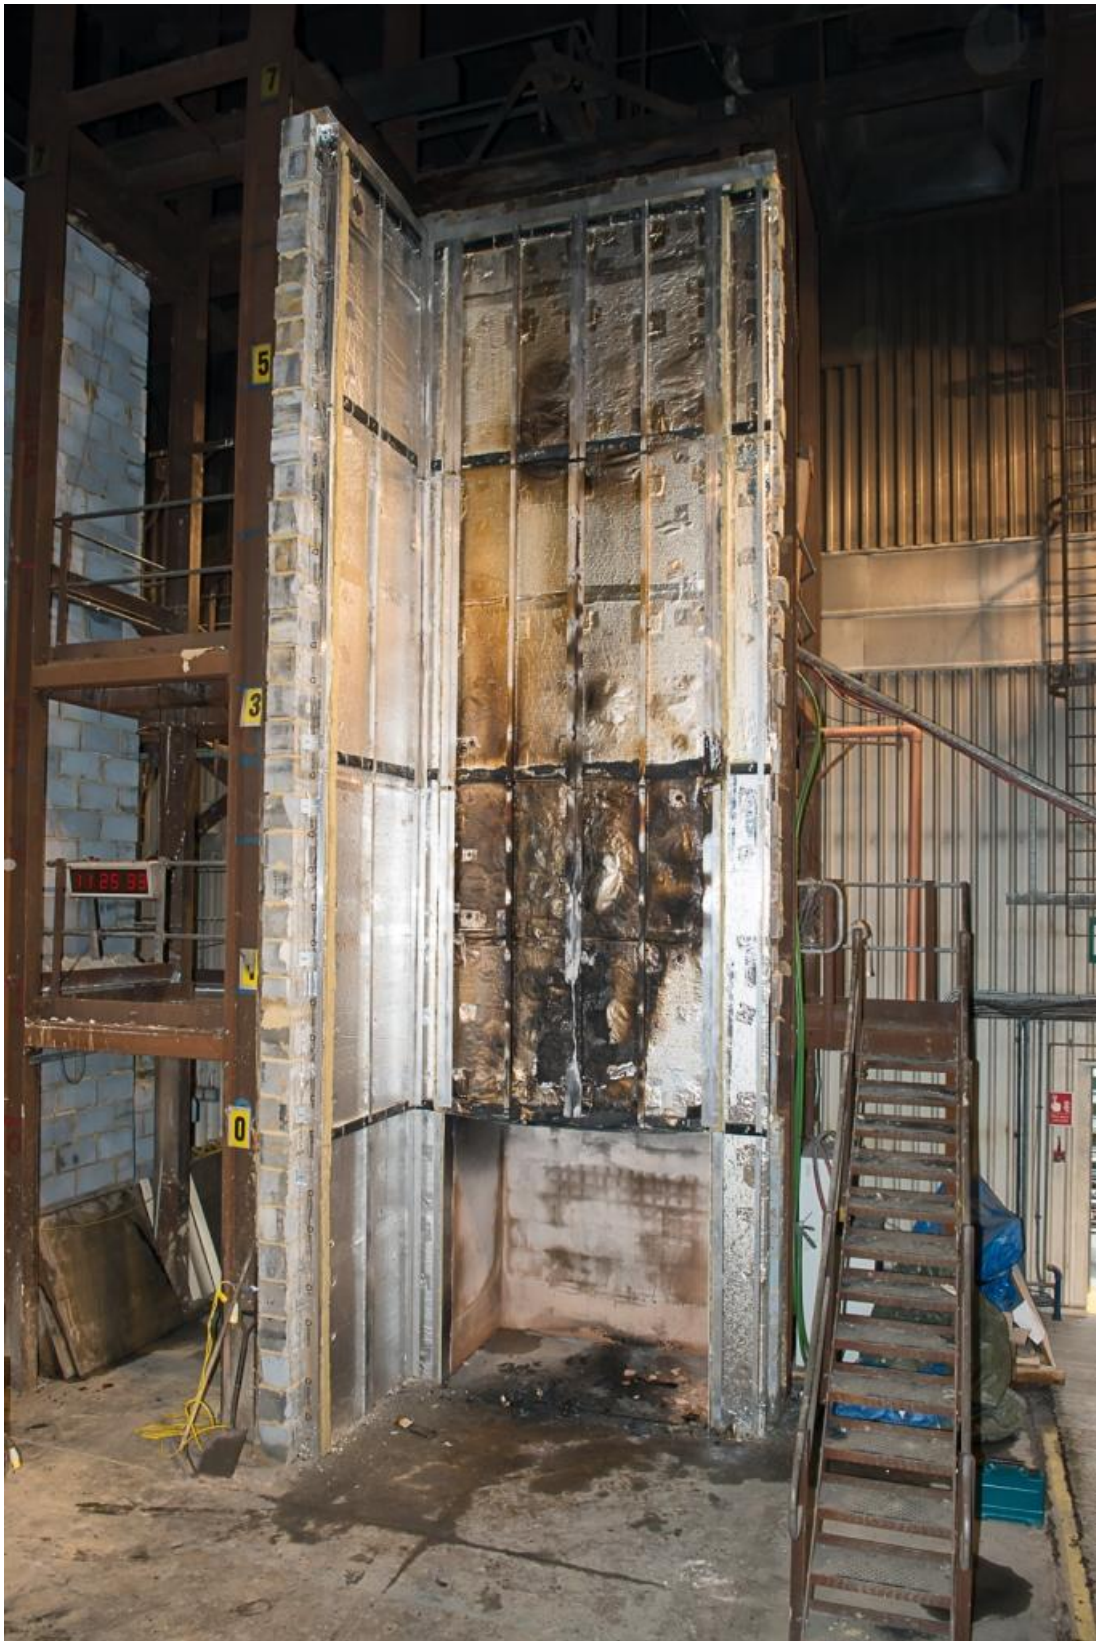
Figure 27. Full height photograph of system following removal of ACM panels.

The outermost face of the central 'T' rail was absent in the region approximately 400-900mm above the top of the combustion chamber – see *Figures 27&28*. This was the only structural damage observed to the rail substructure.

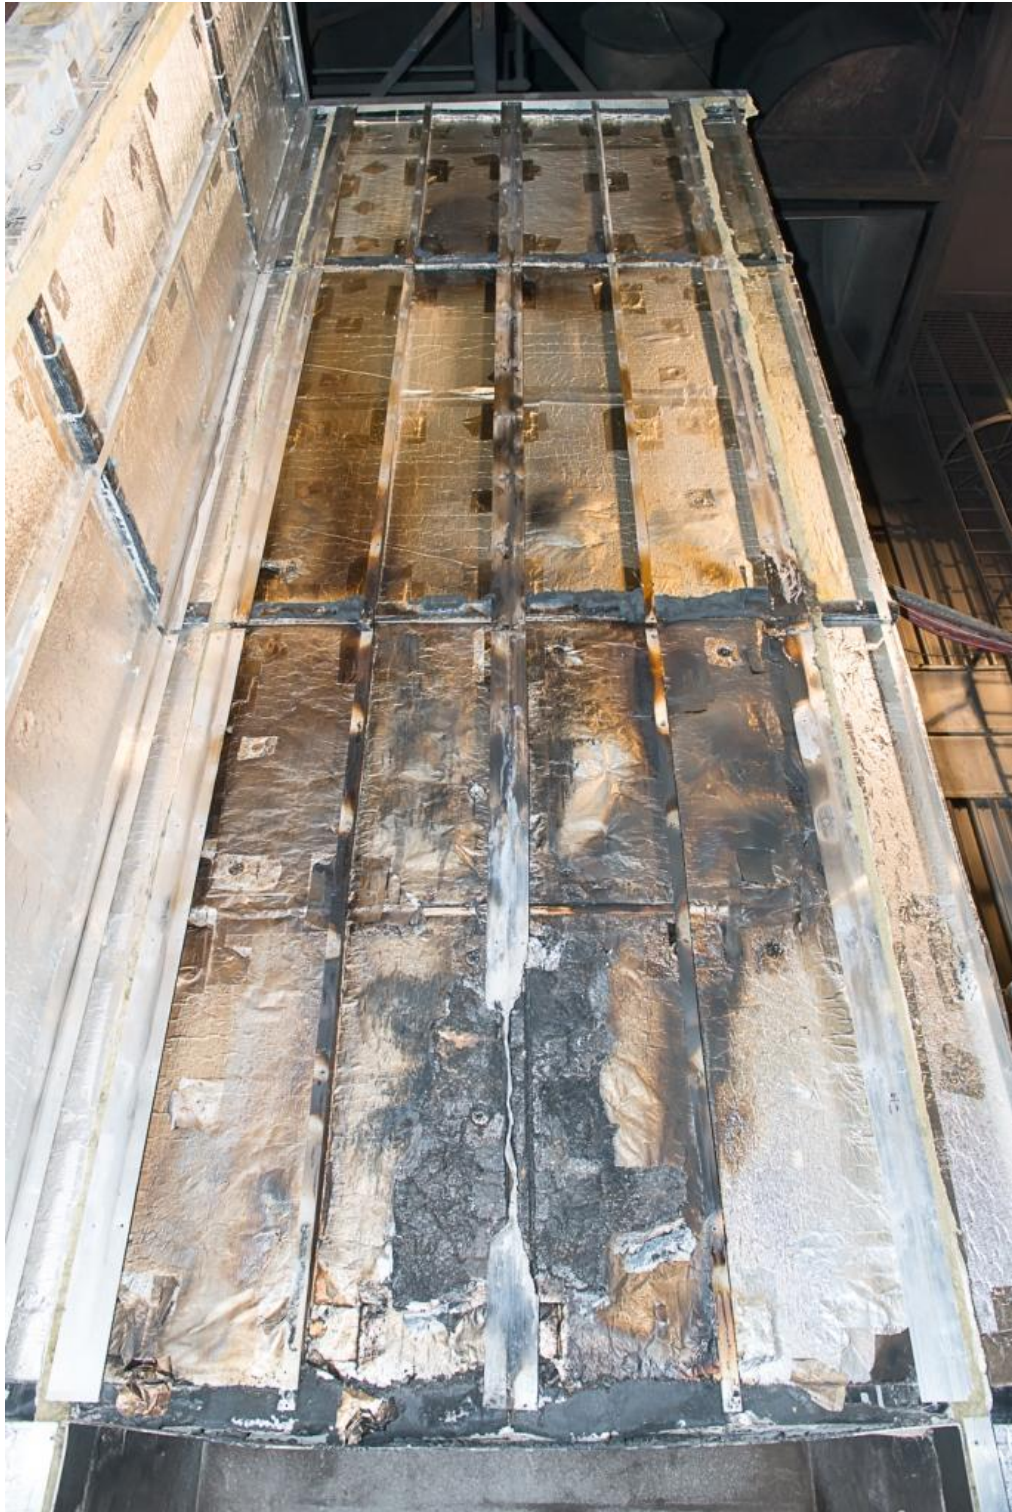
The foil face on the insulation was burnt away and the insulation charred in a rectangular section approximately 600mm-wide and 1000mm-high (0.6m²) centrally located approximately 300mm above the top of the combustion chamber – see *Figure 28*.

The first row of horizontal intumescent cavity barriers directly above the combustion chamber expanded on exposure to the heat to fill the void along the majority of the combustion chamber width – see *Figure 28*.

At the second row of horizontal cavity barriers (approximately 2400mm above the combustion chamber) there was evidence of intumescent activation across the full width of the combustion chamber – see *Figure 28*. On the wing wall, directly adjacent to the main wall, a 500mm-width of the intumescent strip had partially activated – no smoke damage was visible above or below this section of cavity barrier – see *Figure 32*.

The fire damage to the ACM panels and the PIR insulation was within the bounds of the vertical cavity barriers contained within the width of the combustion chamber – see *Figure 28*. The cavity barriers suffered discolouration along the inside edges running parallel to the vertical edges of the combustion chamber.

Figure 28. Damage to cladding system beneath ACM panels directly above the combustion chamber.

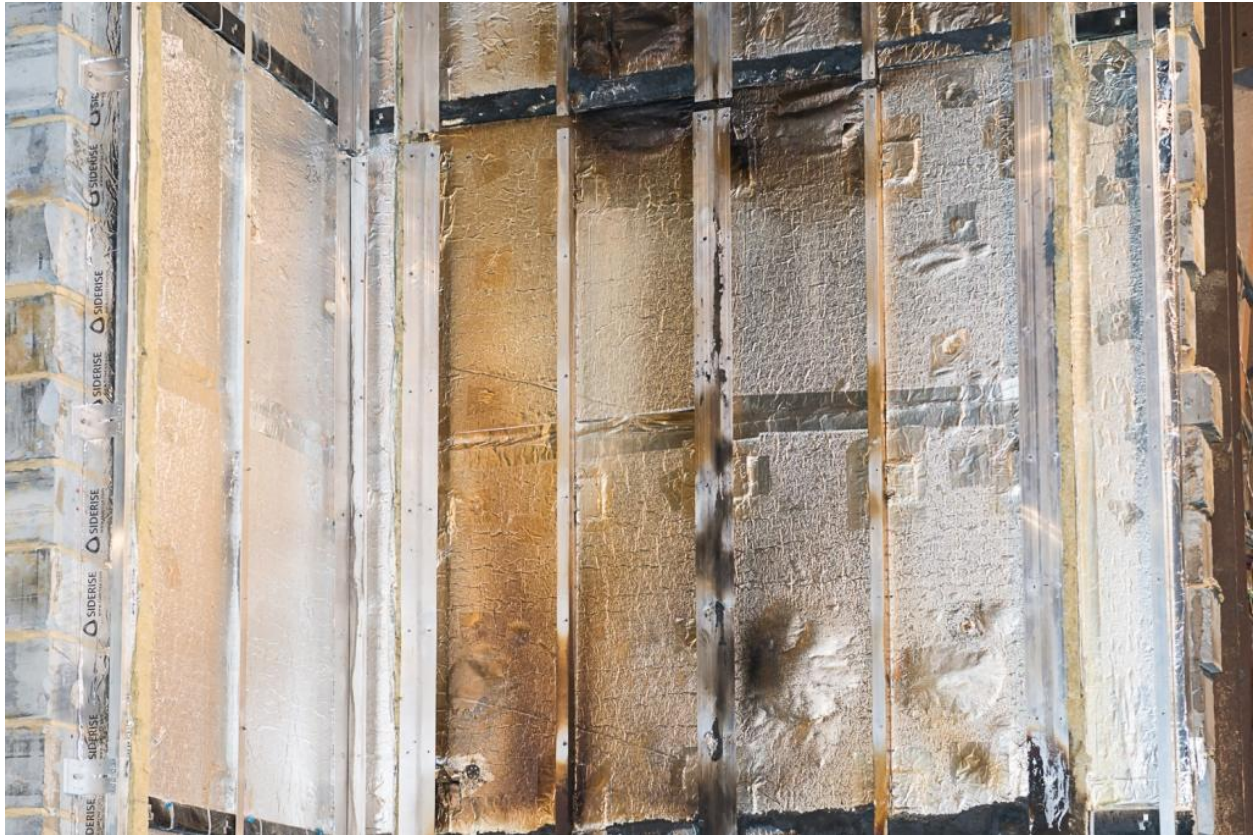
Figure 29. Damage to cladding system beneath ACM panels between the second and third horizontal cavity barrier (approximately 2400-4700mm above combustion chamber).

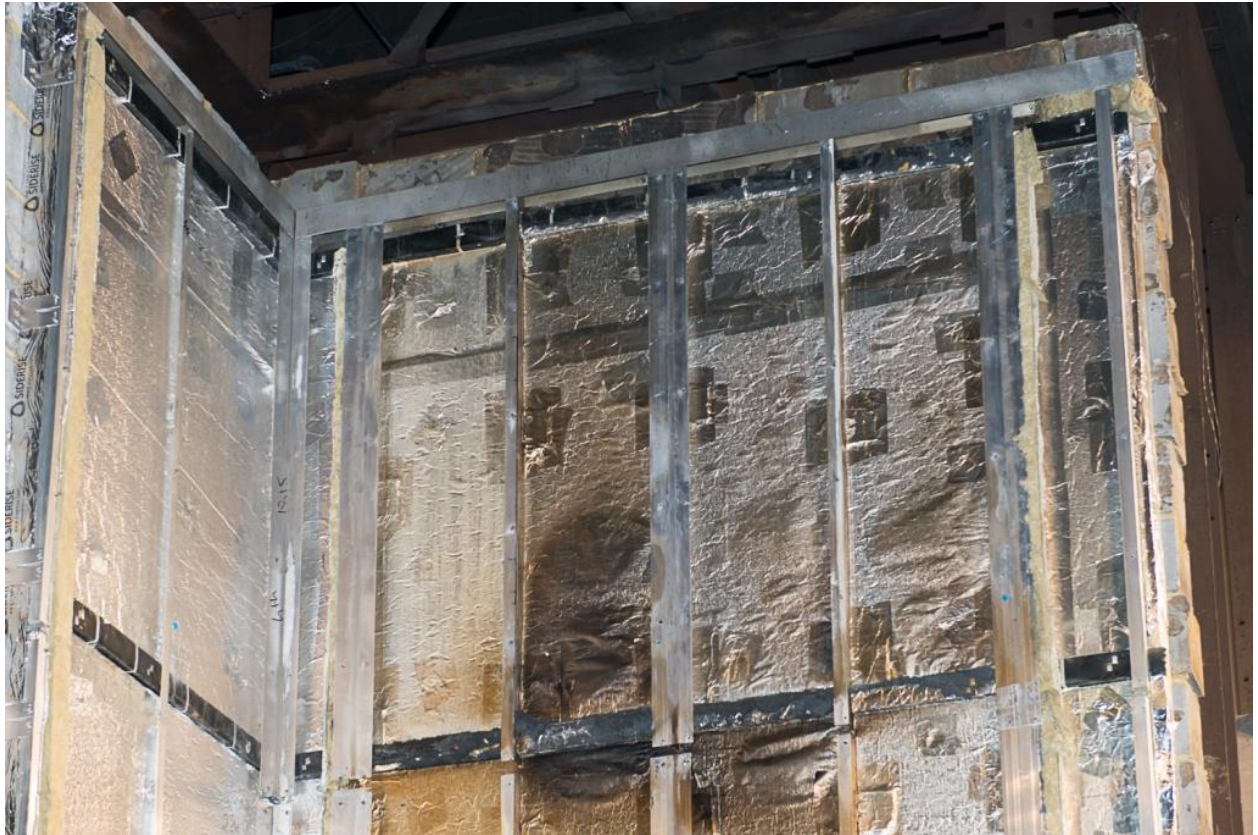
Dark discolouration occurred to the 'L' rails either side and, to a lesser extent, the remaining section of 'T' rail, up to the level of the 2nd horizontal cavity barrier (2500mm above the top of the combustion chamber) – see *Figure 29*. Lighter discolouration occurred, almost exclusively to those three central sections of railing, up to the height of the third cavity barrier (5000mm above the top of the combustion chamber) – see *Figure 30*.

At the third row of horizontal cavity barriers (approximately 4700mm above the combustion chamber, there was again evidence of some intumescent activation on the main wall – see *Figure 30*.

Figure 30. Damage to cladding system beneath ACM panels between the third and fourth horizontal cavity barrier (approximately 4700-6360mm above the combustion chamber).

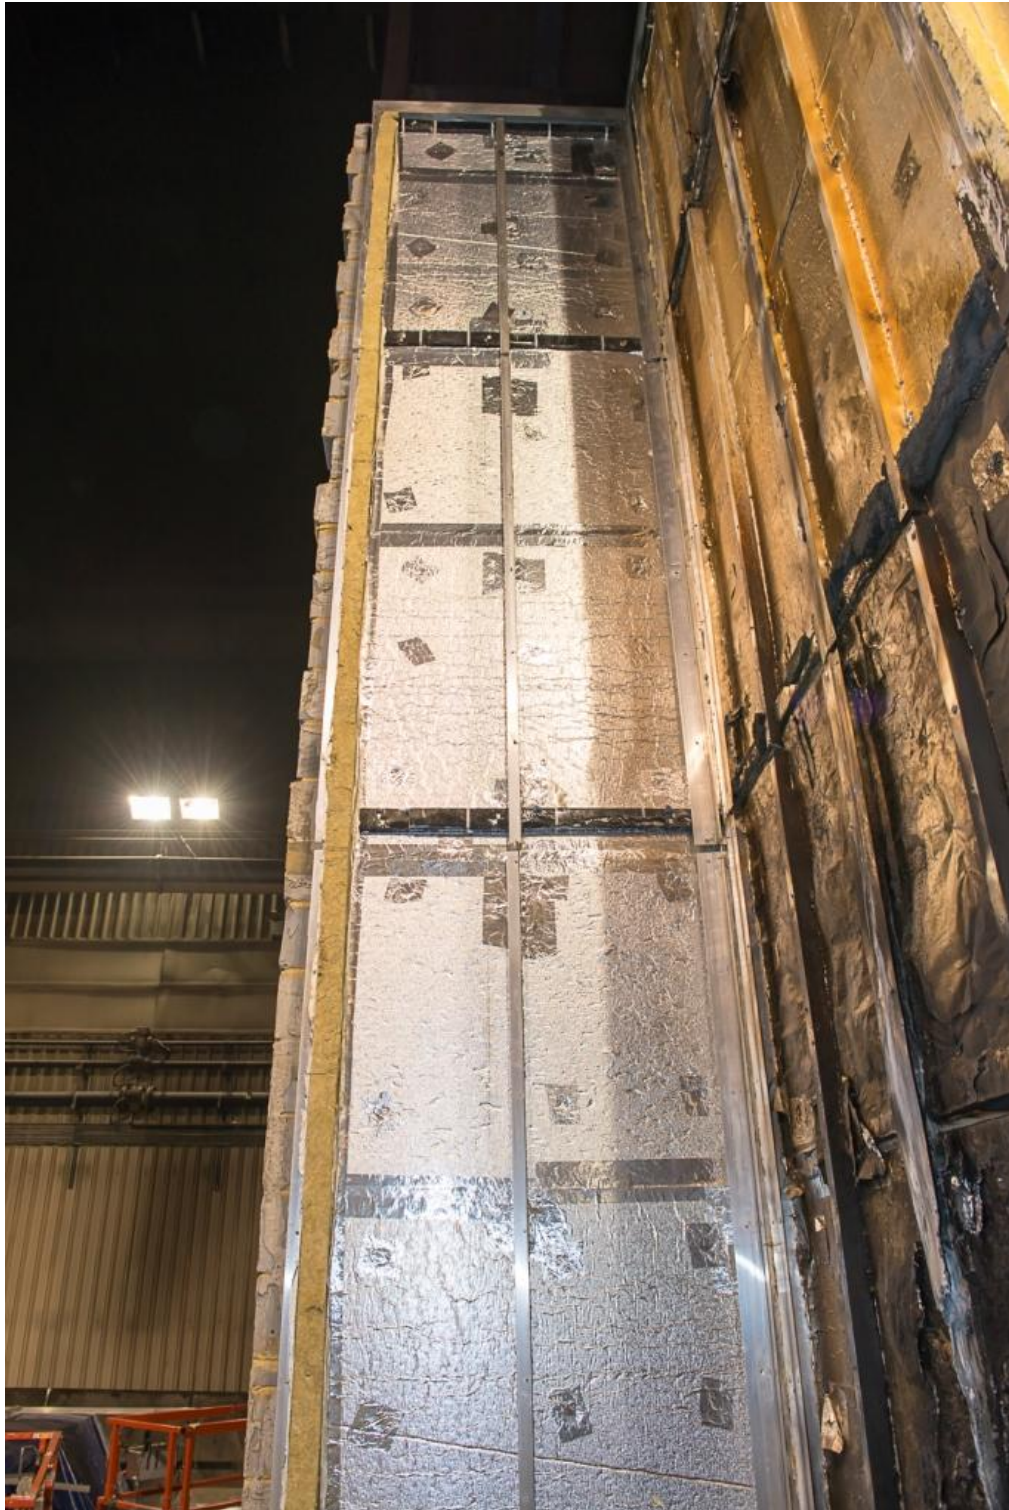
Figure 31. Post-test view of wing wall following removal of ACM panels.

The rail substructure on the wing wall appeared to be almost completely undamaged – see *Figure 31*.

The insulation on the wing wall appeared to be almost completely undamaged – see *Figure 31*.

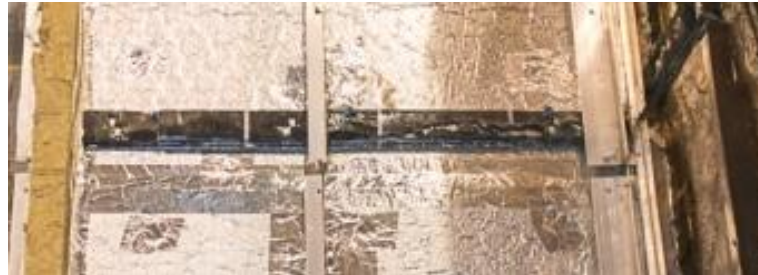
Figure 32. Zoomed view of partially activated horizontal cavity barrier at an approximate height of 2400mm above the combustion chamber, on the wing wall.
