Near miss between a tamper and steel pile near Kirkham, Lancashire, 15 May 2017

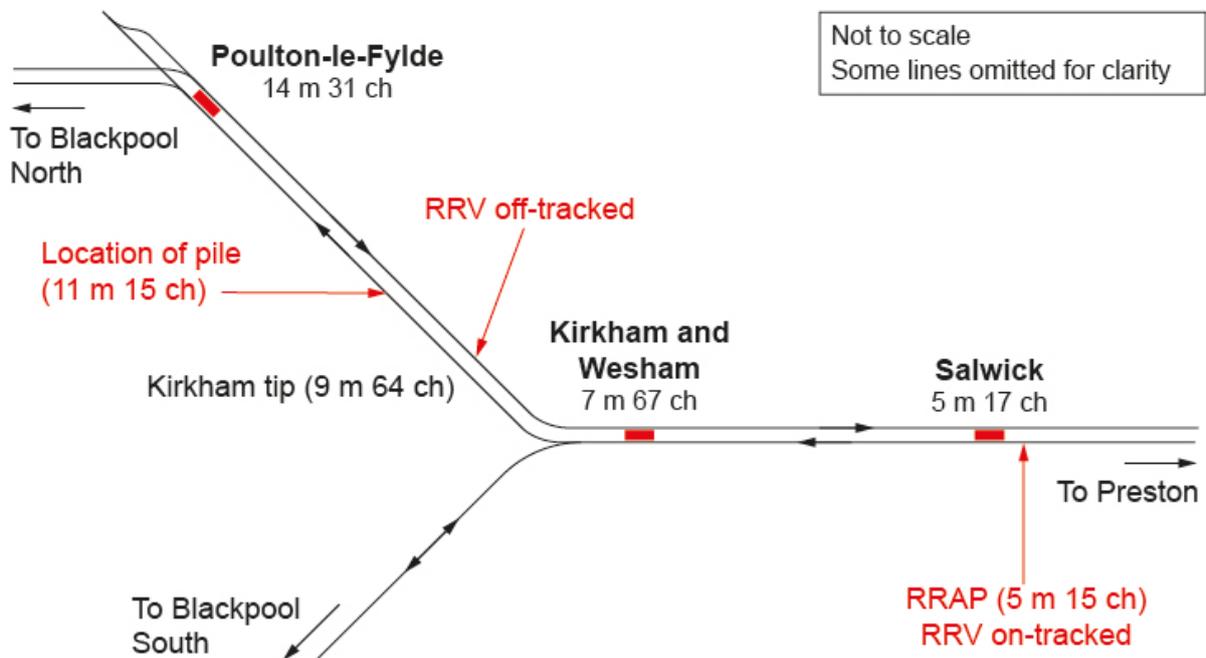
Schematic of area showing locations of pile and road rail access points

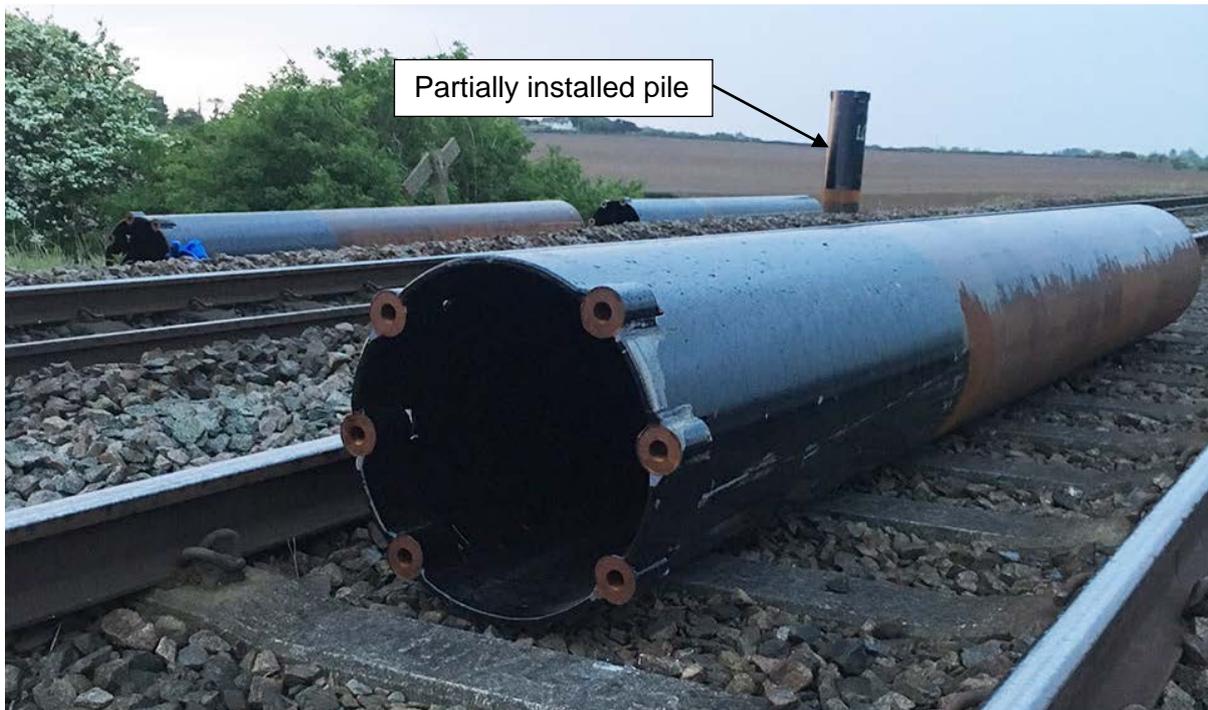
The tamper encountered the pile because it had been temporarily placed on the track earlier. No one had identified that it remained there when the track was handed back and declared safe for the passage of trains once the work was complete. The lack of a clear process for ensuring that the track was clear of obstructions was a factor, which may have been exacerbated by time pressures.

The pile as found by the tamper driver (image courtesy of Network Rail)

Better lighting of the site of work might have reduced the likelihood of the pile being forgotten. The WPP had identified risks with working at night and specified the use of tower lighting at worksites to illuminate work areas. However, the piling operation was lit only by lights on the RRV. This meant that staff were unlikely to be able to see the pile left in the four foot of the down main line when they left the site.
