Near miss between Audley End and Great Chesterford, 21 April 2017

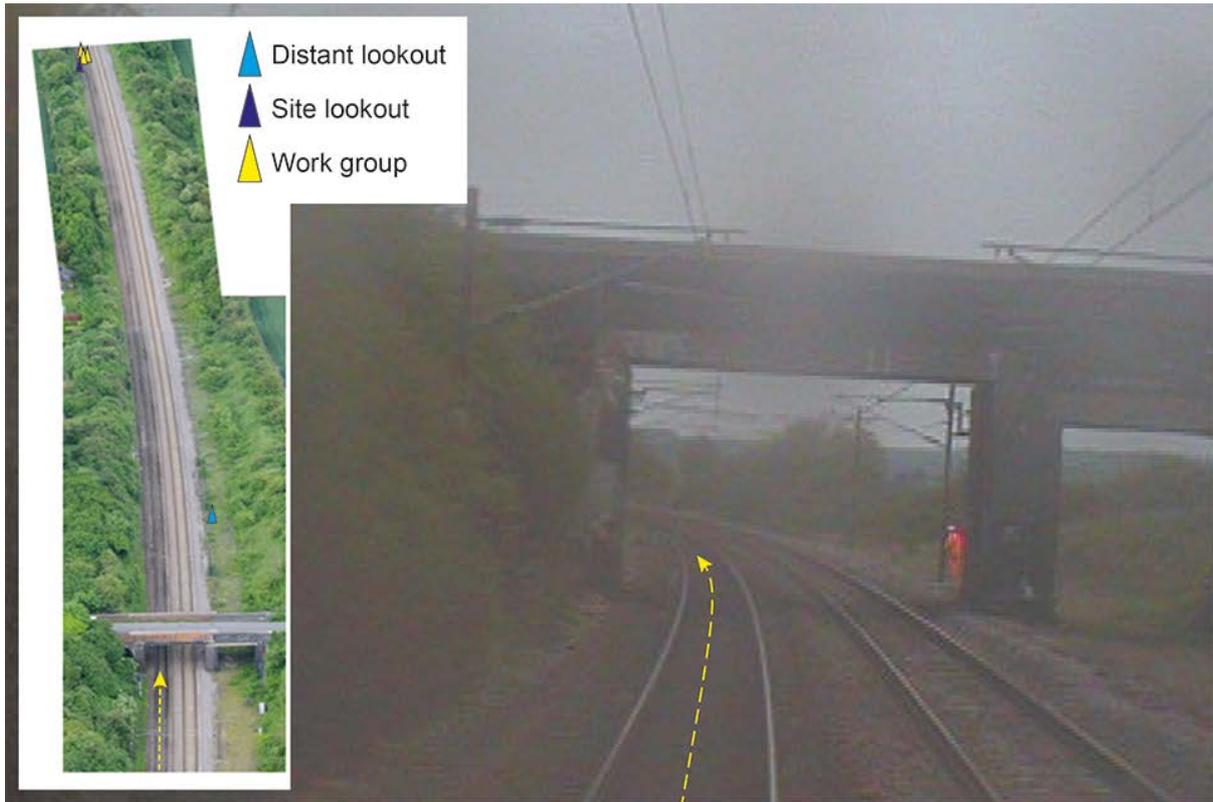
Due to the curvature of the track on the down line, and various bridges which hampered visibility (figure 1), the COSS decided to appoint a site lookout and a distant lookout, and instructed the distant lookout to stand three to four OLE spans (about 180 metres) away from the group, on the far side of the opposite line. The distant lookout was instructed to warn the site lookout of trains approaching on the down line. The site lookout would then warn the group to move clear of the line. Because the site lookout was instructed to look out for trains on the up line, and would therefore not be facing the distant lookout, the COSS instructed the distant lookout to use his horn to warn of the approach of trains, rather than the blue and the white chequered flag which is normally used to give this warning. The COSS did not consider in detail how the visibility available to both lookouts would change as the group moved along the line, or the implications of the distant lookout's visibility being restricted by the curvature of the line or by the bridges.

The curvature of the track at the location of the incident meant that the distant lookout would have been able to see the train when it came into view about 400 metres away from him. Taking into account his distance from the rest of the group, this would have enabled him to give the work group about 16 seconds warning of the approach of a train travelling at 80 mph (129 km/h). This warning was 4 seconds less than the time warning time recorded by the COSS on the RT9909 form. Soon after this, the bridge pier would have obstructed his view of the train until it was about 100 metres from him (figure 1).

Figure 1: Image from FFCCTV (11:32:53 hrs) from train on the down line. Distant lookout is visible in the up cess (image courtesy of Greater Anglia). The inset image shows aerial view of bridge 1525 and position of the distant lookout.

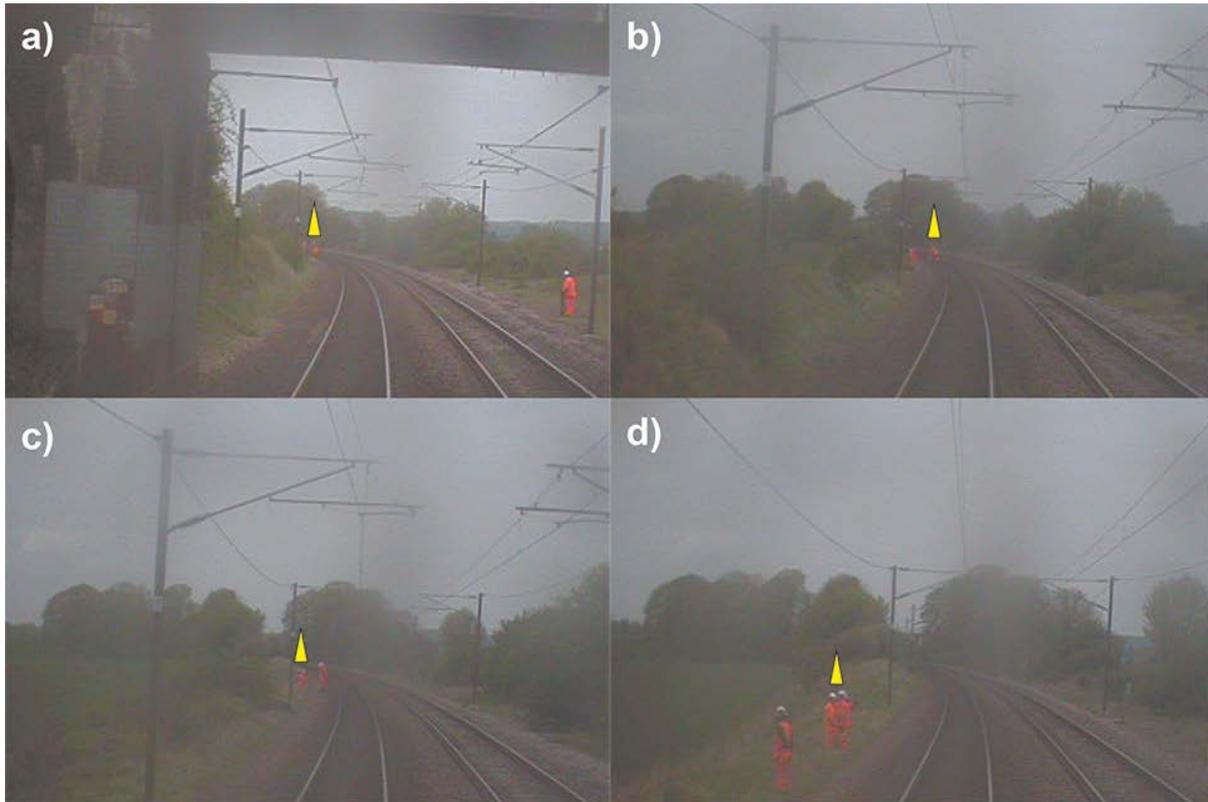
The forward facing CCTV from the train (figure 2) shows the position of the distant lookout at the lineside, about 30 metres beyond a bridge pier. Several staff can be seen in the four-foot of the down line (which is on the inside of the curve). The distant lookout is looking in the direction of the group as the train passes his location (figure 1). The work group then appear to react to the approach of the train, approximately five seconds before it passes them. The work group then move clear of the line and reach a position of safety when the train is only about 60 metres, or 1.8 seconds running time, from the place where they had been working.

When the train came into his view, the distant lookout used his horn to try to warn the group, but witness evidence indicates that 'sudden windy conditions' within the cutting meant that they did not hear the warning and were therefore unaware of the approaching train. The distant lookout realised that the site lookout and the group had not acknowledged his warning, so he blew a series of short blasts on the horn which the group also did not hear. The group only began to move clear when they heard the train's horn and saw it approaching under the bridge (figures 2a to 2d).

Figure 2: a) 11:32:54 Distant lookout in the Up cess, work group on the Down line b) 11:32:56 Workers in the four-foot c) 11:32:58 Workers moving to the cess d) 11:33:01 Track workers in a place of safety. (CCTV images courtesy of Greater Anglia.)
