Rail Accident Investigation Branch

Rail Accident Report

Freight train collision near Logan, East Ayrshire
1 August 2015

Report 13/2016
July 2016

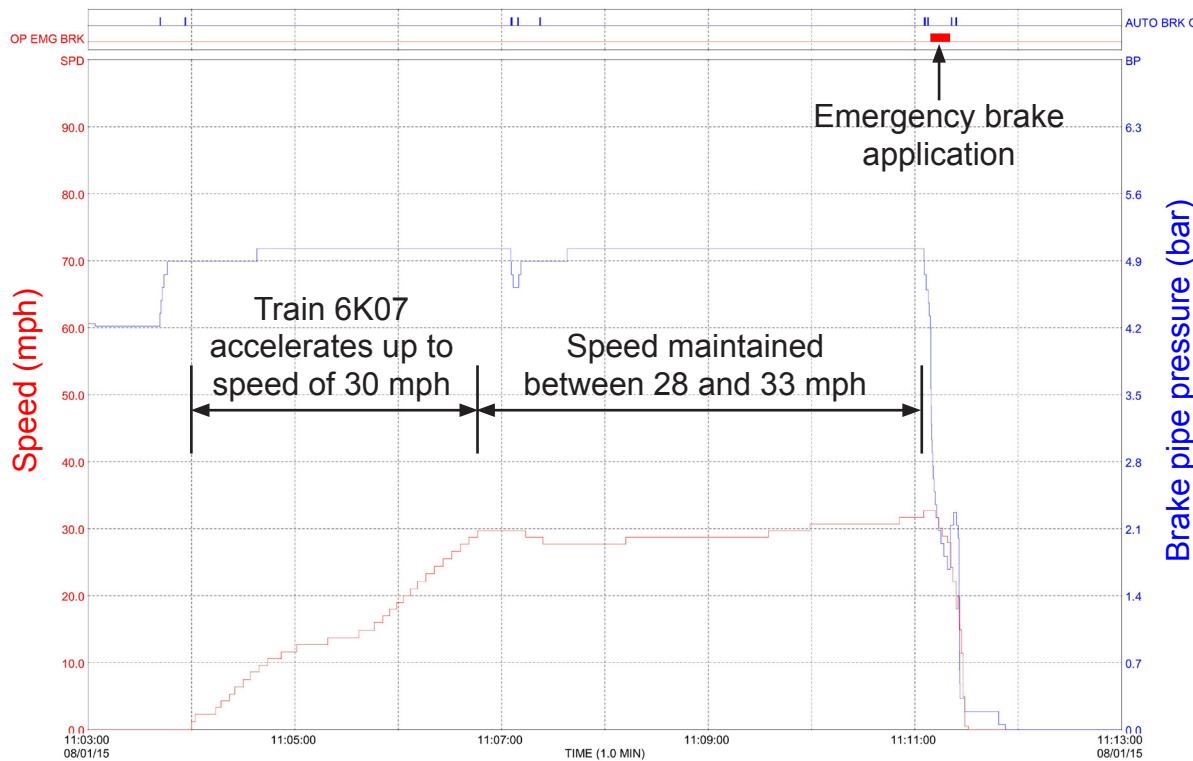
Figure 6: Data recorded by the locomotive's on-train data recorder

- 29 The locomotive's *on-train data recorder* shows that from 11:04 to 11:07 hrs, train 6K07 slowly accelerated until it reached a speed of 30 mph (48 km/h) within the work site (figure 6). For the next four minutes, train 6K07 maintained a speed between 28 mph (45 km/h) and 33 mph (53 km/h).

- 30 At 11:11:05 hrs, the driver made a brake application and the *brake pipe* pressure recorded by the on-train data recorder fell from 5.0 bar to 4.3 bar. This was 210 metres from the point of collision. Four seconds later the driver made an *emergency brake* application while travelling at 33 mph (53 km/h). This was 156 metres from the point of collision. Shortly after this the driver got out the driver's seat and braced himself behind the seat on the right-hand side of the cab as he realised a collision was unavoidable.

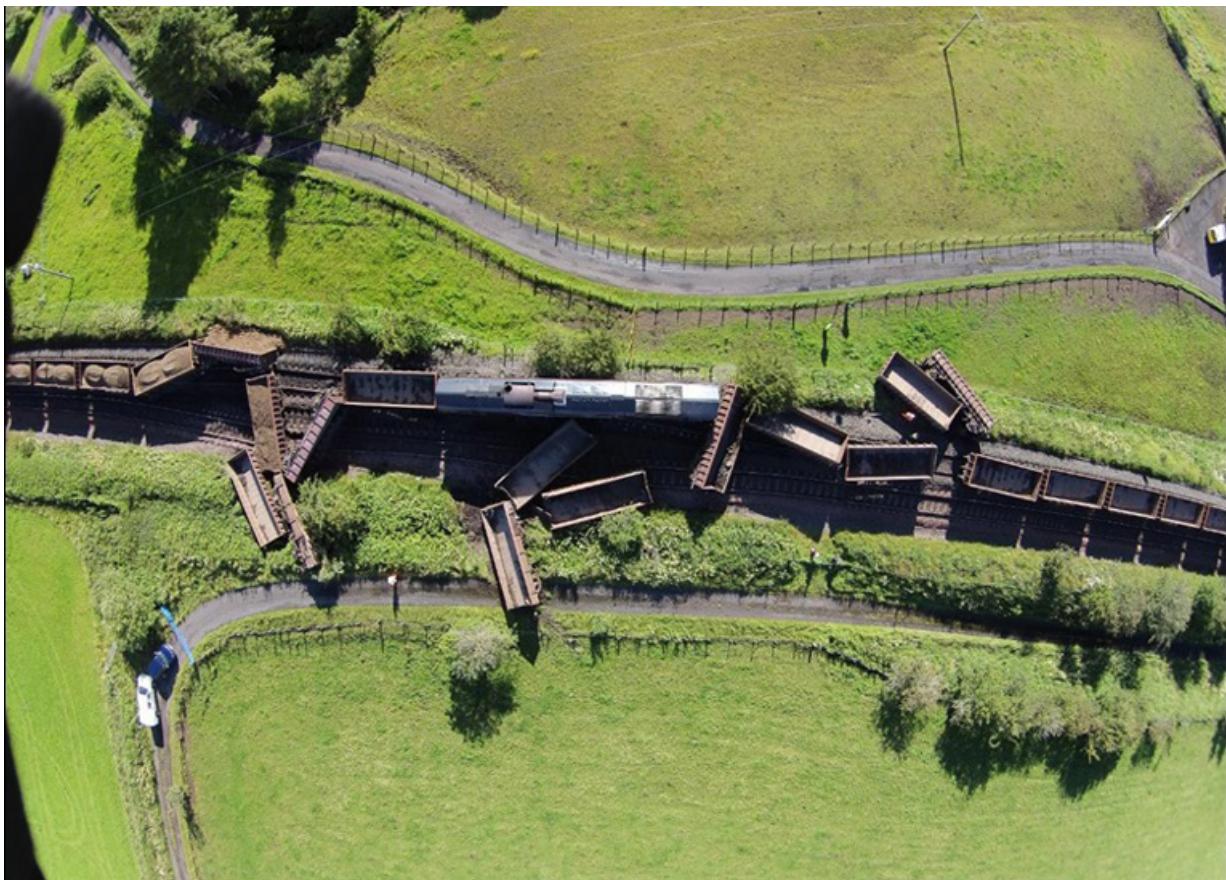
Figure 7: Aerial view of the derailed locomotive and wagons (courtesy of Network Rail)

- 33 Train 6K06 was stationary with just the brakes on the locomotive applied. When struck, train 6K06 was pushed forward and its rear nine wagons derailed (figure 7). The 20th and 21st wagons towards the middle of the train also derailed after overriding (figure 9).

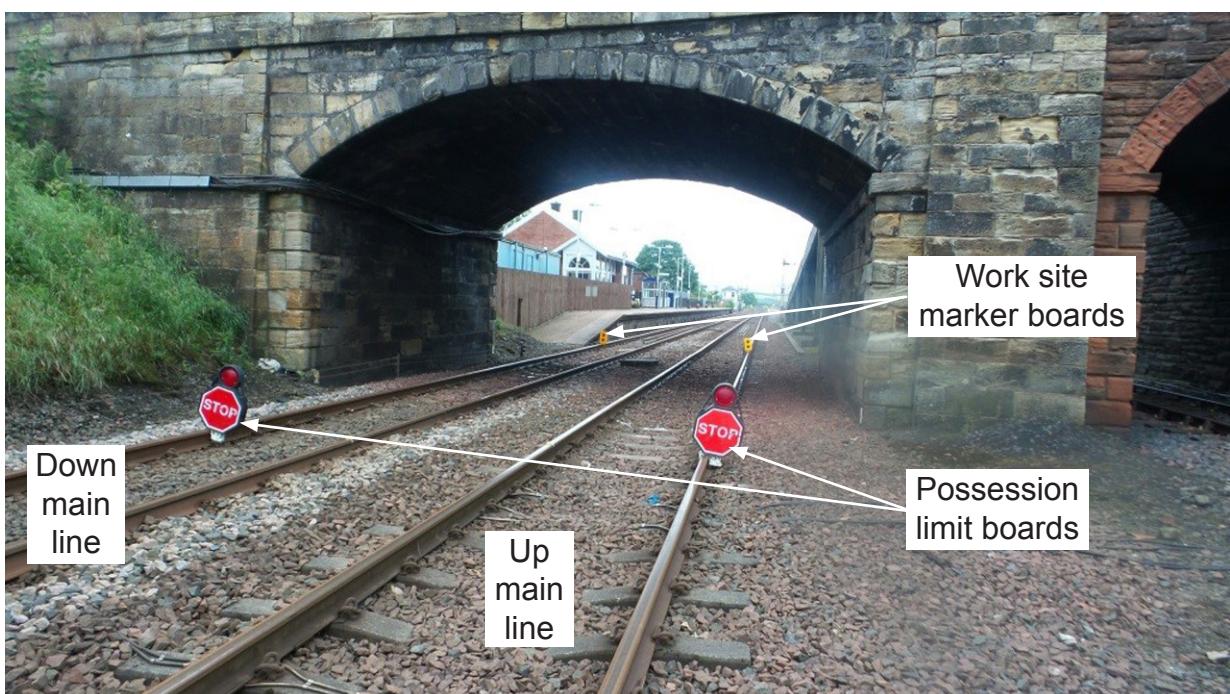
Figure 11: The possession limit and work site marker boards at New Cumnock (image courtesy of Network Rail)⁶

- 63 After the accident, the driver of train 6K07 stated that he might have thought he was driving in a possession rather than a work site while travelling from New Cumnock to site of the track renewal, and so could proceed at a speed of up to 40 mph (65 km/h). The protection arrangements in place at the entrance to the possession and work site may have led to the driver's uncertainty. At New Cumnock, the possession limit boards and the work site marker boards were located together at the possession detonator protection (figure 11). However, when train 6K07 approached, the work site marker board was not visible to the driver as it was lying face down between the rails (figure 12). It is not known when it was placed in this position but the RAIB obtained CCTV footage from New Cumnock station, which began at 10:30 hrs, that showed it was already lying face down by this time.

- 64 Section 3.4 of GE/RT8000/HB12 states that the work site marker board will normally be placed at least 100 metres from the possession detonator protection. It also states that if this distance cannot be achieved, the work site marker board should be placed at the detonator protection along with the possession limit board. At New Cumnock, the work site marker board was placed next to the last detonator, so was placed about 20 metres from the possession limit board which was located at the middle detonator. However, only the possession limit board was visible to the driver of train 6K07.

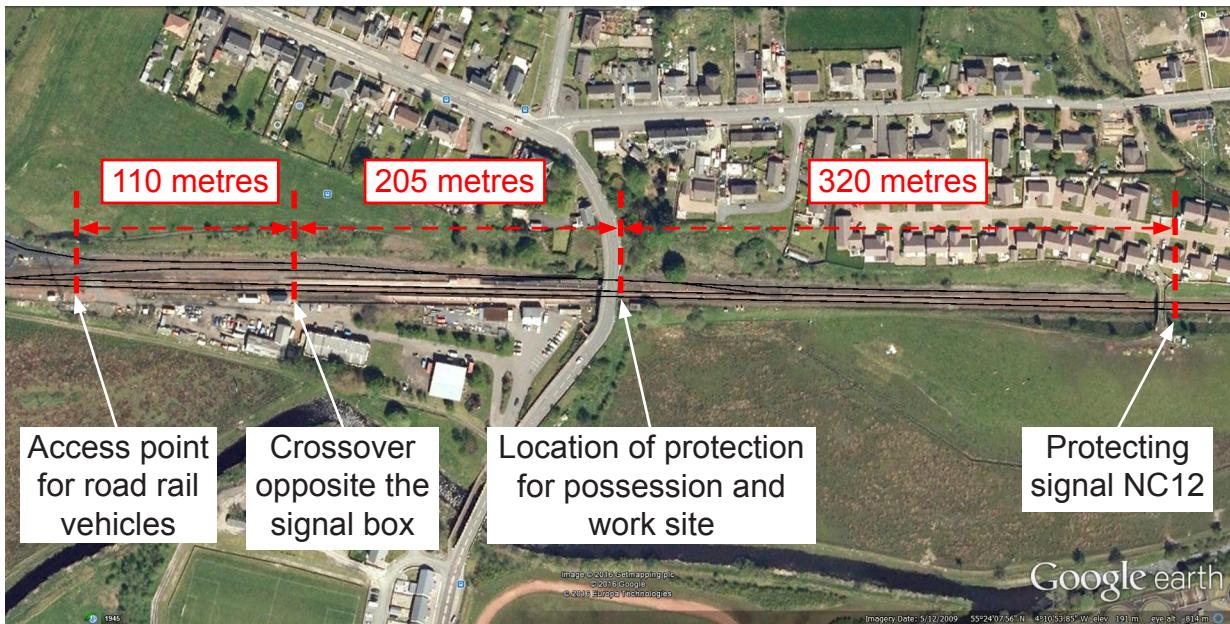
Figure 13: Overview of possession and work site arrangements at New Cumnock

- 66 The protection arrangements at New Cumnock were non-standard for a second reason. Section 2.4 of GE/RT8000/T3 requires the possession detonator protection (and therefore the possession limit board) to be placed a distance of 400 metres from the protecting signal. It was about 320 metres from the protecting signal, NC12, to the possession limit board (figure 13). When the distance of 400 metres cannot be met, GE/RT8000/T3 requires the protection to be placed as close to the standard distance as possible.

- 67 The location of the protection boards at New Cumnock was driven by the operational requirements for the work site. Babcock Rail wanted to include the road rail access point at New Cumnock within the work site (figure 13). Babcock Rail also wanted sufficient space to hold a train at the exit to the work site while its rear was still clear of this access point. Locating the protection boards at the end of the platform ramp was also convenient for staff to get to when trains were coming into or going out of the work site and possession.

- 68 By co-locating the possession limit and work site marker boards, it meant each train that entered the possession and work site was required to pass both boards in one movement. When a train arrived at protecting signal NC12, its driver contacted the signaller. The signaller then obtained permission from the PICOP for that train to move up to the detonator protection by the possession limit board. The signaller then authorised the driver to pass signal NC12 at danger and move up as far as the possession limit board.

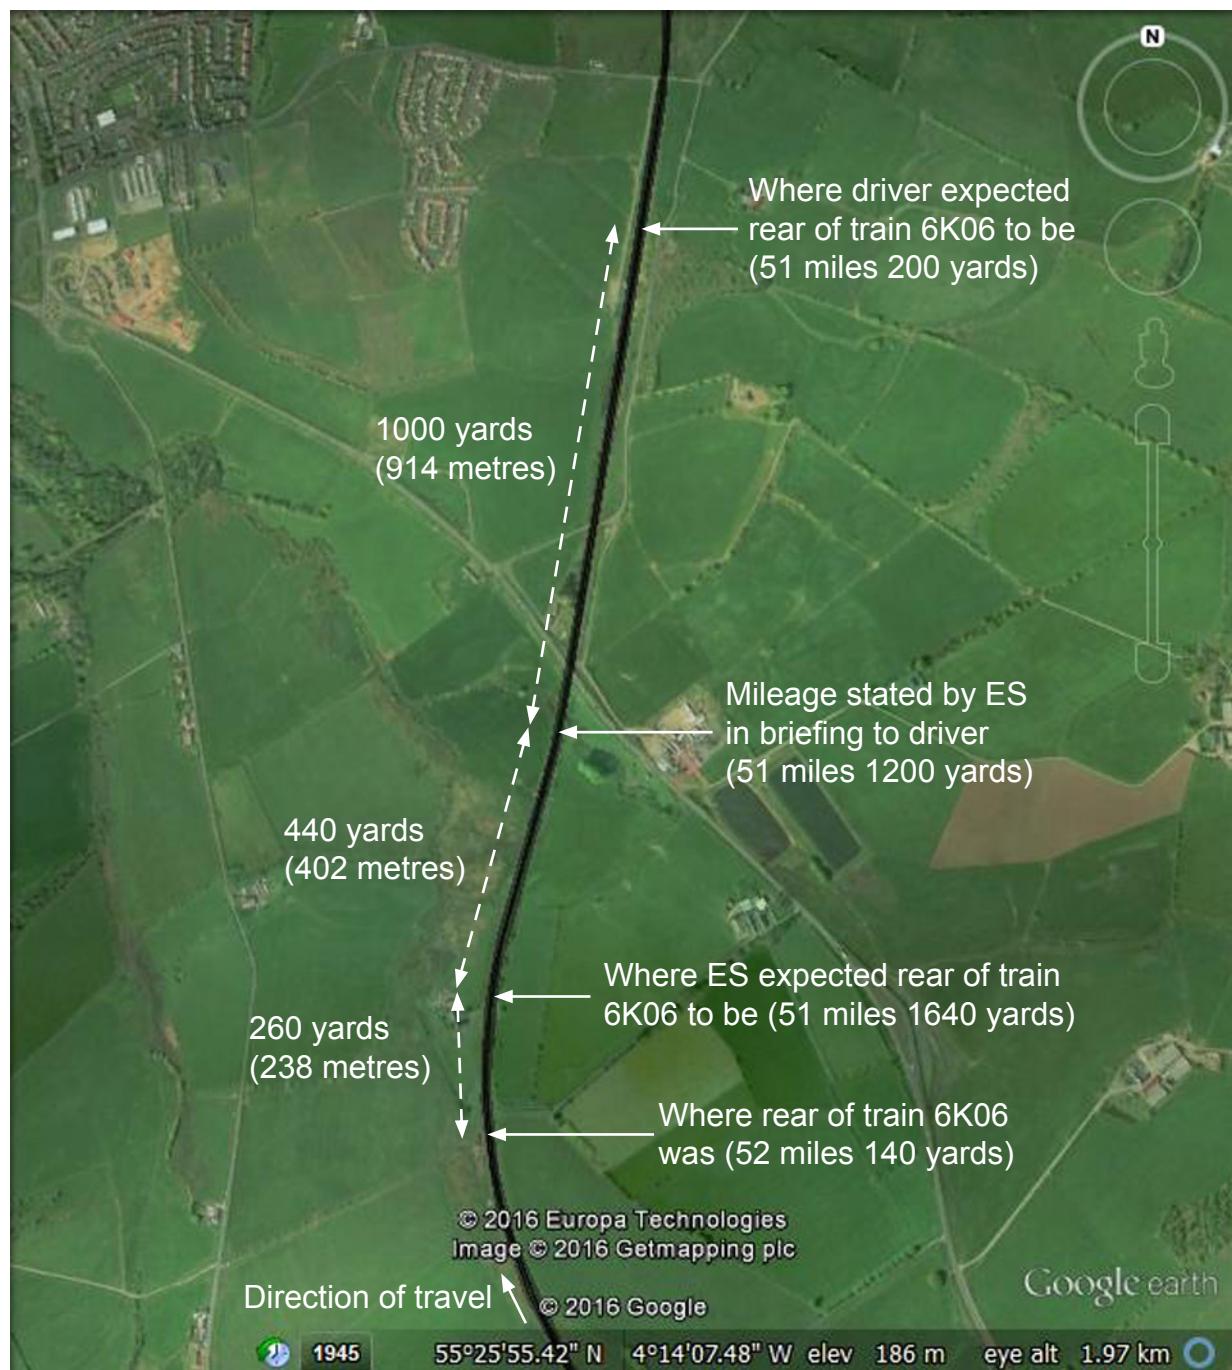
Figure 14: Location of train 6K06 and locations where driver and ES believed the train was standing.

- 77 The driver of train 6K07 believed that train 6K06 was further away than it actually was due to a misunderstanding about the location of train 6K06.
- 78 When the ES briefed the driver before train 6K07 entered the work site, he told the driver to go to 51 miles 1200 yards but stop short of a train ahead that was waiting to go into the track renewal. However, during this briefing a misunderstanding arose and the driver formed the view that 6K06 was standing in the vicinity of 51 miles 200 yards (figure 14). The driver stated he wrote this mileage down, but the RAIB has been unable to locate the paper that this was recorded on.

- 79 When the ES took over responsibility for the work site (paragraph 23), he was told that train 6K06 was waiting to move up into the track renewal site. Based on this information, the ES expected the rear of train 6K06 to be about 440 yards (about 400 metres) short of the start of the track renewal (at 51 miles 1200 yards), which would place the rear of the train at about 51 miles 1640 yards (figure 14). The rear of train 6K06 was actually nearer to New Cumnock at 52 miles 140 yards (figure 14), which was about 1 mile (1.6 km) closer than the driver thought.

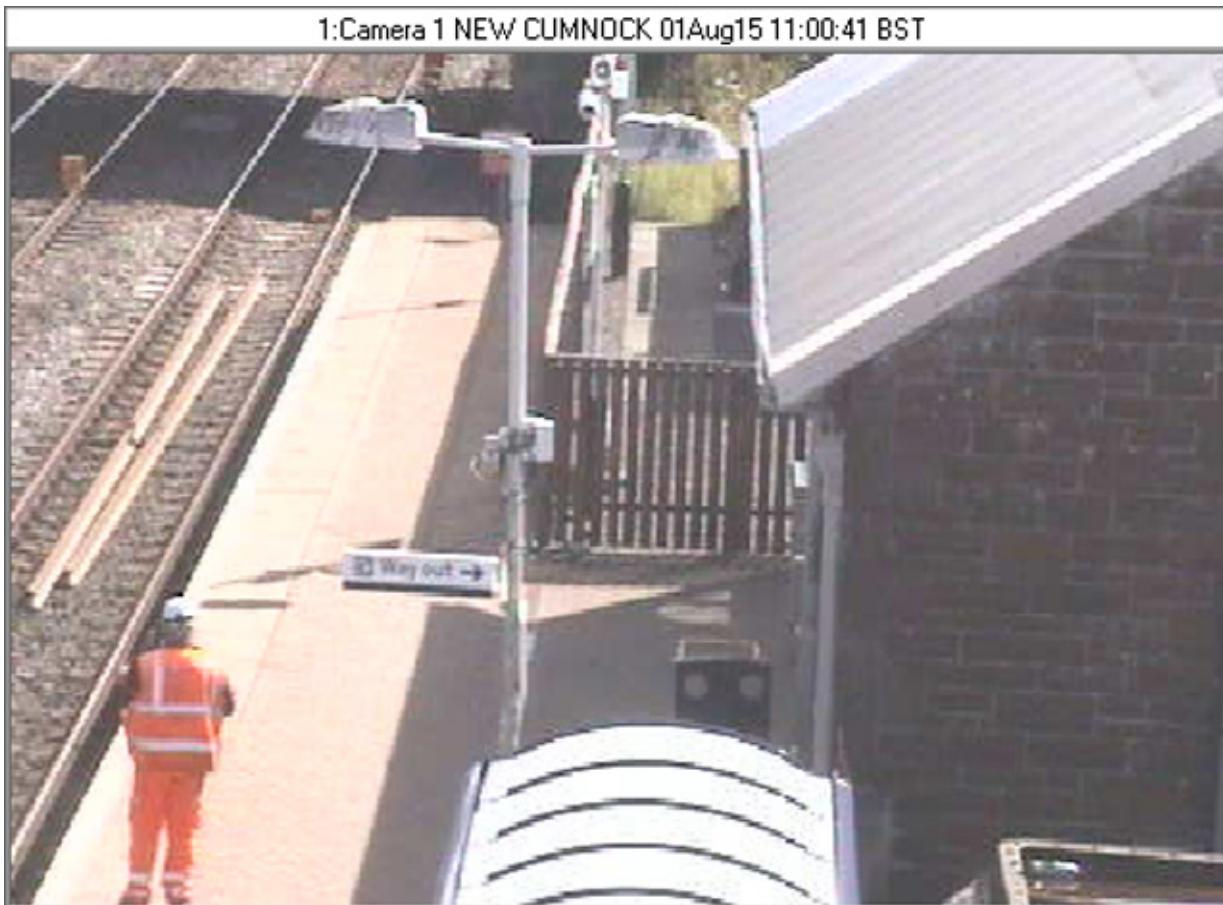
Figure 15: CCTV image of ES on platform at New Cumnock while briefing the driver of train 6K07 (courtesy of ScotRail)

- 89 Giving instructions by mobile phone rather than face to face can increase the potential for misunderstanding. A face to face conversation helps the person giving out the information to determine if the recipient has understood the instructions, by non-verbal means such as the recipient's body language or facial expressions. Technical issues such as a poor mobile phone signal can also cause distortion or a loss of sound during a conversation. This can result in incorrect information being received. To identify these inaccuracies, drivers and engineering staff (including PICOPs and ESs) are trained to repeat back the safety critical information passed during a conversation. Witness evidence is contradictory as to whether information was repeated back. As the conversation between the driver and ES was by mobile phone, there was no recording and so the quality of the communication between the two parties and their use of repeating back could not be checked.

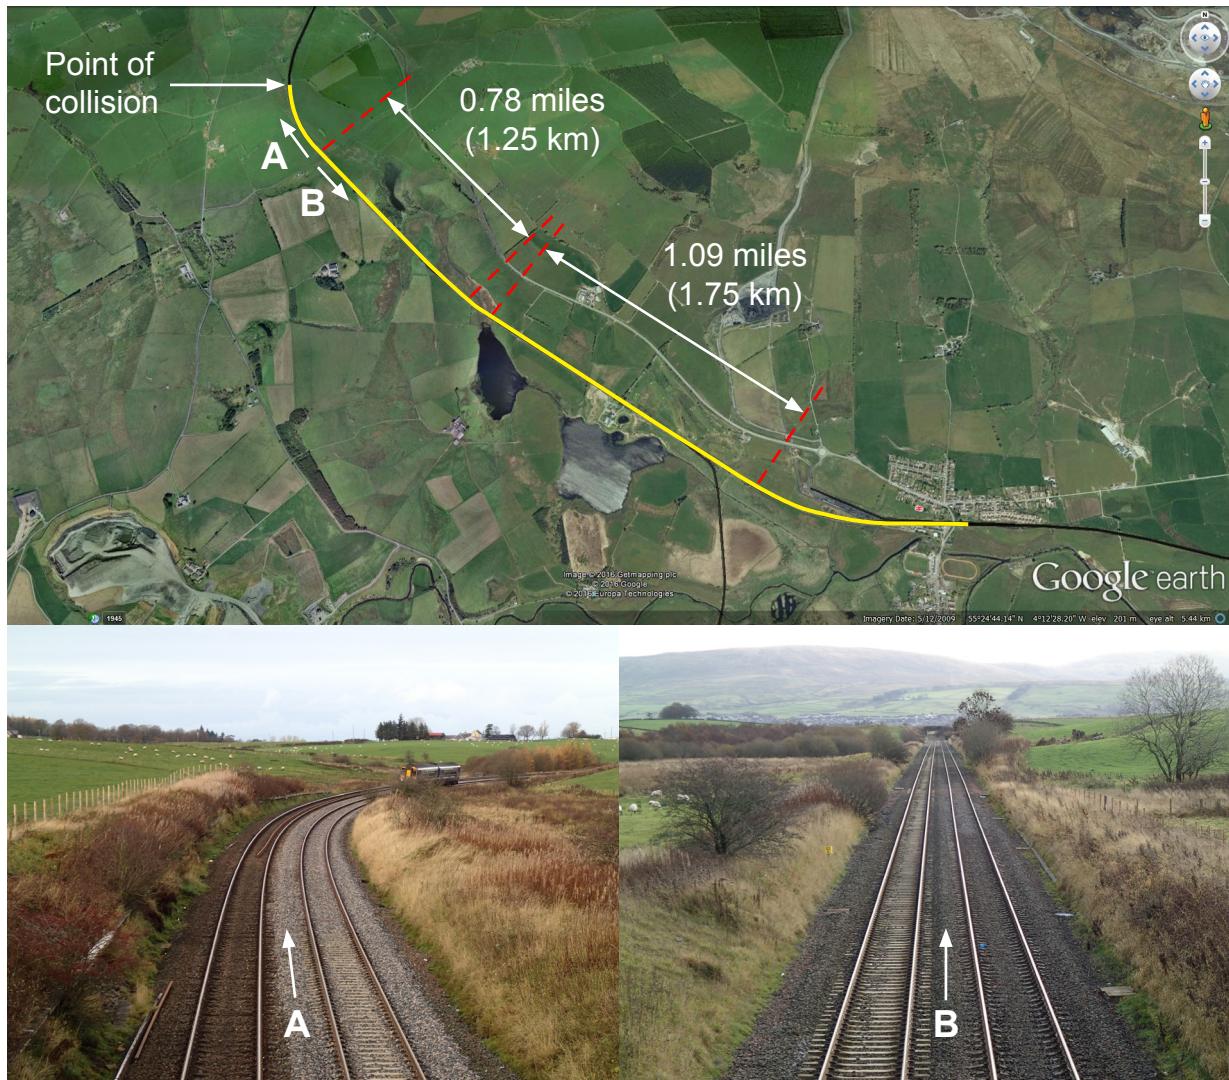
Figure 16: Views of the track from New Cumnock to the track renewal site

104 When possessions and work sites are so long, often there will be sections of railway in which no work will be taking place, so a driver will not see anyone on the track. This was the case when train 6K07 travelled the 3 miles (4.7 km) from New Cumnock to the track renewal site. In many instances, long possessions and work sites will include lengthy straight sections of track. The journey from New Cumnock to the track renewal site included two long straights (figure 16). In daylight and fine weather conditions visibility will be good, so a driver can see a long way ahead to the end of these straights. If drivers can see a long way ahead that the line is clear with no one working on it, it may alter a driver's perception of the risk of moving within the work site and cause some drivers to question the reason for travelling a long distance at such a slow speed. This may therefore encourage a driver to travel faster than the 5 mph (8 km/h) default speed limit and in violation of the rules. Once some drivers view a rule as unnecessary it is likely that they will be more likely to travel in work sites at higher speeds. Since there is no monitoring in place (paragraphs 98 to 102), this behaviour is most often not detected by driver managers or corrected.

105 Additionally, driving a freight train for long distances at 5 mph (8 km/h) is not easy. On rising and level gradients, the driver can vary the amount of traction on the locomotive to control the train's speed. However, driving at 5 mph (8 km/h) becomes more difficult when the train is on a falling gradient, particularly with the wagons in this type of train which have their brakes set to 'goods' timings (paragraph 53). Due to the length of time it takes the brakes to apply and release, drivers need to be particularly careful with how they apply the brakes otherwise the train could come to a stand. The lengthy brake application and release times can also lead to some parts of the train being unbraked while other parts are in a braked condition. If the driver then applies traction, this can cause shockwaves along the train, which can break the couplings and cause the train to divide.

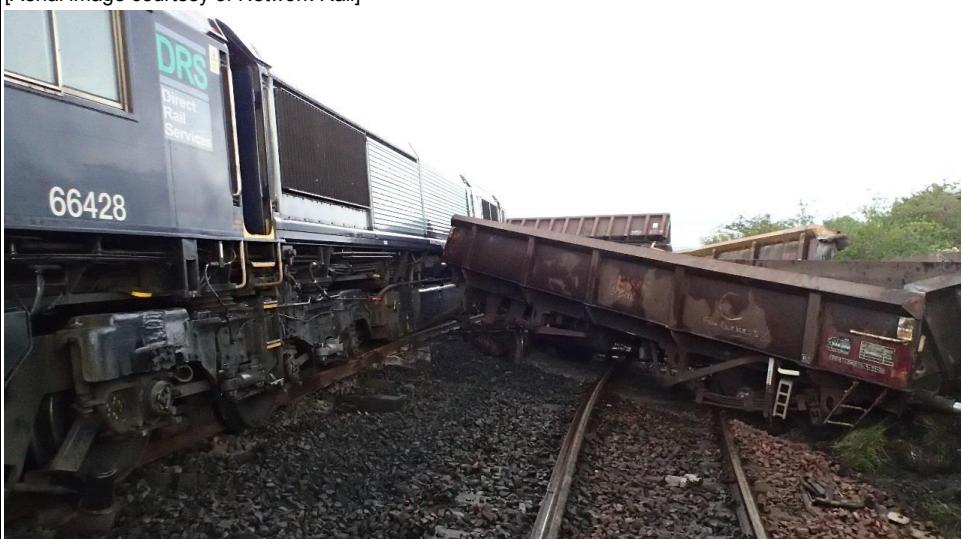
<p>[Close up view of the locomotive from train 6K07 and wagons from train 6K06]</p>
