Maritime &
Coastguard
Agency

SS RICHARD MONTGOMERY SURVEY REPORT 2015

MARITIME & COASTGUARD AGENCY
DECEMBER 2016

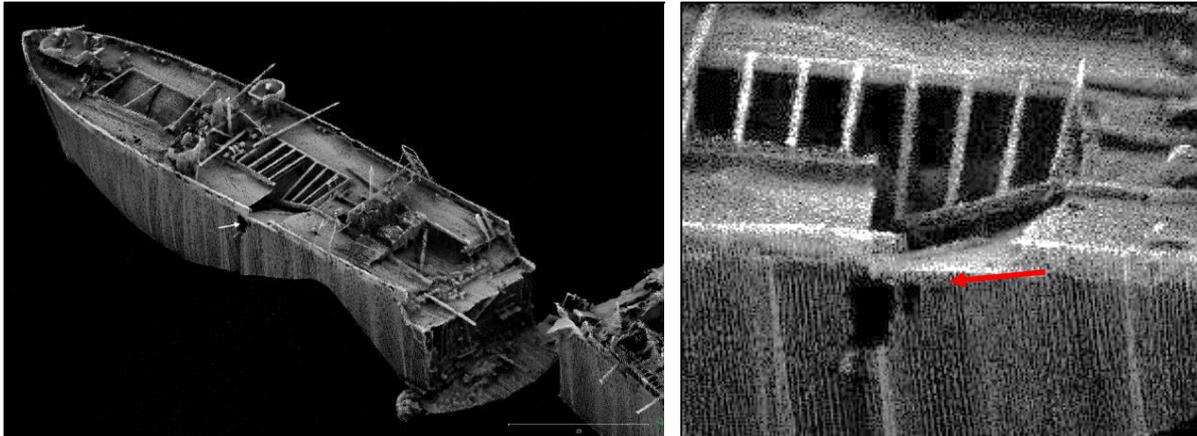
4.7.1 This feature is a crack in the hull located on the port side of the Forward Section of the wreck, adjacent to Hold 2. This feature has been noted in survey reports going back at least as far as the 1970s. Comparisons of point clouds generated from the 2015 and 2014 survey datasets showed that a change in the size of the crack had occurred. This change is in the form of the addition of a small gap in the hull plate that is located to the right of the two original cracks seen in previous years' data.

However, the large bend in the hull plate that extends from the base of the crack to the seabed does not appear to have become more pronounced in the current dataset.

Fig. 2 & 3 - Crack in hull on the port side of the forward section (arrow marks position).

4.7.2 Measurements of the hull crack were made in the 2014 and 2015 datasets and the imagery suggests that a third, smaller hole may now be present that had not been identified in previous datasets.

DIMENSIONS OF CRACK IN HULL (ID04)		
Dataset	Height (m)	Width (m)
2013	3.3	2.2
2014	3.4	2.1
2015	3.2	2.2 (2.9)

Taking the presence of the new gap in the hull to be an extension of the crack, a new width of 2.9m is recorded. This is shown in brackets in the table.

4.7.3 Examining this feature more thoroughly could not confirm whether the crack had expanded to include the new small hole. It has also been noted from reading diver survey reports that the MBES data may over state the dimensions of this crack. This is due to the effect of shadowing being interpreted as a void in the hull plate. It is possible that the new, small hole is a product of an inward bulge in the hull, however, this area is devoid of soundings in the lines that cover this region of the ship. In order to corroborate the finding of this potential new hole, it may be beneficial to utilise a higher resolution system to investigate this section of the SSRM in the future.

7.10 The Crack in Hull on the port side of Hold 2 (Key Area 1) appeared to show some evidence of change in the form on a new small hole opening up in the hull on the southern side of the main crack. This region was examined to ascertain whether this was a new feature or a product of acoustic shadowing. This was inconclusive. However, the main crack did not appear to have increased in size since the 2014 survey.

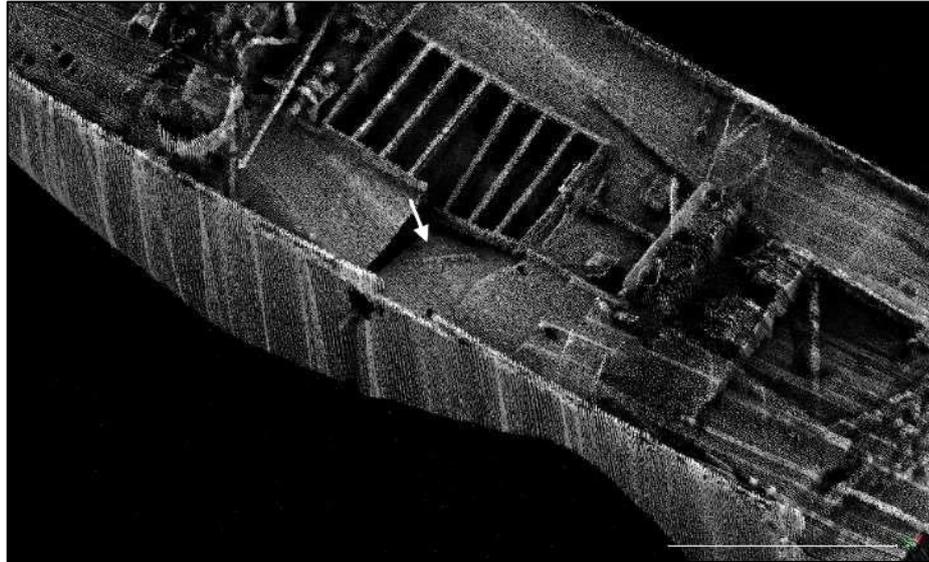
- The deck plating adjacent to Hold 2 has dropped by 25cm, possibly as a result of increased sediment load, and cross-sections through the data at this area of the wreck suggest that the deck plate is very close to (or possibly in contact with) the contents of Hold 2.

4.8.1 Surface difference analysis comparing the 2015 and 2014 datasets indicated that further subsidence of the collapsing deck plate along the port side of Hold 2 had occurred. The shift in the surface difference is between 0.1m and 0.2m and cross-sections through the data confirmed the conclusion of the surface difference results. The collapsing deck plate appears to be nearly in contact with the material present within Hold 2. This may start to reduce the rate of subsidence unless the material is not sufficiently stable to support the weight of the deck. This area will continue to be a key section for the focus of future surveys.

Fig. 4 Collapsed section of deck plate (arrowed) alongside Hold 2

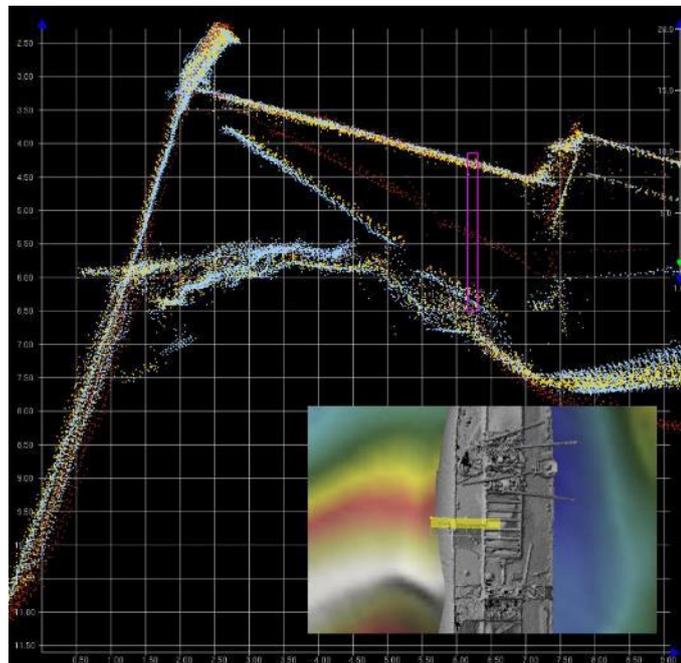
Fig. 5 Cross-section showing the subsidence of the deck plate at hold 2 showing 2010 data (red), 2014 (yellow) and 2015 (blue), the pink rectangle shows the positions from which the measurements were taken.

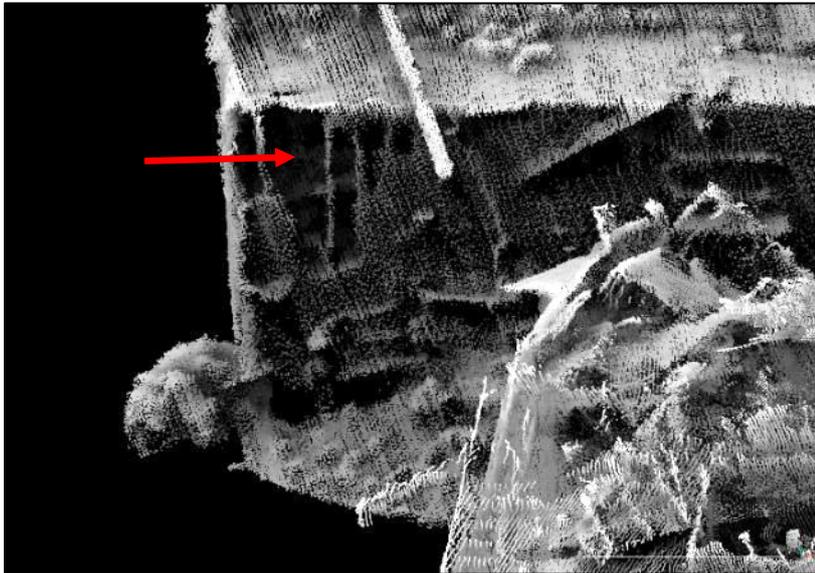
4.9.1 The large aperture on the aft end of the Forward Section was well defined in the 2015 dataset. Cross-sections through the data at this area of the wreck showed a good alignment between the datasets and that there was no visible change to the dimensions of the aperture. Measurements taken indicated that the size of the aperture had not increased since the previous survey.

Fig. 6 Location of Aperture at the aft end of the forward section

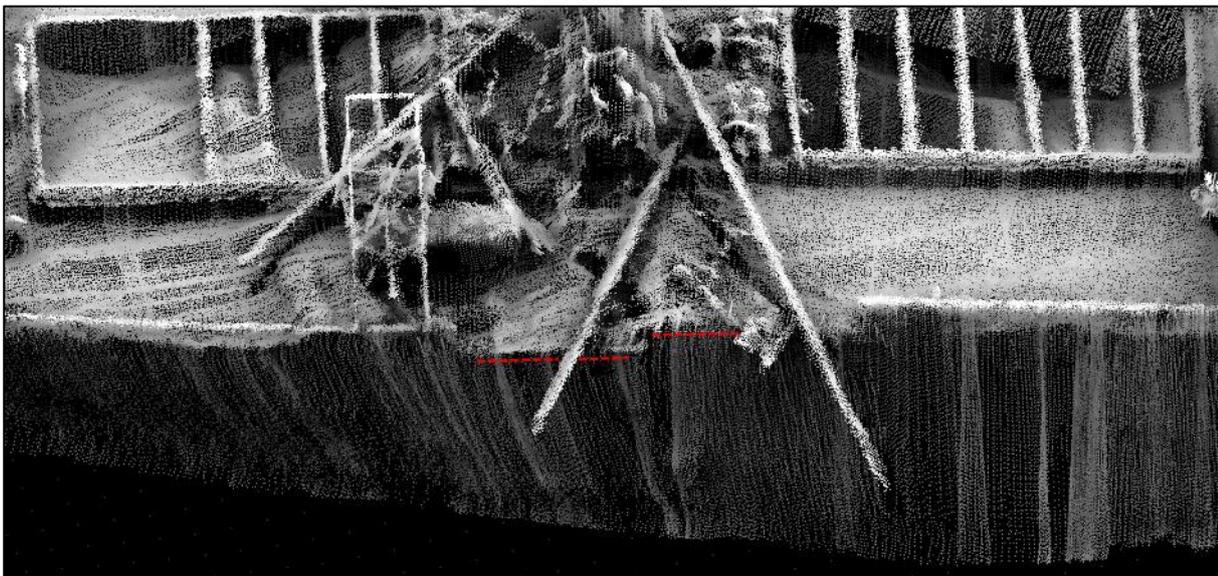
4.10.1 This split in the hull is located on the starboard side of the aft mast on the aft section of the wreck. The feature could easily be identified in the 2015 dataset.

*Fig. 7 The split in the hull (ID22) visible in the 2015 dataset
The red dashed line highlights the distortion of the line of the hull in this area.*

4.10.2 Cross-sectional comparison with the previous survey suggested that the size of the split had not increased over the last 12 months as the two datasets were closely aligned. Further examination of this area was performed by conducting a surface difference analysis over the deck in this area of the wreck as a more pronounced split in the hull would result in a shift in the deck above. The analysis showed that the deck near the gunnel had remained stable with minor variations arising from differences in cleaning the data around the intricate structures in this area of the wreck. Towards the centre of the wreck however, there is some evidence of change, an increase in depth of up to 0.3m. However, viewing cross-sections through this part of the deck showed that the 2015 data aligned with that from the 2010 survey and that the perceived change in depth was most likely a reflection of sediment having been removed from the area over the course of the last year.

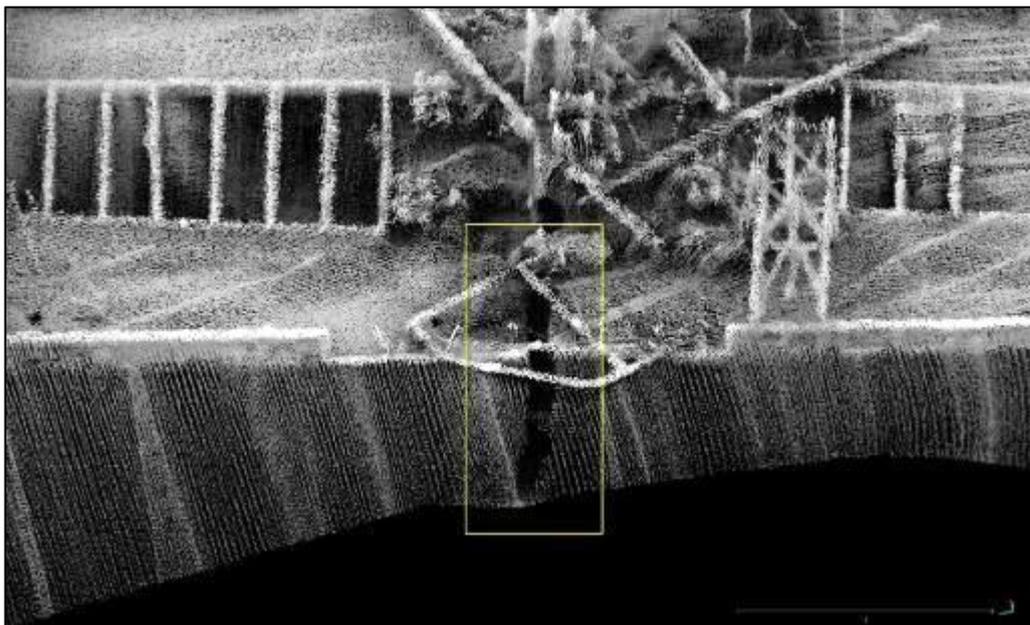
4.11.2 Surface difference results showed that there had been little change in the 12 months between the 2014 and 2015 surveys and any differences with the previous survey appear to be movement of sediment deposits on the deck and in the hold. However, this area will continue to be under close scrutiny in future surveys in order to confirm whether these small changes definitely relate to sediment removal or are a feature of continued collapse.

4.11.3 The findings of the surface difference analysis were supported by viewing cross-sections through the data at this area of the hull and these show a close alignment between the datasets indicating that there has been no further deterioration of the hull or deck since the 2014 survey was performed.

Fig. 8 Split in Hull and Deck (ID24 & ID25) shown in 2015 data.

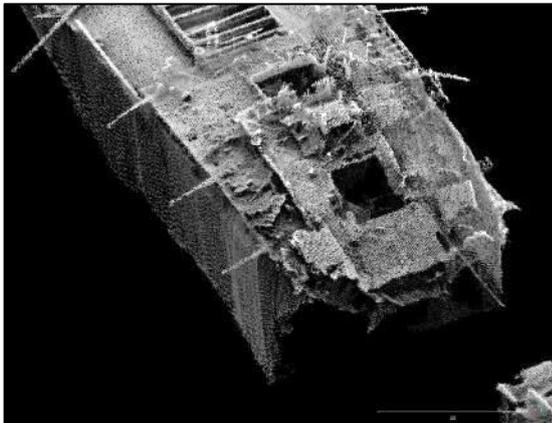
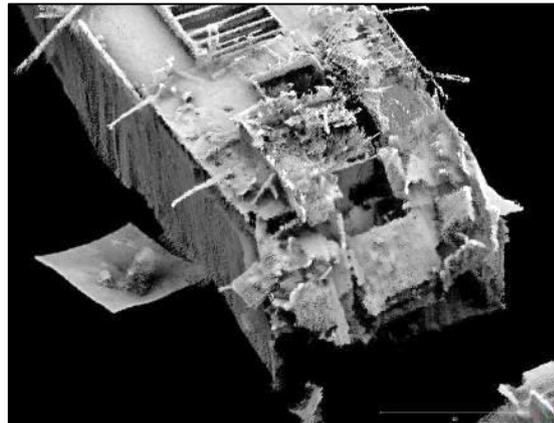
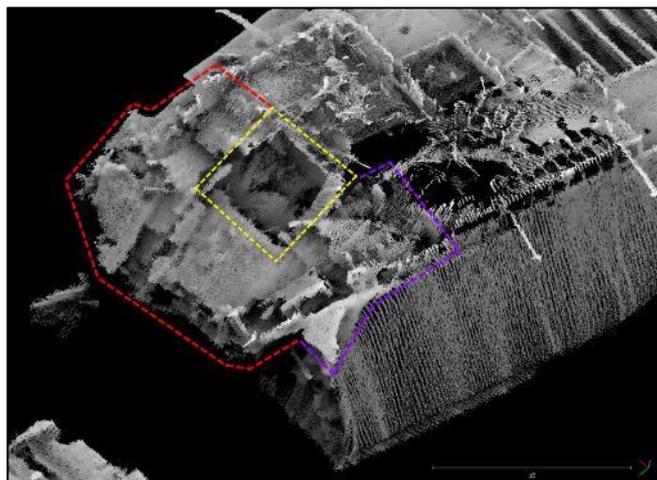
- The clearest evidence of deterioration in the 2015 survey is the advancing collapse of the overhanging bridge section, which sits unsupported at the forward end of the Aft Section of the wreck and, in some areas, has slumped by up to 4m since the last survey.

4.12.1 Area 6 was added to the list of key areas as a result of changes detected in this survey. This section of the wreck has experienced the greatest amount of degradation in the period since the 2014 survey was completed. The subsiding area is expansive and covers the boiler room casing, the collapsed bridge deck and the collapsed boat deck.

4.12.2 Examination of the surface difference results and cross-sections through the combined datasets showed that the collapsing section encompasses the full width of the wreck and extends back up to 8.0 m from the forward edge. This is roughly in line with the mid-point of the boiler room casing. Along the forward edge of the boiler room casing this subsidence is approximately 0.75m and the degree of displacement increases forward, towards the edge of the wreck. The maximum displacement of 4.0m has occurred along the most forward edge of the bridge deck area on the starboard side.

4.12.3 On the port side of this area is the area of the collapsed boat deck. This location is part of the widespread subsidence but there are movements within the complex debris that manifest as an increase in height. The port side exhibits less subsidence, between 0.5m and 1.0m, than the midships area and starboard side.

Fig. 11 Collapse of the structures on the forward end of the Aft Section. Rough outline of the boiler room casing shown in yellow, the collapsed boat deck shown in purple and the red line represents the collapsing bridge deck

7.8 It is recommended that this section of the vessel is the focus for future surveys (it has been added to the list of Key Features) and would benefit from repeat surveys on a more regular basis to track the progress of the deterioration.

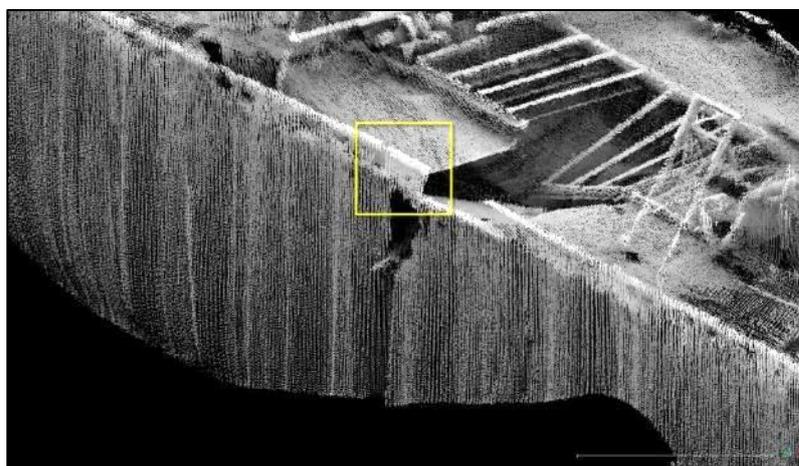
4.14.1 The break in the gunnel located on the port side of Hold 2 on the Forward Section of the wreck showed that a small amount of movement may have occurred since the 2014 survey. The maximum shift between the datasets is observed at the southern end of the tilted gunnel section and shows movement of approximately 0.05m. This small shift is possibly a product of the misalignment of the datasets as it is approximate to the accuracy of the post-processed position. But, as stated in the 2014 report, the gunnel is moving in tandem with the collapsing deck plate, which does show an identifiable shift in the 2015 dataset.

Fig. 12 The break in gunnel shown in the 2015 dataset

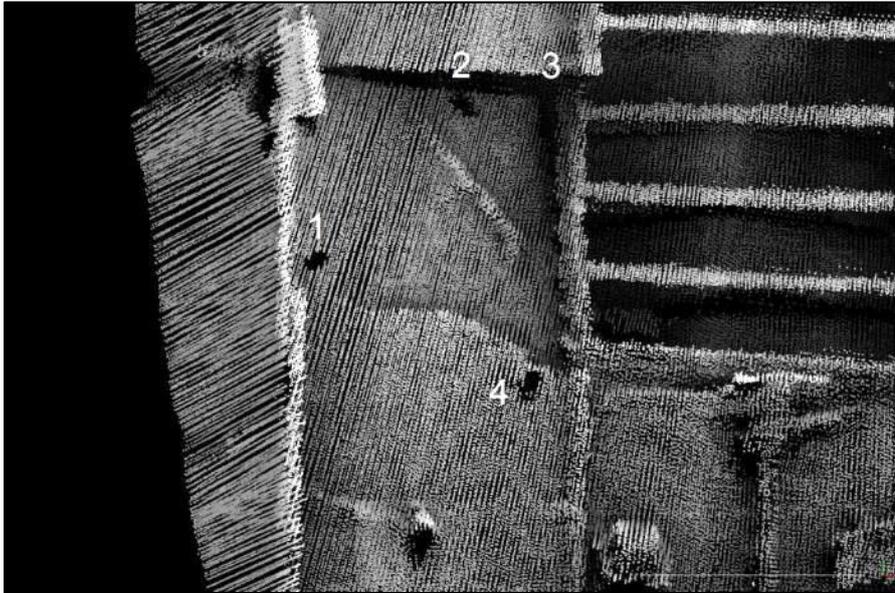
4.15.1 The holes in the area of the collapsing deck plate on the port side of Hold 2 were well represented in the 2015 dataset. These were not visible in survey results in 2010 but are clear by the 2014 and 2015 surveys. Measurements were made of the length and width of the holes and these were compared to those taken from the 2014 dataset. Evidence of deterioration was seen in the hole marked as number 2 on the image below, which has increased in length by 0.3m between the 2014 and 2015 surveys. Measurements made across the remaining holes indicated that no identifiable deterioration had occurred.

Fig. 13 Holes in Deck Plate shown in the 2015 point cloud

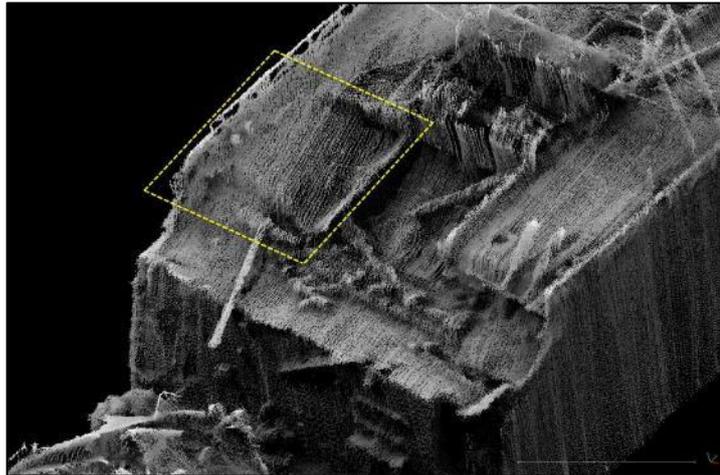
- The deck plate along the port side of Hold 3 has shown an increase in height from 0.1m to 0.2m. This is unusual as one might expect the wreck to collapse with sections increasing in depth but this rise is consistent over a large area and the difference is observed when comparing data from 2014 and 2010.

4.17.1 To identify movement in the inclined deck plate at this point on the wreck, surface difference analysis was performed. This showed that there had been a slight elevation of the deck since 2014, between 0.1m and 0.2m. Cross-sections through the data confirmed that this had occurred. This direction of movement is unexpected, although it is not considered to be a result of a positional misalignment as the 2015 data forward and aft of the collapsed area shows a consistent alignment with the historical data.

Fig. 14 Collapsed deck plate and hatch coaming in 2015 dataset

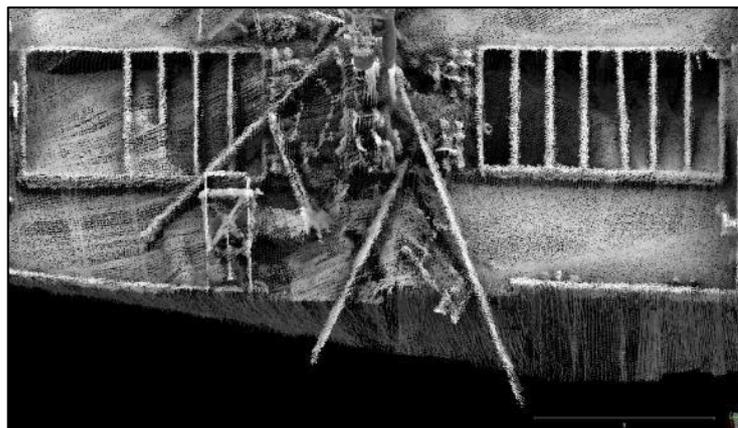
4.18.1 This feature is closely related to the split in the hull plate at this point in the hull and both are located on the starboard side of the aft mast house. The deck in this area is quite complex with collapsed booms, holes in the deck and an unidentified frame-like structure all present on the deck. These structures can obscure the access of the MBES to the deck structure below. Despite the debris the 2015 data shows a good density of soundings on the deck in this region and this has shown an increase in depth of up to 0.3m. This is likely to be the result of sediment deposits being removed over the course of the year.

Fig. 15 Split in deck plate along the starboard side of the Aft Mast House

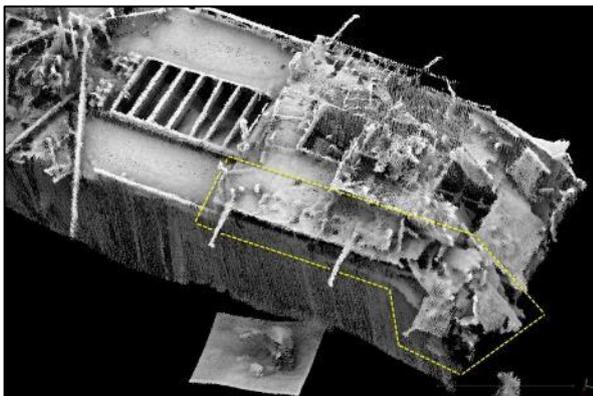
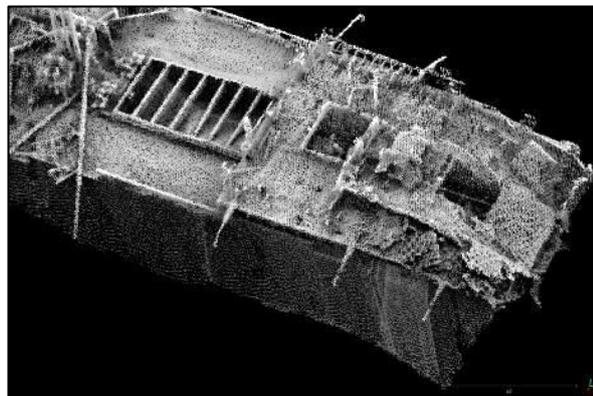
4.20.1 Located on the starboard side of the remains of the central superstructure is the boat deck, which was established as being present in the 2012 report, it is a site that has undergone a significant amount of subsidence since the 2014 survey. The forward end of the boat deck on this side forms part of the overhanging section that has subsided by up to 4.0m in the past year (the new Key Area 6). This is clearly evident in the surface difference analysis and in cross-sections through the data.

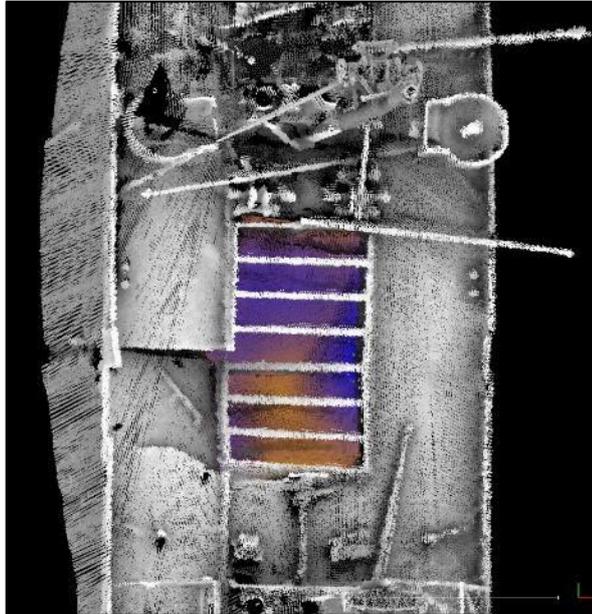
4.21.1 Over the last three surveys, it has been established that the lower hold cover in Hold 2 is not observable in the MBES data. This is due to the opening to the Hold becoming a sediment trap and the hold cover being completely obscured by mobile deposits. This mobility results in year on year changes in the position of the surface within the hold opening. Surface difference analysis with the 2014 survey showed the variability of the surface with areas becoming deeper (maximum of 0.4m) and shallower (maximum of 0.7m).

*Fig. 18 Plan view of the area of Hold 2 (ID30 & 31)
A smooth undulating surface is present (coloured by depth in brown and blue)*

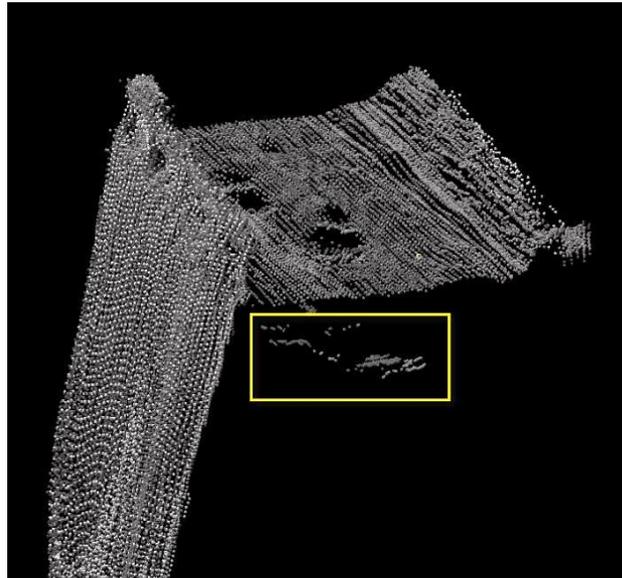
4.24.1 The holes in the deck plate located on the port side of Hold 1 enabled the MBES to obtain data from within the hull. This was not achieved in the 2014 survey, hence this feature has been listed as one that has changed. The data returned from the hull penetration is sparse and incomplete

but may represent an undulating surface, possibly similar to that seen in the Tween Deck Cargo on the port side of Hold 2.

Fig. 19 Point cloud data showing the data received from the wreck interior indicating the presence of material between decks,

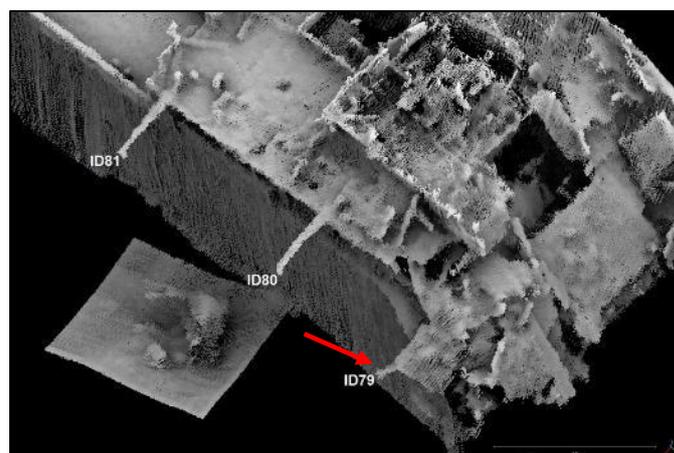
- One of the life raft davits on the stern section of the wreck demonstrates this deterioration around the remains of the superstructure and, since the last survey, it has increased in depth by 2.9 m and is now partially covered by a sheet of debris.

4.25.1 The section of the vessel on which the davit is mounted has been subjected to a large degree of subsidence that has occurred over the last year. The davit is partially obscured by a piece of sheet metal that is supported by the davit's presence. A cross-section through this part of the wreck from 2010, 2014 and 2015 datasets shows that the depth of the tip of the davit has increased from 7.5m in 2010 to 10.4m in the 2015 dataset. The horizontal position of the davit has also changed. The tip now lies 1.8m towards the south-west from its position in 2014. Again, this area of subsidence is part of the new Key Area 6 which is detailed above.

Fig. 20 Lifeboat Davit, starboard side of aft section

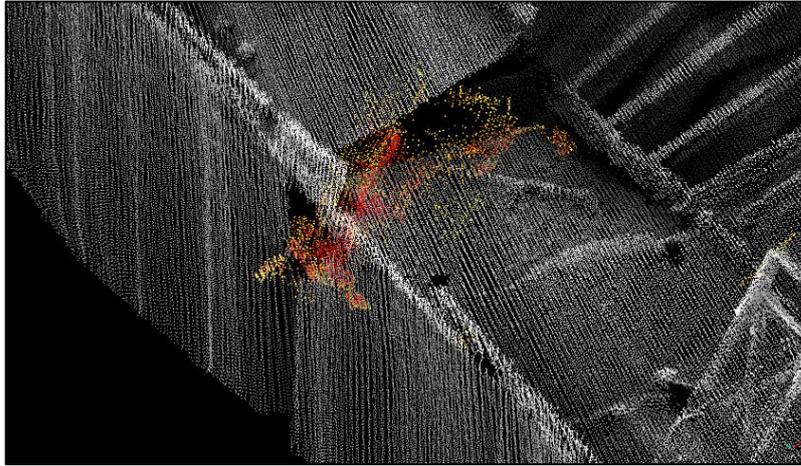
4.27.1 At a number of points in the wreck it has been possible in previous surveys to visualise material inside the holds. In some cases this may represent cargo and in others it may represent sediment build-up. For the 2015 survey, the large crack in the hull at Hold 2 showed some data from within the hold. The Data is sparse but indicates no change from 2014. Examination of the tween deck cargo at Hold 3 showed some subtle differences which are more likely to result from small positional misalignments than movement of debris. The aperture at the aft end of Hold 3 allows the MBES to access the interior of Hold 3. The data acquired during the 2015 survey shows some contents of the hold. Comparisons with the historical datasets showed that the area covered in 2015 matched the 2014 survey, which suggested that none of the items within the hold had been displaced. Greater density of soundings obtained in the 2015 survey showed that some of the exposed items had circular profiles and that they were stacked into 3 or 4 rows.

Fig. 21 Tween deck cargo data (ID35 and 36) on the port side of Hold 2 visible in the 2015 dataset
