Dangerous occurrence at Broad Oak level crossing near Canterbury, Kent, 29 June 2017

2. Summary of the incident

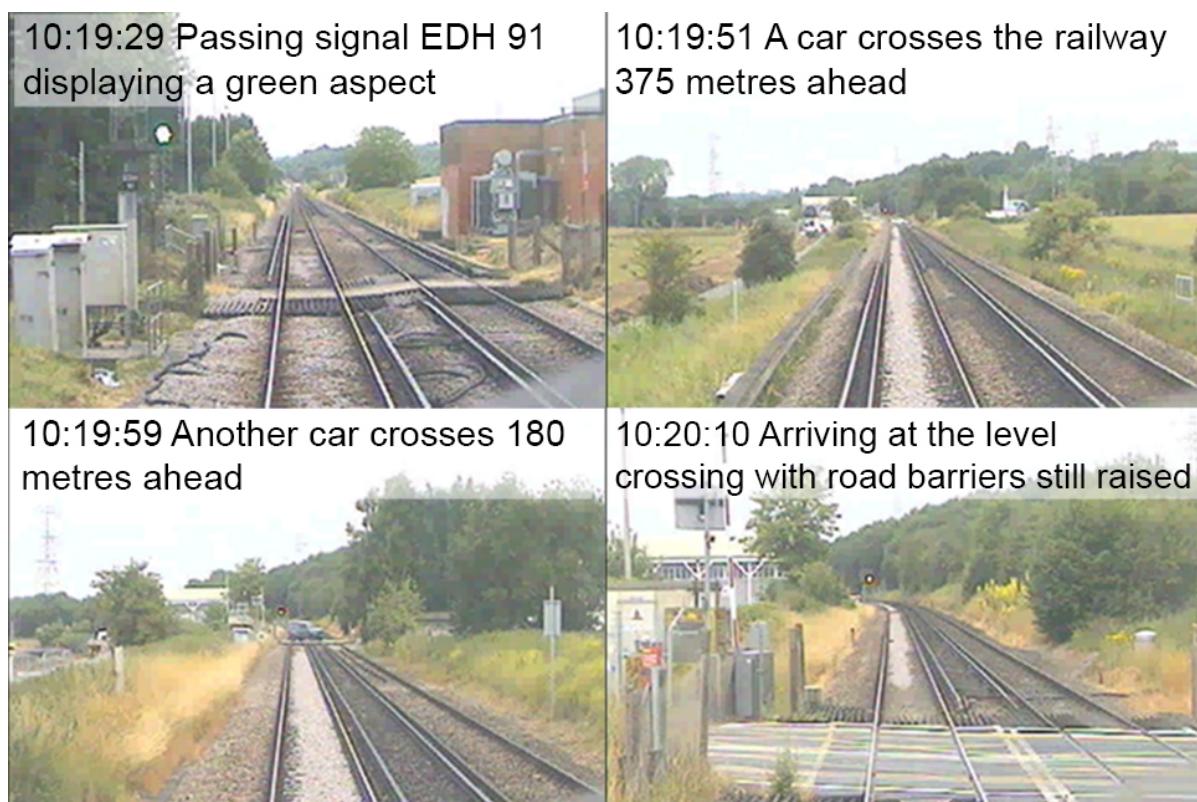
On 29 June 2017, at about 10:20 hrs, a passenger train was approaching Canterbury West station, in the up direction, after passing signal EDH 91 displaying a green (proceed) aspect. As it approached Broad Oak level crossing at 70 mph (113 km/h), the train driver saw vehicles passing over the level crossing at a time when he expected the level crossing to be closed to road traffic. The driver then noticed that the level crossing's barriers were raised, so he promptly made an emergency brake application and sounded the train's horn for 6.5 seconds.

At the time of the incident the level crossing was under the control of a Network Rail mobile operations manager. When he heard the approaching train he operated a switch to start the sequence to lower the barriers. The level crossing's amber road traffic signals illuminated about three seconds before the train arrived and its red road traffic signals started to flash as the train arrived at the crossing while travelling at 17 mph (27 km/h). The barriers started to lower five seconds later, just as the train stopped on the level crossing. Road vehicles that were approaching the level crossing at the time also stopped. There was no collision, but the train driver was shaken by what had happened.

The sequence of events as seen by the forward facing CCTV of the train (images courtesy of Southeastern)

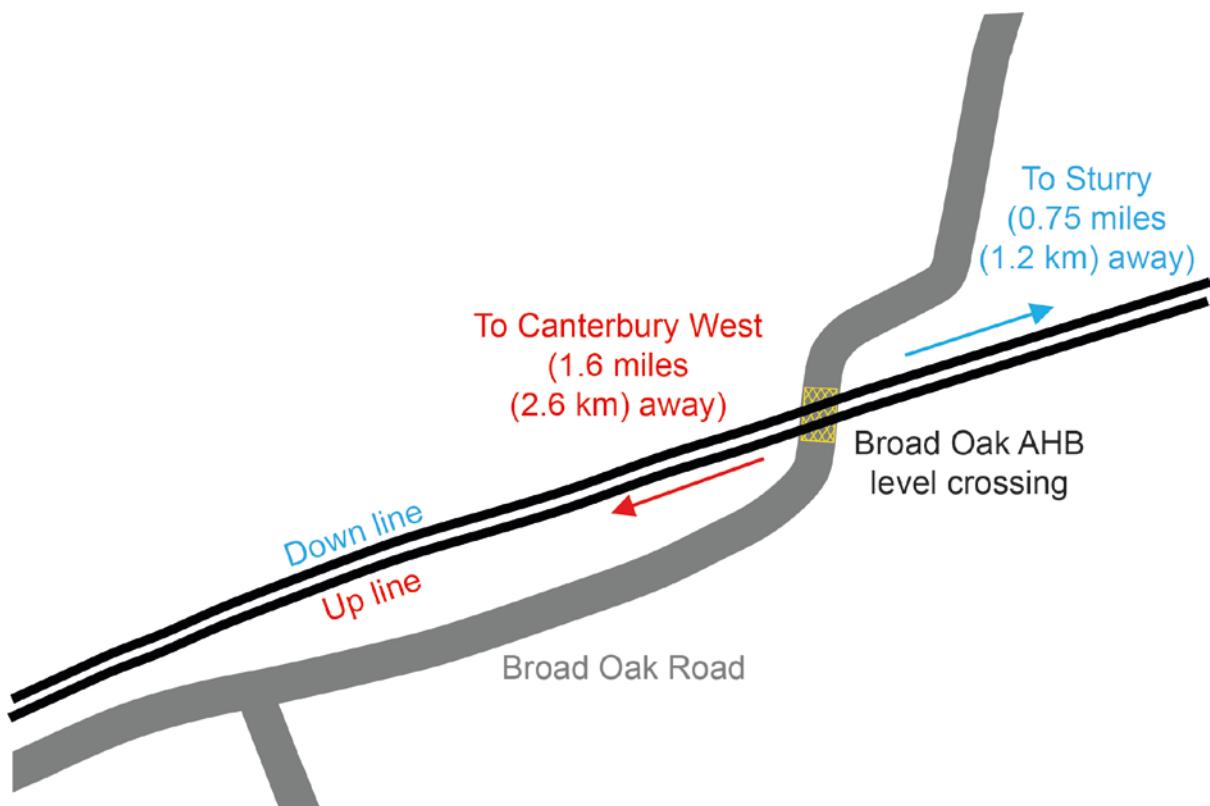
Broad Oak level crossing is an automatic half barrier (AHB) crossing and is located between Canterbury West and Sturry stations. Trains operate over the level crossing in the down direction towards Sturry and in the up direction towards Canterbury West, with a permitted speed of 70 mph (113 km/h) for trains on both lines. Broad Oak Road, which is a single-carriageway road that is subject to the national speed limit, crosses the railway at this location.

Layout of Broad Oak level crossing

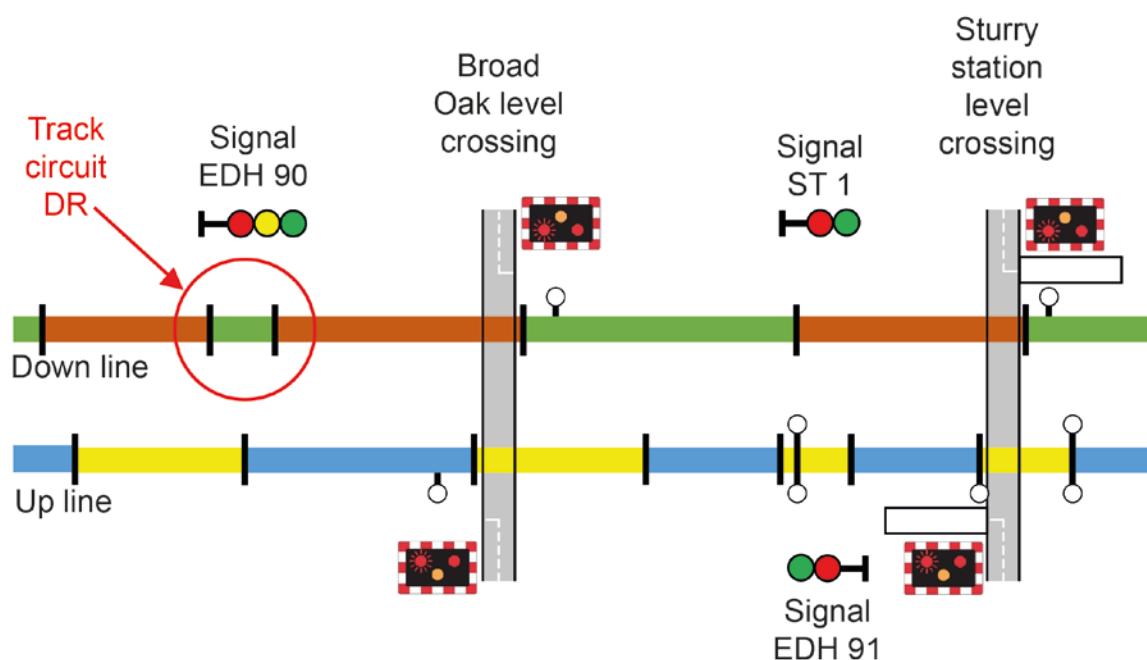
On 20 June 2017, remote condition monitoring equipment detected that track circuit 'DR', which is near to Broad Oak level crossing on the down line, had a high probability of failing. This resulted in the local Network Rail signalling maintenance team being tasked with testing the track circuit. As track circuit 'DR' is part of the level crossing's control circuits, the signalling maintenance team knew that their testing would require the level crossing to be taken under local control.

Schematic showing the level crossing, signals EDH 90 and EDH 91, and track circuit DR
