AAIB Bulletin

10/2017

Published 12 October 2017

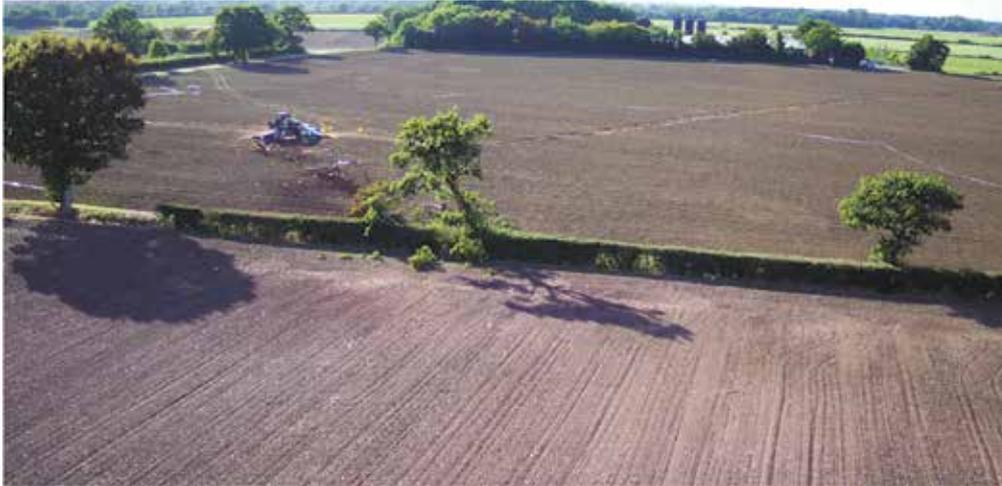
Figure 3
Accident site

The aircraft had struck a mature oak tree on the boundary between two fields with marks showing that one of the propeller blades had been the first point of impact. This had been rotating with sufficient power to slice upwards through the trunk and into a bough of the tree which detached and fell away. The tip of this blade was left deeply imbedded in the remainder of the trunk. After the propeller had hit the tree, the aircraft continued onward with the tree passing along the left side of the fuselage. The inner section of the left wing was struck by the tree causing the wing to detach, before the left tailplane then detached as it was also hit by the tree.

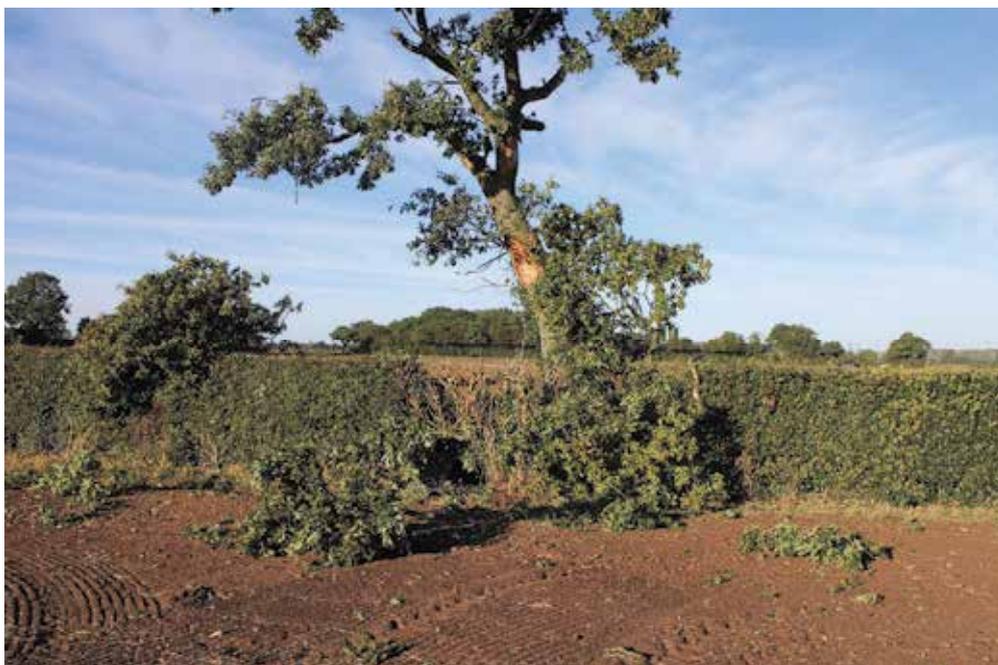
Figure 4
Tree strike in direction of aircraft travel

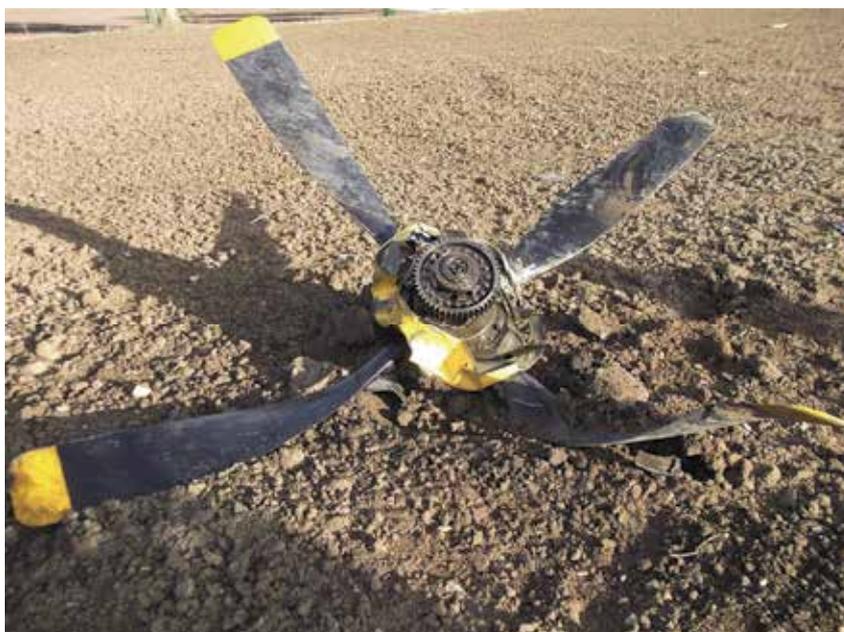
The propeller had detached from the engine along with its drive gear and was lying in the wreckage trail close to the aircraft. All but one of the blades were complete but all were heavily distorted.

Figure 5 (right)
Propeller damage

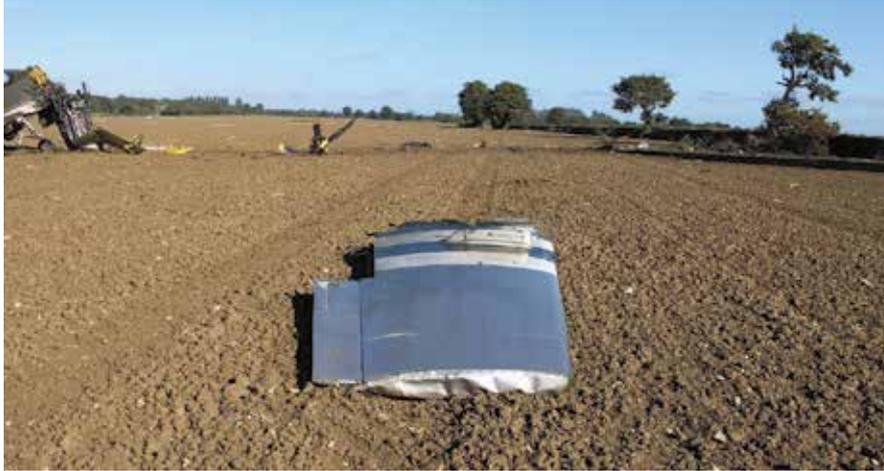
The left tailplane was lying in a ditch near the base of the tree and the left flap and elevator was lying a short distance further on. The left wing was lying upside down in the field 65 m from the tree away from the main wreckage. The left main landing gear was still attached to the wing but was in the retracted position.

Figure 6
Left wing

The right main landing gear was down and locked but the left main gear was fully retracted within the separated wing. However, the left gear hydraulic extend and retract ram assembly had completely detached during impact with the tree and was found at the base of the tree. This allowed the left main gear to pivot freely into its retracted position in the upside down wing due to gravity.

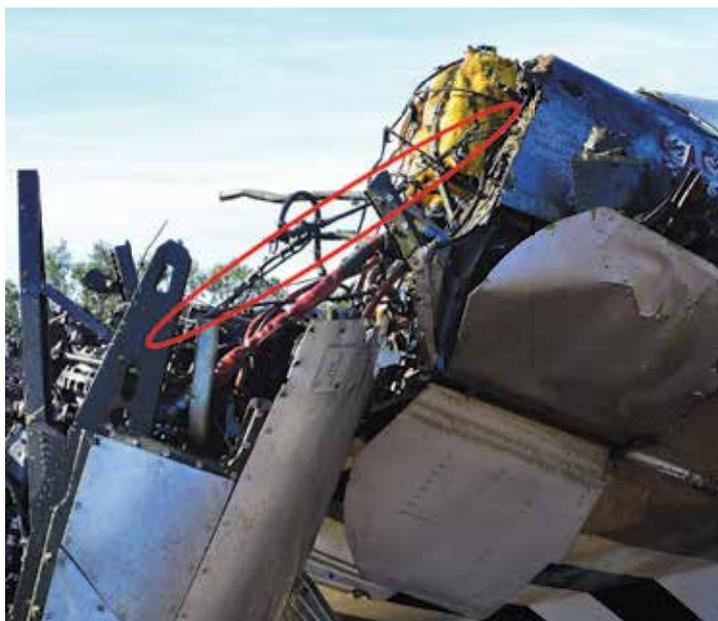
The engine was partially detached from the fuselage but bent downwards resting on the ground on the remains of the reduction gearbox. The engine bearers were broken and distorted and the engine control cables and rods were still connected but had been pulled forward and were under tension. Various oil and coolant flexible pipes had been split or had parted from their rigid pipe connections. Figure 7 shows the partial detachment of the engine and the effect on the engine control linkages.

Figure 7
Engine control linkages under tension

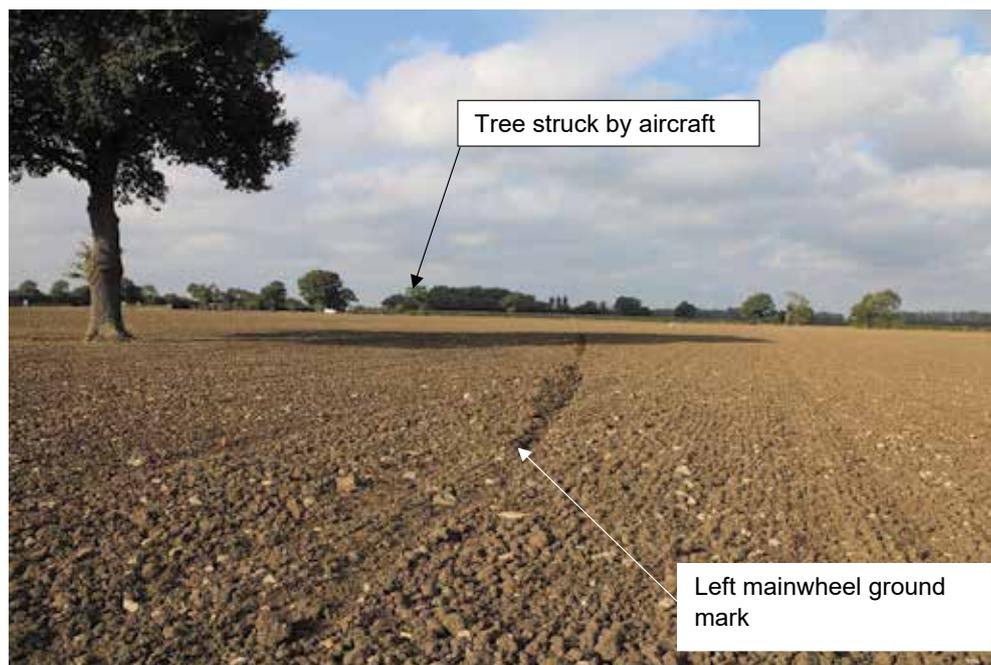
There were more wheel marks on the ploughed surface of the field next to the runway. These marks started with a tail wheel imprint and then the left mainwheel, the mainwheel mark being curved slightly to the left and approximately 100 m in length. About 29 m along the mark there was a parallel mark made by the right mainwheel. Both marks ceased as they approached the concrete track which ran across the field. There was another left mainwheel mark 100 m further on in the field on the other side of the concrete track. This mark was approximately 30 m long and was very distinctive as if the tyre had been running at an angle to the direction of travel, gouging the soil. There were no more ground marks up to the impact point with the tree. Figure 8 shows the final ground mark and the position of the tree hit by the aircraft.

Final tyre mark and impact tree

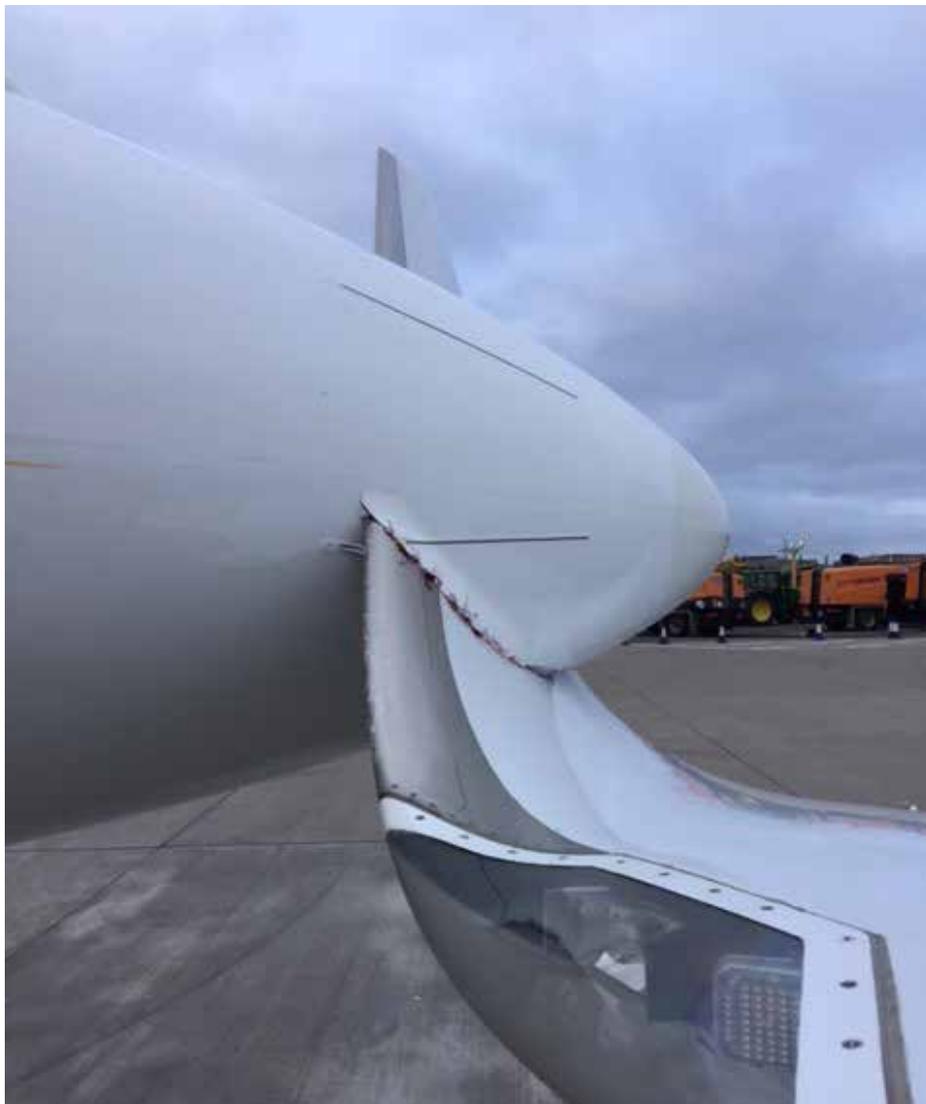
Figure 3
Damage caused by the collision

Although the damage to the radome and radar antenna of VQ-BSF was significant, the winglet of VQ-BSO only suffered minor abrasions and, following an engineering inspection, required no maintenance action. There were no injuries to persons on board either aircraft or on the ground.

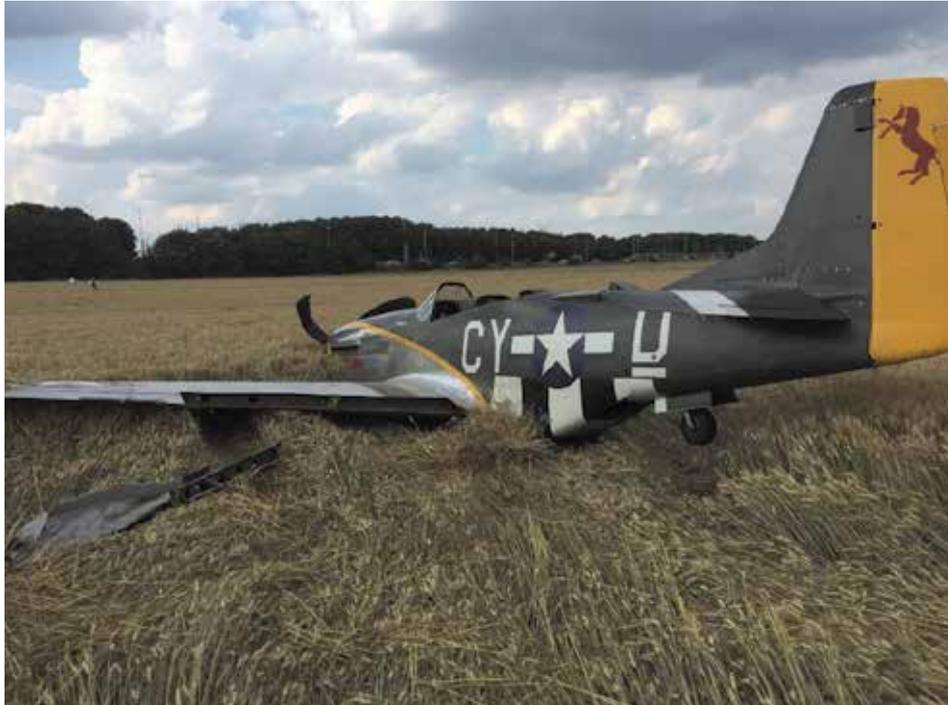
Figure 1

G-TFSI after the accident
(Image reproduced with the permission of the pilot)

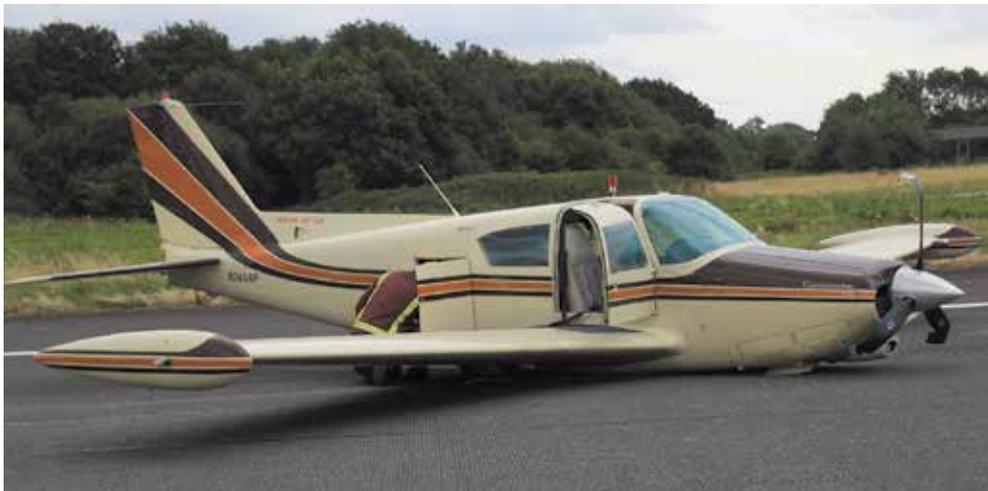
Figure 1

According to the passenger, the nose landing gear collapsed on impact and the aircraft skidded along the runway with the propeller striking the surface and causing the engine to stop. The main landing gear collapsed before the aircraft came to a halt. The pilot then turned off the master switches and the fuel while the passenger opened the door and moved the mixture control to CUT OFF. The two occupants evacuated the aircraft (Figure 1) without injury, prior to the arrival of the airport’s rescue service.

View of N7456P shortly after the crew evacuated
(Photograph courtesy of Dave Grimsdale – Photographer - Retford (Gamston) Airport)

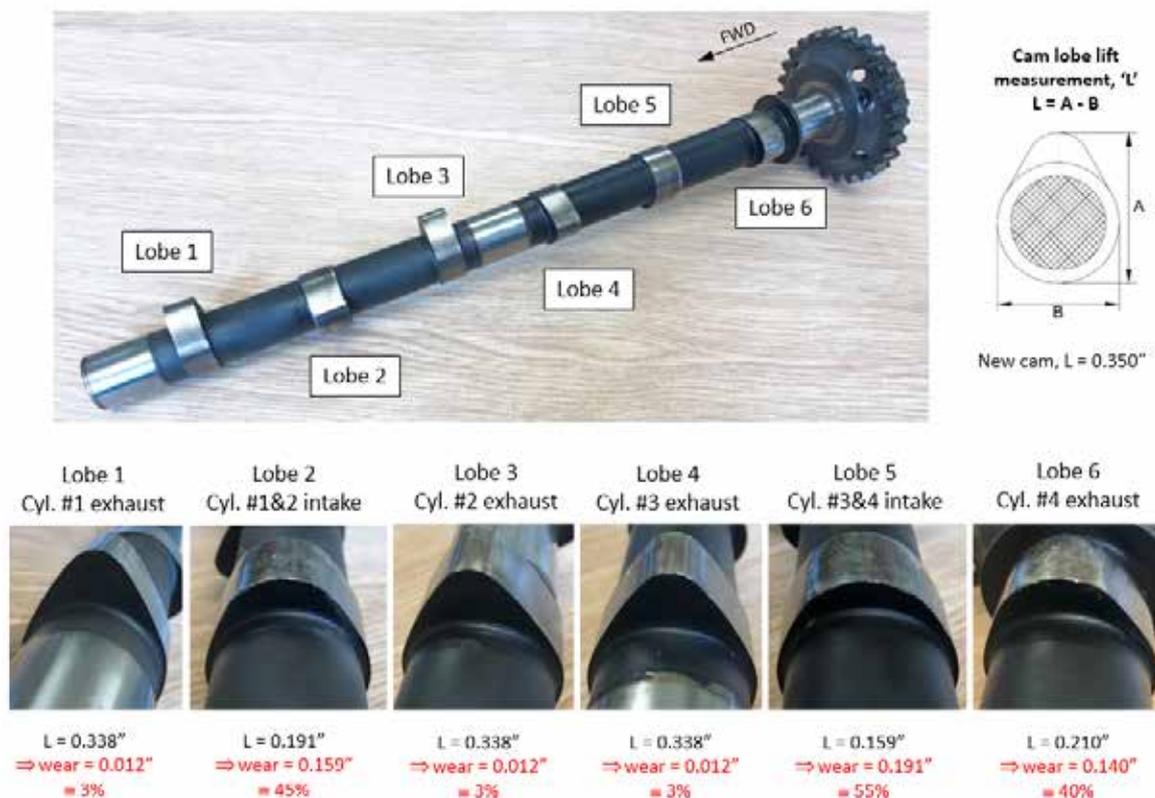
Figure 1

The aircraft's engine was inspected following its disassembly at an engine overhaul facility; the engine has accumulated 1,126 operating hours since its last overhaul. There were no failures evident that would account for an abrupt and complete loss of engine power, although it was noted that the camshaft lobes 2, 5 and 6 were significantly worn, Figure 1. The respective bearing faces of the tappet bodies were also heavily worn, with extensive surface spalling, Figure 2.

Worn camshaft removed from G-ATVO

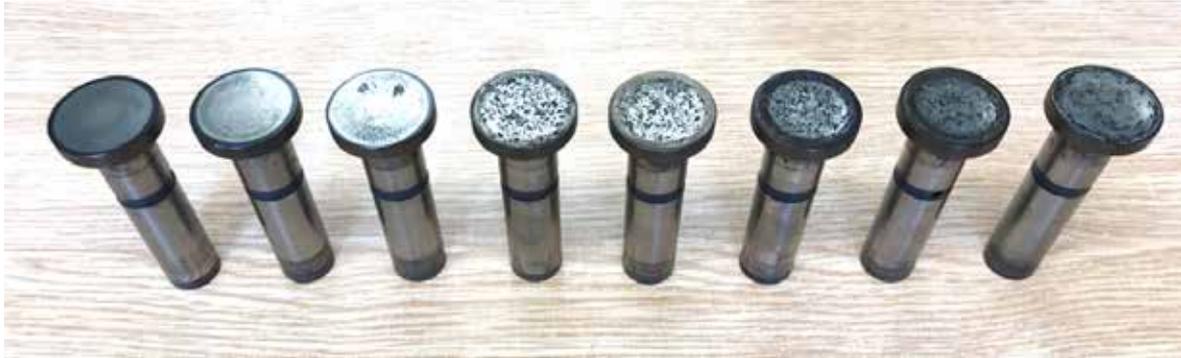
Figure 2

Tappet bodies removed from G-ATVO, showing spalling of the tappet faces

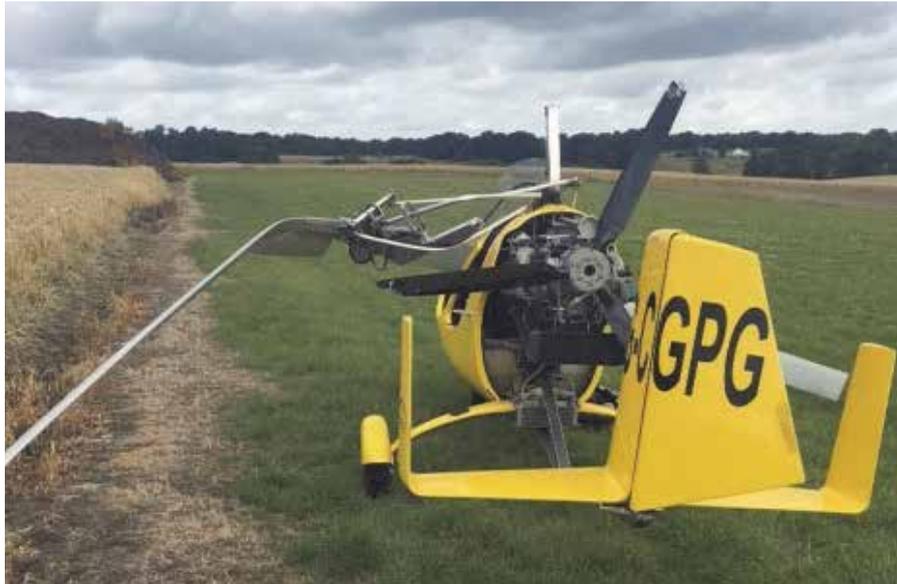
Figure 1

Rear view of G-CGPG after it came to rest at the edge of the runway, next to a crop

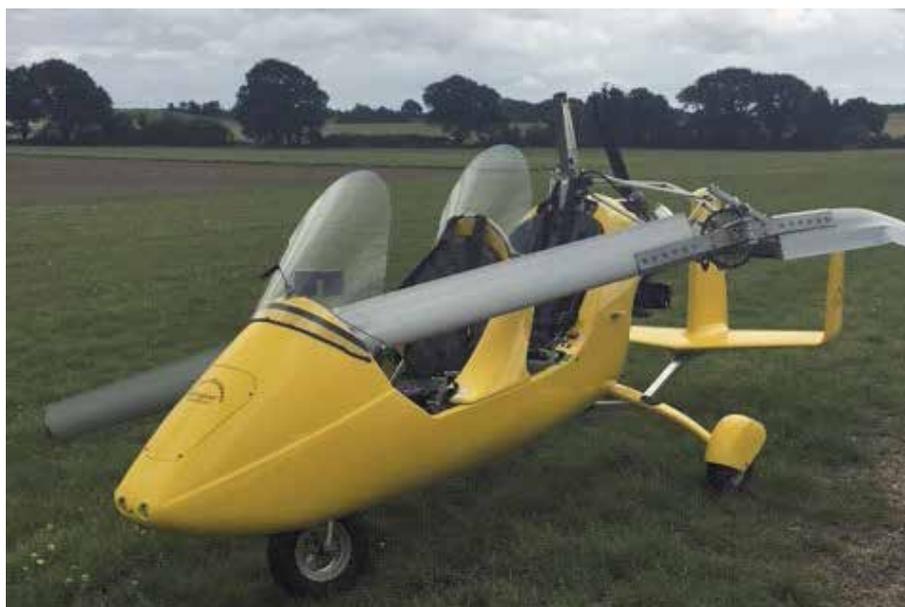
Figure 2

As the rotor blades slowed to a halt, one of them dropped gently into the pilot's lap, without injuring him, and he was able to lift it, unstrap and step out (Figure 2). All three propeller blades were damaged and the pilot assumes they made contact with the rotor during the accident.

View showing broken rotor mast and rotor blade resting across the pilot's seat
