Collision with buffer stops at King's Cross station, London, 15 August 2017

2. Summary of the accident

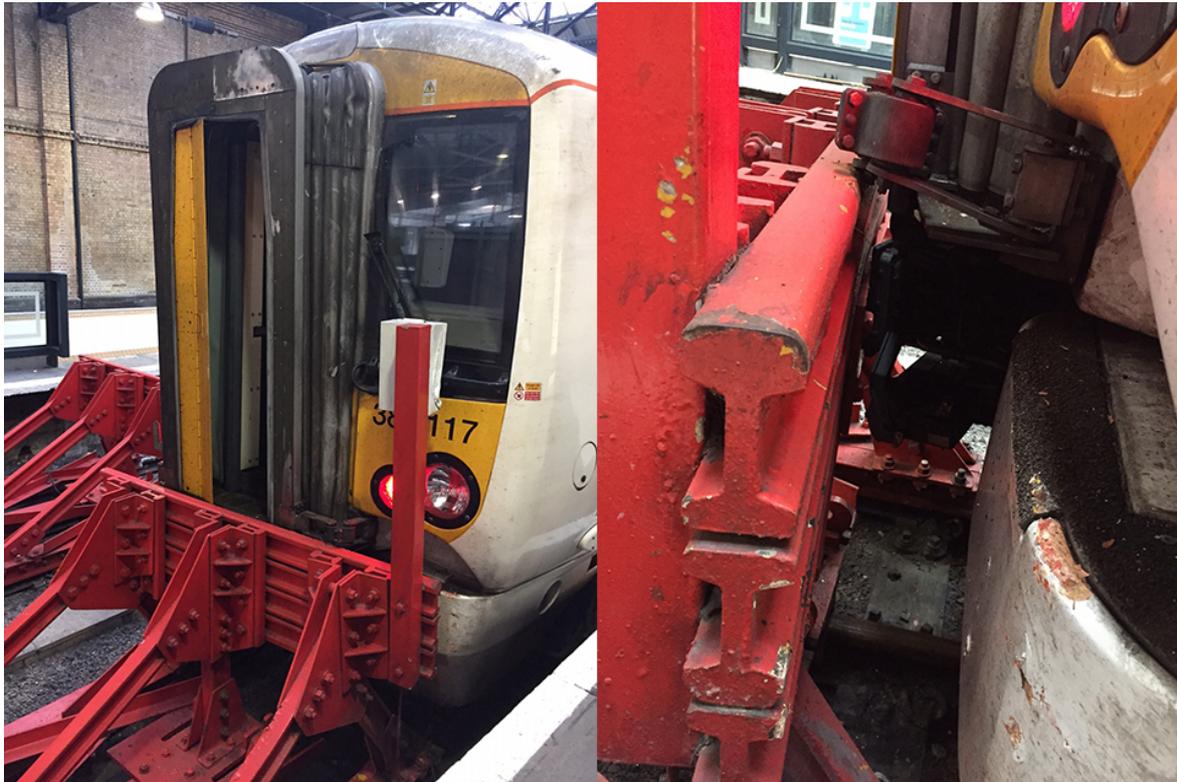
At around 06:23 hrs on Tuesday 15 August 2017, a passenger train collided with the buffer stops at platform 9 at London King's Cross station. The train was the 05:13 hrs Great Northern service from Royston, formed of a four-carriage class 387 unit. It was travelling at about 4 mph (6 km/h) at the time of the collision. Four passengers and one member of staff reported minor injuries as a result of the accident, and there was minor damage to the train and the buffer stops, which were pushed back by over one metre.

The accident occurred because the driver was suffering from fatigue and apparently experienced a microsleep in the last few seconds of the approach to the buffer stops. The driver reported being aware of passing the TPWS sensor but then briefly closed her eyes because they felt tired and were stinging. When she opened them, she was close to the buffer stops and, although she made an emergency brake application, it was too late to avoid a collision.

The train and the buffer stops after the collision (images courtesy of Network Rail)
