Published 9 November 2017

CONTENTS**SPECIAL BULLETINS / INTERIM REPORTS**

S3/2017 HPH Glasflugel 304 eS	G-GSGS	10-Aug-17	3
-------------------------------	--------	-----------	---

Aircraft Type and Registration:	HPH Glasflugel 304 eS, G-GSGS	
No & Type of Engines:	1 LZ Design D.O.O FES-HPH-M100 brushless electric motor	
Year of Manufacture:	2016 (Serial no: 059-MS)	
Location:	Parham Airfield, West Sussex	
Date & Time (UTC):	10 August 2017 at 1121 hrs	
Type of Flight:	Private	
Persons on Board:	Crew - 1	Passengers - None
Injuries:	Crew - None	Passengers - N/A
Nature of Damage:	Fire damage to FES batteries and FES battery compartment	
Commander's Licence:	British Gliding Association Gliding Certificate	
Commander's Age:	55 years	
Commander's Flying Experience:	314 hours (of which 25 were on type) Last 90 days - 9 hours Last 28 days - 7 hours	
Information Source:	AAIB Field Investigation

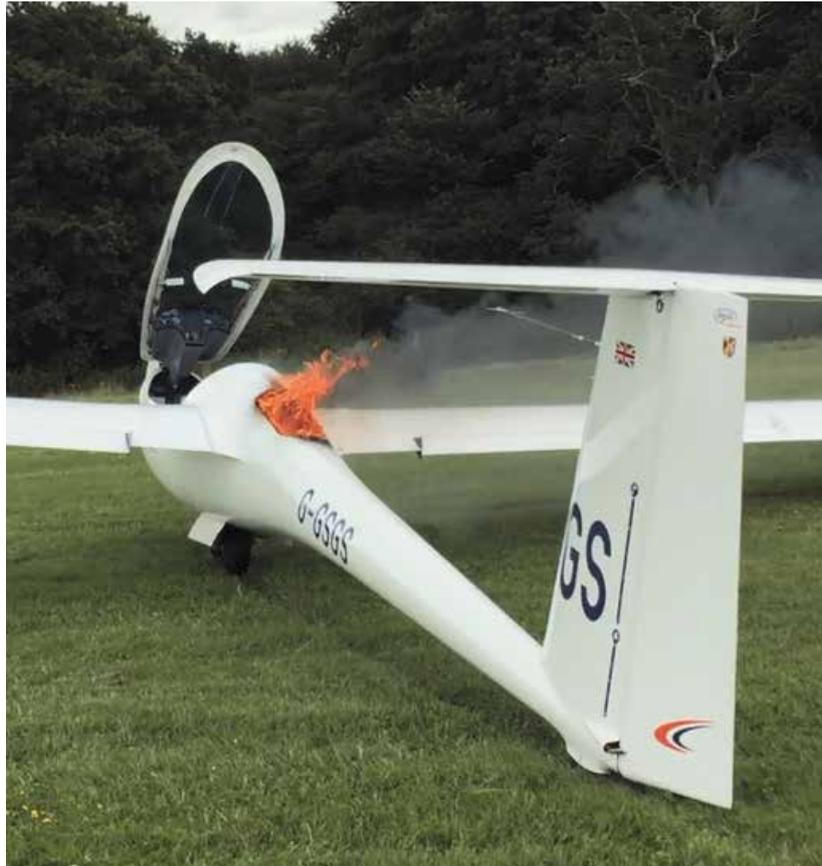
Figure 1

As the glider slowed during the ground run, the pilot smelled burning and the cockpit filled with smoke that was moving forwards from behind the pilot's head. The pilot did not report observing any warning messages or illuminated LEDs on the FCU, although his attention was drawn outside the cockpit during landing. He vacated the cockpit normally, without injury, and observed that the FES battery compartment cover was missing and that smoke, followed shortly by flames, was coming from the battery compartment. The airfield fire truck arrived promptly and an initial attempt was made to extinguish the fire using a CO₂ gaseous extinguisher, but this proved unsuccessful. Aqueous film-forming foam (AFFF) was then sprayed into the FES battery compartment and the fire was extinguished.

Fire in the FES battery compartment following the landing roll

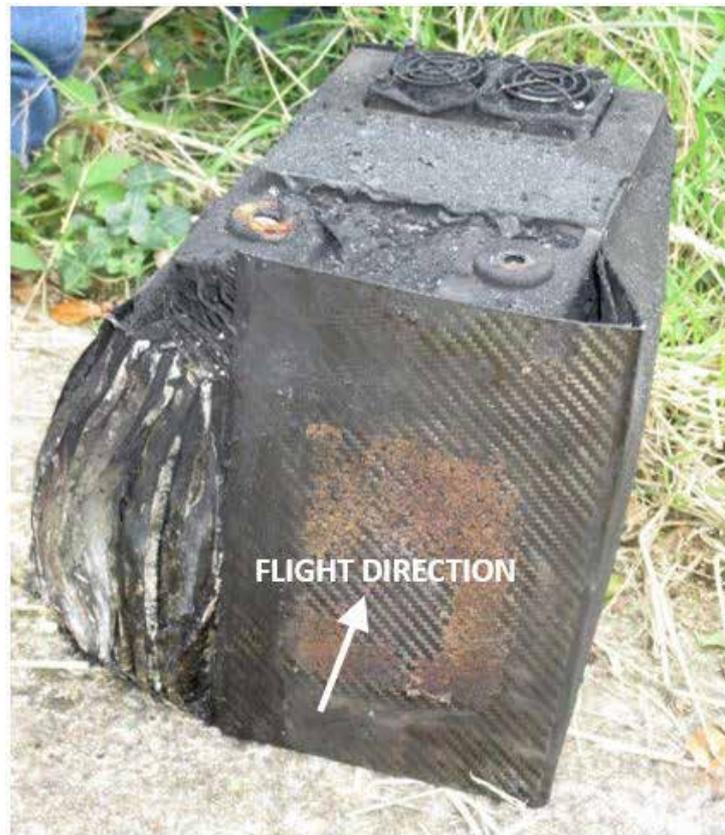
Figure 4

The origin of the fire was the forward FES battery; its battery box was ruptured along the rear left corner and the battery assembly was heavily fire damaged, Figure 4. The rear FES battery box suffered from external fire damage although the internal components were only slightly damaged and the cells remained charged.

Fire damage to the forward FES battery

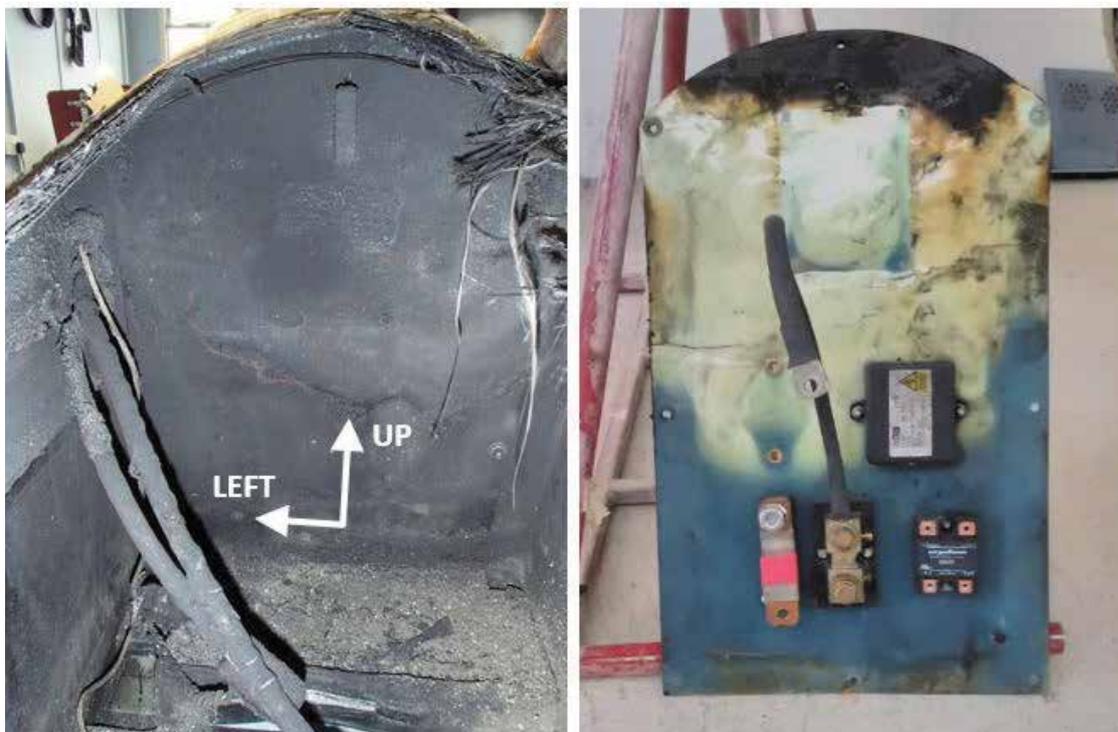
Figure 5

The FES battery compartment was heavily fire damaged with burning of the composite material's resin on the internal faces of the battery compartment and around the external cut-out in the upper fuselage skin. The top edge of the removable access panel that forms the front panel of the battery compartment (Figure 5) was also burned on its forward face and the FES electrical components in the equipment bay between the cockpit and the FES battery compartment were covered in soot deposits, demonstrating that the battery compartment had not contained all of the smoke and fumes released by the FES battery fire.

Fire damage to the FES battery compartment front access panel (left image, looking forwards), and to the forward face of the front access panel (right image, looking aft)

It is recommended that the European Aviation Safety Agency (EASA) requires that all powered sailplanes, operating under either an EASA Restricted Type Certificate, or an EASA Permit to Fly, and fitted with a Front Electric Sustainer (FES) system, are equipped with a warning system to alert the pilot to the presence of a fire or other hazardous condition in the FES battery compartment.

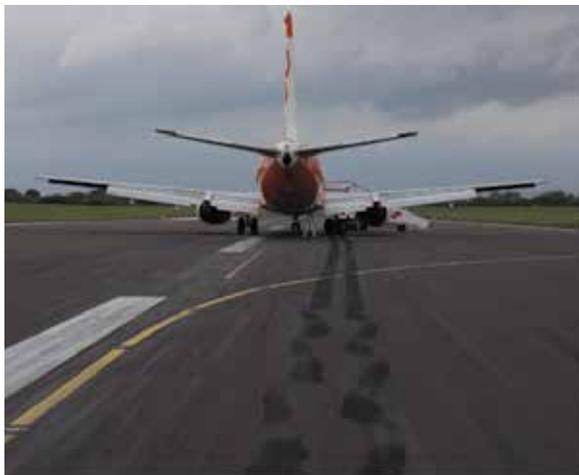
Figure 3

A pair of parallel tyre marks to the right of the centre line on Runway 25 had a distinctive 'S-shaped' pattern, and started approximately 900 m from the threshold of Runway 25. They continued to the main wheels on the right MLG leg; however for the last 60 m the two marks became straight (Figures 2, 3 and 4).

Image showing tyre marks close to the aircraft

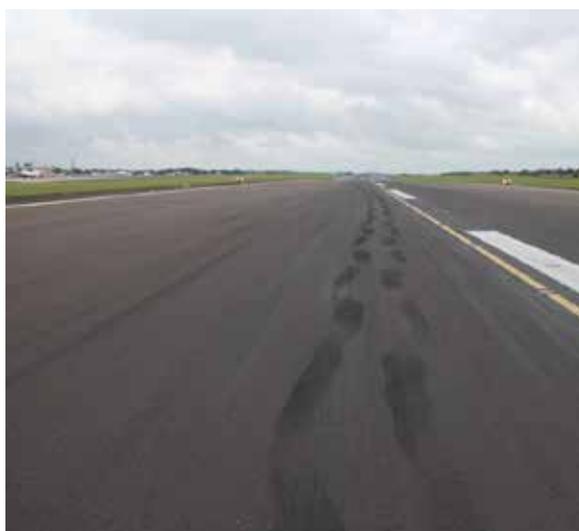
Figure 4

Image looking approximately east showing tyre marks

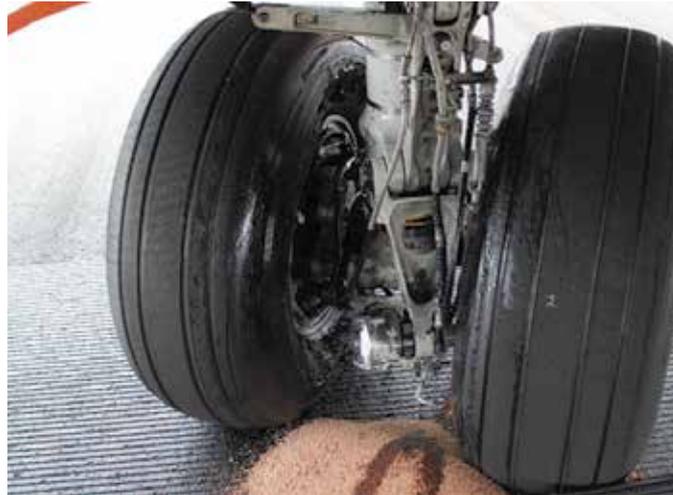
Figure 5

When inspected, both wheels of the right MLG were skewed to one side and there was significant damage to both wheel hubs and both tyres (Figure 5). Both tyres had remained inflated.

The lower torsion link on the right MLG had fractured. Several pieces of debris were recovered from the runway, including pieces of the bushings from the apex where the upper and lower torsion links join. It was not possible to make an accurate assessment of the shimmy damper link condition due to the high level of damage.

Image of right MLG showing torsion link

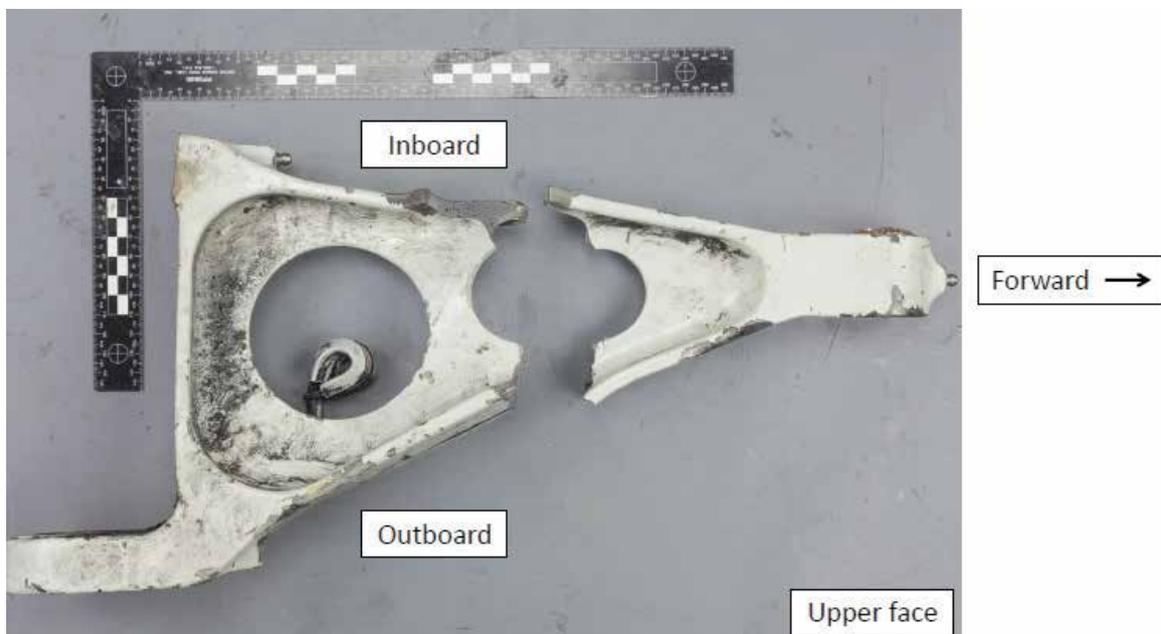
Figure 8

The two pieces of the fractured lower torsion link (Figure 8) were sent to a metallurgical laboratory for an assessment of the fracture surfaces (note the inboard lug at the top left of the image was cut during removal from the aircraft).

The assessment concluded that the torsion link had failed in overload. There was no evidence of fatigue. It was concluded that the failure of the torsion link was caused by shimmy.

Image of fractured torsion link (courtesy of QinetiQ)

The physical and recorded evidence indicate that the fracture to the lower torsion link on the right MLG leg was most likely caused by shimmy. This and previous occurrences show that the Boeing 737 MLG is susceptible to shimmy, particularly at higher landing speeds and for softer landings.

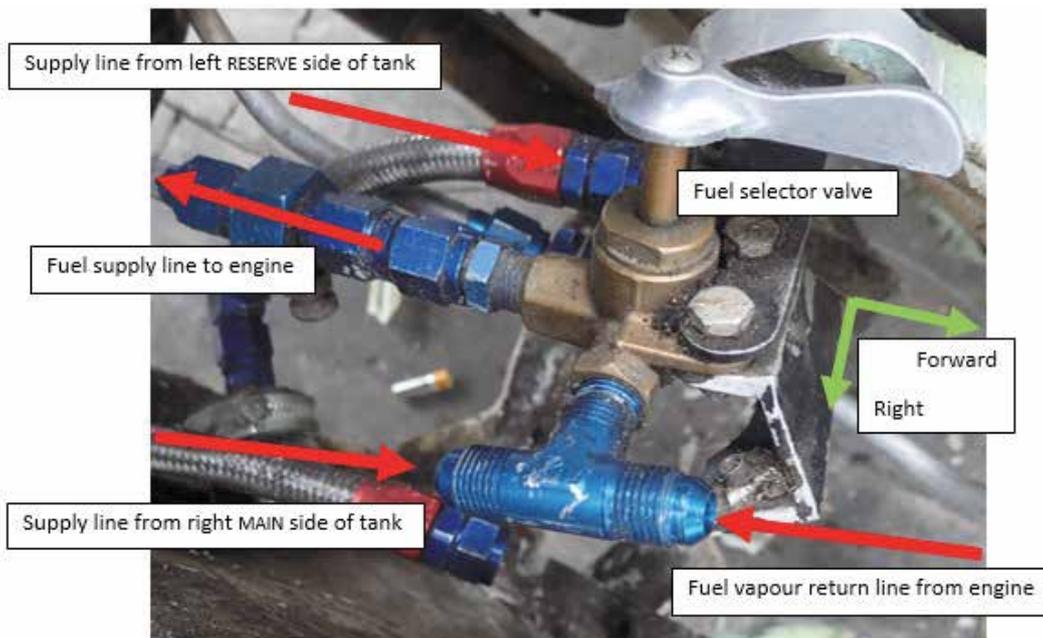
Figure 5

The fuel vapour return line was routed to a 'T' fitting on the fuel selector where it combined with fuel from what had been configured as the main tank (Figure 5).

Fuel selector valve showing 'T' fitting on inlet from right side of tank

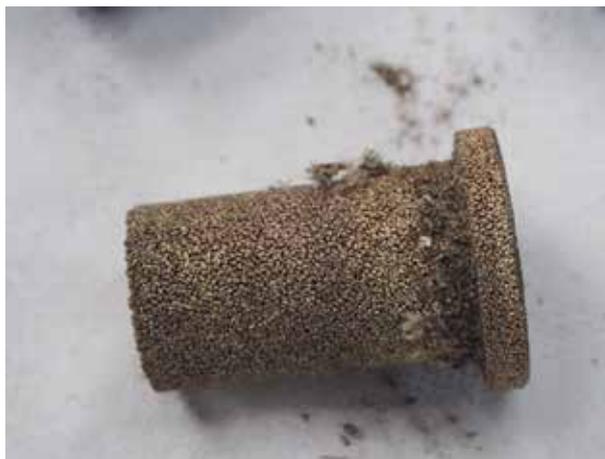
Figure 6

The fuel filter assembly was removed and its sintered bronze filter element was inspected. It was found contaminated with general dirt and debris which included insect remains (Figure 6).

Fuel filter element showing contamination found

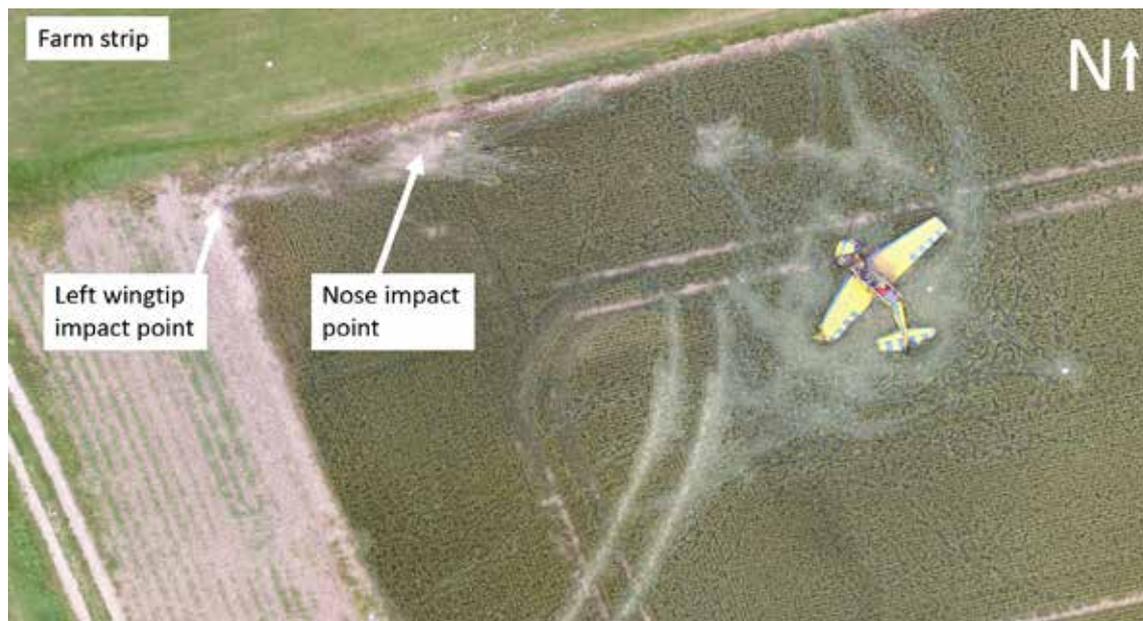
Figure 4

The ground impact marks showed that the aircraft had struck the ground left wingtip first, in a steep left bank; this was followed by a heavy nose impact (Figure 4). The aircraft had then bounced backwards, probably striking its tail, before bouncing again into the location where it was found, resting upright, 35 m from the initial impact point.

Aerial view of accident site (North up)

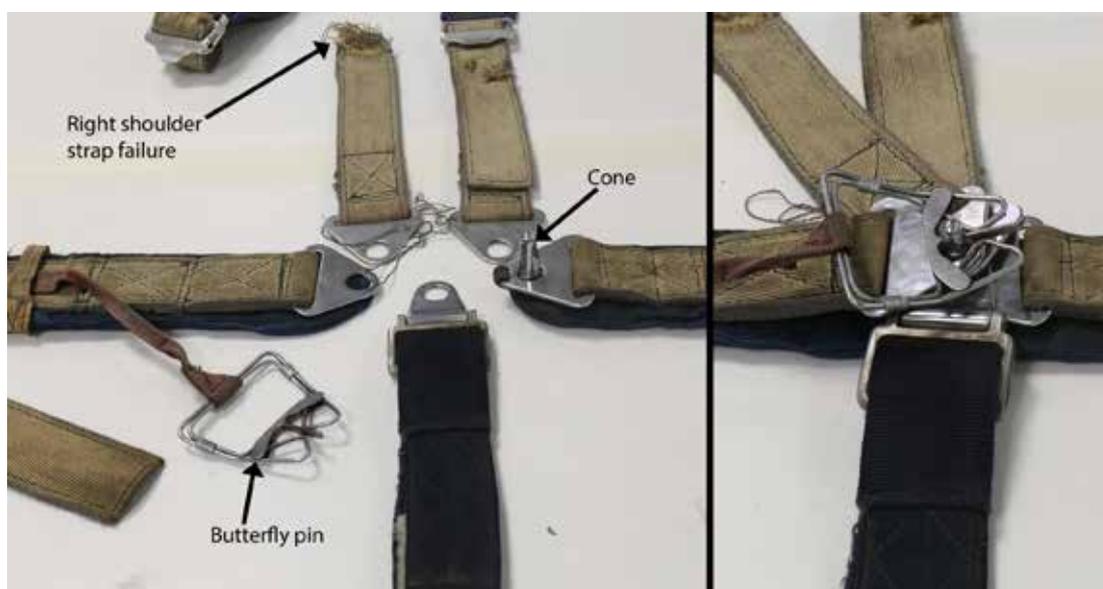
Figure 10

The front and rear seats were fitted with 5-point harnesses. The straps were secured using a pin and cone fitting (Figure 10). The strap ends with holes are slotted over the cone and then held together by a butterfly pin. This pin is pulled out sideways to release the straps and a short lanyard tethers the pin to the right lap strap. The front and rear seat lap straps were made of a tan linen outer layer and a nylon inner layer, which was the type of strap fitted at original manufacture. The front and rear seat crotch straps and upper portions of the shoulder straps were made of a blue nylon material which was similar to the original type used, but could not be confirmed as such. The lower portions of shoulder straps were made of the same tan linen/nylon material as the lap straps. The blue nylon straps were about 1.6 mm thick but doubled up in some areas. The tan linen/nylon straps were about 4 mm thick and consisted of 2 mm thick layers stitched together.

Front seat 5-point harness as found (left); all straps secured (right)

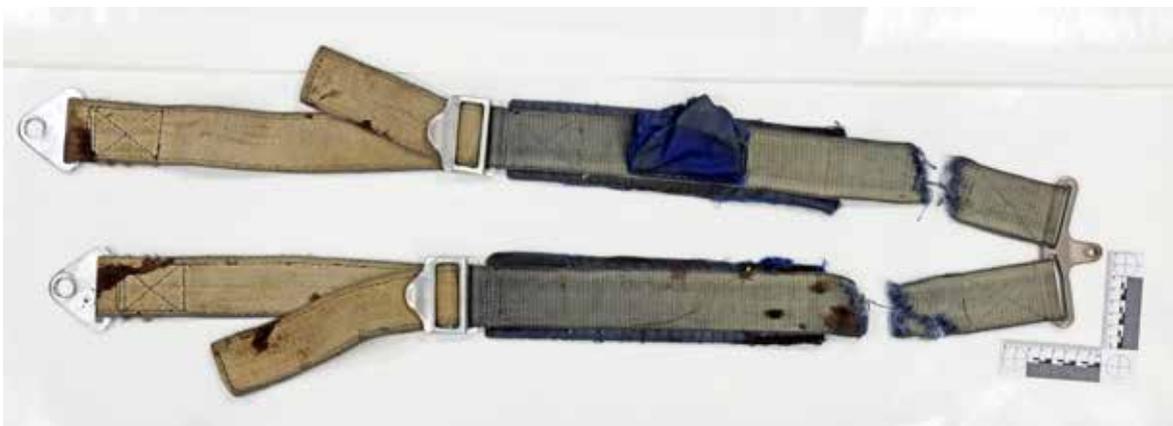
Figure 11

The rear seat upper shoulder straps had both failed in overload above the adjustable buckles (Figure 11), and the rear seat left lap strap had failed at the adjustable buckle (Figure 12). The butterfly pin was also out, but one witness who attended the scene believes he removed it to help the commander out of his seat.

Rear seat shoulder harnesses (both failed at upper strap)

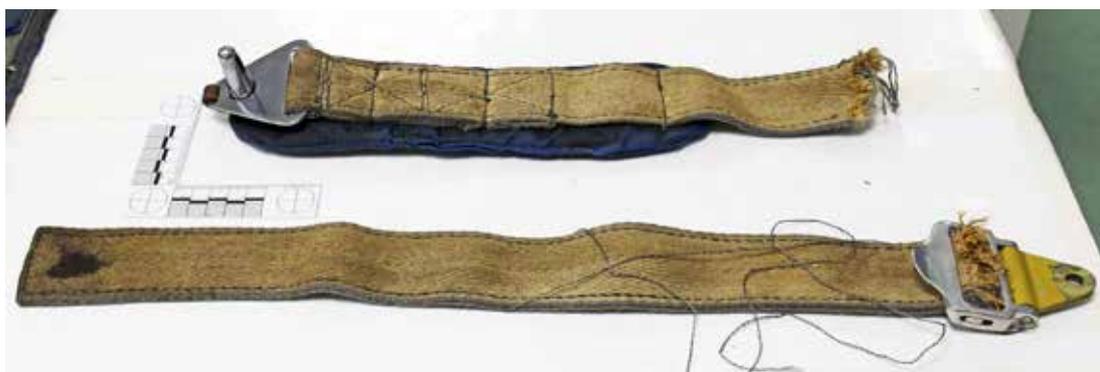
Figure 12

Rear seat left lap strap (failed at adjustable buckle)

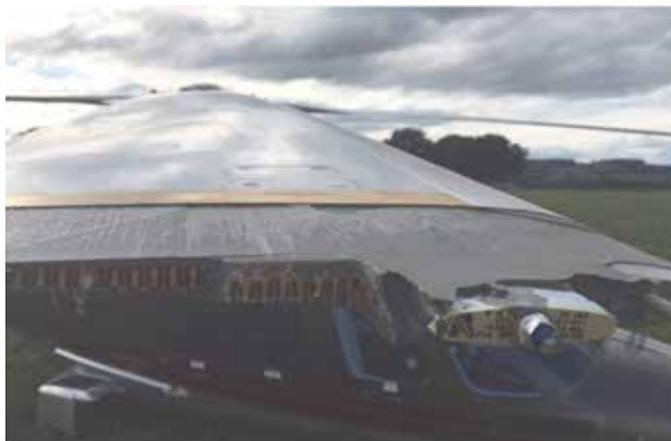
Figure 1

After shutdown it was apparent that the tip cap of one of the main rotor blades was missing (Figure 1). The cap was not recovered.

Damaged main rotor blade tip (looking towards the main rotor hub)

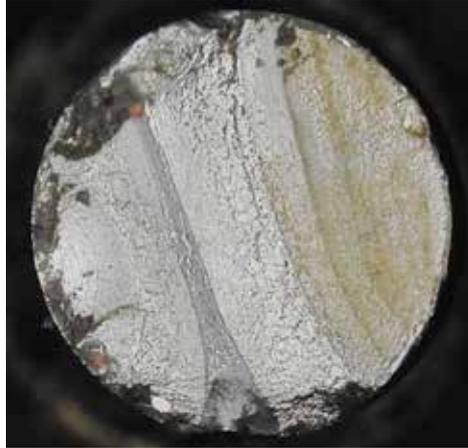
Figure 1

The upper drag link attachment bolt was found to be broken and the fracture faces showed evidence of reverse bending fatigue (Figure 1). Contamination/corrosion products indicated that the fatigue had been propagating for some time.

Broken drag link bolt, indicating reverse bending fatigue

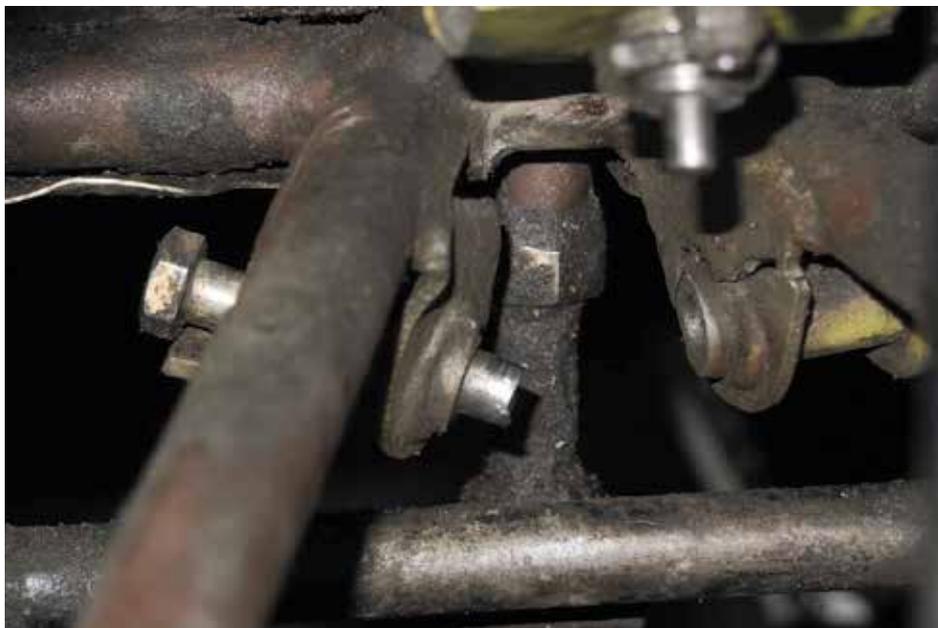
Figure 2

The upper drag link attachment lugs were distorted and both inboard lugs were cracked (Figure 2). The accumulation of dirt on the fracture faces indicated that the cracks had existed for some time.

Cracked and distorted drag link attachments
(remnants of the drag link bolt are still in-situ)

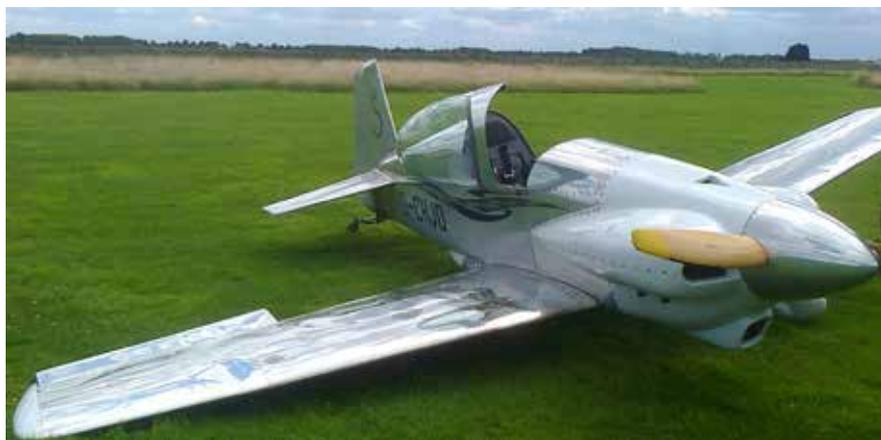
Figure 1

Following a firm landing, the aircraft rolled for approximately 100 m before the right main landing gear leg collapsed. The aircraft veered to the right and after it came to rest, in long grass adjacent to the runway, the pilot shutdown the engine and exited the aircraft normally. A photograph of the aircraft was taken (Figure 1) after it was moved to a grass parking area.

G-CHJO following failure of the right main landing gear leg

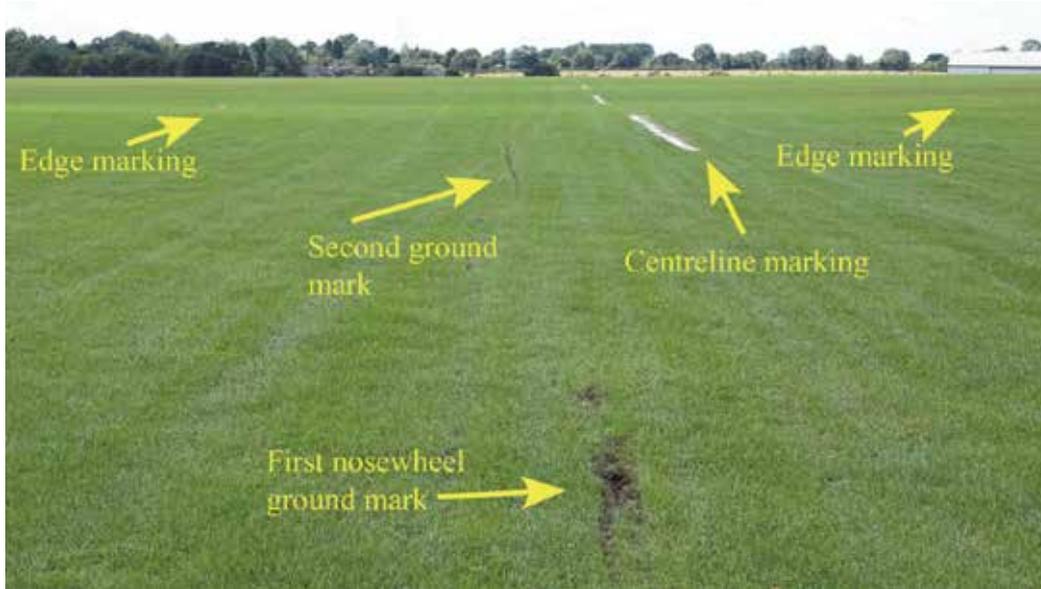
Figure 2

Marks on runway seen from eye level
(Photograph courtesy of Mr Jeff Bell)
