# Passenger train derailment, London Paddington, 20 August 2017

## 2. Summary of the accident

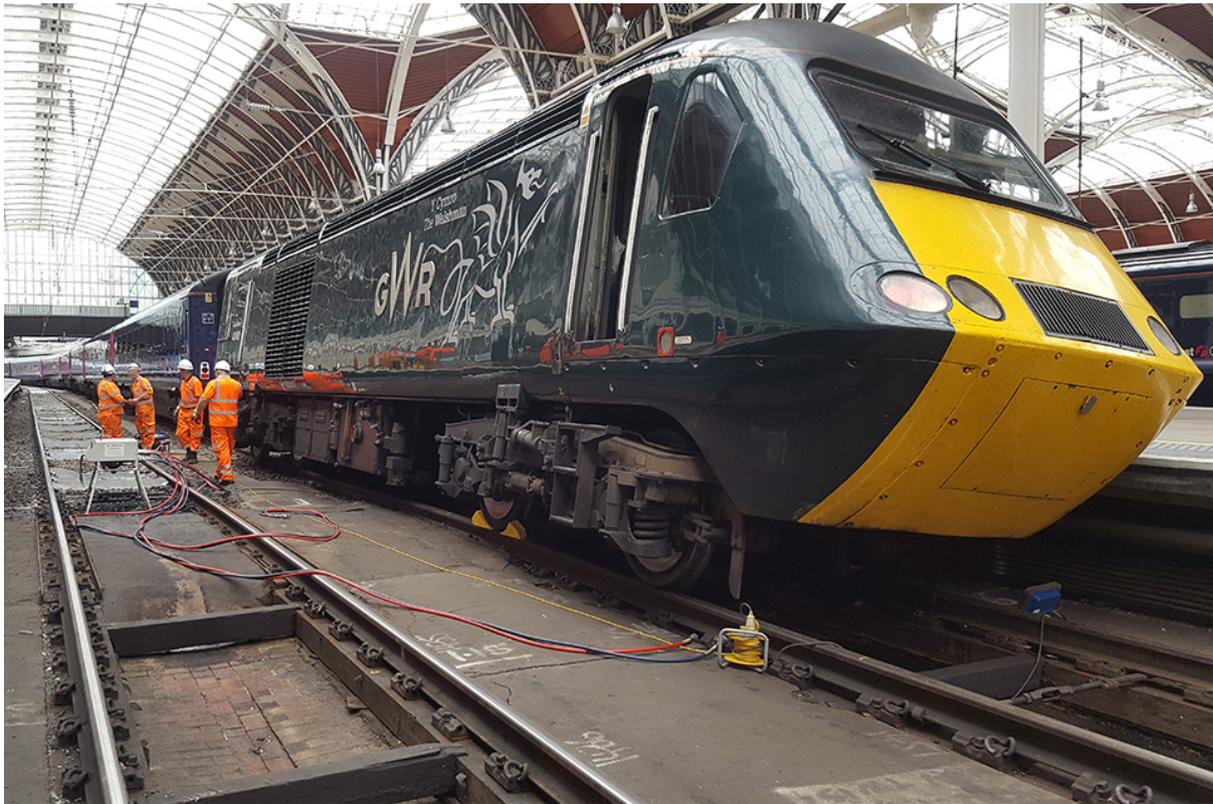
The rear power car of an InterCity 125 high speed train, destined for Penzance, train number 1C81, derailed at 11:57 hrs on departure from platform 2 at Paddington station. Both wheels of the leading axle of the power car and the right-hand wheels of the trailing bogie derailed due to gauge spread (a condition in which the two rails of a track move apart, allowing train wheels to drop into the space between them).

**Derailed power car**

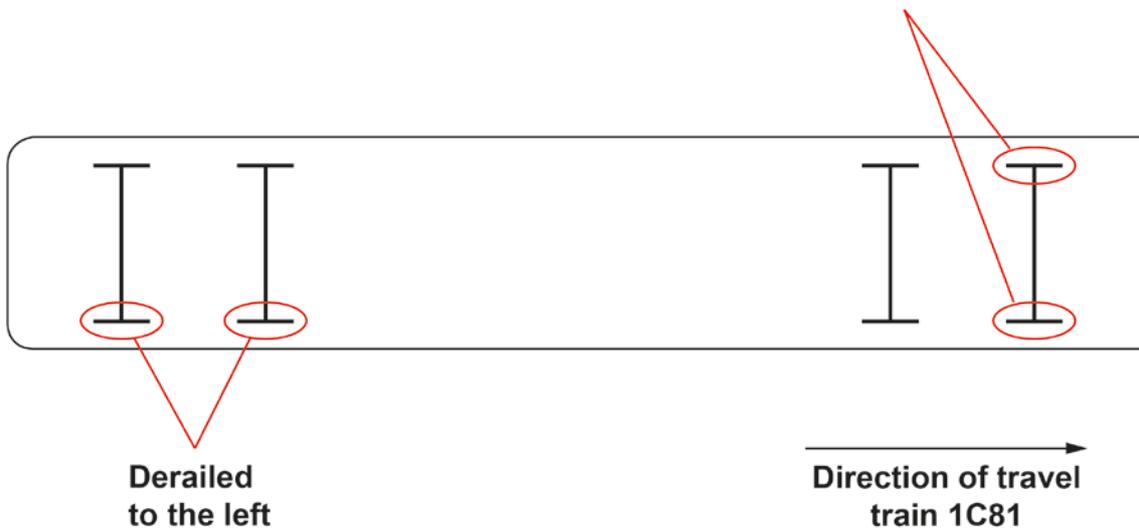
**Power car  
cab end**

**Derailed  
to the left**

**Layout of derailed wheels**

The train derailed because the right-hand rail moved laterally under the weight of the train. As a consequence, the first, third and fourth right-hand wheels of the power car dropped into the space between the rails. The first left-hand wheel of the power car was later forced over the left-hand rail as the gauge tightened again when the power car reached a section of track that was more securely fixed.

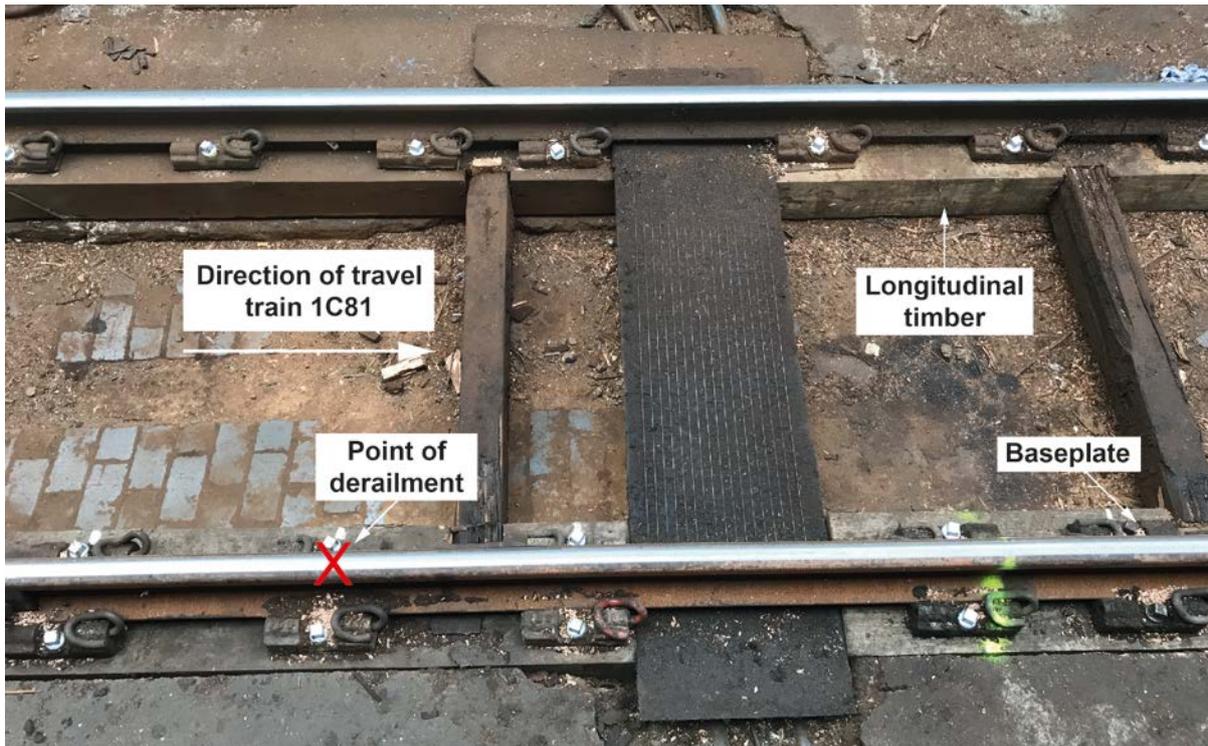
The track at platform 2, Paddington station, is supported on longitudinal timbers; these run parallel to the rails and the baseplates (metal castings that hold the rail in place) are fastened to them with chairscrews. The right-hand timbers had decayed to the point that they were no longer able to maintain the alignment of the track as train 1C81 passed over them.

**Point of derailment following repairs to the track**

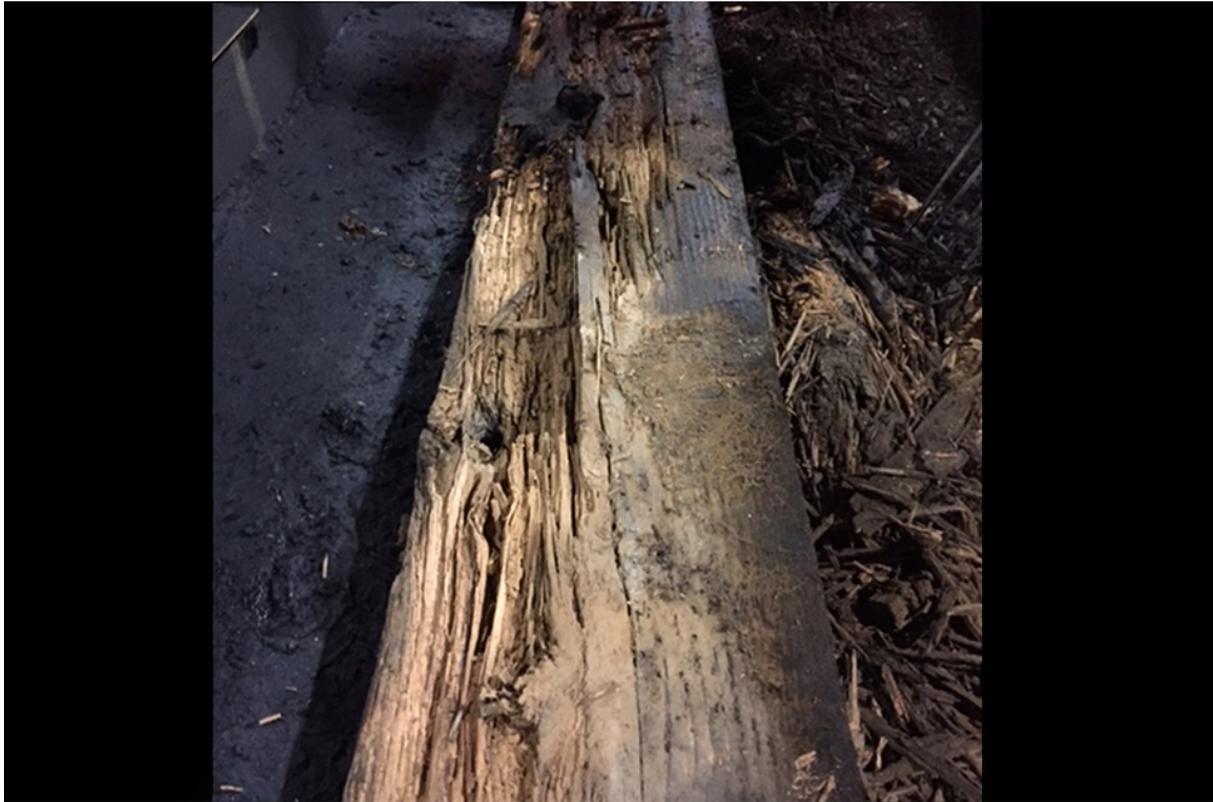
The failed timbers had been identified as needing replacement during their preceding detailed annual inspection, which had been carried out by the local track section manager in November 2016. The inspection report recommended that approximately 30 metres of the right-hand timbers should be changed 'as soon as practicable'. The report also stated that the timbers were being damaged by toilet waste and water leaking from trains.

**Underside of decayed right-hand timber (image courtesy of Network Rail)**

Detailed examination of the longitudinal timbers at Paddington station is made more difficult because only two faces of the timber are accessible to a visual inspection. The decay that was present on the underside of the timbers was therefore hidden, and it is possible that staff carrying out the routine visual inspections that were undertaken since the detailed annual examination may not have been aware of the extent of the decay. Witness evidence indicates that local track maintenance staff have since sought guidance on inspection techniques from a specialist team based in Network Rail's Kent Route, which has more extensive experience of longitudinal timber installations.

Replacement of the decayed timbers was subsequently planned for June 2017. However, witness evidence indicates that this work was postponed in order that works associated with electrification of the Great Western Main Line could be carried out. At the time of the accident on 20 August, replacement of the timbers had been rescheduled for September 2017.
