Air Accidents Investigation Branch
Farnborough House
Berkshire Copse Road
Aldershot
Hants GU11 2HH

This bulletin contains facts which have been determined up to the time of compilation.

Published 14 December 2017

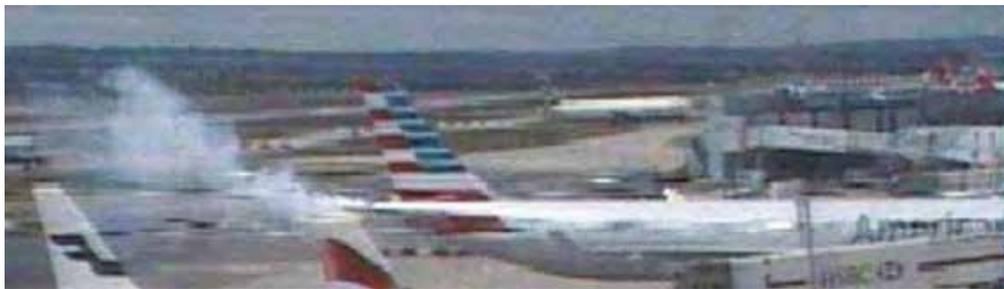
Figure 2

Image from CCTV showing white smoke immediately behind the aircraft

The APU control system had initiated an auto-shutdown due to high oil temperature. This caused the bleed air valve to close, shutting-off the air supply to the cabin. Excess air was directed overboard via the gas generator exhaust, causing the plume of smoke seen by ATC.

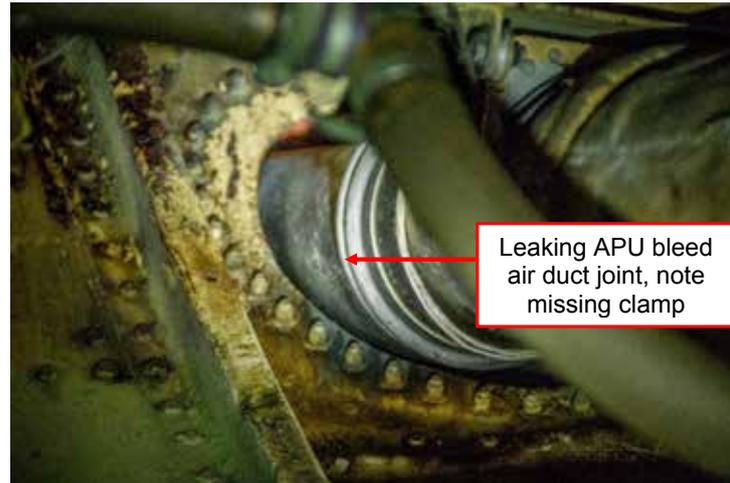
Figure 5

Investigation by the operator's engineering personnel revealed that a V-band clamp⁴ had separated from a joint on the APU bleed air duct in the rear equipment bay, immediately forward of the aft pressure bulkhead, beneath the main deck cargo floor in the vicinity of fuselage station (STA) 1016, Figure 4.

Overheating damage to the aircraft's structure adjacent to the APU bleed air duct leak

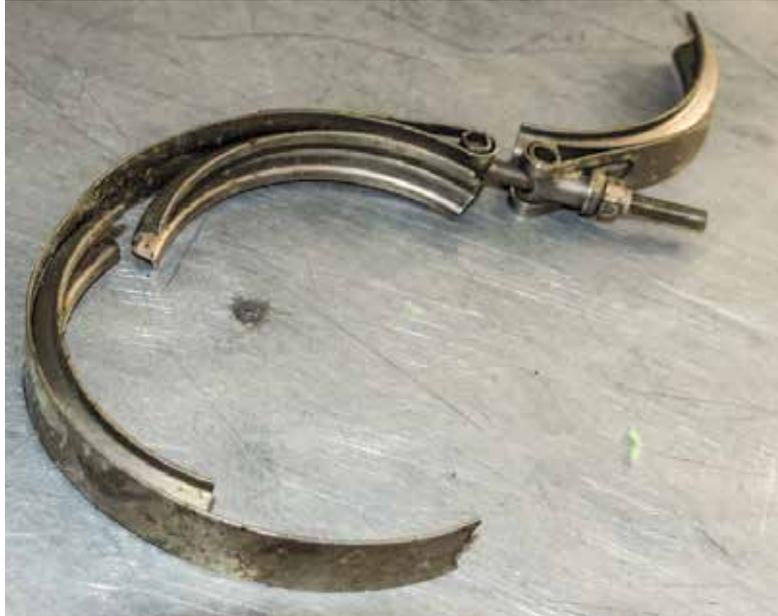
The broken clamp was recovered from the rear equipment bay, Figure 6 and subjected to detailed examination.

Broken V-band clamp

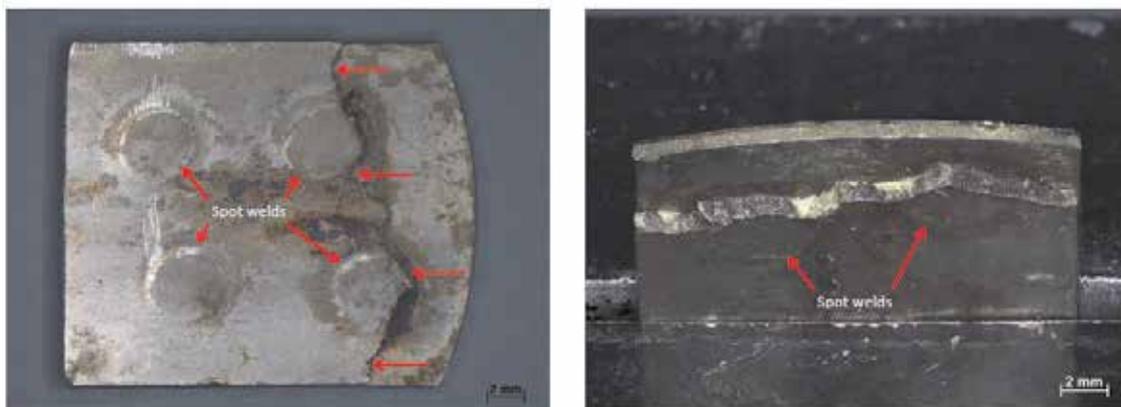
Figure 7

The clamp's tension band had fractured at the point where the upper folded part of the band is attached to the main lower part of the band by two staggered rows of spot welds, Figure 7.

V-band clamp fracture location at spot welds

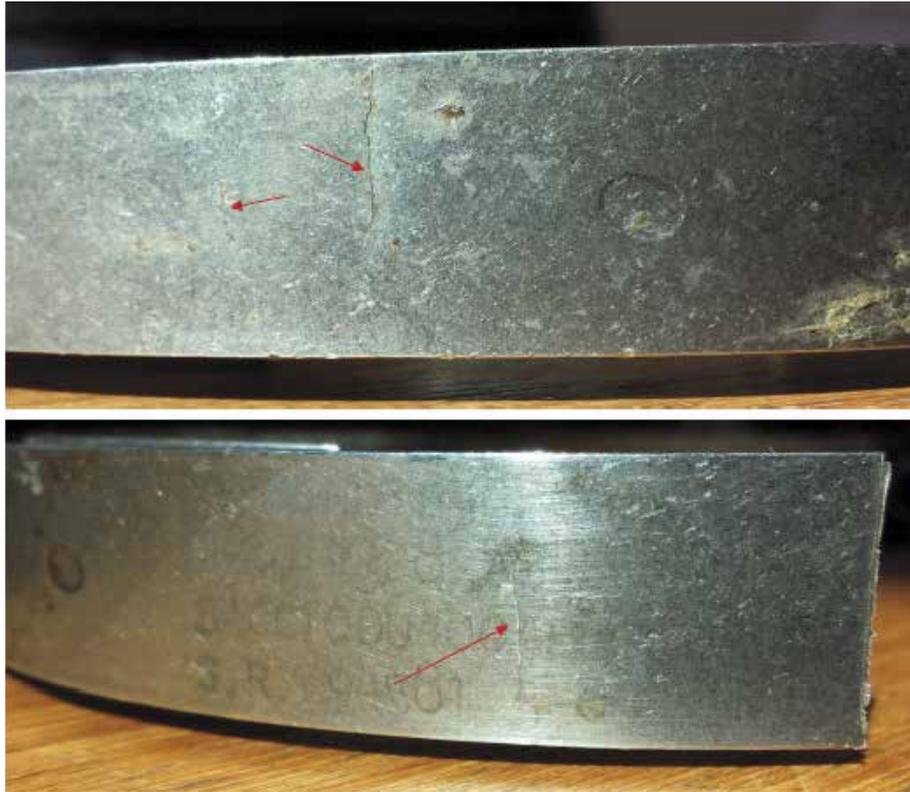
Figure 8

In addition to the main fracture, three further cracks in the clamp's band were identified, Figure 8. These additional cracks were located at points on the band between where the inner profiled segments were attached, at points where the band bending loads were highest.

Other cracks identified in the V-band clamp band

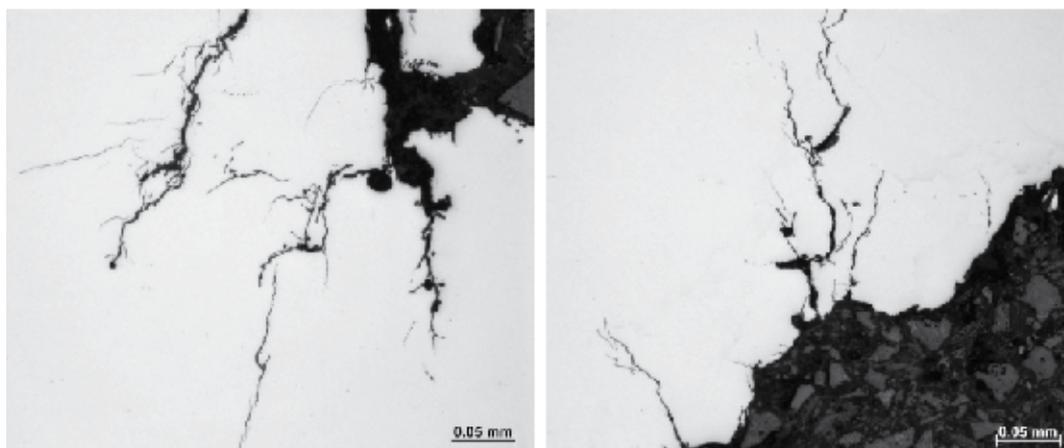
Figure 9

Metallographic section of band fracture face, showing branching crack paths

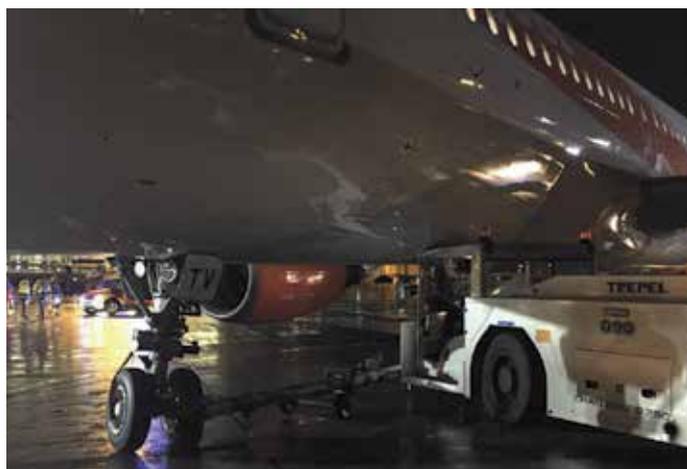
Figure 1

Ground crew from adjacent stands came to assist and found the towbar was still connected to both the tug and to the aircraft. The nose gear leg was rotated approximately 90° to the left and the tow bar was bent around the front corner of the tug (Figure 1). The shear pins on the towbar had fractured (Figure 2), and pieces were later found within the boundary of the stand, but the central retaining pin remained intact. The passengers and crew disembarked without injury from the rear right exit door.

Position of the tug and the towbar after the accident

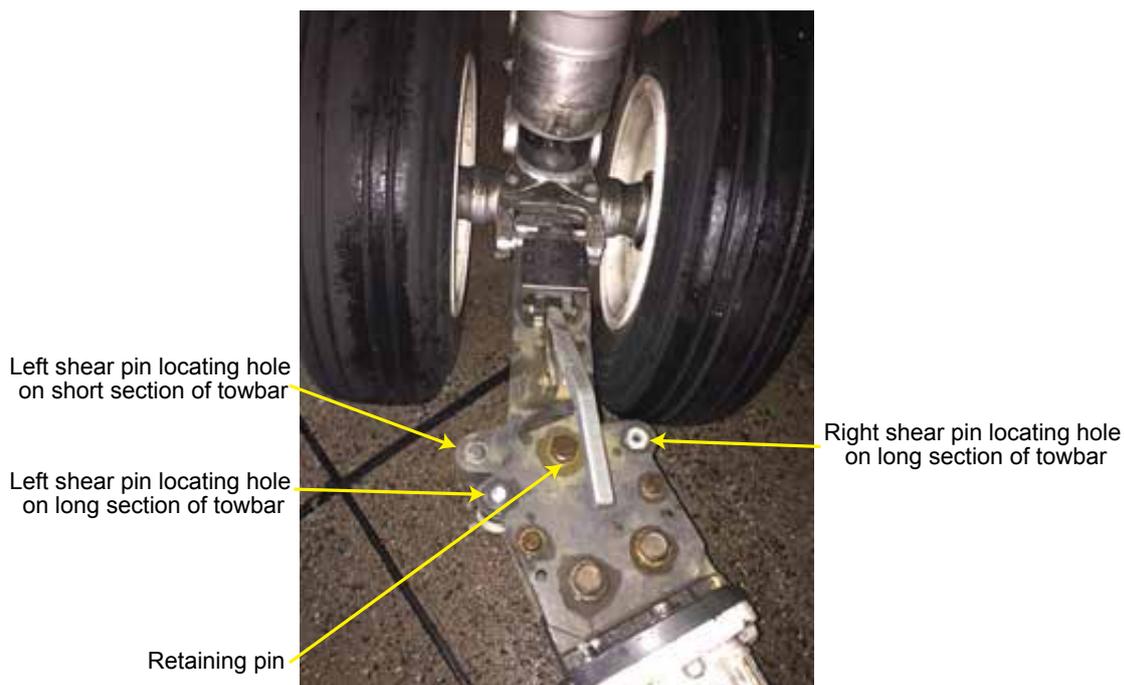
Figure 2

Image showing head of retaining pin and locating holes for failed shear pins

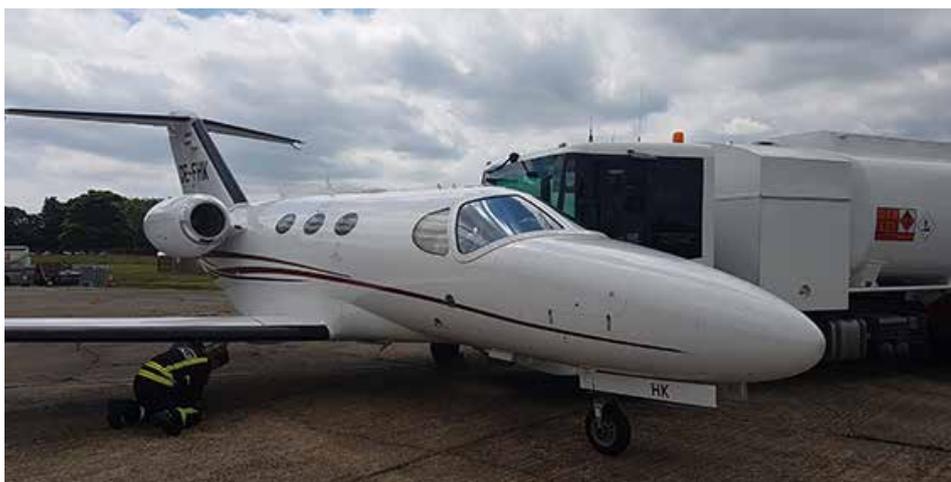
Figure 1

OE-FHK after colliding with the fuel bowser

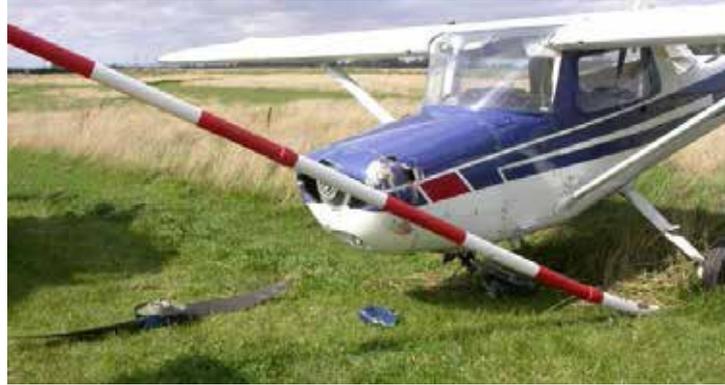
Figure 1

The aircraft in its resting place with the detached propeller on the ground to the left (photograph courtesy of Hull Aero Club Ltd)

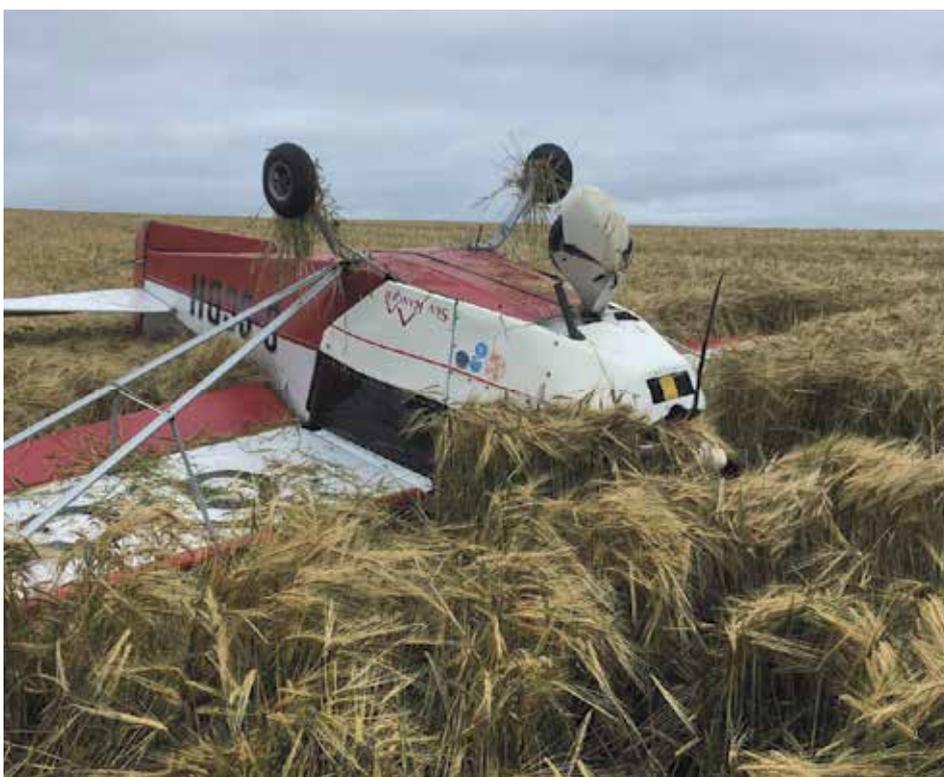
Figure 1

G-CCDH after impact
