AAIB Bulletin

1/2018

Published 11 January 2018

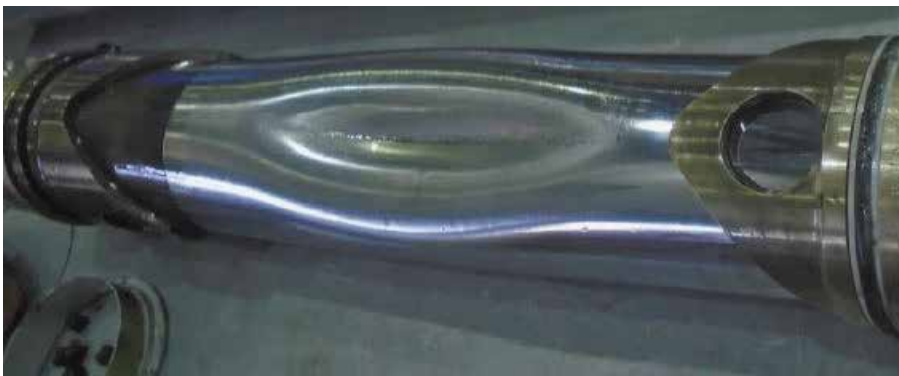
Figure 1

On the advice of the manufacturer, all three landing gears on the aircraft were replaced and sent for detailed inspection. These inspections revealed that both the nose landing gear and the right main landing gear had suffered excessive loads during the landing and could not be returned to a serviceable condition. The nose landing gear shock-absorber cylinder was found buckled (Figure 1) with the barrel and forestay lower arm pin found to be out of tolerance. The right main landing gear sliding tube and shock-absorber were also found to be outside acceptable tolerances when measured. The left main gear was undamaged.

Nose landing gear shock absorber cylinder

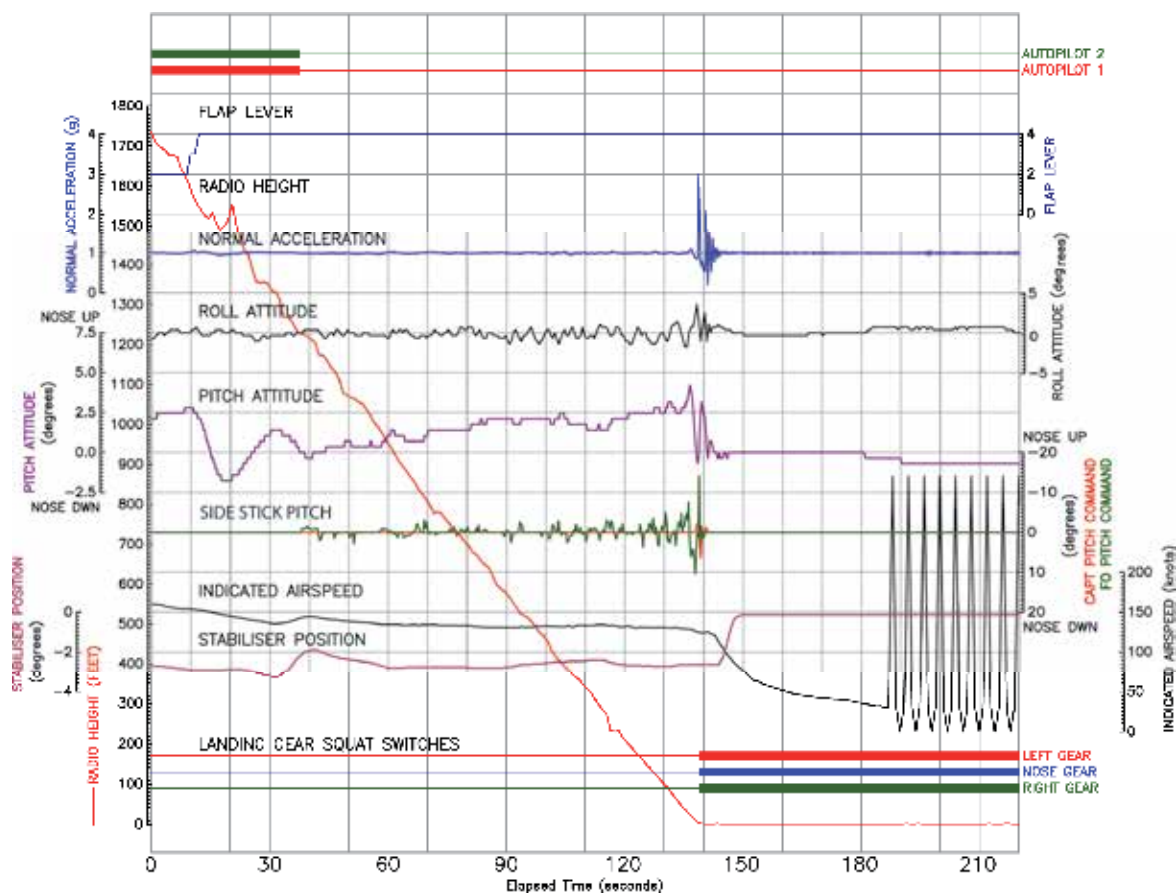
Figure 2

The data (Figure 2) shows the aircraft established on a stable ILS approach, correctly configured and at the approach speed. At 1,228 ft radio altitude, the AP and A/THR were disconnected. As the aircraft approached 30 ft radio altitude, there was a forward sidestick input and the pitch attitude began to decrease. The aircraft reached close to 1° nose-down less than a second before touchdown. At around 10 ft radio altitude, the PM applied a small amount of aft stick but this had a negligible effect on the pitch attitude and touchdown.

The LOAD <15> report showed that, at touchdown, the aircraft's attitude was 0.7° nose-down with a slight roll to the right, and its rate of descent was 11.9 ft/sec. The maximum recorded vertical acceleration was 3.01 g.

Salient FDR parameters for the approach and touchdown

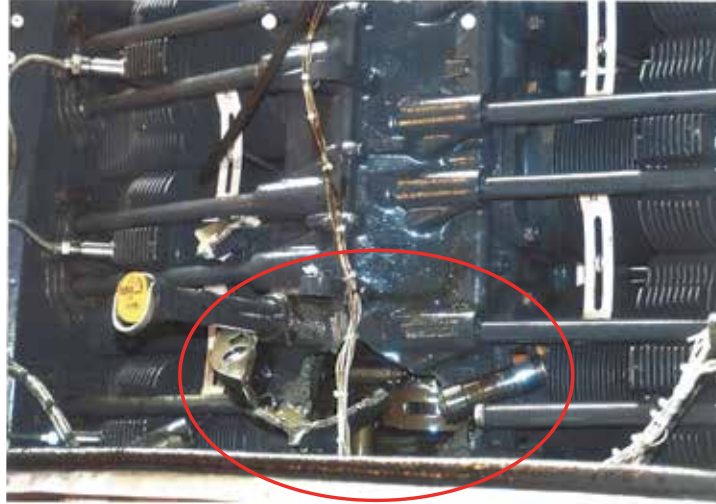
Figure 1

Initial inspection found a hole in the left engine top cowling. When the cowling was removed, a hole in the crankcase and some liberated internal engine parts were apparent (Figure 1).

View of top of left engine showing hole in crankcase and liberated parts

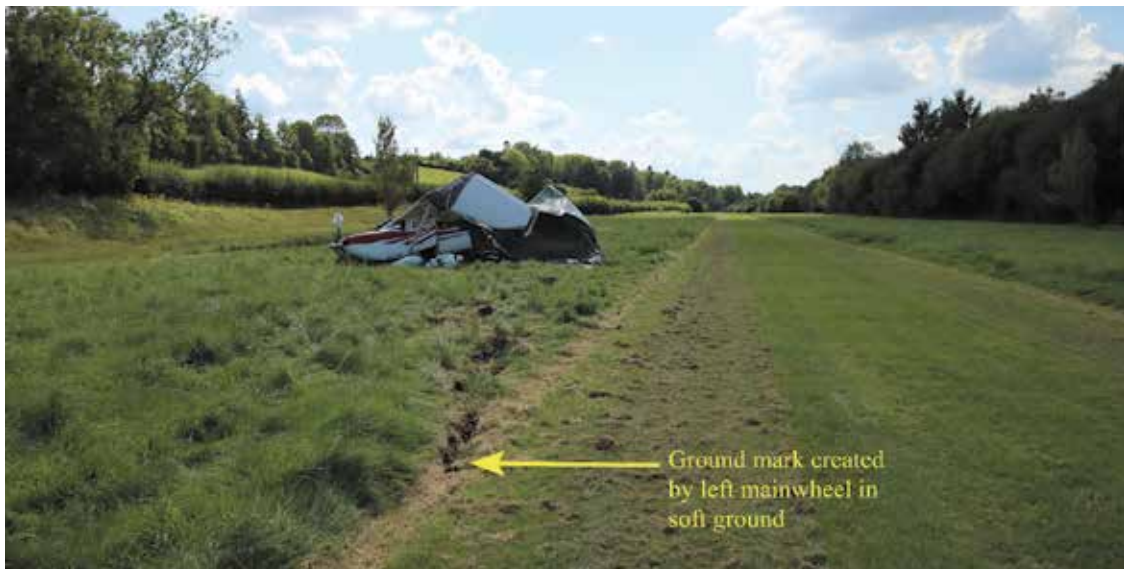
Figure 2

Photographs taken after the accident indicated the grass airstrip had been cut to a width of approximately eight metres. An engineer who examined the aircraft found evidence that the left mainwheel deviated into long grass on the left side of the strip before the left wing and the propeller struck the ground. This caused the aircraft to spin around to the left quickly and shock-loaded the engine and the airframe. Both wings were damaged, the fuselage was distorted and the nose and right main landing gear legs were detached, while the left main landing gear collapsed (Figure 2).

A southerly view along Runway 18, showing the aircraft pointing to the north-east, with the left wing severely damaged and with a tarpaulin over the rear fuselage

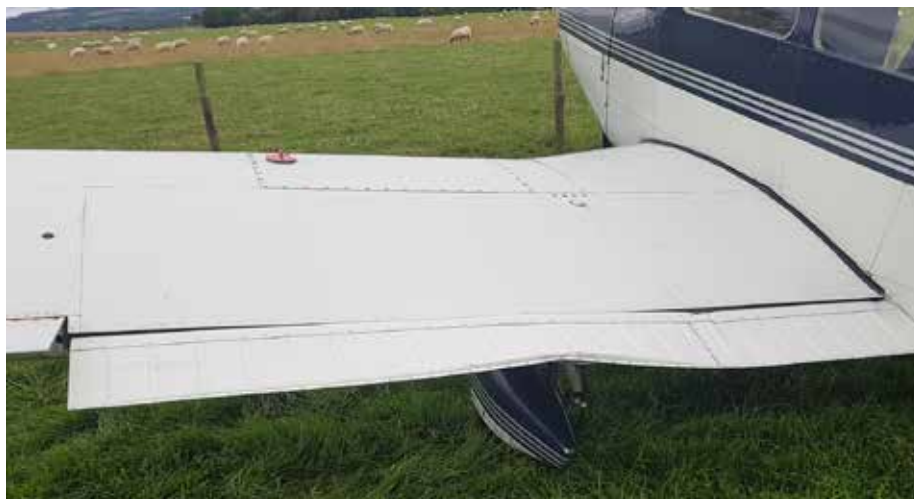
During the subsequent ground roll several sheep ran in front of the aircraft and one was hit, causing the damage shown in Figures 1 and 2. The aircraft was stopped close to a second fence and the electrics and fuel were then turned OFF before the crew exited through the door. Some unidentified debris was later found in the carburettor but the examining engineer was unsure if this was sufficient to have caused the engine failure.

Figure 1
Damage to left flap

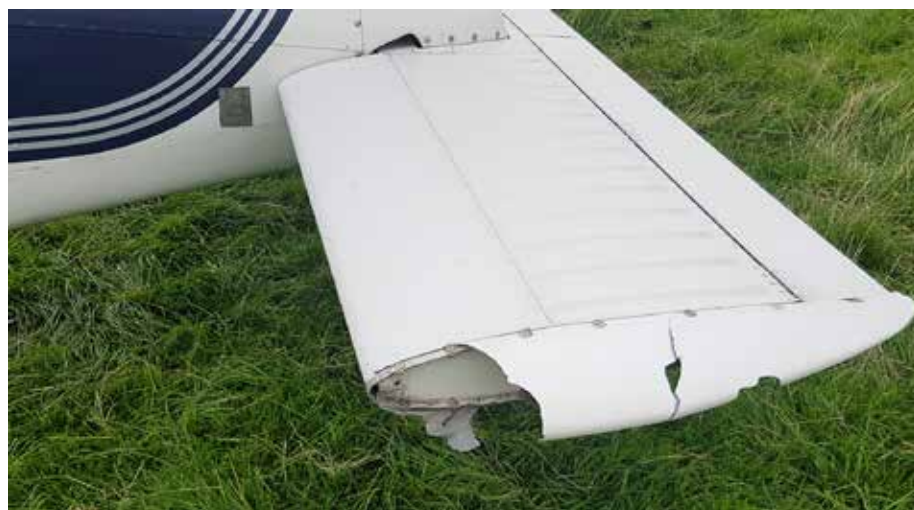
Figure 2
Damage to tip of left stabilator

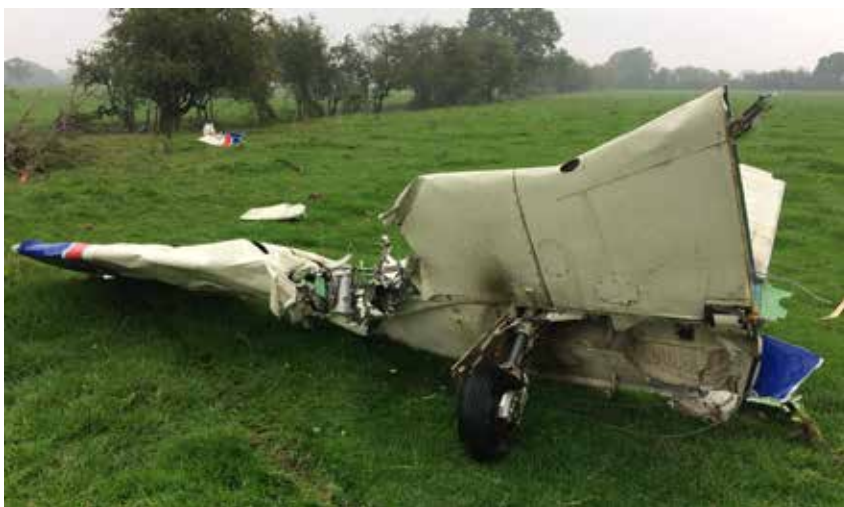
Figure 1

Detached right wing with trees which the aircraft hit in the background

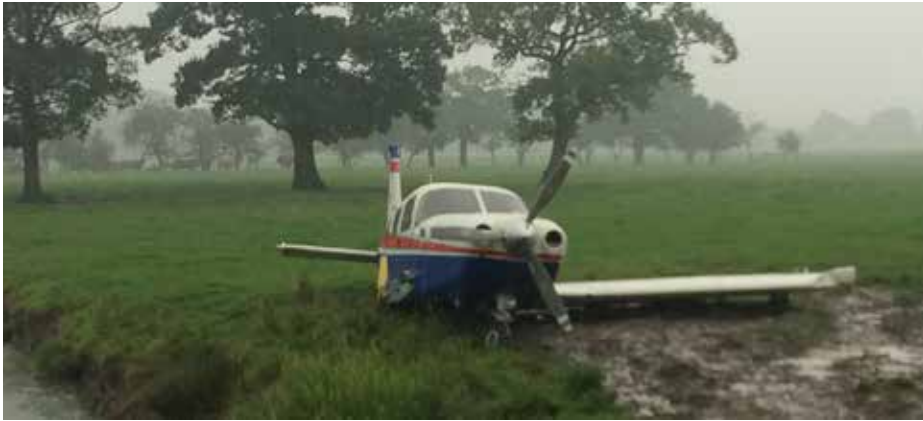
Figure 2

The aircraft came to a halt approximately one metre from the edge of one of the ponds (Figure 2) and the pilot, who was uninjured, escaped through the door without difficulty. He checked the left wing tank and estimated it still held 25 gallons of fuel but the tank in the right wing had burst and he was unable to determine how much fuel it contained at touchdown.

Final position of N414AG close to the pond

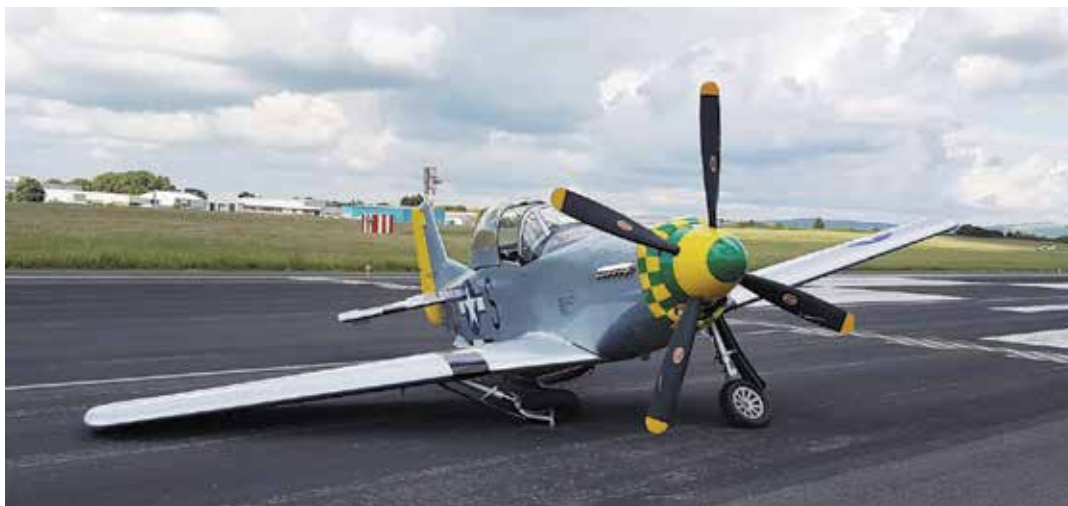
Figure 1

Following a local flight in good weather conditions, with light winds, the pilot landed the aircraft normally on Runway 27. As the aircraft slowed to approximately 10-15 mph at the end of the landing roll the pilot gently applied the brakes, but as he did so the aircraft yawed to the left which he could not control using right rudder and right brake. The pilot reported that the wings remained level as the aircraft yawed to the left. The weight transferred to the right main landing gear leg, which collapsed inwards, causing the propeller and right wingtip to contact the runway as the aircraft came to a stop, Figure 1.

G-DHYS following the collapse of the right main landing gear

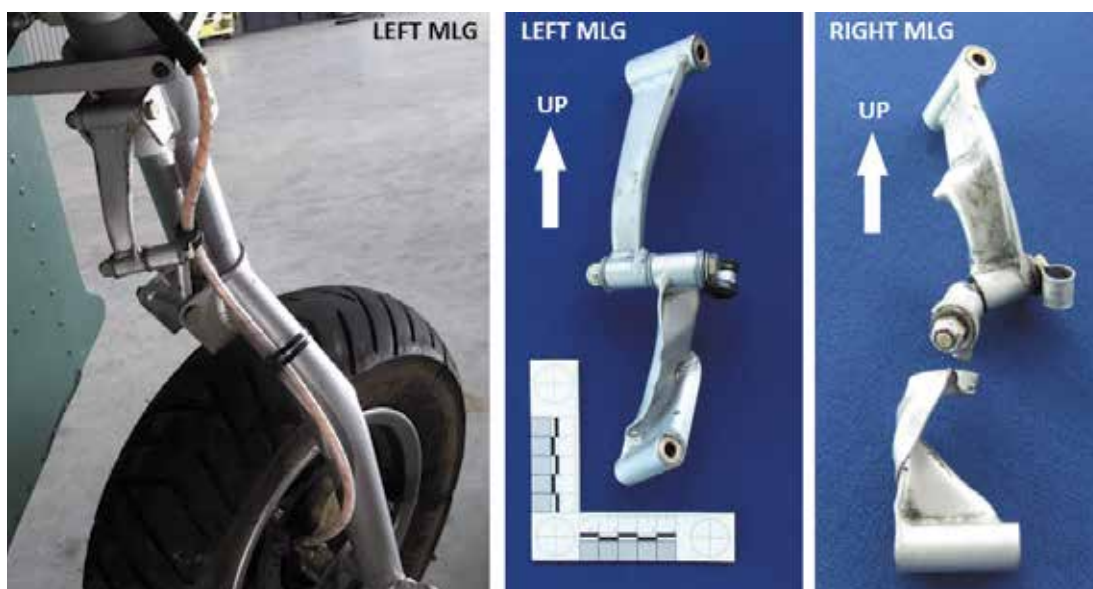
Figure 2

G-DHYS left MLG leg (left), left MLG torque link (centre) and right MLG torque link (right)

Examination of the aircraft revealed that the right MLG torque links had buckled, allowing the right mainwheel to rotate inwards. This would have caused an inboard side-loading on the MLG leg. The right MLG adjustable-body link was damaged due to excessive bending, caused by the right MLG collapsing inwards whilst the landing gear hydraulic actuator remained in the 'down' position, Figure 3.

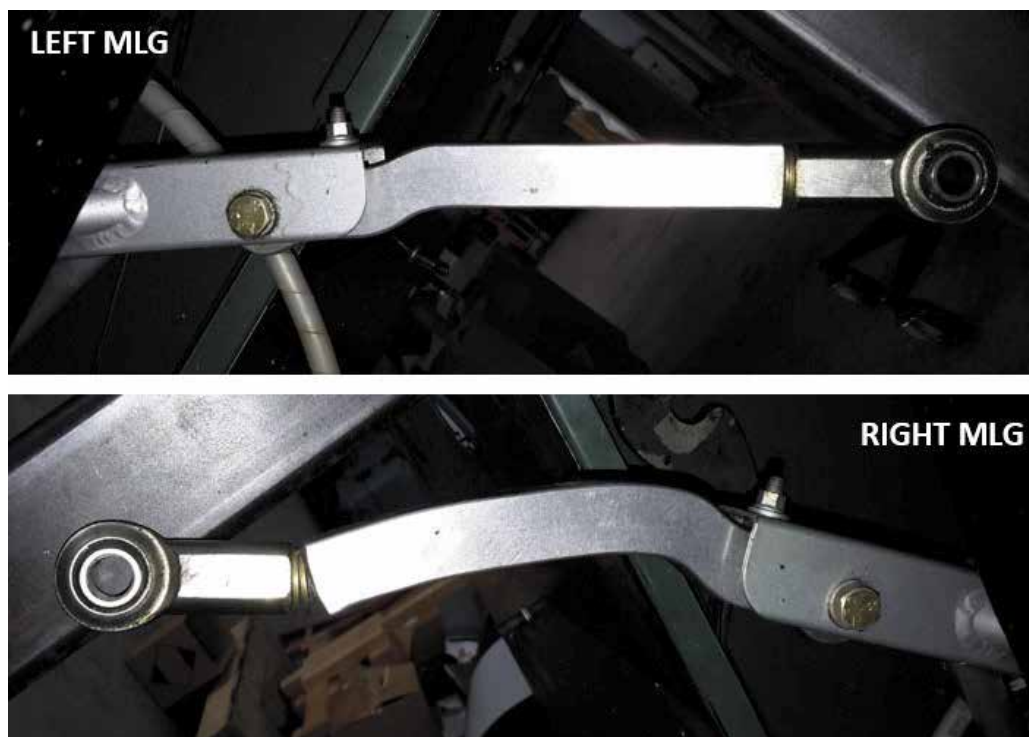
Figure 3

The left MLG adjustable-body link was undamaged, consistent with the left MLG remaining locked down during the event. The left MLG torque links were buckled due to excessive side loading, as a consequence of the collapse of the right MLG leg.

G-DHYS left MLG adjustable-body link (top), and overload-damaged right MLG adjustable-body link (bottom)

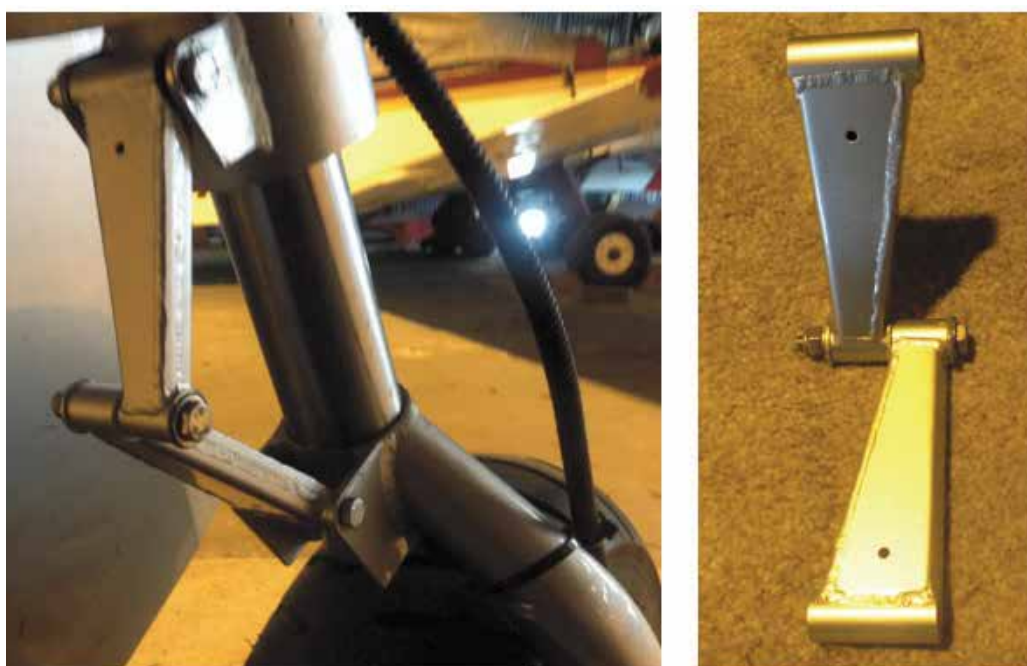
Figure 4

Strengthened MLG torque links installed on G-FION

The LAA has approved a set of modified torque links, Figure 4, for installation on G-FION, another T-51 Mustang aircraft that is currently under construction. The modified stronger torque links were developed as an LAA modification as a result of concerns raised by the accident with G-DHYS. If this modification is successful, the LAA will require that T-51 Mustang aircraft, powered by the Suzuki V6 engine and operating on an LAA Permit to Fly, are modified in this manner.

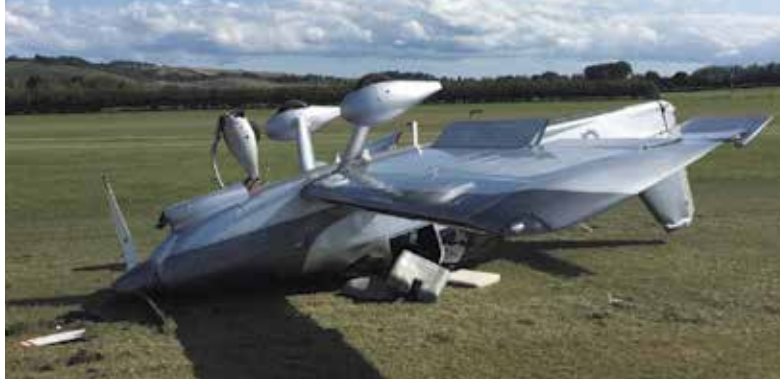
The pilot was circuiting to the grass Runway 24 at Old Sarum, in good visibility but with a 40° crosswind from the right of 10-15 kt. On the fourth circuit and during the last 200 ft of the approach, he experienced turbulence which culminated in a sudden downdraught when crossing the threshold at 10-15 ft. He responded by applying full power and pitching up but the aircraft made a hard touchdown in a level attitude before climbing away. There was no indication that the aircraft had been damaged but, for the subsequent landing, the pilot decided to hold the nosewheel off the ground for as long as possible, in case it had been weakened. Despite the pilot's efforts, after the nose landing gear touched down, it collapsed rearwards and when the propeller hit the ground the aircraft flipped inverted and then came to a stop. The pilot managed to shut-off the fuel and electrics and bystanders raised the tail of the aircraft, which allowed him to open the canopy and escape (Figure 1).

Figure 1
G-CCVS after the accident

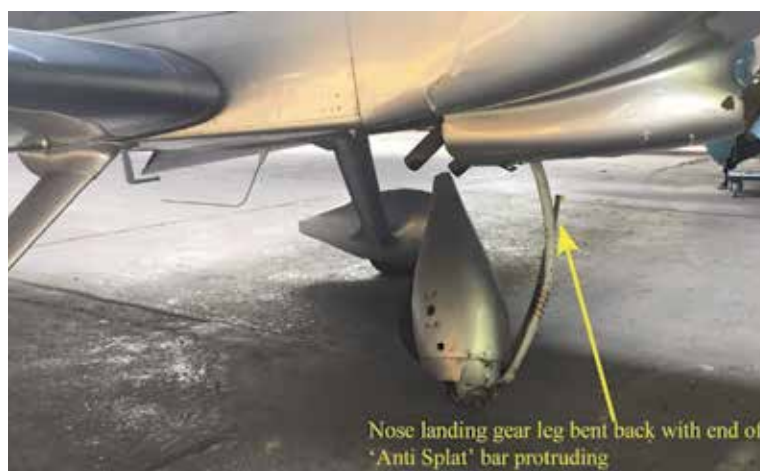
The AAIB has reported on several previous accidents in which the nose landing gear leg of a Vans RV series aircraft has bent back or collapsed. AAIB Bulletin 3/2017 contains a report concerning G-RPRV, an RV-9A that flipped upside down, and a list of other recorded instances in the UK during which the nose landing gear leg bent back. The report also mentions an 'Anti Splat' kit (Figure 2) which is intended to restrain the nose landing gear leg from tucking under.

Figure 2
An 'Anti-Splat' kit was fitted to the nose landing gear

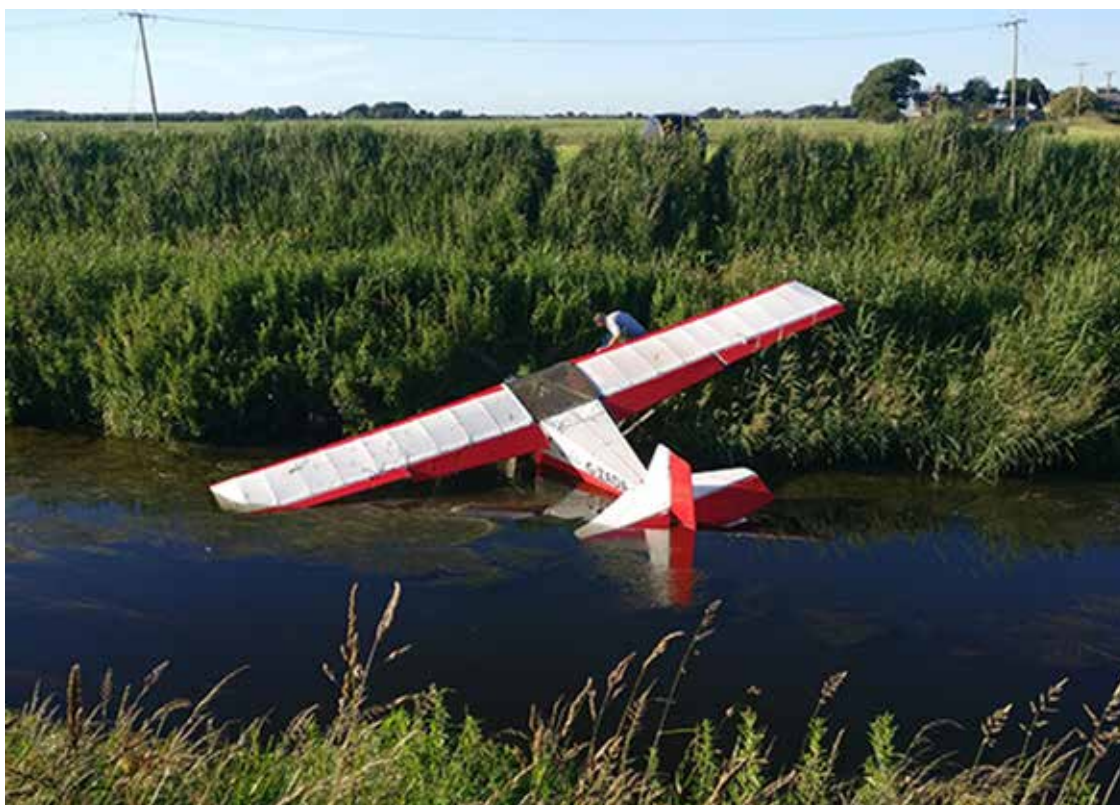
Figure 1

Once on the runway the pilot applied maximum braking but was unable to halt the aircraft before the end of the runway, where there is a steep river bank. The aircraft overran the runway and crossed over the shallow river, which was approximately 10 m wide, before hitting the far bank and coming to rest (Figure 1). The occupants had no difficulty escaping from the aircraft but the passenger subsequently experienced chest pains and was later diagnosed to have fractured a rib.

View of the aircraft in its resting place by the north bank of the River Alt.
Note power lines which cross the extended centreline of Runway 36
