Rail Accident Investigation Branch

Rail Accident Report

**Train driver receiving a severe electric shock at
Sutton Weaver, Cheshire
23 September 2014**

Report 07/2015
June 2015

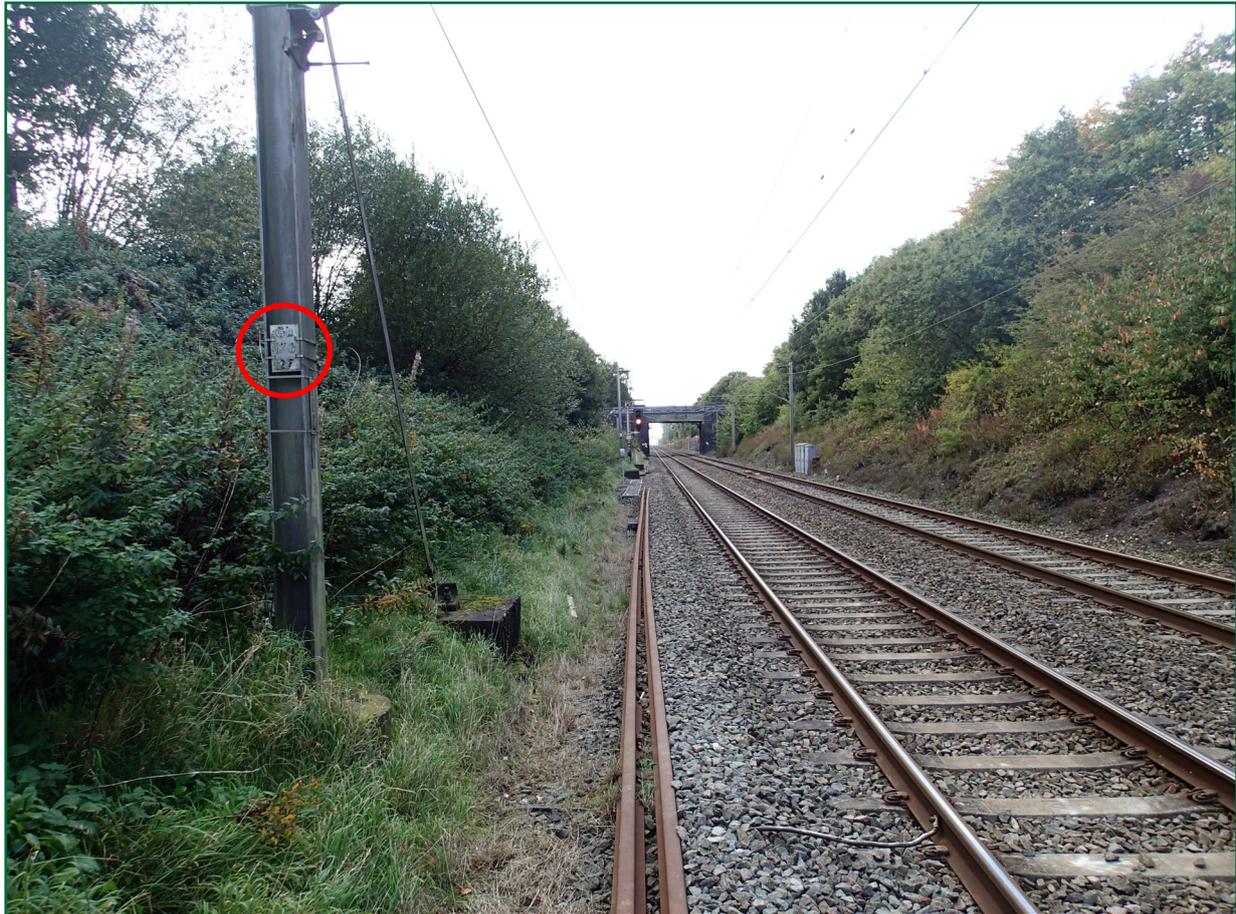
Figure 2: Location of the accident as viewed in the direction of travel of train 1F22 on the approach to HN103 signal, visible in the centre of the picture, and the OLE mast identification plate (ringed)

- 72 The RAIB has observed that the letters and numbers on the OLE structure number plate closest to the train were in a worn condition (figure 2). The RAIB consider that even if in a better condition, it would have been difficult to read them from a distance 18 metres through a wet train windscreen and with the light conditions present at the time.

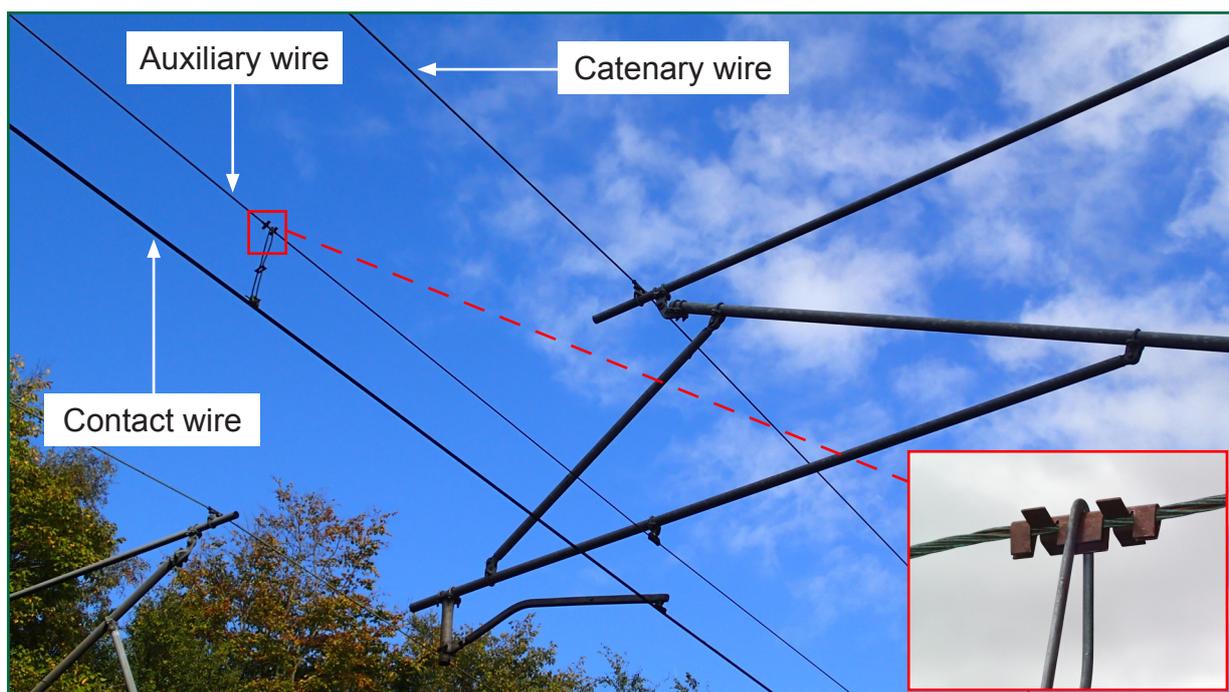
- 18 Mk 1 compound OLE comprises an upper catenary wire, a middle auxiliary wire and the lower contact wire (figure 3). The *pantograph* of a train pushes up against the contact wire to obtain electric power. The catenary and auxiliary wires are structural elements that support the contact wire. They are suspended from cantilevered masts along the track. Between adjacent pairs of wires are dropper wires (generally known as *droppers*) which support the wire below.

Figure 3: Mk 1 compound catenary with the three wires labelled. Inset shows auxiliary wire protective sleeve on the auxiliary wire.

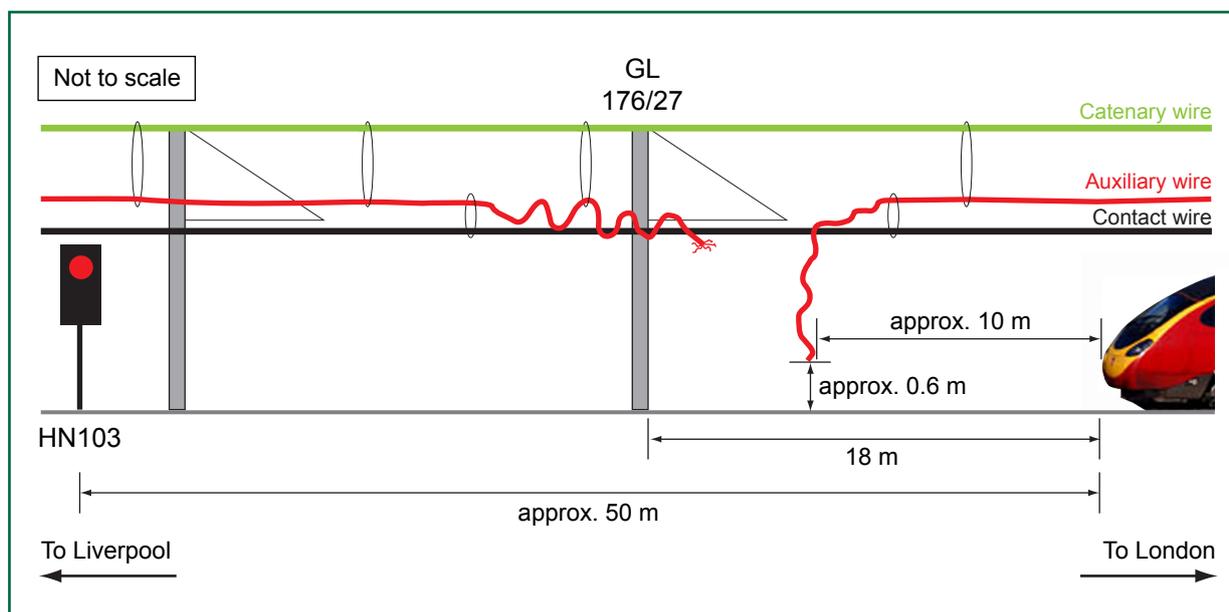
57 The approximate positions of the two ends of the broken auxiliary wire following the accident are shown in figure 4. The end closest to London was hanging low to the ground, and the end closest to Liverpool remained close to the catenary and contact wires.

Figure 4: Approximate positions of the ends of the broken auxiliary wire, the train, HN103 signal and the nearest OLE mast

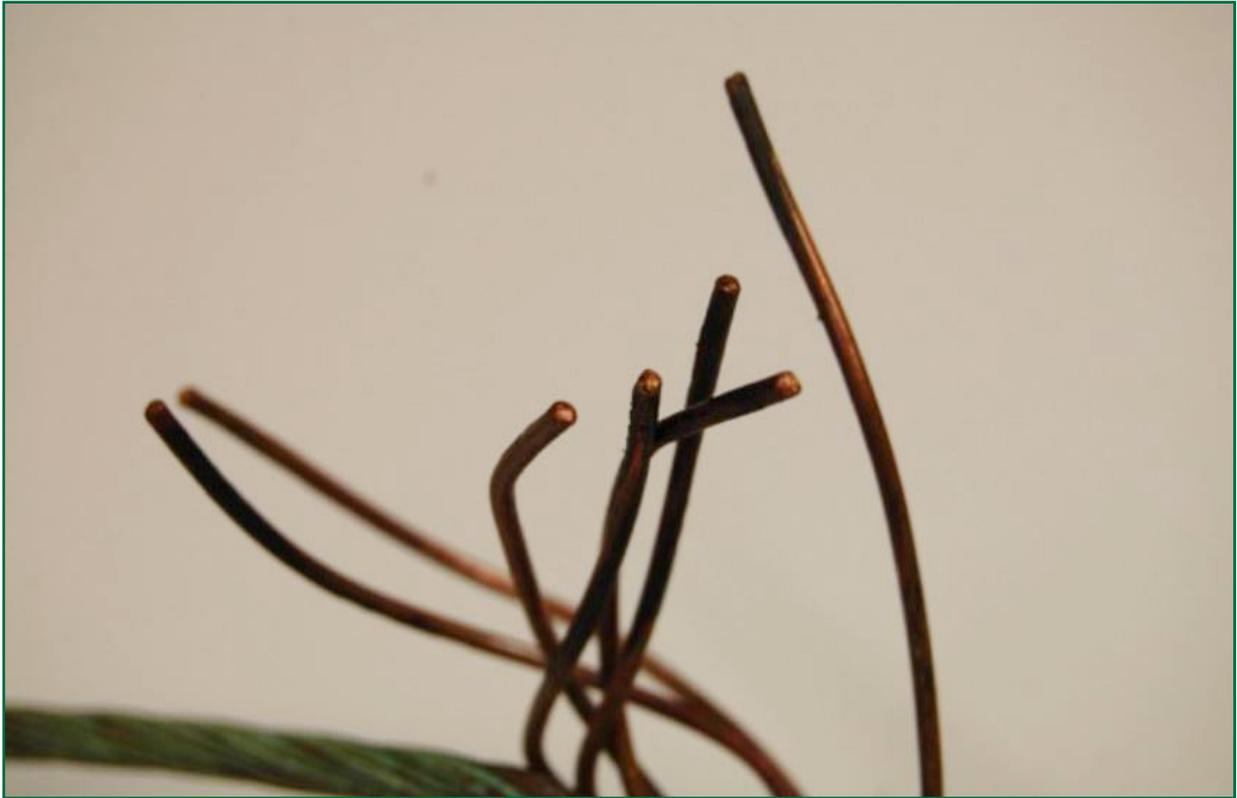
- 58 Examination of the recovered sections of the auxiliary wire showed that the broken end closest to Liverpool had signs of mechanical damage in the form of unwound strands at various angles, together with fused copper deposits on the strand ends (figure 5). Some areas on the section closest to London showed signs of electrical arcing and mechanical damage (figure 6). This damage and the reported flashes are indicative of the broken wire making contact with the two trains preceding train 1F22. Examination of train 1F52, found arcing damage to parts of its pantograph.

Figure 5: Splayed wire strands on the Liverpool section of the broken auxiliary wire

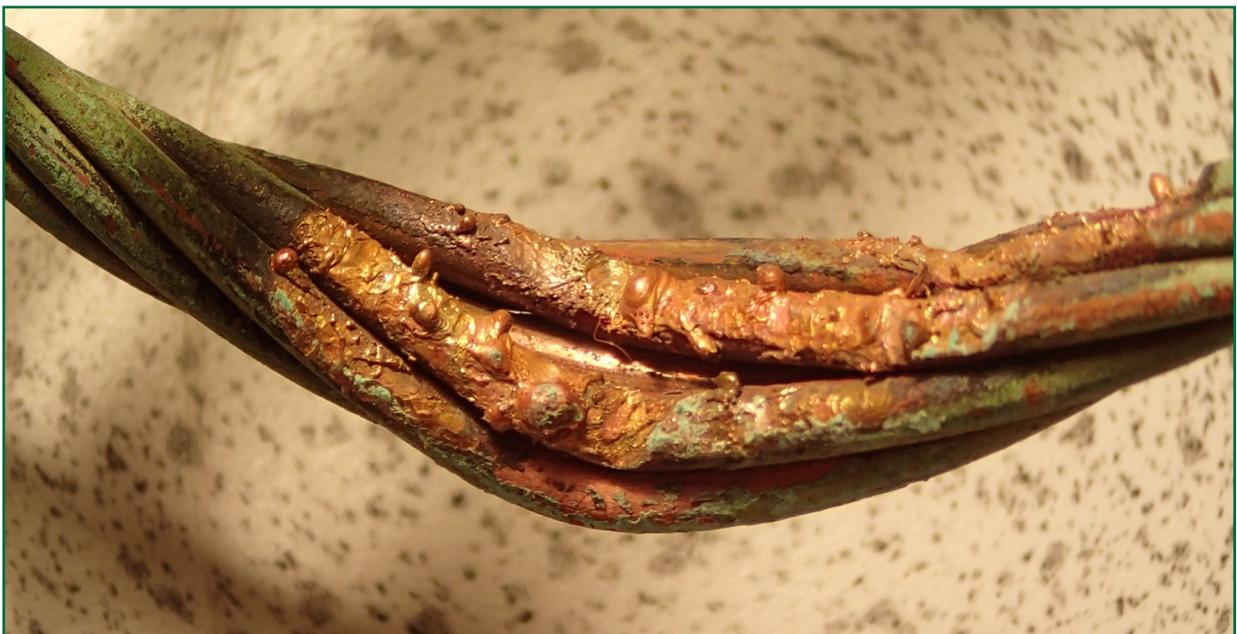
Figure 6: Electrical arcing damage on the London section of the broken auxiliary wire

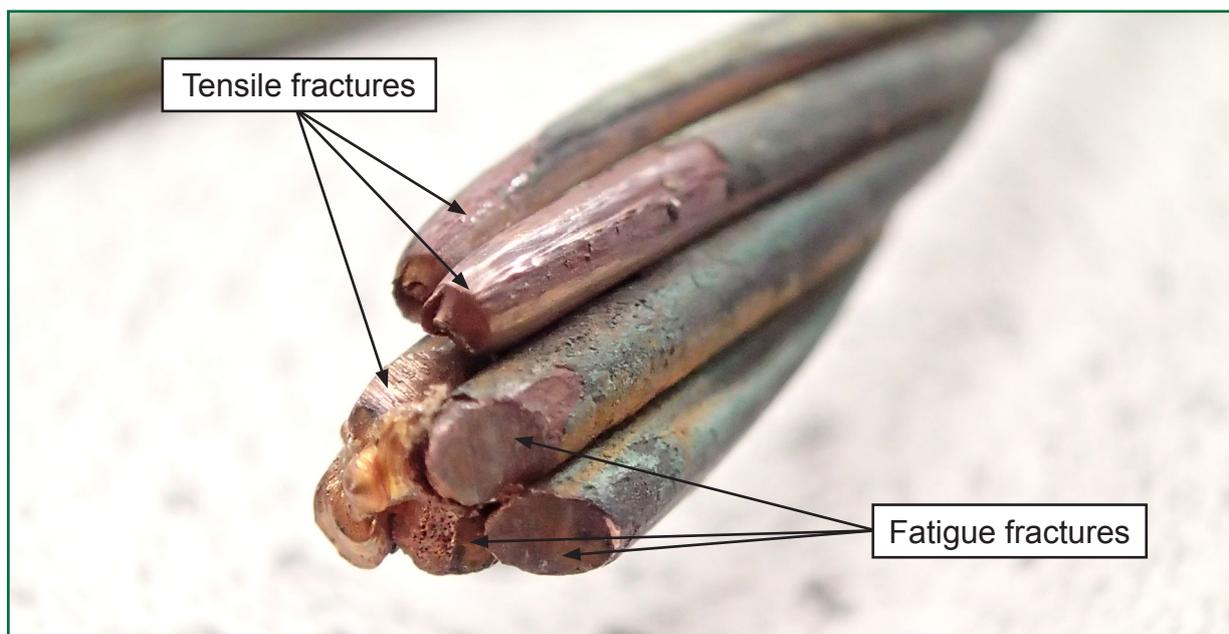
- 59 Metallurgical examination of the strand ends of the wire section closest to London showed that it had failed by two distinct mechanisms (figure 7). The angled fracture faces on at least three of the seven strands are fatigue fractures⁵ which had developed following many load cycles and not just a few overloading events. The remaining three or four strands then failed in tension as they were no longer able to carry the normal tensile load applied to them in supporting the contact wire below. The wire was also examined for possible overheating damage caused by electrical arcing. None was found, discounting this as a possible contributor to the failure.

Figure 7: End of the London section of the broken auxiliary wire

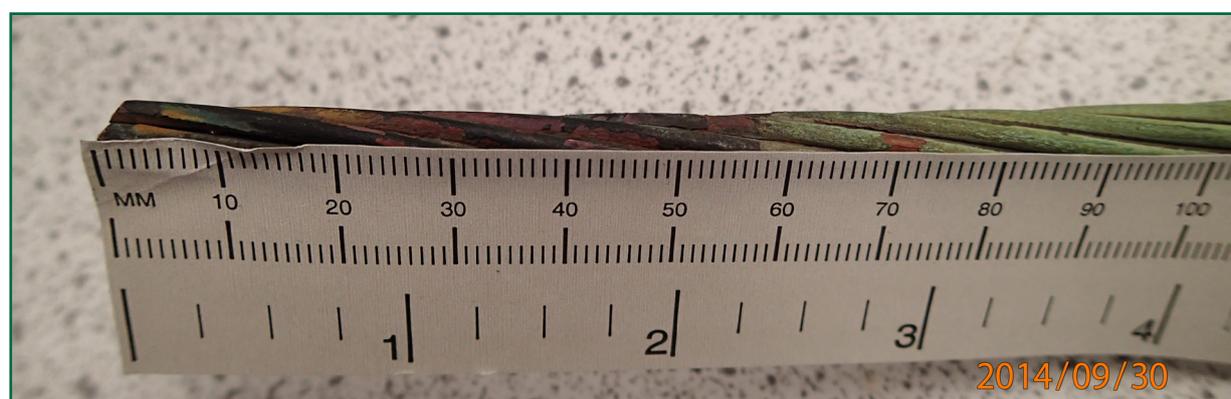
- 60 The wire had developed a green coating (known as verdigris) on the exposed surfaces of the strands. However a short length of the wire at the broken end of the section closest to London was discoloured black rather than green. This suggests that the failure took place within a section of wire within a protective sleeve (figure 8).

Figure 8: End of the London section of the broken auxiliary wire showing dark discolouration where it has been within the protective sleeve

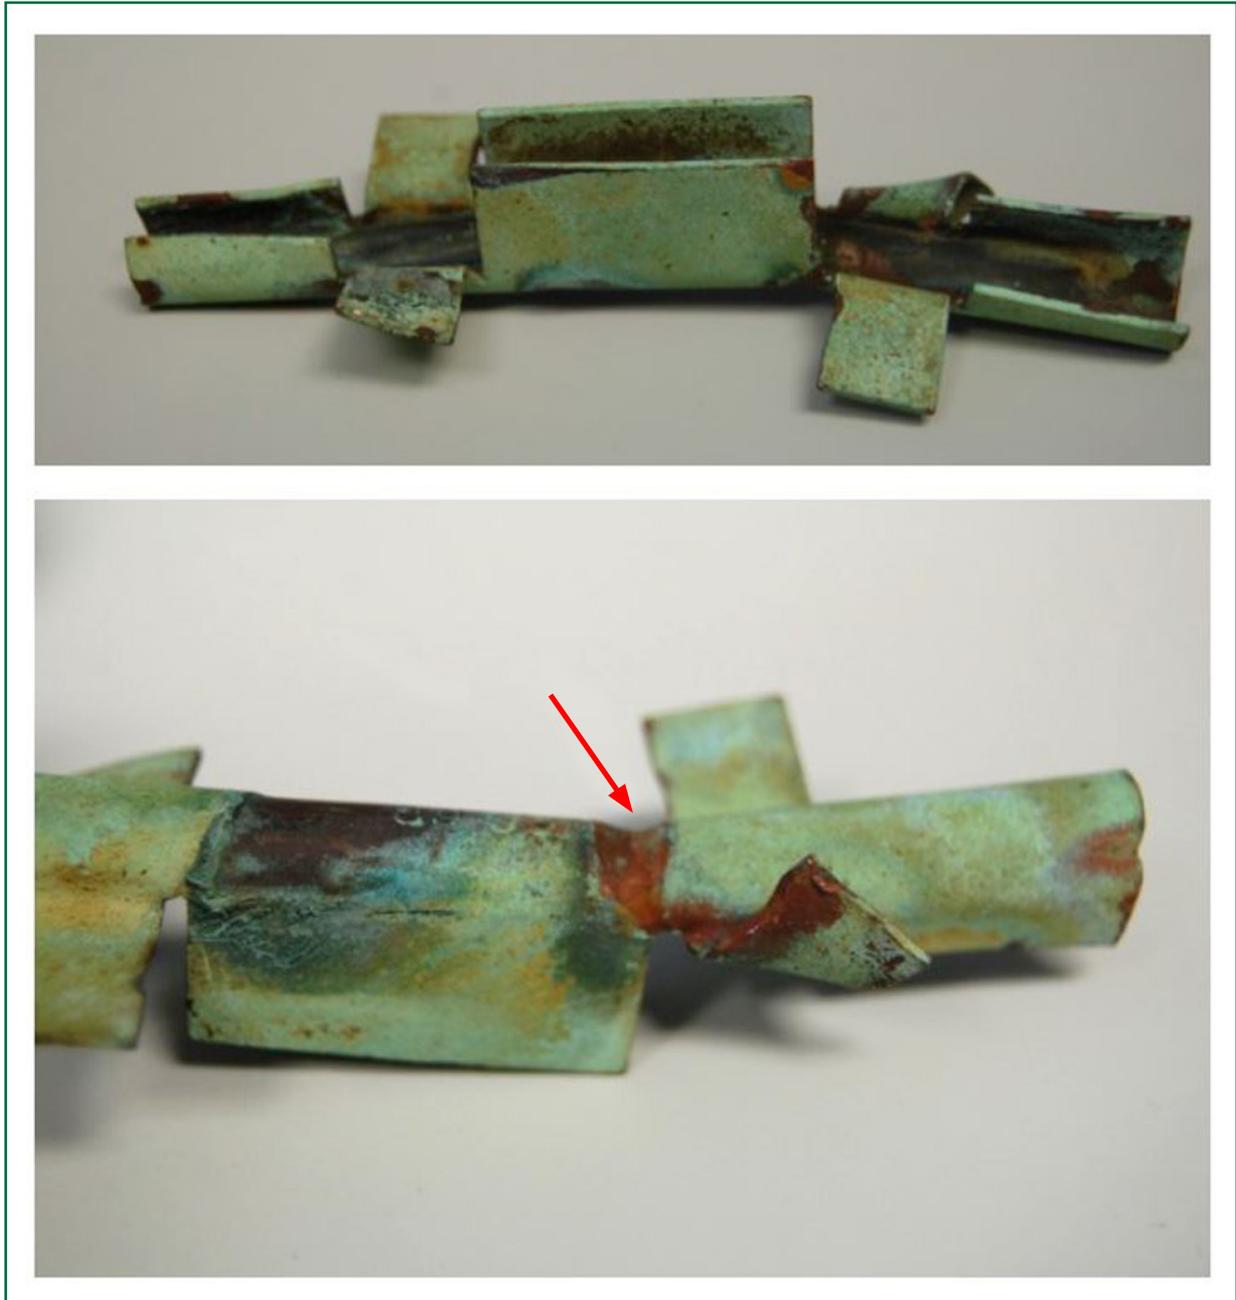
- 61 Several days after the accident, a damaged protective sleeve was found adjacent to the auxiliary wire failure point (figure 9). When the broken end of the wire was placed in the position in the sleeve indicated by the discolouration, the break was found to be coincident with an area of the sleeve that had been subjected to localised loading by the upper loop of the dropper wire impacting on it. This has led the RAIB to conclude that the recovered sleeve is likely to have been the one present prior to the auxiliary wire breaking.

Figure 9: Protective sleeve found at the scene of the accident. Red arrow indicates the groove created from contact with the loop of the auxiliary wire dropper.

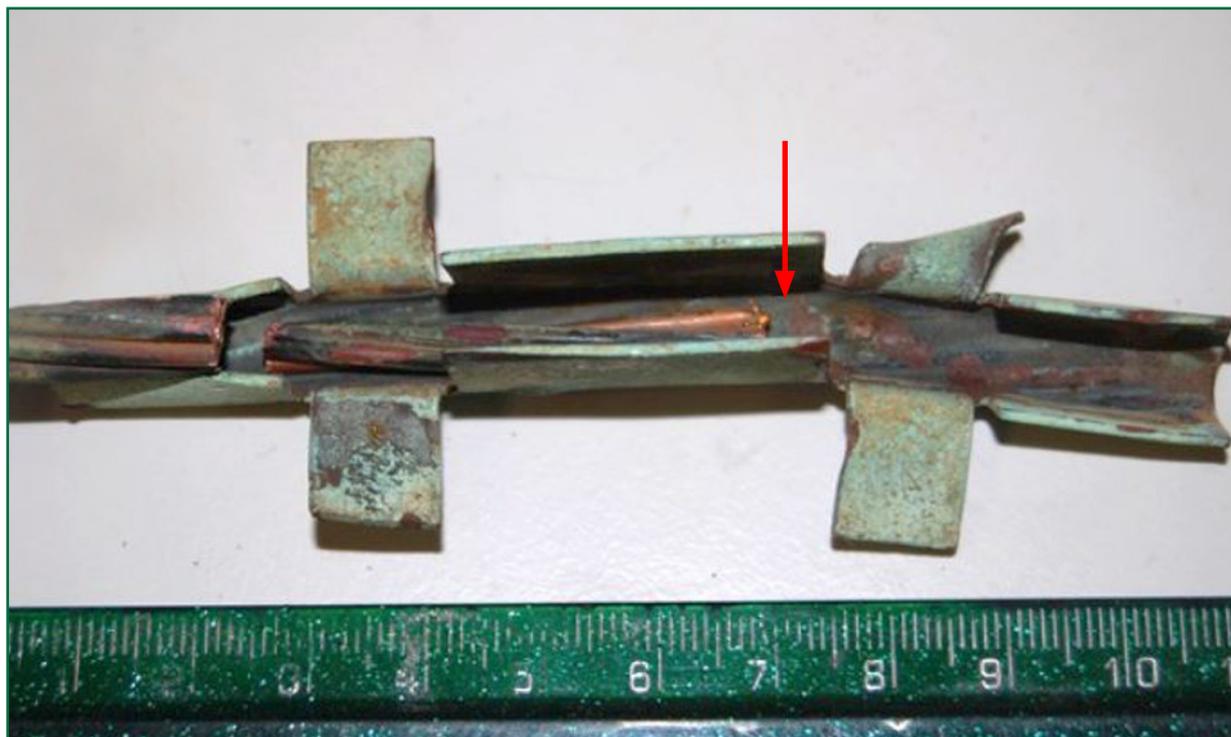
Figure 10: Position of the London end of the broken auxiliary wire relative to the protective sleeve. Red arrow indicates line of wire breakage coincident with the sleeve inner protrusion, which is coincident with the groove shown in figure 9.

62 The localised loading had caused a groove on its upper surface and an associated inner protrusion (figure 10). It is likely that this protrusion caused a local high stress area on the wire which contributed to the initiation and propagation of the fatigue fracture. Network Rail provided the RAIB with two other sections of broken and partially frayed auxiliary wires and protective sleeves. The broken wire section was associated with a circuit breaker trip at another location in June 2014, and the partially frayed wire section was found during a routine inspection. The regions of the completely broken and partially frayed strands on the respective samples were also related to their positions within protective sleeves. The breakage line of the completely broken wire coincided with the end of the sleeve and some of its strands showed signs of fatigue fracture. The ends of the sleeve are other likely positions at which the stress in the wire may be increased (as there is a localised change in stiffness) promoting the initiation and development of fatigue fractures.

Network Rail should revise its work instructions so that inspection staff are aware of what to look for, including possible fatigue damage precursors as found during the metallurgical examinations of this investigation, and during the inspections Network Rail has already carried out (paragraph 99a).

It should produce a plan for the extension of its current detailed examinations of auxiliary wires close to, and within, protective sleeves to identify and rectify broken and damaged wire strands and protective sleeves on all of its Mk 1 compound catenary. Following this, its routine inspections should include this additional examination.
