Rail Accident Report

Runaway of a maintenance train near Markinch, Fife 17 October 2017

Report 01/2018
January 2018

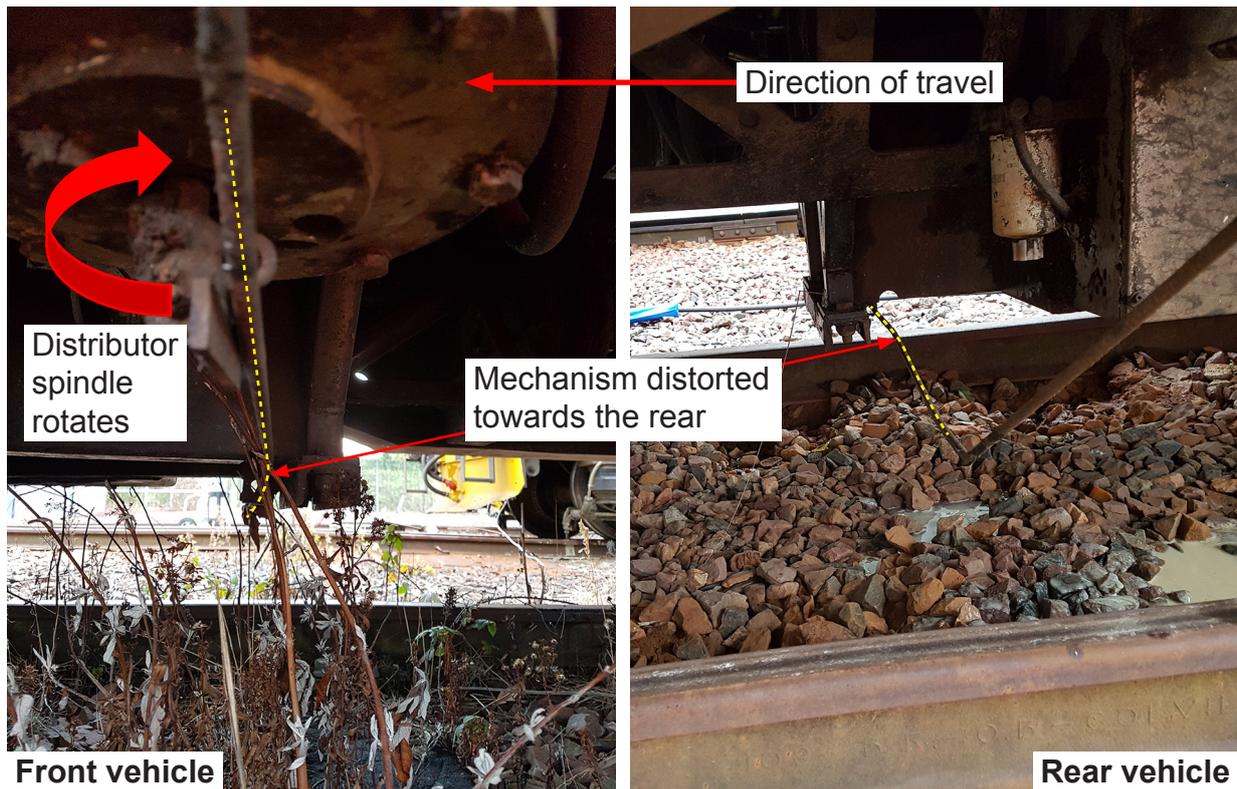
Figure 6: Distortion to brake distributor release mechanisms.

29 The brakes were released because the brake distributor release mechanisms were operated on both vehicles by the debris from the tree passing underneath the train.

- 32 Examination of the front and rear vehicle distributor release mechanisms indicates that both had been distorted towards the rear of the train, as it was travelling at the time of the collision with the tree (figure 6). This is consistent with them having been hit by the tree debris. It is likely that the release spindle (figures 5 and 6) on each brake distributor was rotated briefly during the impact, causing the air pressure to be vented from the brake cylinders for each vehicle and the brakes to be released.

Network Rail should identify and implement suitable measures to mitigate the risk of a runaway initiated by multiple unintended operations of the brake distributor release mechanisms on its Windhoff Multi-Purpose Vehicles by objects and debris that might reasonably be encountered on the track during operation.

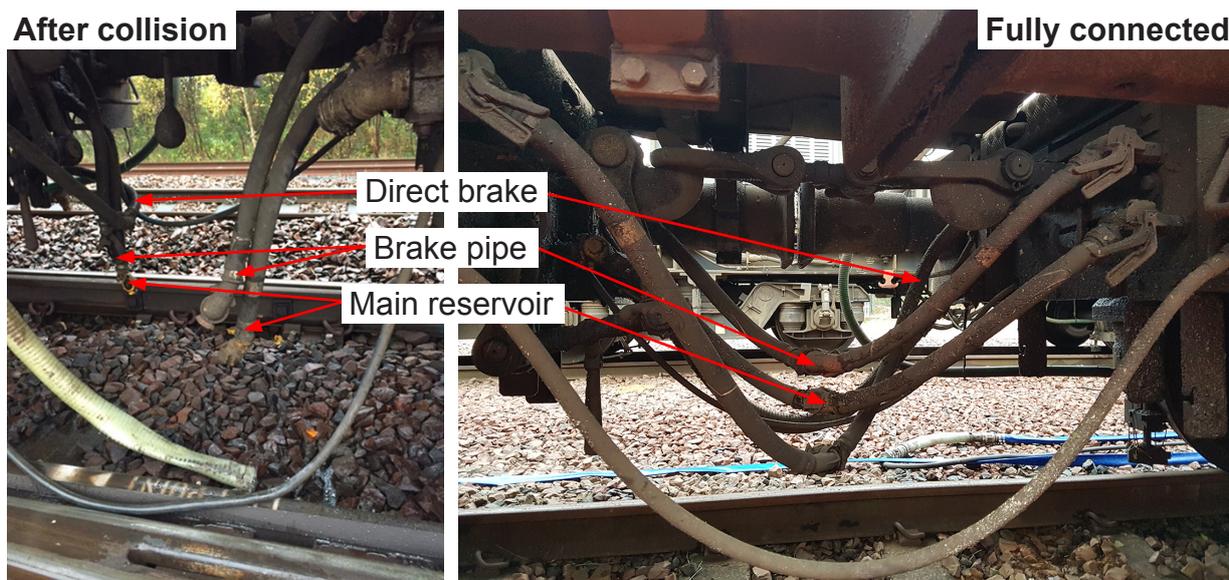
Figure 7: Comparison of normal configuration of brake pipes with that after collision (Post-collision photograph (left) courtesy of Network Rail)

- 35 The driver initially tried several times to apply the brakes using the emergency brake plunger and the brake controller handle. However, these had no effect because the tree debris passing underneath the train had separated all three brake pipes connecting the vehicles (figure 7).

- 36 The main reservoir pipe and the brake pipe had separated at the couplings, but were undamaged. The design is such that the coupling is easily released when the two hoses are perpendicular to each other. It is likely that the tree debris lifted the hanging part of the hoses, rotating the coupling until the two hoses became perpendicular. The direct brake pipe remained coupled but was pulled out of the end of the rear vehicle (figure 8).

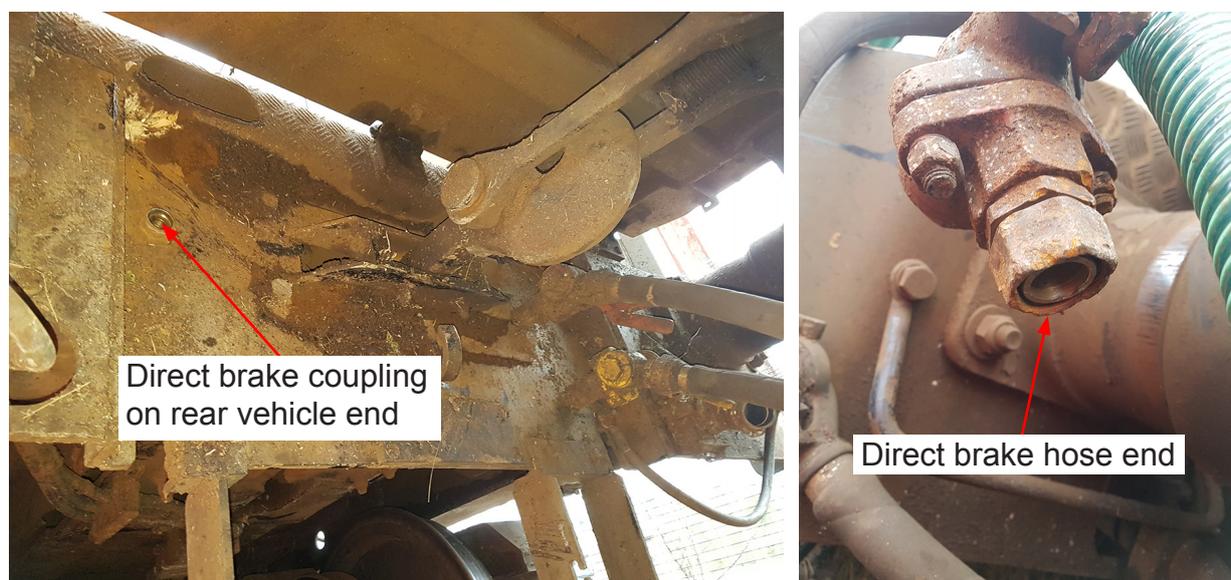
Figure 8: Direct brake pipe pulled out

- 40 Separation of the direct brake pipe also had little effect on the operation of the brakes. The system is configured such that the direct brake can be used as an alternative to control via the brake pipe. That means that the direct brake cannot be used while the brake pipe is being used. Selection of which system is active is made using a control on the desk which can only be used when the train is stationary, and therefore was unavailable. Furthermore, the direct brake would not have been operative because the direct brake pipe had separated between the two vehicles.
