Rail Accident Report

**Child nearly falling through a missing toilet floor, South Devon Railway
22 June 2017**

Report 02/2018
January 2018

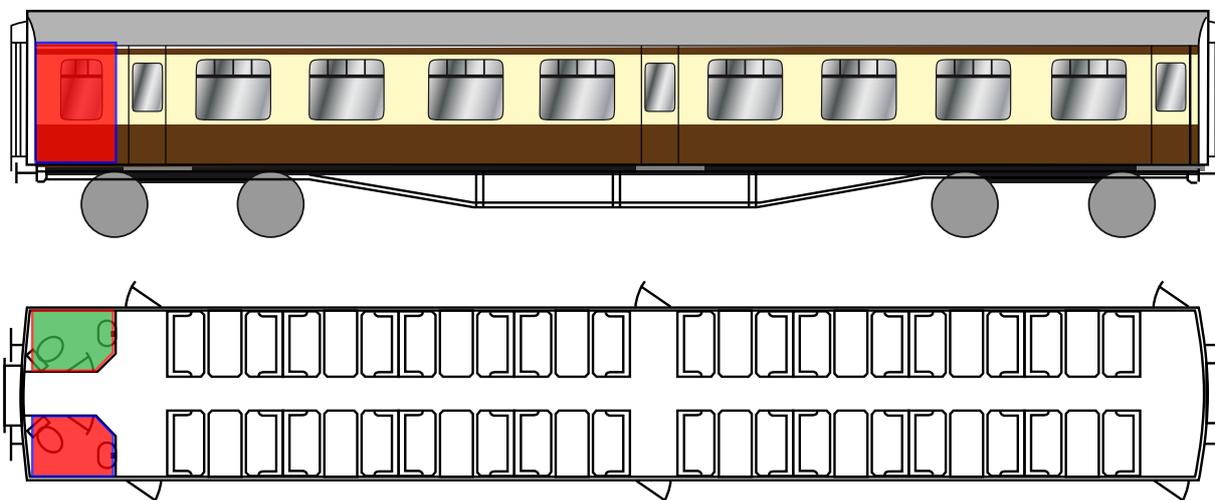
Figure 3: Side elevation and plan of the carriage showing the location of the toilet cubicle with the floor missing (green box). The toilet opposite (red box) was also out of use.

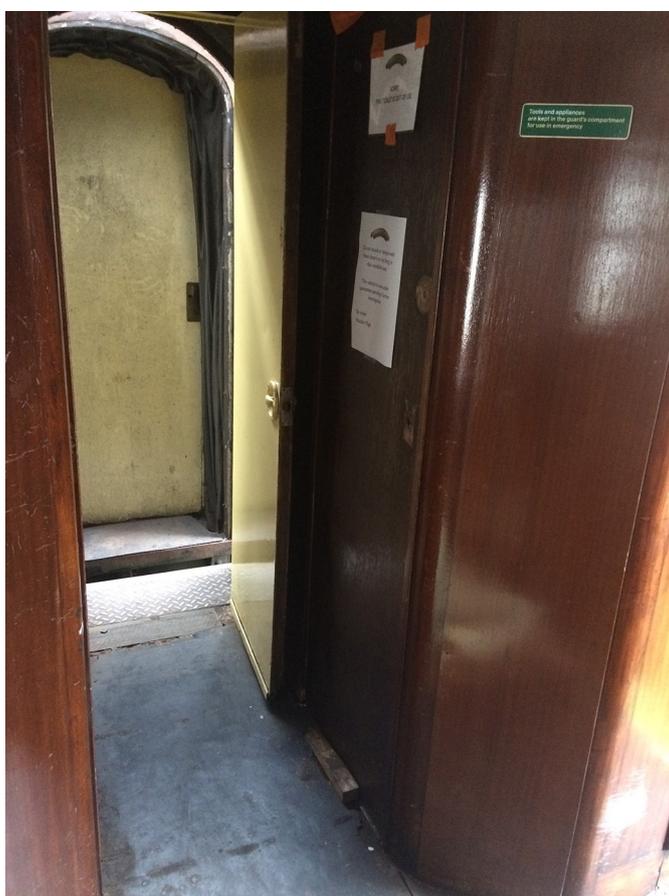
Figure 4: The outside of the toilet cubicle involved in the accident

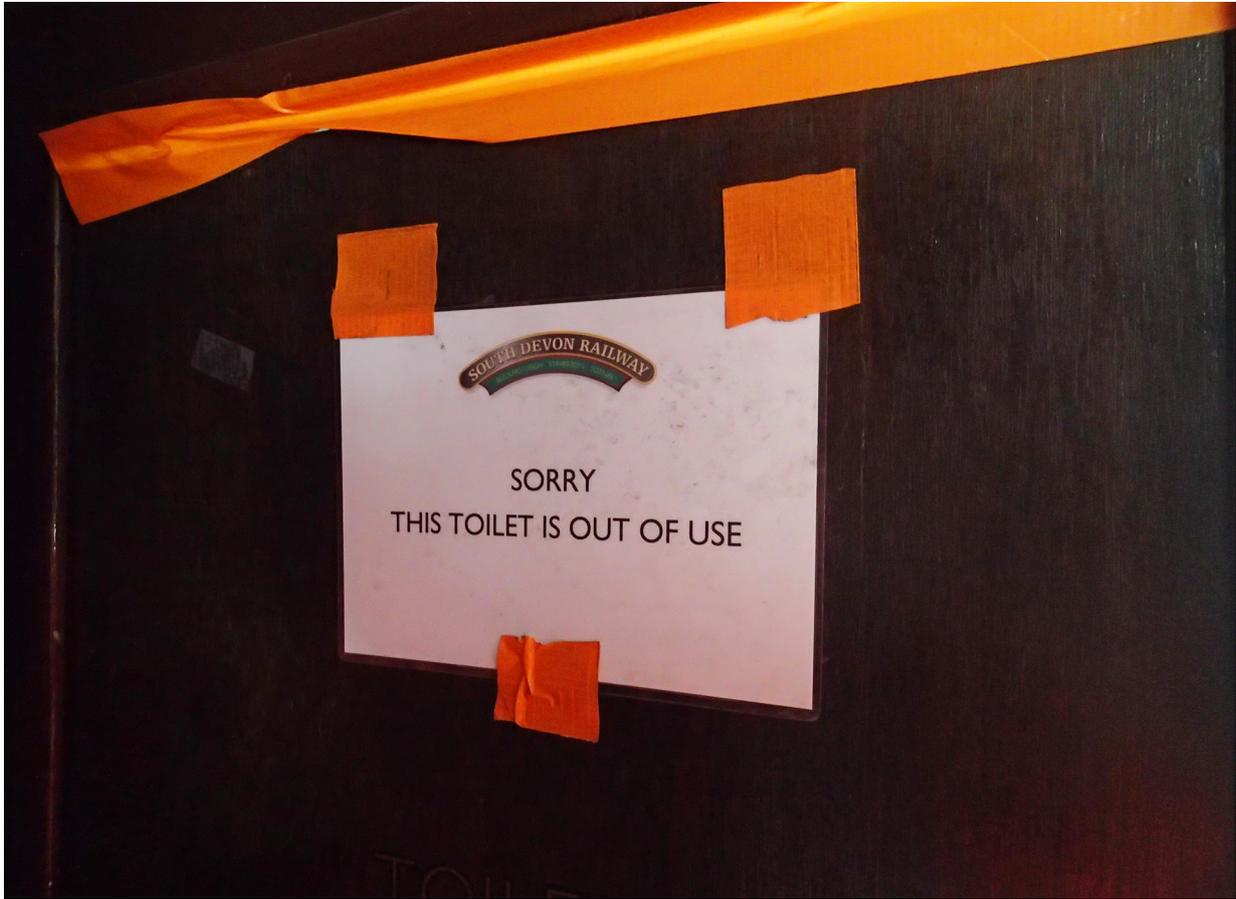
- 18 Although the toilet cubicle door was supposed to have been secured closed (see paragraphs 30 to 37), the child was able to enter the cubicle (it is not known whether he used the door knob or simply pushed the door). The door of the toilet cubicle opened inwards. The mother stated that the child fell forward towards the track, breaking his fall on the brake pipe. The mother reacted quickly and grabbed the child's arm, preventing him from falling onto the track (figure 8).

Figure 5: The 'out of use' sign and orange tape placed on the toilet cubicle door

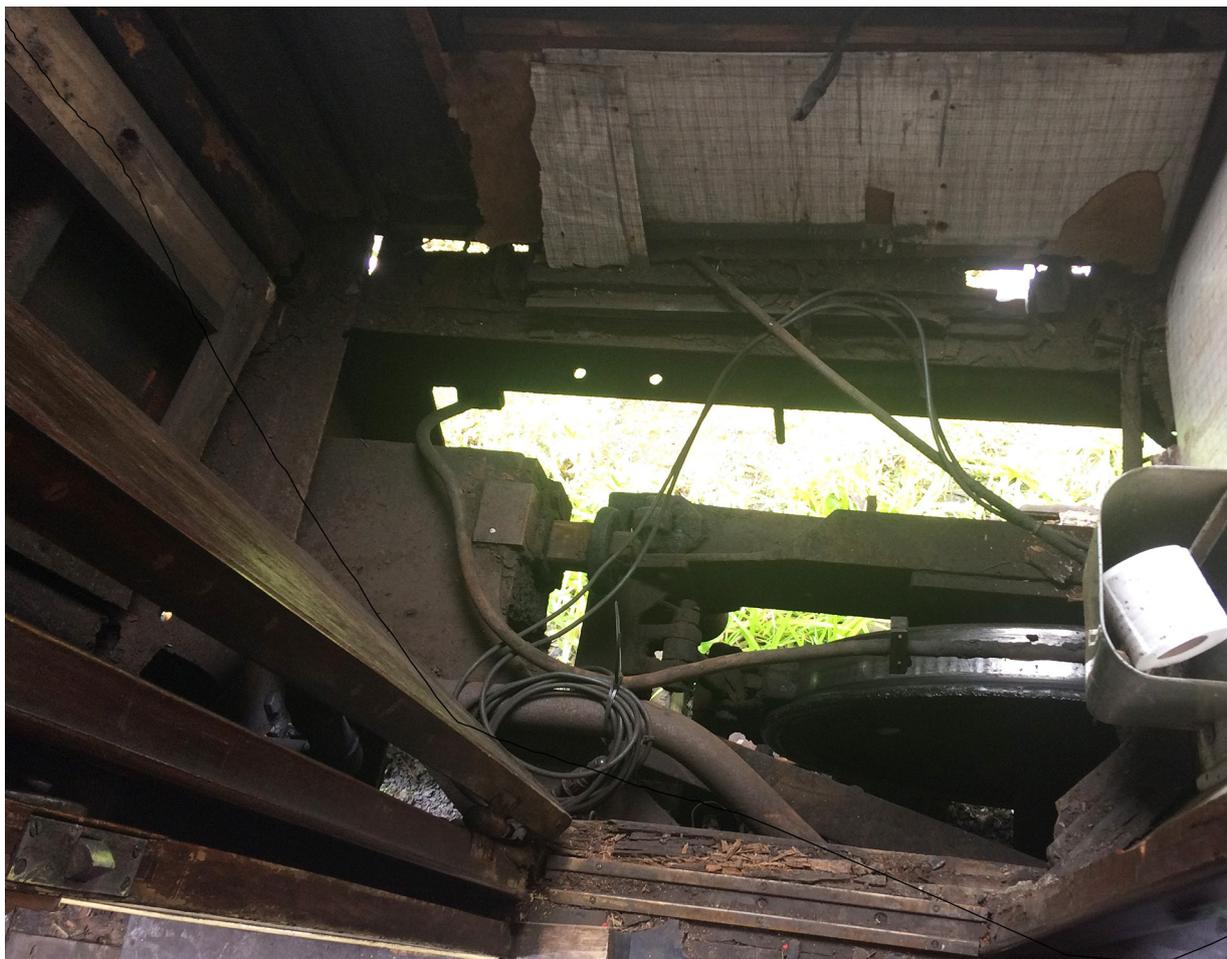
Figure 8: The interior of the toilet cubicle on carriage 4805

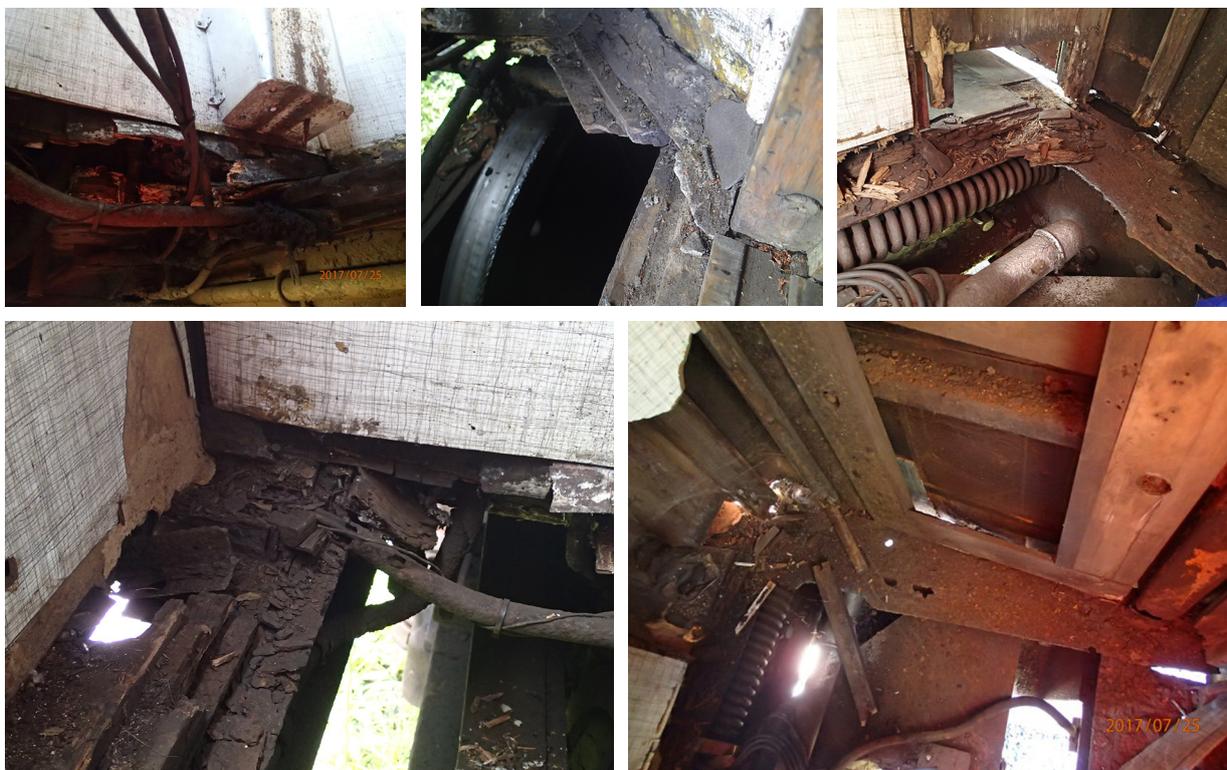
Figures 9 to 13: Details of the condition of the toilet cubicle on carriage 4805

- 32 The position of the fault in the brake pipe (between the toilet floor and structural member) meant the maintenance staff could not see the fault nor could they gain access to repair it. As, at the time, the SDR had no resources available to lift the carriage, the engineering manager and carriage and wagon superintendent decided the most effective method of gaining access to undertake the repair, was to remove the toilet cubicle floor. This was done on 2 April. Removal of the floor revealed a previously unsuspected level of corrosion of the underframe and wood rot in the toilet floor and partition walls (figures 9 to 13).

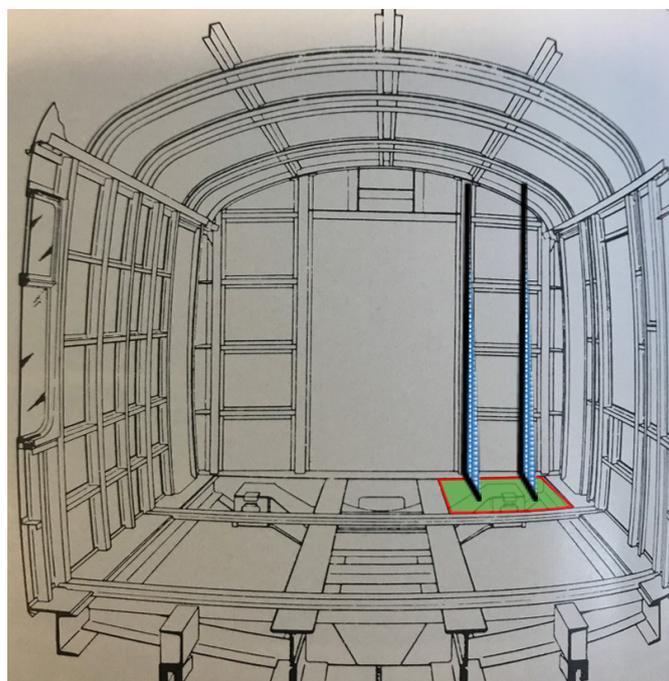
- 27 The area of the vehicle around the ends and the toilet compartments is prone to damage and deterioration caused by ingress of water through joints in the roof, via door and window openings, and spillage from the lavatory equipment, and from substances used to clean the toilet areas. These penetrate the floor and, if not dealt with effectively, may result in wet rot affecting the toilet floor and the partition wall bases, and corrosion of the underframe cross-members and bracing (figure 14).

Figure 14: Diagram showing the structure of the Mark 1 carriage. Probable areas where water may enter the carriage panelling are shown in blue. The green shaded area shows the location of the toilet floor (see figure 7). (Image courtesy of the Institute of Locomotive Engineers).

- 67 The investigation identified that water from the exterior of the carriage is likely to have leaked into the body causing the corrosion to the cross members of the chassis, and that the normal usage and cleaning of the toilet facilities would have contributed to the wood rot within the timber floor and panelling on the carriage (paragraph 27). At the time of the accident the SDR was in the process of building undercover storage facilities (see paragraph 90 (vii)) for its carriages, which were still being kept outside. When stored outdoors, normal weather conditions would have exacerbated the decay of carriage 4805.

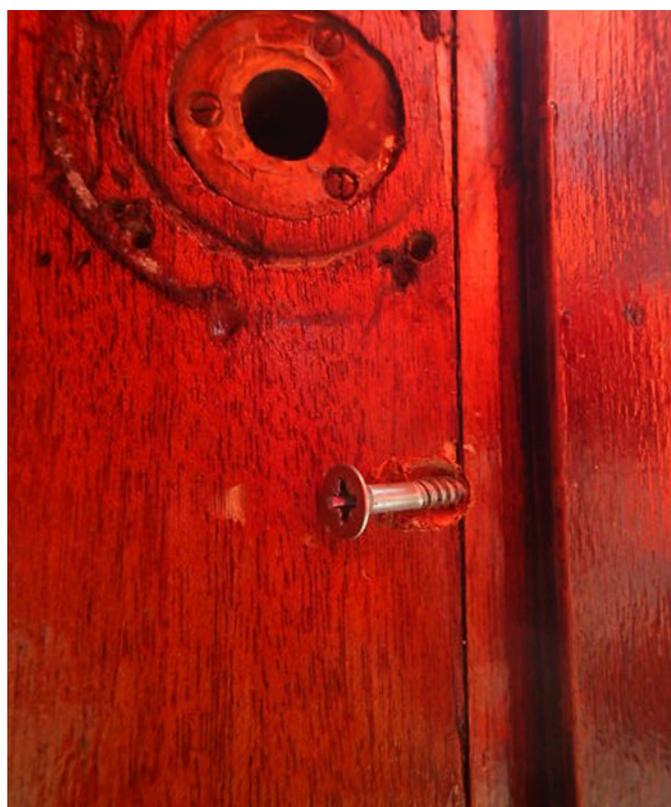
36 The method of securing the toilet door, with screws through the door into the frame (figure 15), had been previously used on another vehicle without incident in 2016. As a result, the engineering manager and carriage and wagon superintendent believed that this method was adequate as a temporary measure. An 'out of use' sign was placed on the door and orange tape was attached to the door frame surround. The toilet cubicle door was inspected by the carriage and wagon superintendent and the engineering manager, and the railway manager was advised that the carriage could be put back into service.

Figure 15: The method of securing a toilet cubicle door using screws through the door and frame

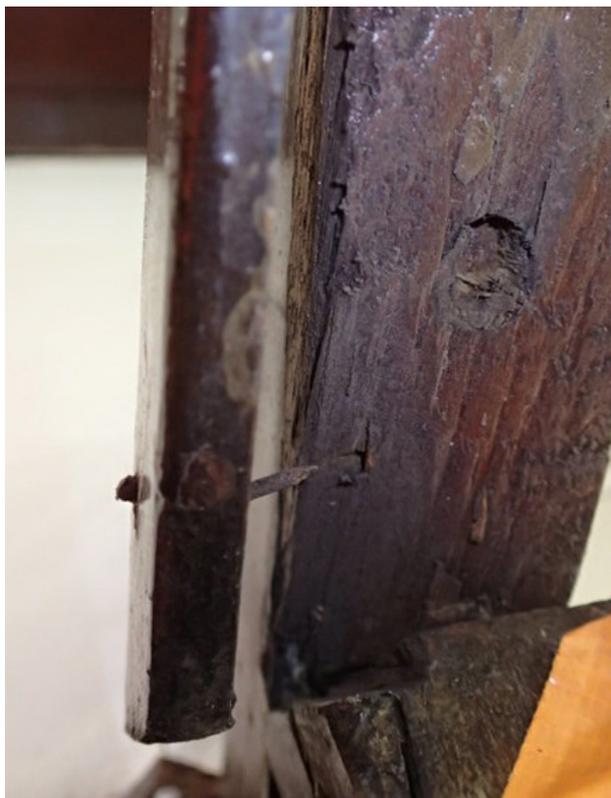
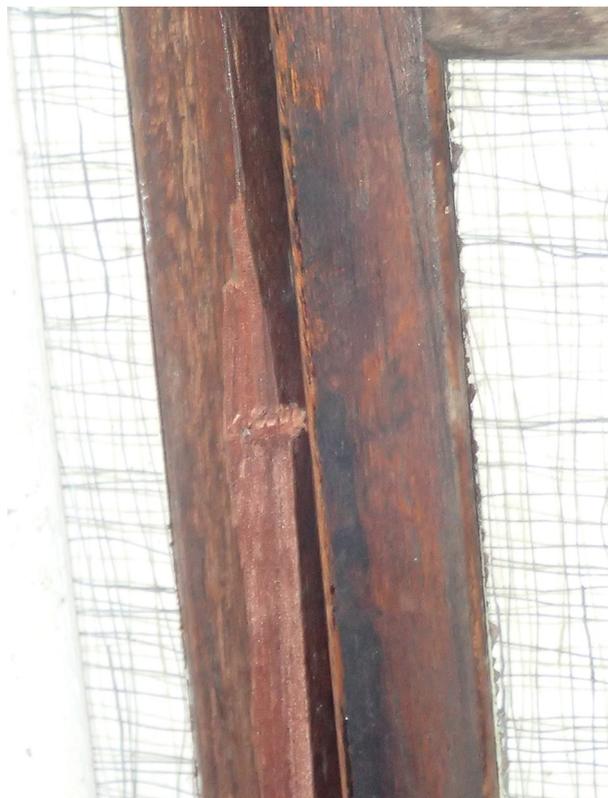
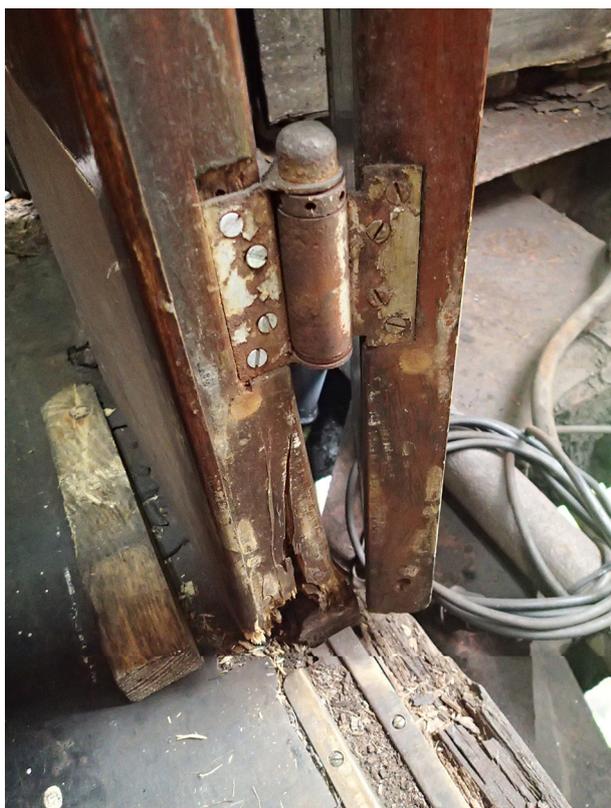
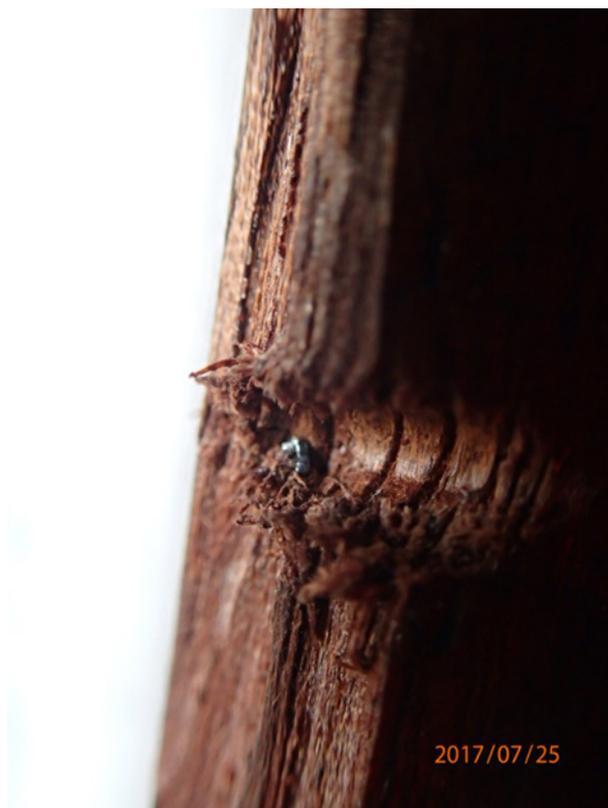
- 37 The RAIB's examination of the toilet cubicle and the damage to the door and the frame, after the accident and the subsequent repairs, found that the screws were inserted through the door frame and door at an angle (figures 16 to 19). Although the physical evidence is not conclusive, the RAIB considers that the screws could have become ineffective as a result of one or a combination of the following factors:

- a. The door was accidentally or intentionally forced open, resulting in damage to the door frame, allowing the screws to become loose or fall out.
 - b. The removal of the toilet floor and the decay at the base of the partitions resulted in a loss of integrity of the structure of the toilet cubicle, because the floor was no longer tying the partition walls together. This meant the structure was no longer rigid, and the movement of the train may have resulted in the door frame and the door moving relative to each other. This movement caused the screws securing the door to become loose, fracture or fall out.

Figures 16 to 19: The damage to the toilet cubicle frame and door of carriage 4805
