# ***AAIB Bulletin***

***3/2018***

<b>Aircraft Type and Registration:</b>	Cessna 402C, N603AB
<b>No &amp; Type of Engines:</b>	2 Continental TSIO-520-VB piston engines
<b>Year of Manufacture:</b>	1997 (Serial no: 402C0603)
<b>Date &amp; Time (UTC):</b>	11 February 2017 at 2004 hrs
<b>Location:</b>	Virgin Gorda Airport, British Virgin Islands (BVI)
<b>Type of Flight:</b>	Commercial Air Transport (Passenger)
<b>Persons on Board:</b>	Crew - 1                      Passengers - 8
<b>Injuries:</b>	Crew - None                      Passengers - None
<b>Nature of Damage:</b>	Extensive damage to the landing gear and aircraft structure
<b>Commander's Licence:</b>	Commercial pilot's licence (FAA)
<b>Commander's Age:</b>	29 years
<b>Commander's Flying Experience:</b>	5,458 hours (of which 809 were on type) Last 90 days - 225 hours Last 28 days - 80 hours
<b>Information Source:</b>	AAIB Field Investigation

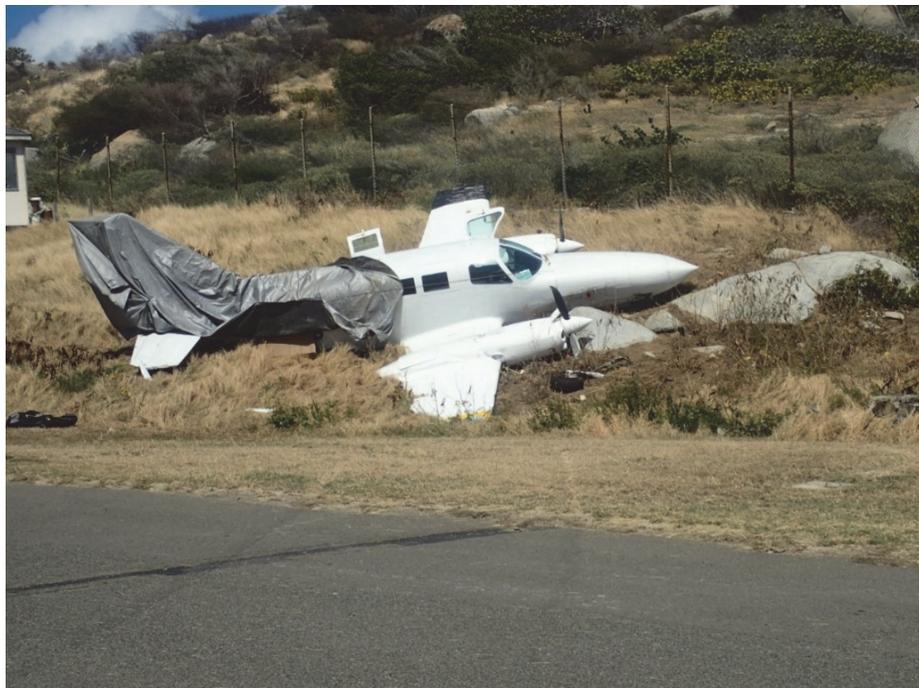
**Figure 2**

In the accident of 11 February 2017 the aircraft came to rest on a grassy slope within the airport perimeter and adjacent to the northern edge of the tarmac apron (Figure 2).

General view of the accident site

Distinct tyre marks from all three wheels were visible across the apron and grass and this indicated heavy sideward loading as the pilot tried to turn to avoid over-running into the sea. There was no evidence of locked brakes, such as pronounced skid marks or marks caused by loose stones dragged across the surface.

As the aircraft traversed the grass it struck a frangible runway sign before passing through a low retaining wall. The nose landing gear collapsed and the right main landing gear was broken off. After encountering rising ground and colliding with a group of substantial rocks, the aircraft slewed to rest through about 45°.

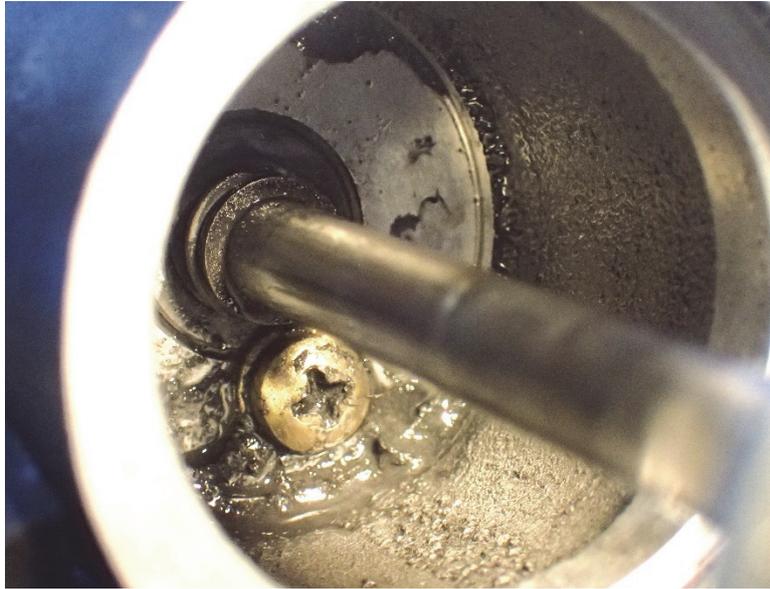
**Figure 4**

Debris and contamination inside the oil reservoir was analysed and identified to be general environmental dirt and aluminium flakes (Figure 4).

Debris in the left master cylinder oil reservoir

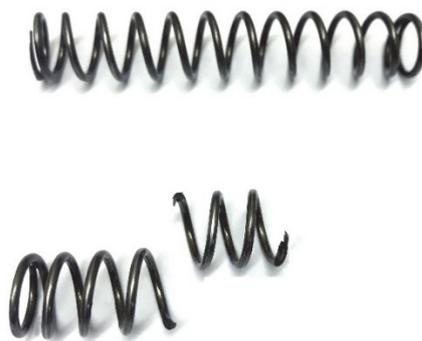
**Figure 5**

The piston rod and return spring were removed, revealing two pieces of a broken return spring in the lowest section of the housing bore. The broken pieces, when placed end to end, had a combined length that was approximately half a complete spring (Figure 5). The coil was wound in the opposite direction to the intact spring.

The intact piston return spring and the remains of the broken spring

The omission of the rubber ring seal from the left master cylinder would have had no effect on braking performance but was indicative of a shortfall during maintenance. The remains of a broken spring in the left master cylinder was unlikely to have interfered with system operation but they also were indicative of a shortfall during maintenance. The operator did not know when the spring failure occurred and considered the omission to remove the broken parts to be an error on their part.

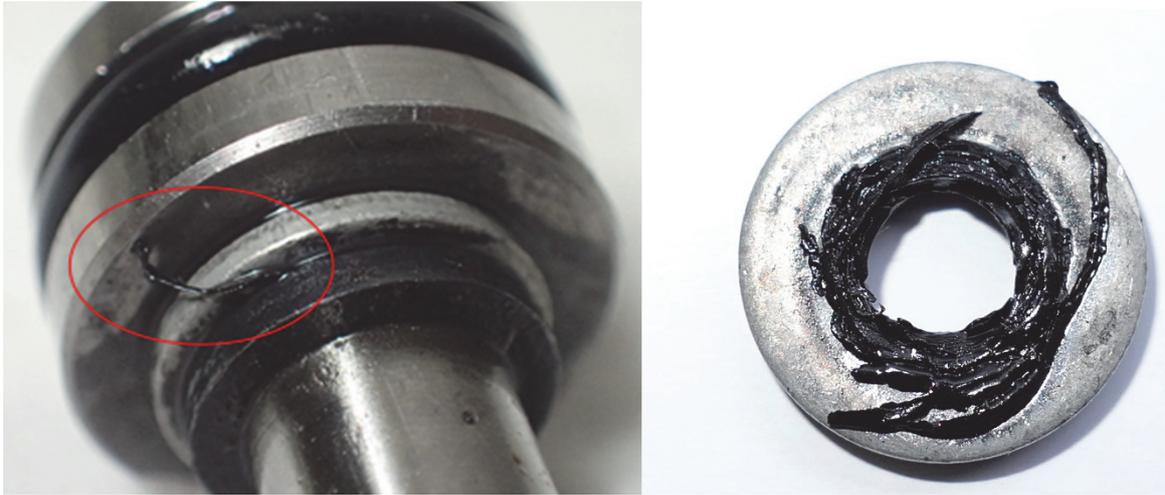
**Figures 6a and 6b**

Examination of the piston rod revealed debris trapped between the stat-o-seal and the washer (Figure 6a). This was subsequently identified to be part of the stat-o-seal, which was in poor condition (Figure 6b).

Trapped seal debris and general condition of the stat-o-seal

The stat-o-seal in the left master cylinder was degraded to the extent that it was breaking apart and its ability to create a reliable, effective seal would be compromised. A leak past

the stat-o-seal will have an adverse effect on brake performance and, in the worst-case scenario, will result in the brake pedal bottoming and total brake failure on the affected system.

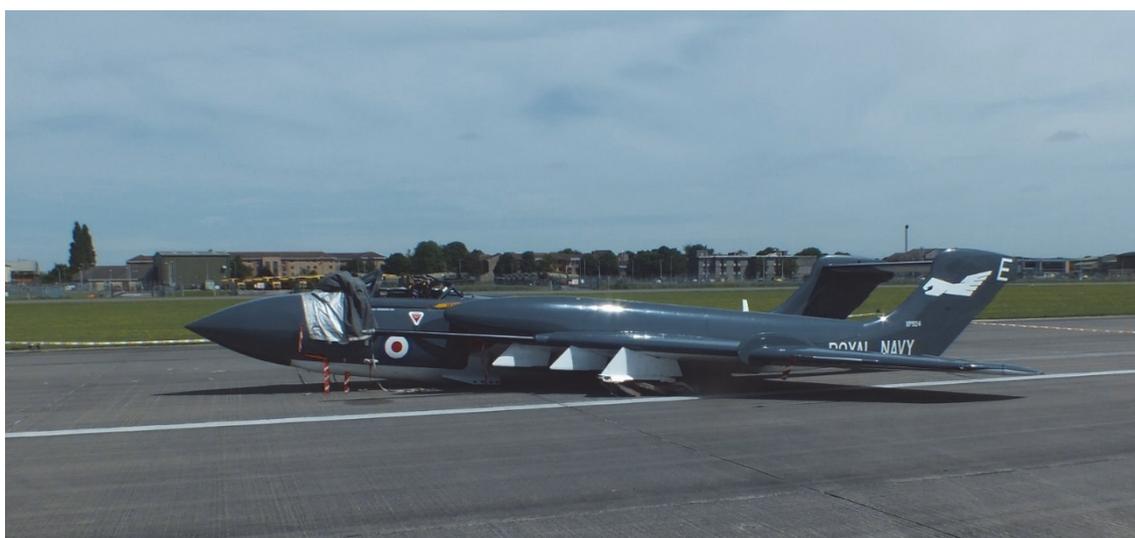
There was no fire or fuel leakage but the aircraft had sustained significant damage to its fuselage underside, particularly in its engine bay area including the accessory gearbox casing. Figure 1 shows the aircraft on the runway.

**Figure 1**  
G-CVIX on the runway prior to recovery

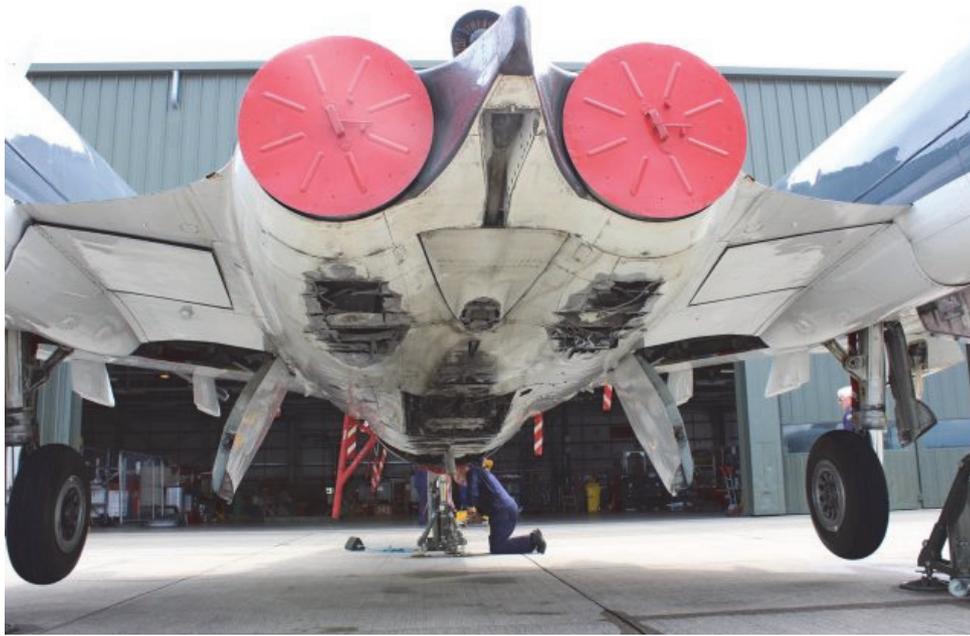
**Figure 2**

The surface of the runway had caused severe abrasion through the aluminium alloy fuselage skin, stringers and frames and into the casing of the accessory gearbox, to the extent that some of the gear train was exposed. The reinforced section, which attaches the drop tanks to the pylons, was all that remained of the left and right drop tanks still attached the aircraft. The canopy and its frame sustained damage consistent with being ejected from the aircraft whilst still at speed and landing behind the aircraft. There was no fuel leakage or fire during the landing. Figure 2 shows the damage to the underside of the aircraft.

Damage to the underside of G-CVIX.

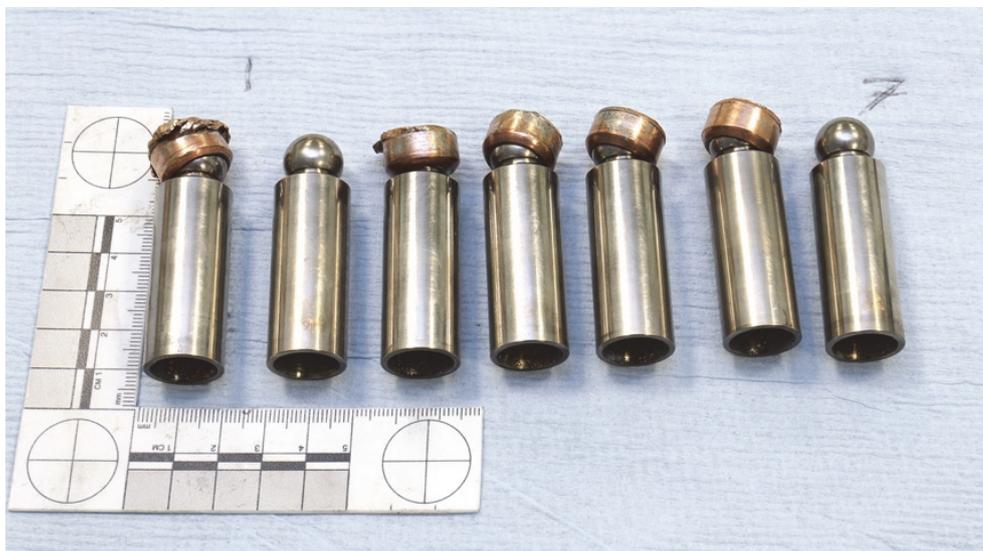
**Figure 4**

synchronising plate, were free to move and were undamaged. The servo piston and linkage to the swashplate was also seized. All the piston head collars had fragmented leaving just the ball and socket at the top of each piston (Figure 4).

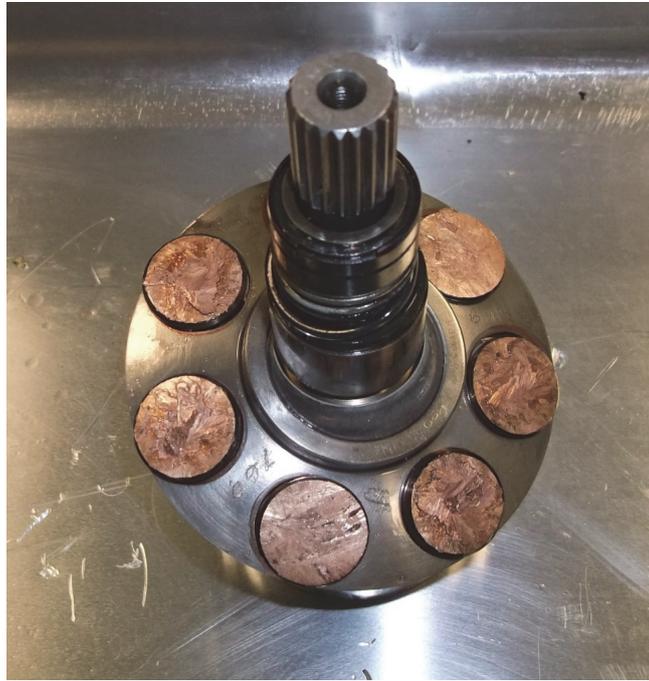
**Figure 5**

where they contacted the swashplate but were otherwise intact and correctly positioned in the synchronising plate. The servo piston was correctly attached to the swashplate and free to move. Figures 5 and 6 show the Green pump components.

Green pump piston heads and synchronising plate

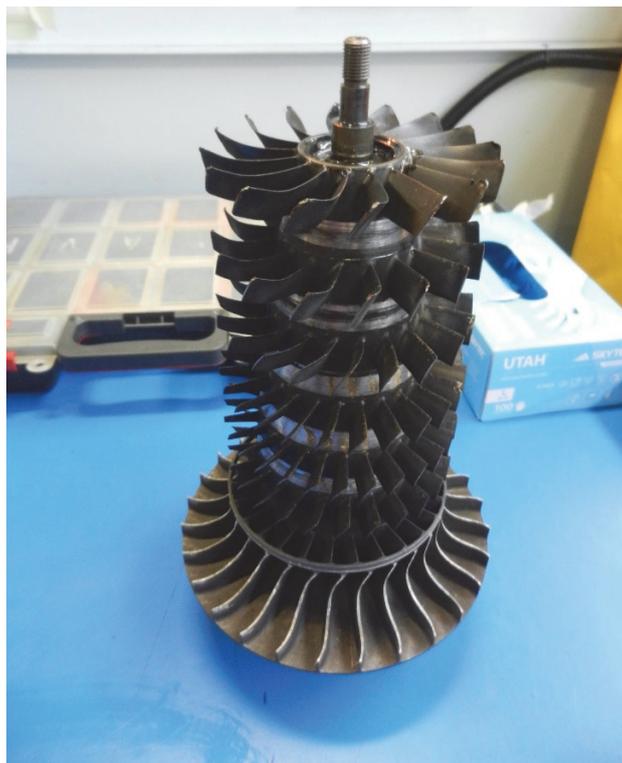
**Figure 8**

During the removal of the compressor from the gearbox, it was found that the retaining feature of the impeller drive coupling shaft had failed, allowing the shaft to be released. Examination of the remains of the shaft showed evidence of bearing impact marks on the shaft consistent with forces experienced during the impact sequence. Disassembly of the compressor and impeller module revealed that all the compressor vanes and stators were present. However there was clear evidence of rotational damage to the forward stages of the axial compressor (Figure 8), with associated loss of the compressor abraidable liner. There was also evidence of rotational contact between the impeller and the impeller shroud.

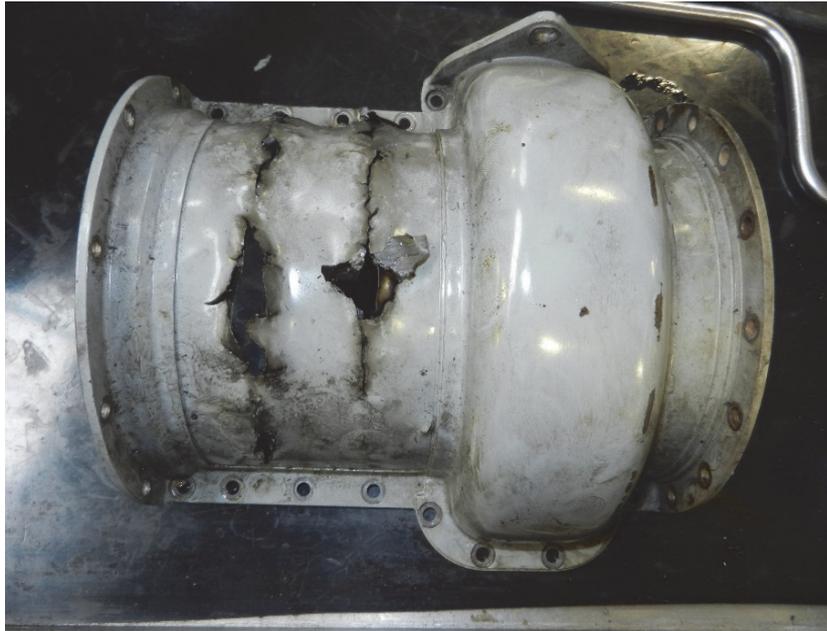
**Figure 9**

The compressor case exhibited multiple penetrations (Figure 9) typical of significant axial compressor blade release.

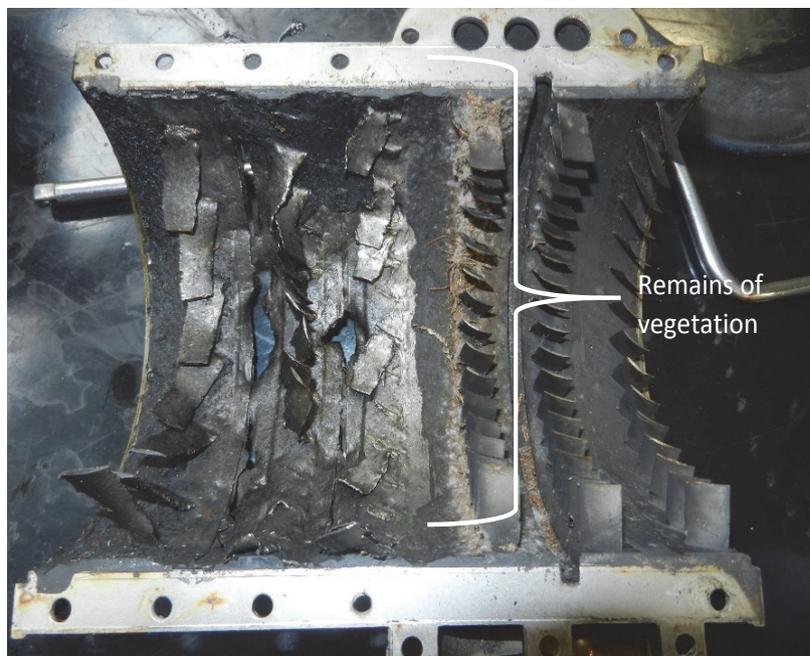
**Figure 10**

Disassembly of the compressor assembly revealed significant damage to all the stator vanes in the first three stages of the axial compressor, and the remains of vegetation was observed on the fourth stage stator vanes (Figure 10).

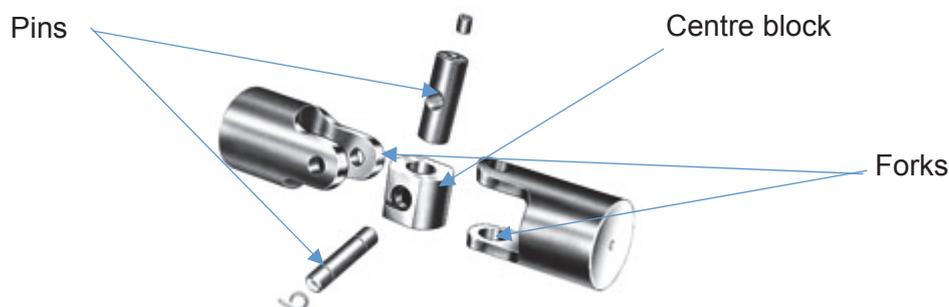
**Figure 2**

It was not possible to carry out any investigation of the aircraft's instrumentation due to impact damage. Examination of the aileron control circuit confirmed that it had been correctly rigged but the universal joint within the control circuit had fractured and the centre block was missing, Figure 2.

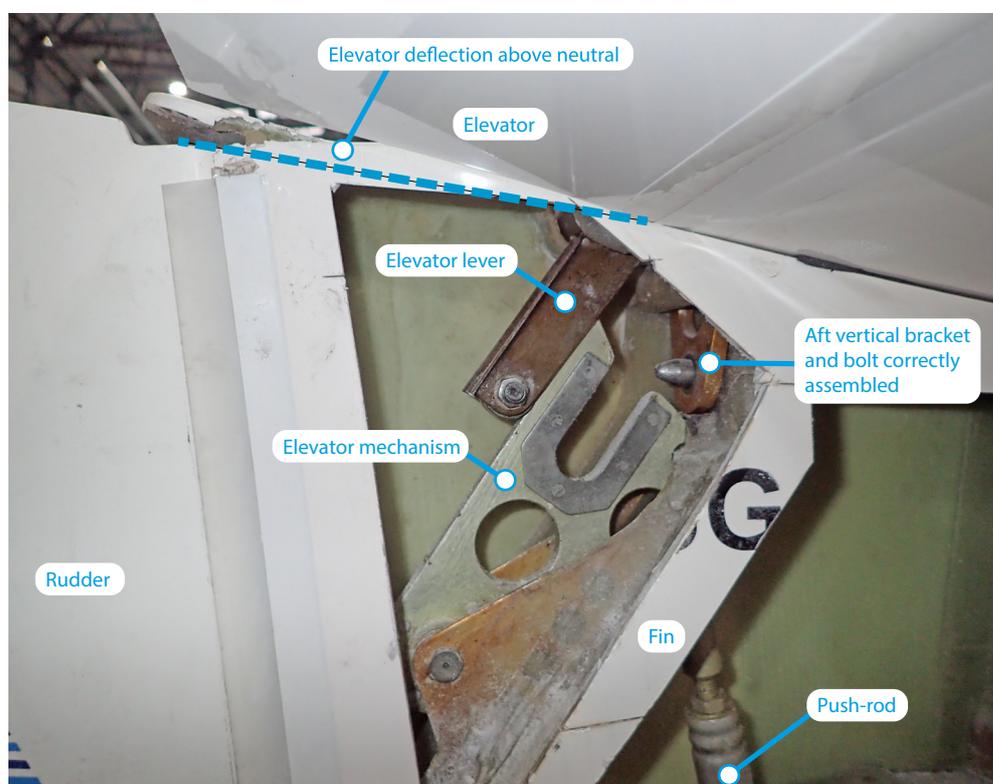
**Figure 6**

The tailplane was correctly seated on top of the tail fin with no obvious gap between the tailplane and the fin. Access panels were cut in the tail fin to inspect the elevator control connection. It was observed that the tailplane structural connections were correctly made, and the securing bolt correctly inserted. However, the elevator lever was not engaged in the elevator mechanism, but was instead sitting aft of the mechanism (Figure 6).

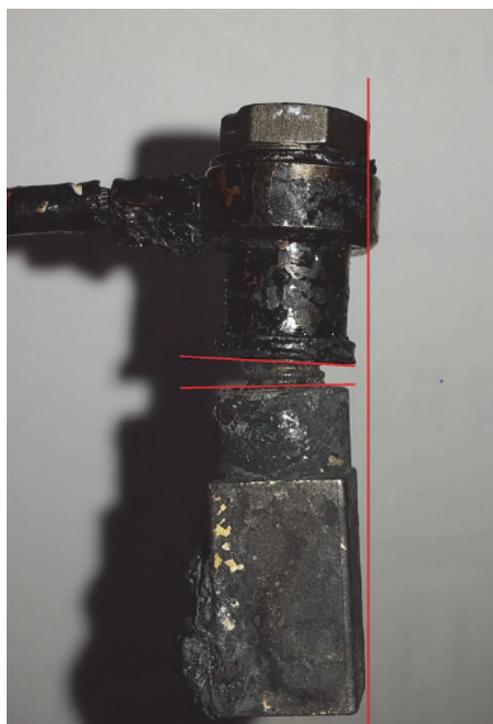
**Figure 1**

Following removal, the operator initiated a more detailed examination of the affected parts. It identified that the terminal lug was not parallel to the terminal block; this could allow the mounting screw to become loose, creating a high resistance connection with the potential for overheating, Figure 1. No reason for the incorrect alignment was identified.

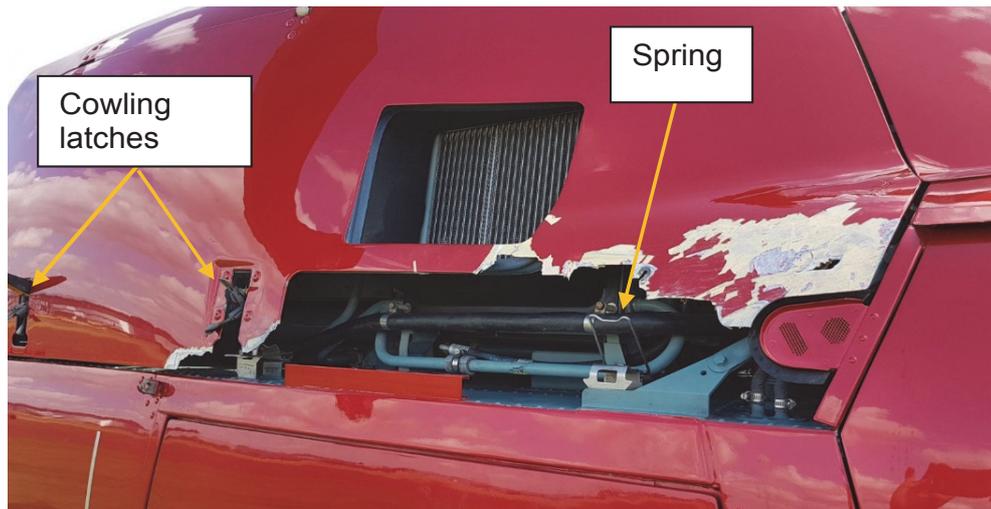
**Figure 1**

After flying for approximately one hour the pilot returned to land. During the flare he became aware of an unusual noise and landed immediately. Examination of the helicopter showed that the lower forward edge of the right engine cowling was damaged, the forward cowl latch assembly was missing and the centre latch had been damaged (Figure 1). Damage was also observed on the inboard sections of all the main rotor blades.
