AAIB Bulletin

4/2018

Published 13 April 2018

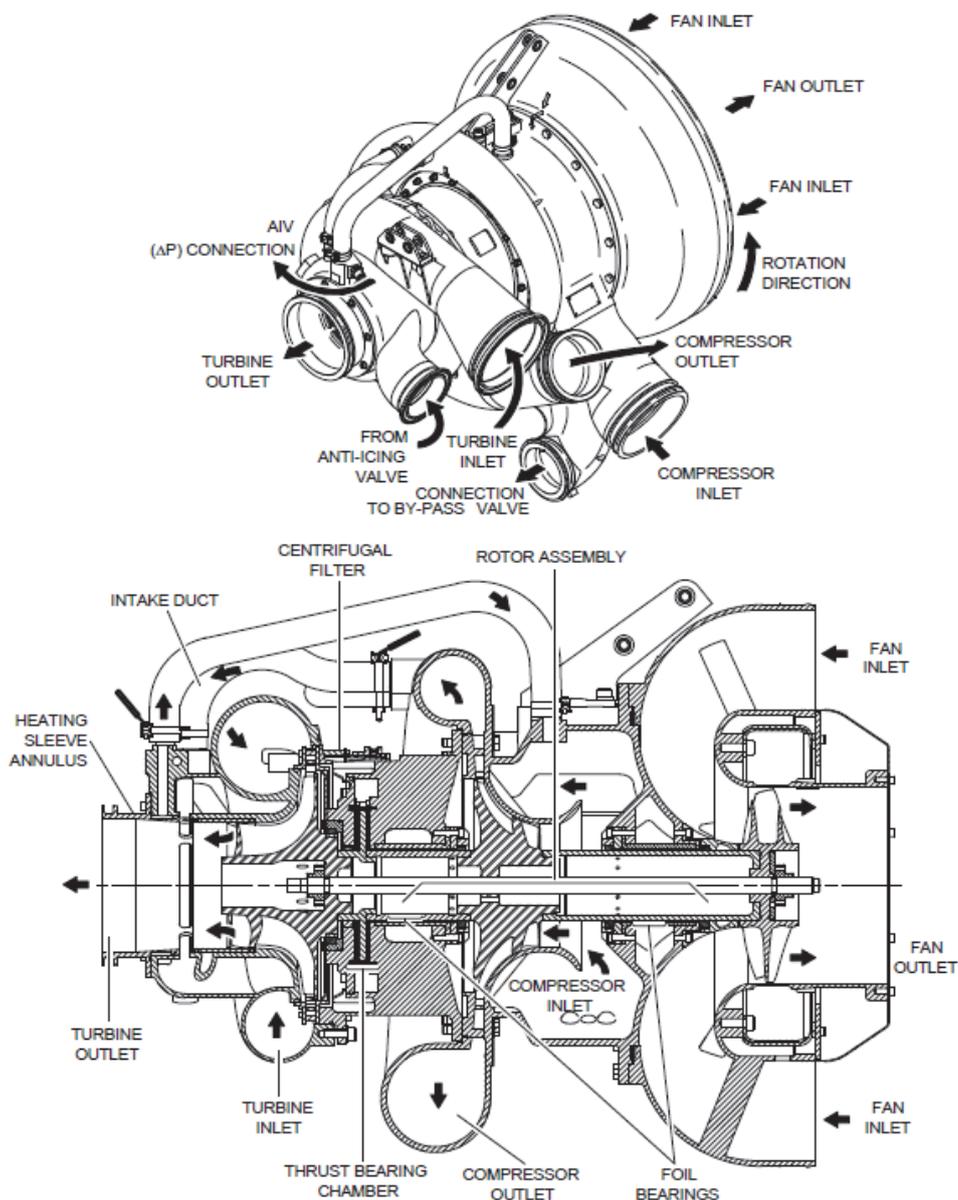
Figure 2
Schematic of ACM

was tested faulty with rotary body seized'. The repair documentation revealed that the turbine wheel was found damaged by friction on the turbine scroll and the rotary tie rod was also found damaged by friction, so the whole rotary body was replaced. The fan housing was not replaced, which indicates that the fan wheel had probably not touched the housing, and so the fan wheel had probably not been damaged.

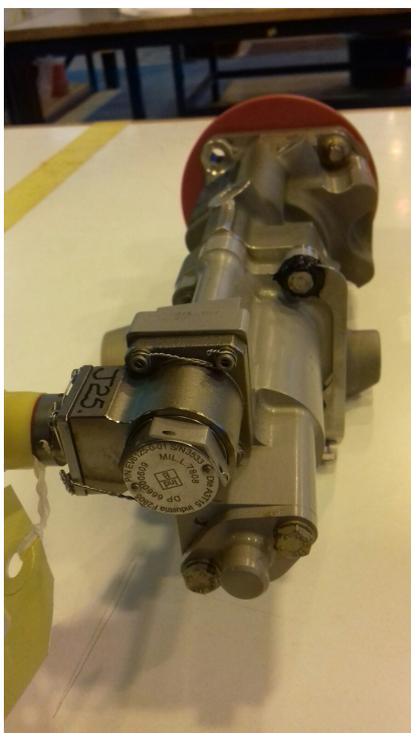
Figure 1

During examination of the No 2 engine on G-PRPH after the landing, it was observed that the propeller overspeed governor ground reset solenoid valve cap had separated from the body of the unit. Engine oil had therefore leaked under pressure until most of the system contents were lost.

General view of propeller overspeed governor unit

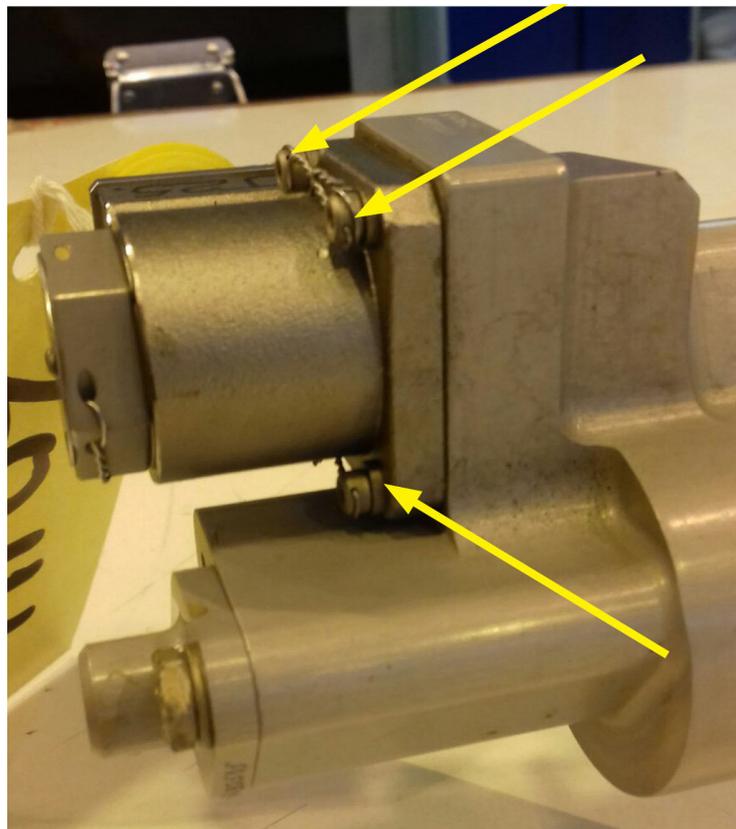
Figure 2

The No 2 engine overspeed governor unit was removed from the reduction gearbox and sent to the AAIB. Examination showed that the cap over the ground reset solenoid had detached as a consequence of failure of the four ultra-high tensile steel bolts securing it to the body of the governor unit (Figure 2). The hydraulic nose had fractured approximately in the plane of the bolt failures. The component was examined by the manufacturer in the presence of the AAIB. It was noted that considerable fretting was present on the shim under the end cap and on the mating faces. The separated heads of the four bolts remained joined in pairs by wire locking and were recovered.

The failed bolts were forwarded to a specialist laboratory for examination. One bolt showed evidence of predominant fatigue failure, a second started as fatigue then changed to serial overload. The third started in fatigue in the reverse direction to the previous two, whilst the fourth was a complex fracture, probably indicating this was the last of the four to fail. Attempts at fatigue striation counting indicated that one of the bolts had suffered in excess of 7,000 cycles to failure. The numbers of cycles to initiation are not known.

Arrows showing position of bolt group which failed on G-PRPH

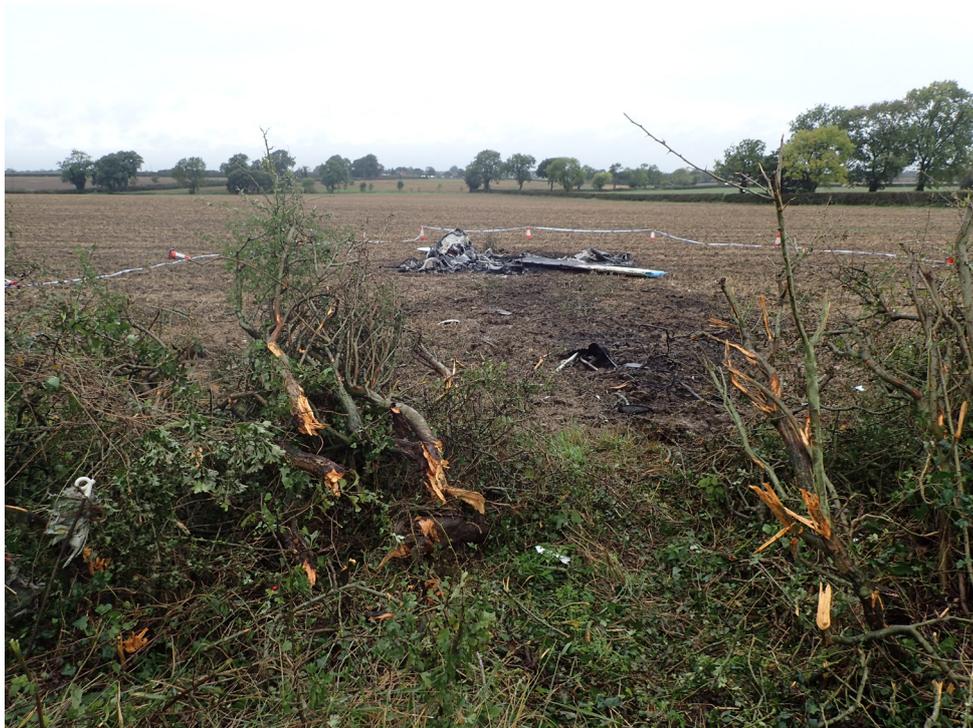
Figure 1

The internally mounted flap drive crosstube and its hinge attachments were found close to the hedge suggesting they had become detached as the aircraft passed through the hedge; the first signs of fire were visible on the ground in the vicinity. The engine and firewall forward section of the fuselage remained upright but the remainder of the aircraft was found inverted and the fuselage was substantially disrupted in the cockpit area; both doors were present. A post-impact fire, which burnt for over 30 minutes, consumed or severely damaged large parts of the aircraft including almost all the fuselage and empennage, but also the inboard parts of the wings and flaps.

General view of accident site from the end of the runway through the hedge

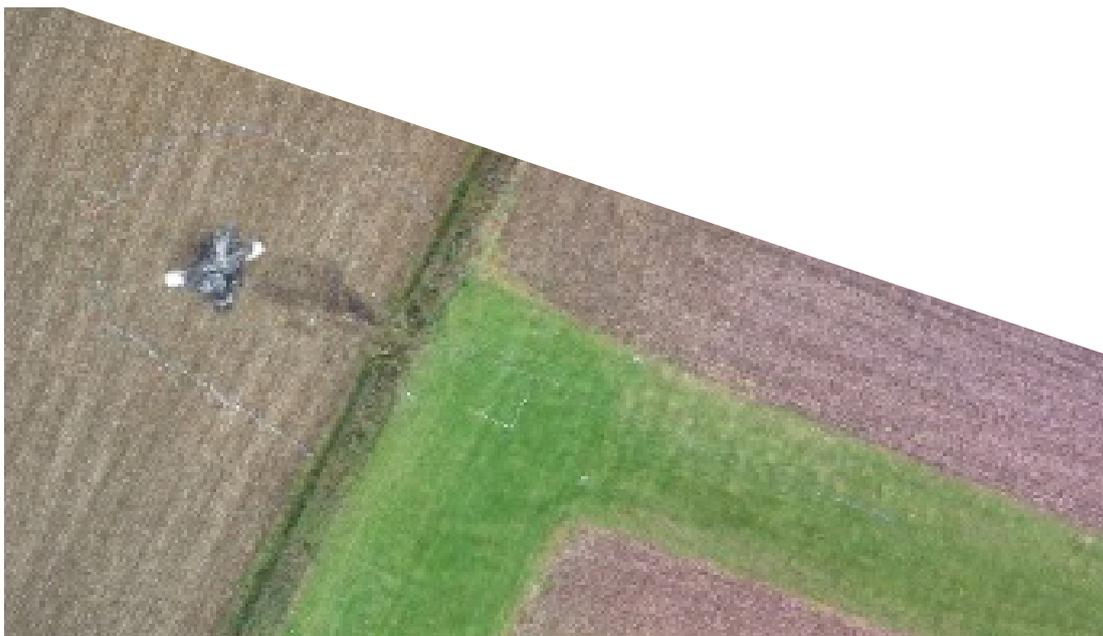
Figure 2

General overhead view of the accident site (from AAIB UAS)

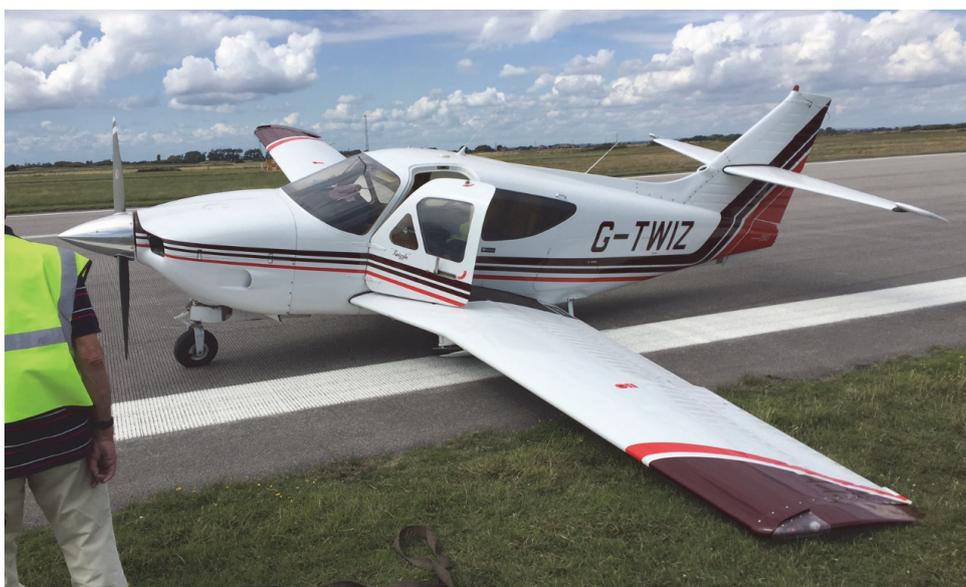
Figure 1

left MLG leg folded inwards. The commander turned the fuel selector and battery master switch to OFF before the aircraft stopped, and he guided the aircraft to the grass to the left of the runway. Once the aircraft came to rest, the commander and his passenger exited the aircraft without difficulty. The aircraft sustained damage to the left wing and left cabin access step. During the recovery of the aircraft it was discovered that the left MLG upper side-brace had fractured, preventing the left landing gear leg from retracting, or locking in the extended position.

G-TWIZ following the collapse of the left MLG (photo courtesy James Giller)

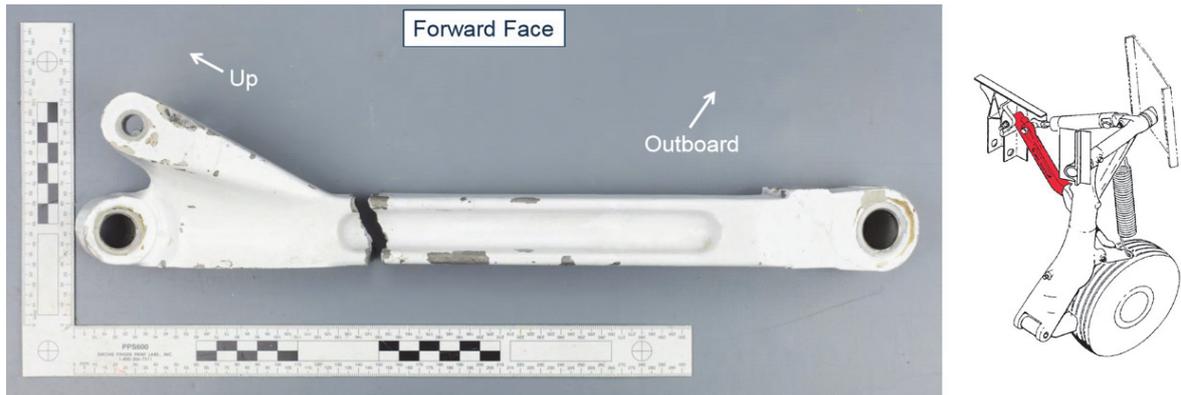
The fractured landing gear upper side-brace, part number 45304-1, was removed from the aircraft and subjected to metallurgical examination.

Figure 2
Fractured left MLG upper side-brace

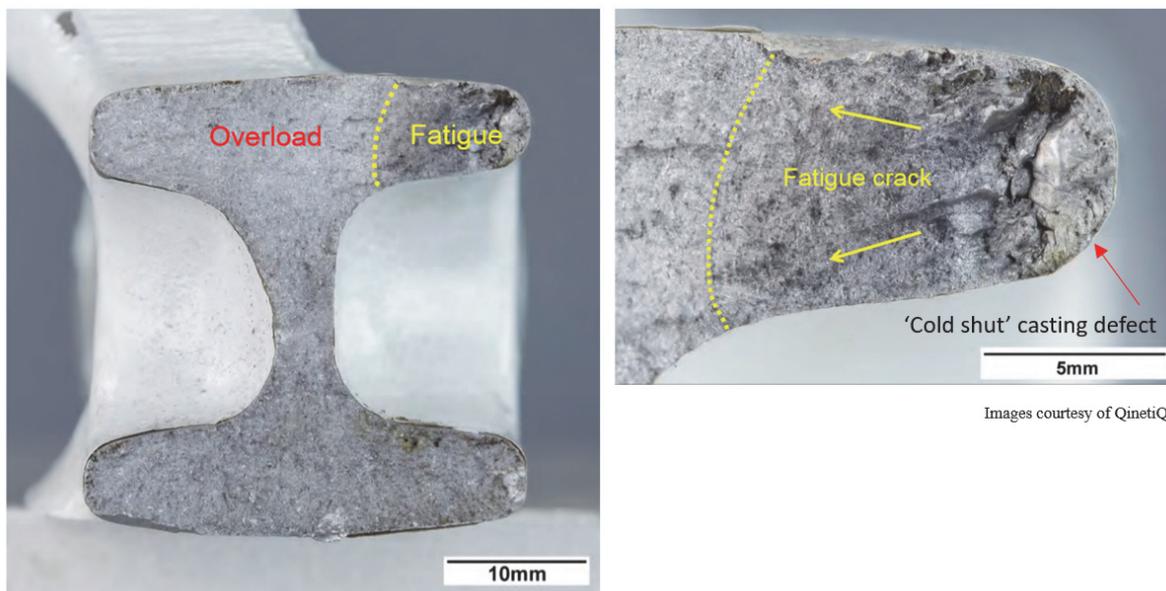
Ink markings on the surface of the casting, beneath the external paint layer, indicated that it had been manufactured in October 1977. The metallurgical examination indicated that a fatigue crack had initiated at the location of a 'cold shut'¹ casting defect. The fatigue crack and casting defect extended to approximately 14% of the cross-sectional area of the side-brace section. The remainder of the fracture surface consisted of ductile overload and no crack arrest marks were observed. The metallurgical analysis also revealed the presence of additional internal and surface-breaking casting defects and sand particles within the casting, adjacent to the fracture surface.

Figure 3
Casting defect and fatigue crack region

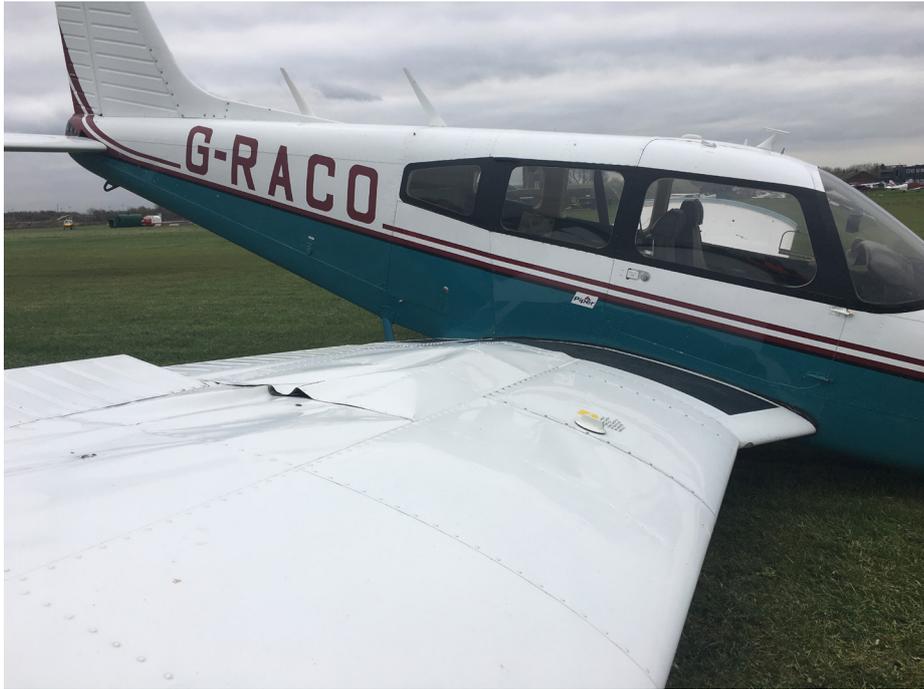
Figure 1

Deformation in wing around main undercarriage mounts

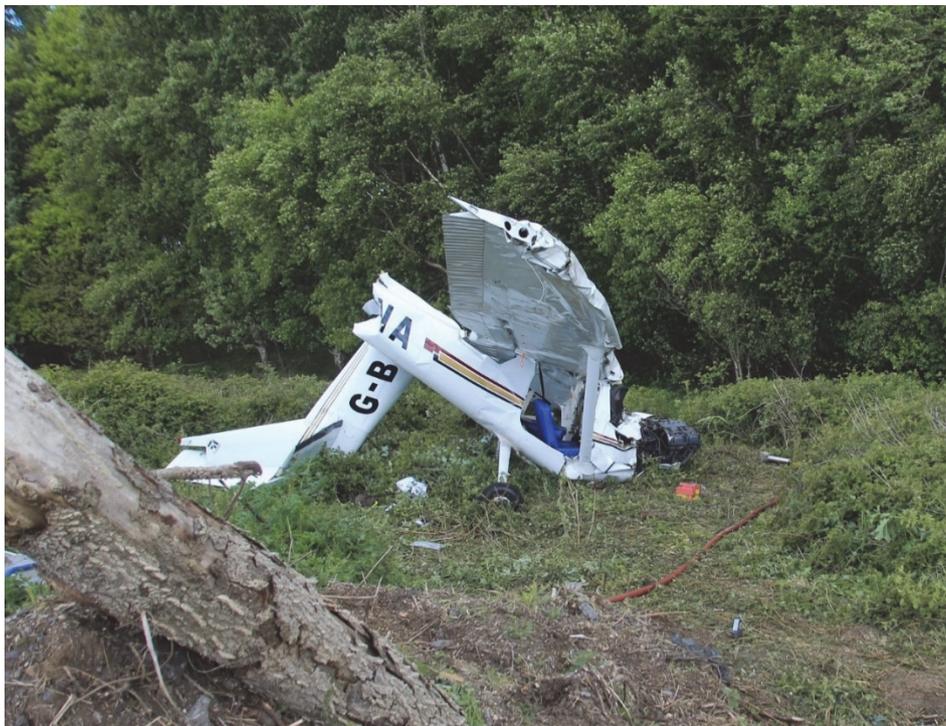
A loss adjustor attended the accident site (Figure 2). He reported that the aircraft appeared to have hit the ground vertically in a steep nose-down attitude. He checked the flight controls and did not find any defects. The left flap was down, the right flap was up, the flap selector was up but the flap indicator showed 30°. However, the flap lever could have easily moved in the impact sequence and the mismatch between the flap indicator and the right flap showed that the flap mechanism was disrupted and therefore this indication could not be relied upon as a valid pre-impact position. If the flaps had been asymmetric

as found it would have caused a right roll instead of the left roll that occurred. Therefore it is highly likely that the flap mechanism was damaged in the impact.

Figure 2
G-BHNA accident site

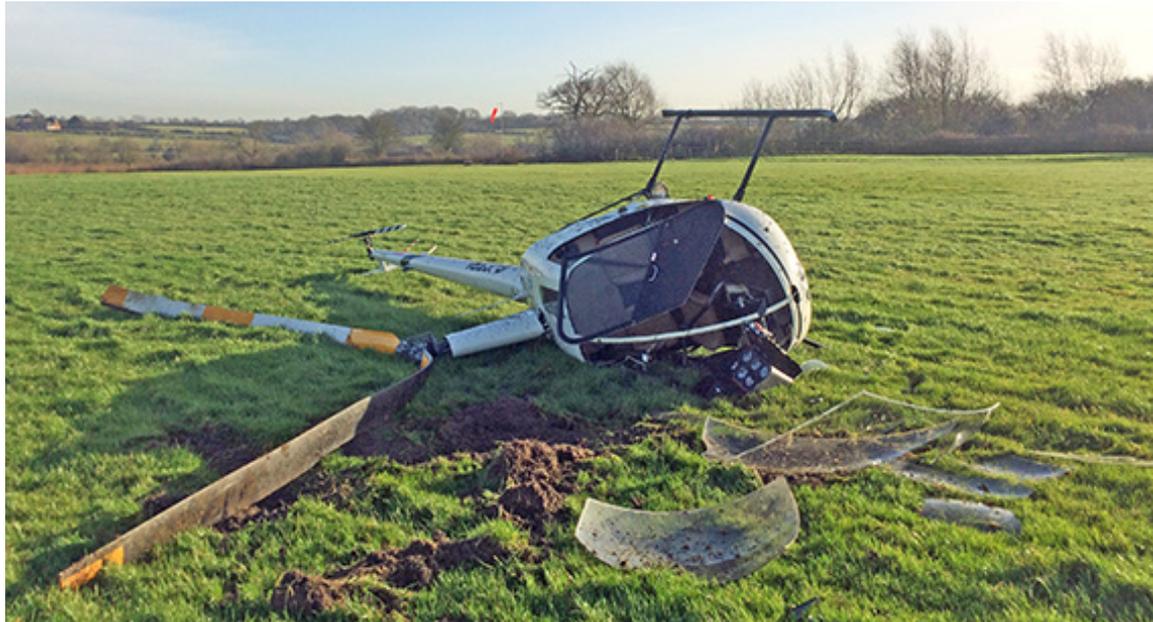
Figure 1

G-CTRL after the accident with the front transparencies broken and the left door open

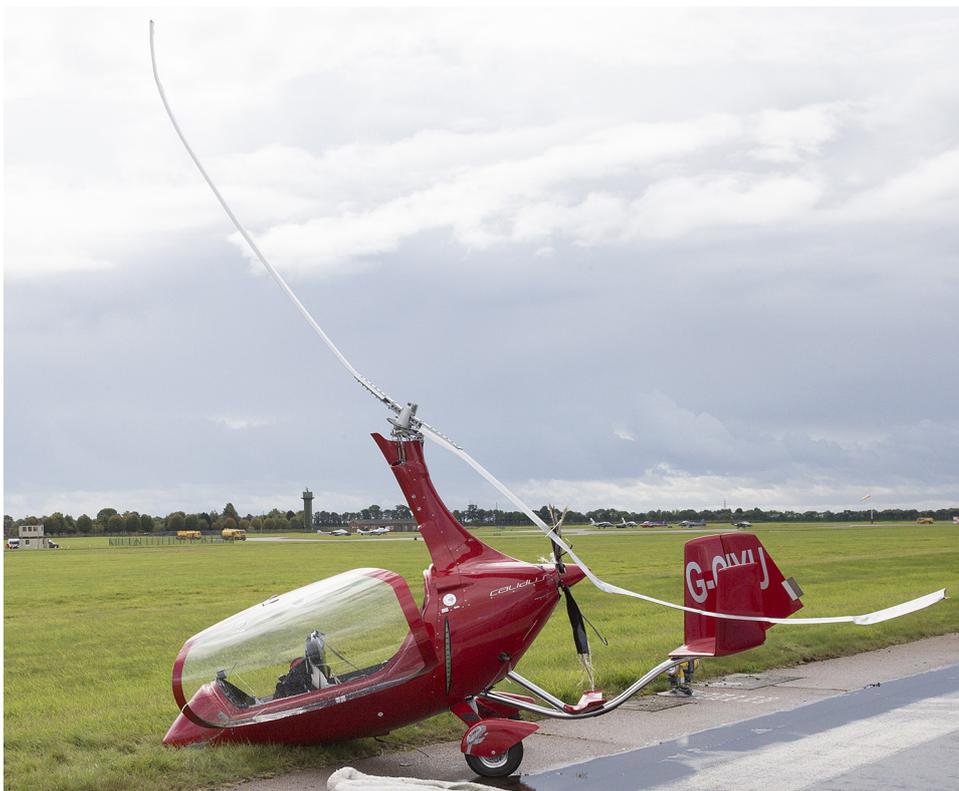
Figure 1

G-CIYU after righting and with the canopy open
(Photograph MoD/Crown Copyright)
