Urgent Safety Advice 02/2018: Safety of the line after engineering work

Published 19 March 2018

Lines handed back for traffic in an unsafe condition following engineering possessions.

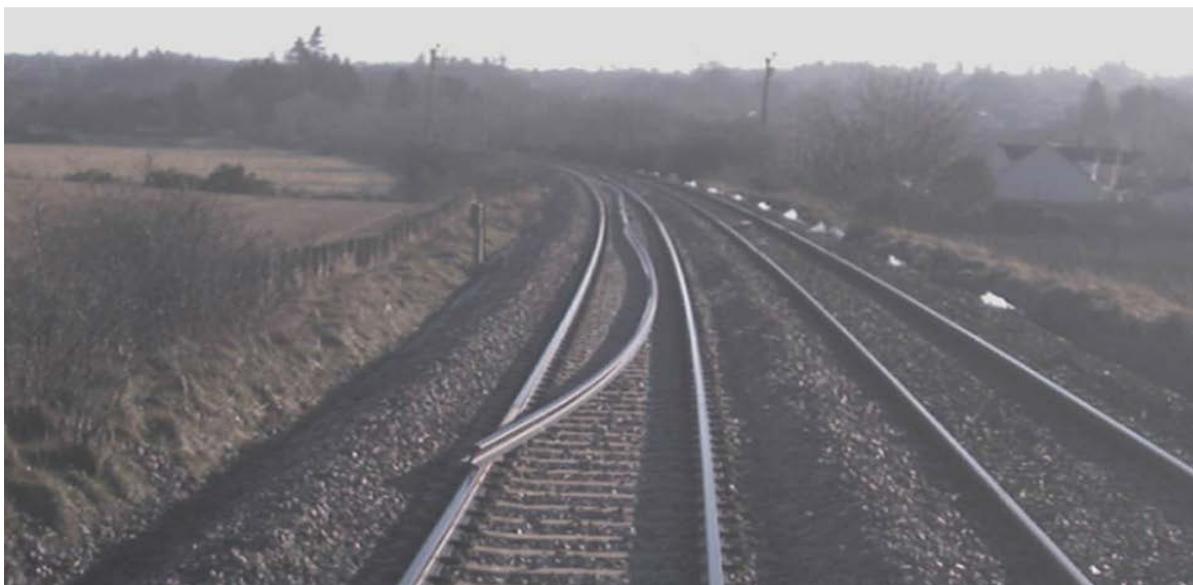
On 25 February 2018 at about 09:47hrs, a train from Inverness to London, travelling at about 53 mph (85 km/h), struck the end of a piece of rail about 130 metres (425 feet) long, which had been left on the up line at Cradlehall, a short distance south of Inverness. This was the first train to pass over the route that day.

CCTV image showing the rail on the track shortly before the train struck it (image courtesy Virgin Trains East Coast)

The train pushed the whole length of rail aside into the cess and so did not derail. The rail had been moved from the cess on the opposite side of the line during engineering work which took place the previous night. Network Rail has company standards that require that, on completion of engineering work, a nominated competent authorised person must undertake an inspection of the track to confirm that it is safe for trains to travel over at the authorised speed. It is not yet clear why this requirement was not effective on this occasion.

In light of these incidents, and given the serious nature of the most recent incident, the RAIB advises Network Rail to take urgent steps to review the effectiveness of the steps it has already taken to address this risk, and to implement any additional measures that are required to ensure the safety of the line following engineering works.
