# ***AAIB Bulletin***

***5/2018***

<b>Aircraft Type and Registration:</b>	Boeing 737-8AS, EI-EBW	
<b>No &amp; Type of Engines:</b>	2 CFM International CFM56-7B/3 turbofan engines	
<b>Year of Manufacture:</b>	2009	
<b>Date &amp; Time (UTC):</b>	14 January 2017 at 1645 hrs	
<b>Location:</b>	On descent to Manchester Airport	
<b>Type of Flight:</b>	Commercial Air Transport (Passenger)	
<b>Persons on Board:</b>	Crew - 6	Passengers - 89
<b>Injuries:</b>	Crew - 1 (Serious)	Passengers - None
<b>Nature of Damage:</b>	None reported	
<b>Commander's Licence:</b>	Airline Transport Pilot's Licence	
<b>Commander's Age:</b>	31 years	
<b>Commander's Flying Experience:</b>	4,977 hours (of which 4,833 were on type) Last 90 days - 156 hours Last 28 days - 29 hours	
<b>Information Source:</b>	AAIB Field Investigation

<b>Aircraft Type and Registration:</b>	Piper PA-28R-201 Cherokee Arrow III, G-CEOF	
<b>No &amp; Type of Engines:</b>	1 Lycoming IO-360-C1C6 piston engine	
<b>Year of Manufacture:</b>	1988 (Serial no: 2837008)	
<b>Date &amp; Time (UTC):</b>	25 May 2017 at 1050 hrs	
<b>Location:</b>	Two miles north-east of Skipness, Kintyre peninsula	
<b>Type of Flight:</b>	Private	
<b>Persons on Board:</

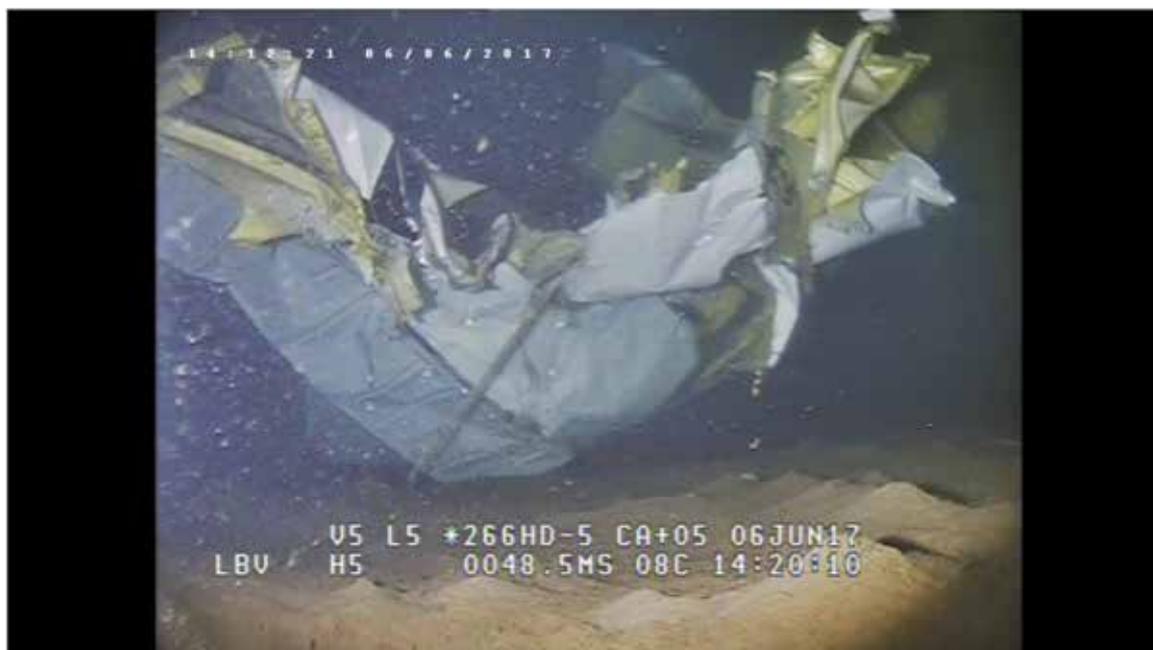
**Figure 7**

The witness descriptions of the floating sections of the aircraft, the AAIB examination of the aircraft seats, and the condition of the left wing found on the seabed (Figure 7) all indicate that the aircraft broke up when it struck the water.

Left wing on seabed

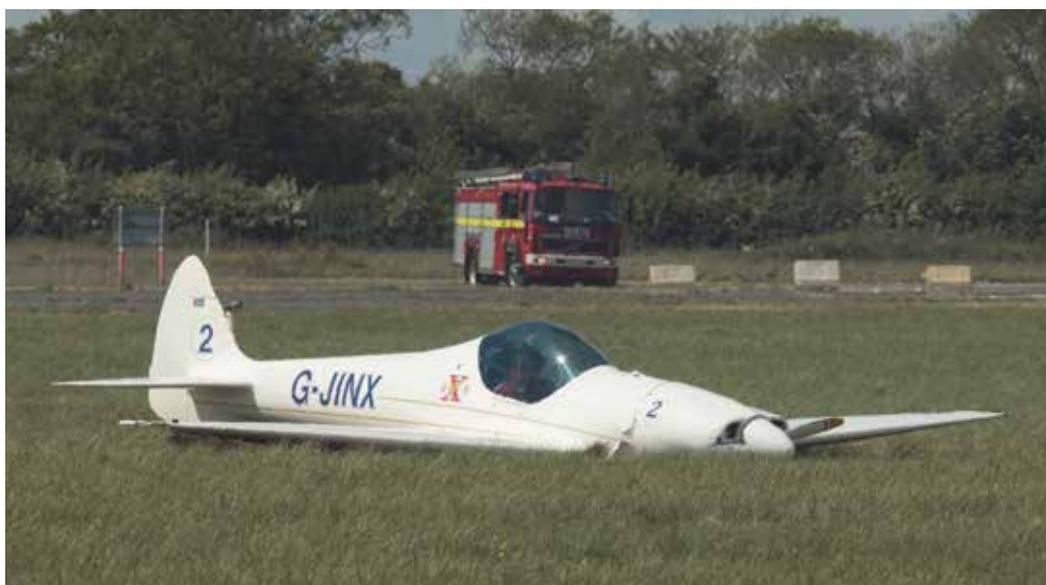
**Figure 2**

G-JINX after accident  
(Picture courtesy of Peter Thomas)

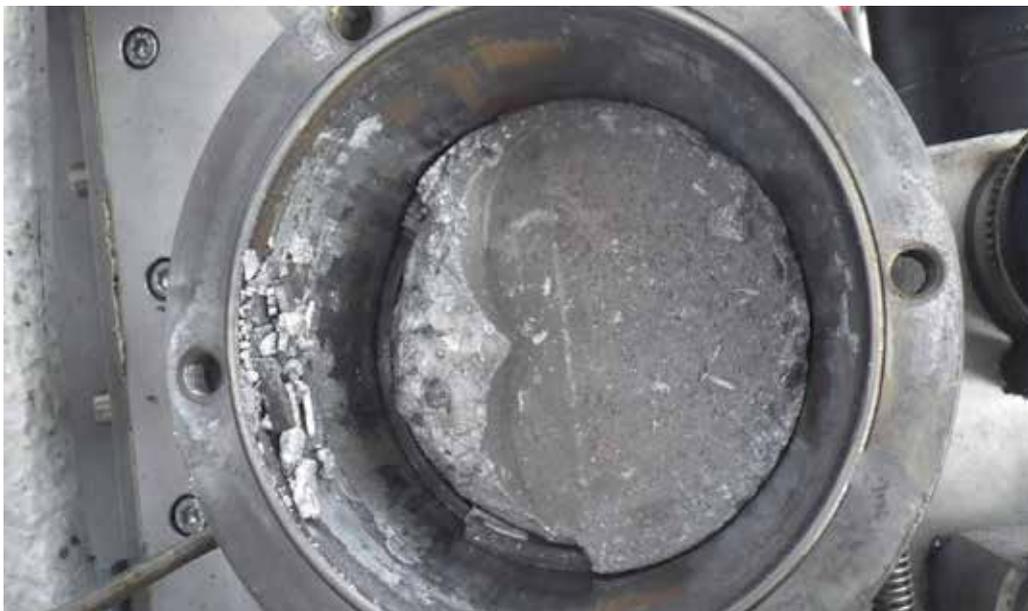
**Figure 7**

The investigation found that the engine seized following the loss of its oil during the accident flight.

The engine could not be rotated by hand. Externally there was no obvious damage other than to the oil cooler and propeller. On removing the cylinder heads it was discovered that the No 3 piston had been badly damaged and a significant section had broken away (Figure 7). There was no evidence of detonation or cracking of the piston. The inside of the cylinder was dry, and marks on the side of the piston and inside of the cylinder bores indicated that the piston had seized in the cylinder. The piston rings and scraper had all been damaged. The remaining three cylinders were also dry and there was damage to the sides of all the pistons and cylinders indicating that the pistons had expanded and had started to 'grab' the side of the cylinder.

Damage to No 3 piston and cylinder

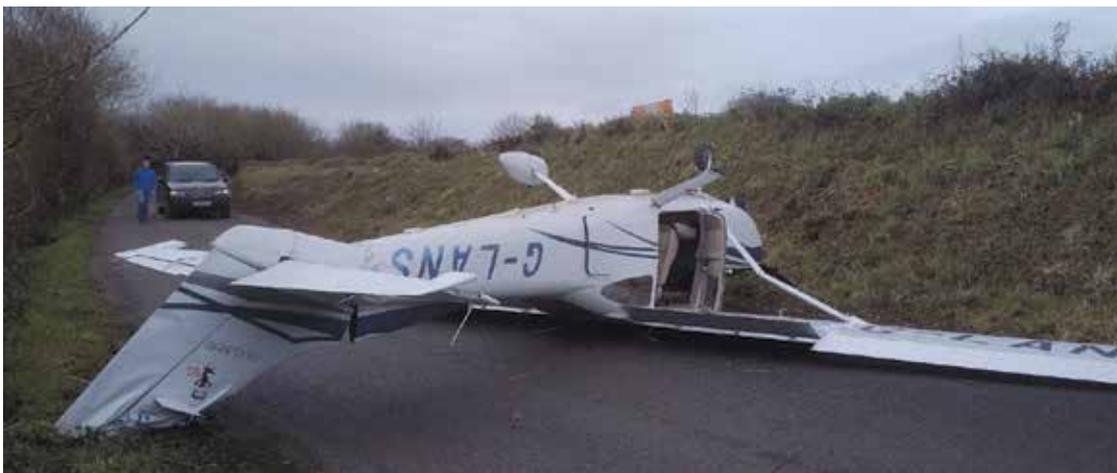
**Figure 1**

G-LANS inverted on the perimeter road following the accident.

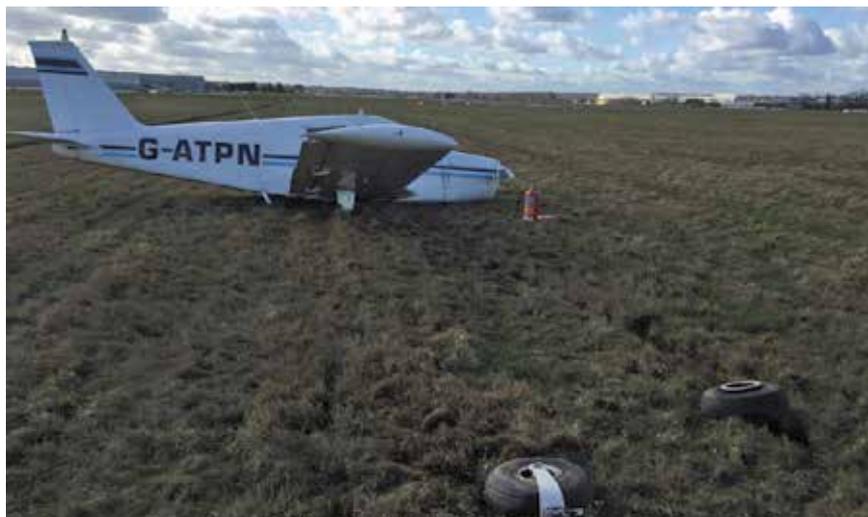
**Figure 1**

G-ATPN in its resting position approximately 95 m from the centreline of Runway 23

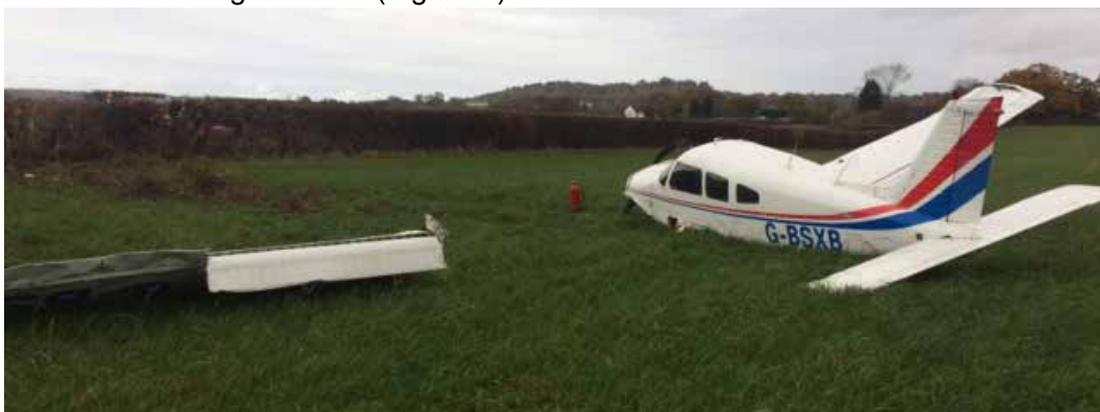
**Figure 1**

G-BSXB, with its left wing detached, facing back towards the second hedge

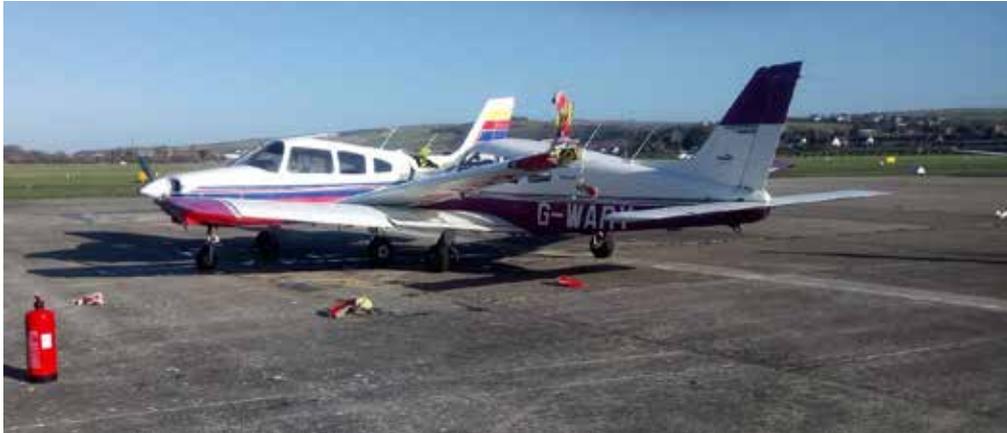
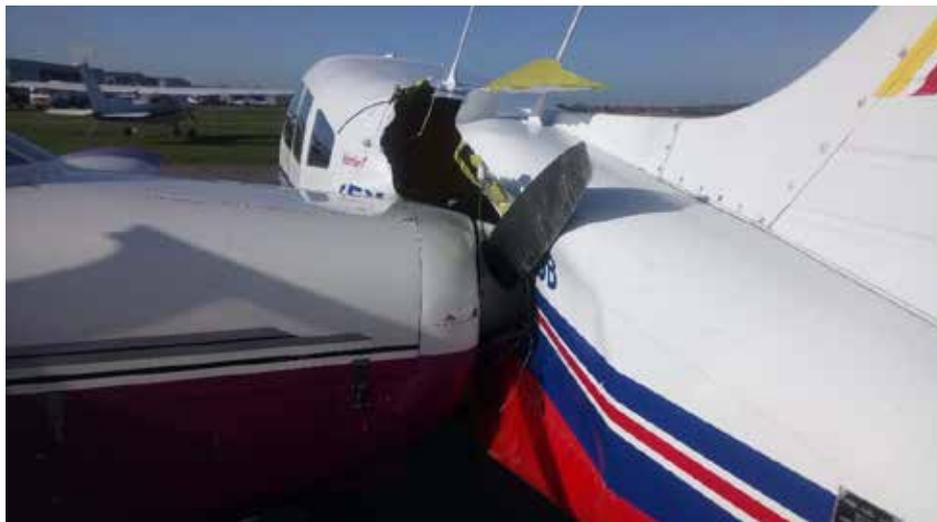
until the turning propeller penetrated its rear fuselage and brought everything to a stop. The aircraft were now interlocked and substantial damage was caused to G-WARZ, as shown in Figures 1 and 2.

G-WARY and G-WARZ interlocked  
(Pictures courtesy of Shoreham Airport)

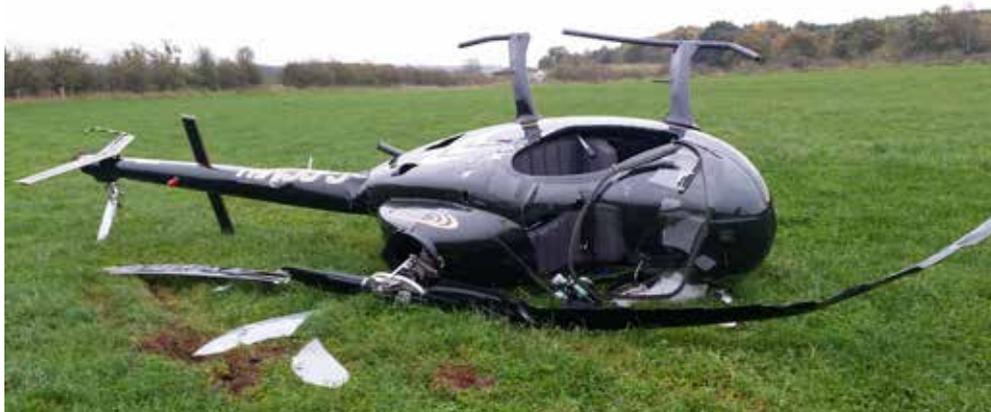
**Figure 1**  
G-CCMU after the accident

The pilot commented that he had allowed his airspeed to reduce excessively during his approach and may have inadvertently entered a hover out of ground effect. This requires a collective input and a significant increase in power. If insufficient engine power is applied, the rotor speed will drop. This can reduce tail rotor effectiveness and is likely to have resulted in the spin.

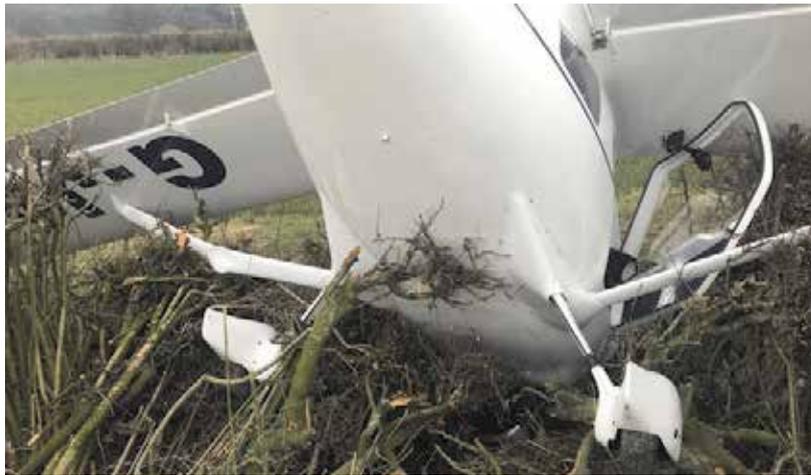
**Figure 1**

G-JAXS enmeshed in the airfield boundary hedge
