Rail Accident Report

**Fatal accident at Trenos footpath crossing near
Llanharan, Rhondda Cynon Taf, South Wales,
1 June 2017**

Report 07/2018
May 2018

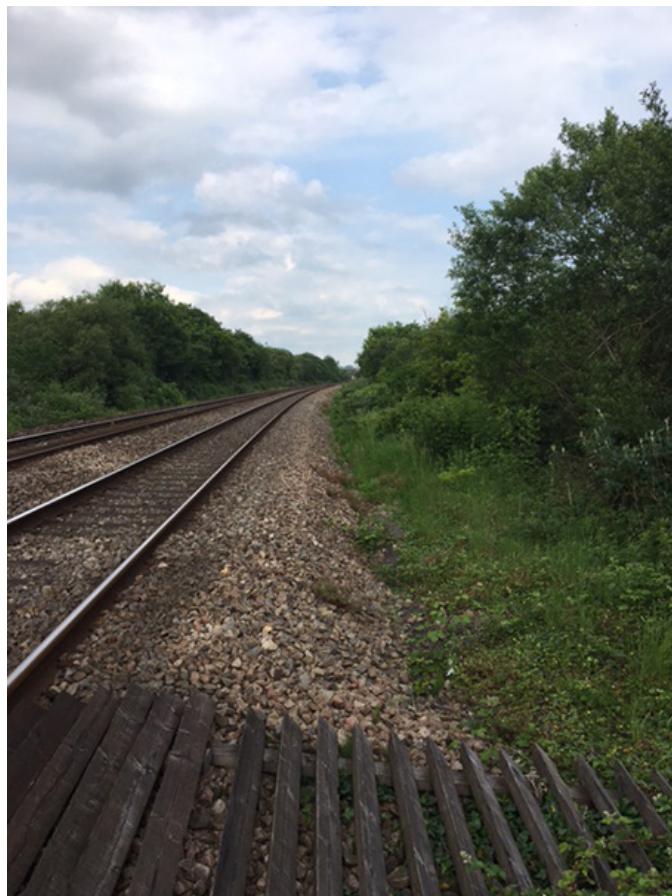
Figure 5: View from south side of crossing looking east towards down trains on 1 June 2018 (photograph courtesy of Network Rail)

- 13 The approach from the south side is up a sloping path (figure 3 and figure 4). A pedestrian's view from this side of the railway looking towards trains approaching on the down line, the line used by the train which struck the pedestrian, is shown in figure 5.

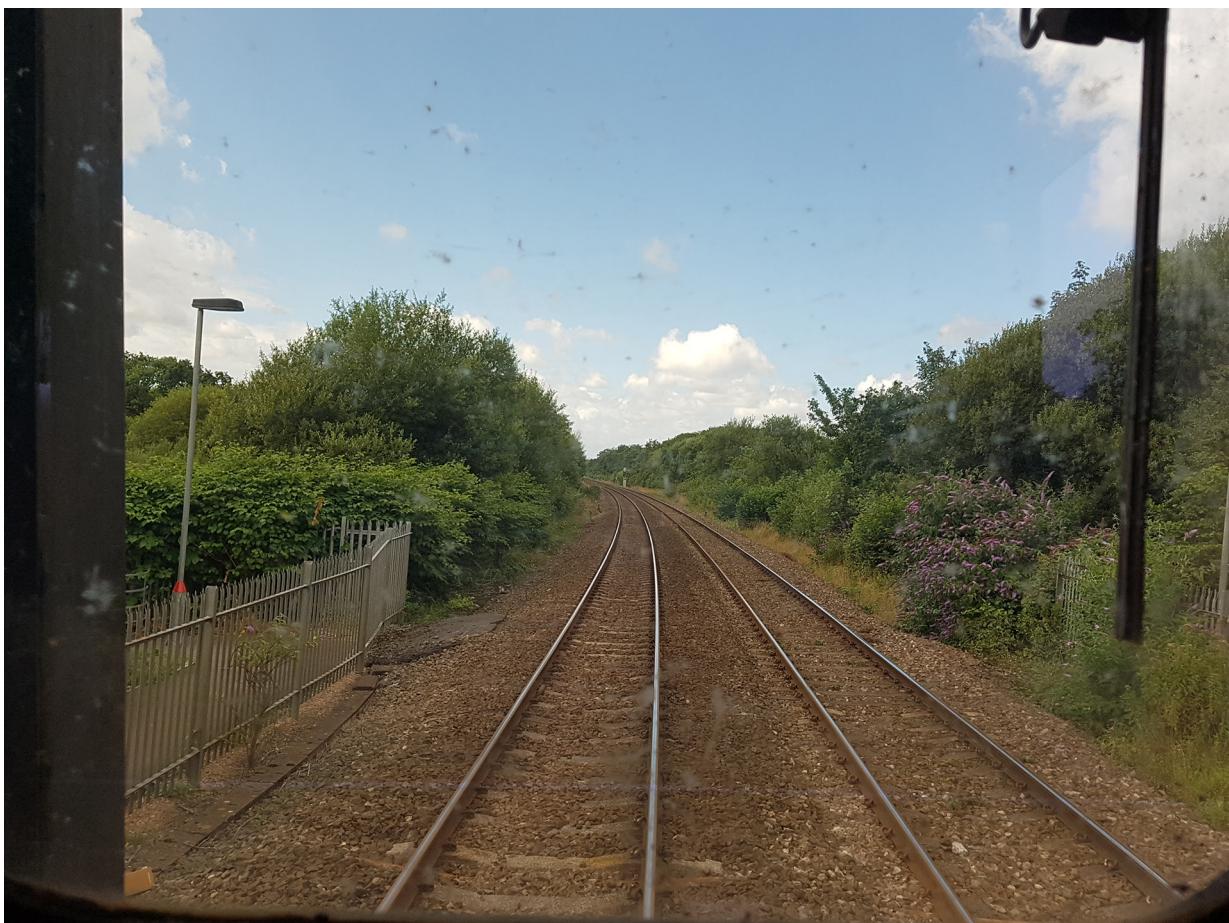
Figure 6: driver's cab view showing site of former Llanharan crossing, photographed in July 2017

- 17 A bridleway level crossing (Llanharan crossing) was 80 metres west of Llanharan station until 2007. Railway telephones were provided to allow crossing users to contact the Port Talbot signaller. For this reason, Llanharan crossing was shown on the signaller's display screen in common with three other telephone-equipped crossings in the signaller's area.
- 18 Llanharan crossing, located 1.2 km east of Trenos crossing, was closed and fenced off when Llanharan station was re-opened in December 2007. The remainder of its crossing equipment (ie telephones and crossing deck) was removed in 2009 (figure 6). However, the signalling system was not updated and Llanharan crossing continued to be shown on the signaller's display screen.

59 The display screen used by signallers operating Port Talbot signal box panel 'A' continued to show Llanharan crossing despite it having been closed in 2007 and removed in 2009 (paragraph 18). The signaller's display was not updated to reflect the removal of the crossing when this happened. Network Rail's Signalling Design Handbook, standard NR/L2/SIG/11201⁸, stipulates that design, such as the removal of level crossings, should be complete and fit for purpose. To be considered complete, the design for the removal of Llanharan crossing should have specified the removal of Llanharan crossing references from the complete signalling system, including the signaller's display.

- ## **Actions reported that address factors which otherwise would have resulted in a RAIB recommendation**
- 70 The Network Rail operations manager responsible for Port Talbot signal box has taken steps to update the booklet containing line diagrams used by signallers at Port Talbot signal box to remove references to Llanharan crossing (paragraph 64).

Network Rail Wales Route should check that signallers' displays for level crossings accurately reflect changes to level crossing arrangements made since the displays were designed. It should take suitable risk mitigation measures where this is not the case, and inform other Routes of the extent of inconsistencies found (paragraph 68b).

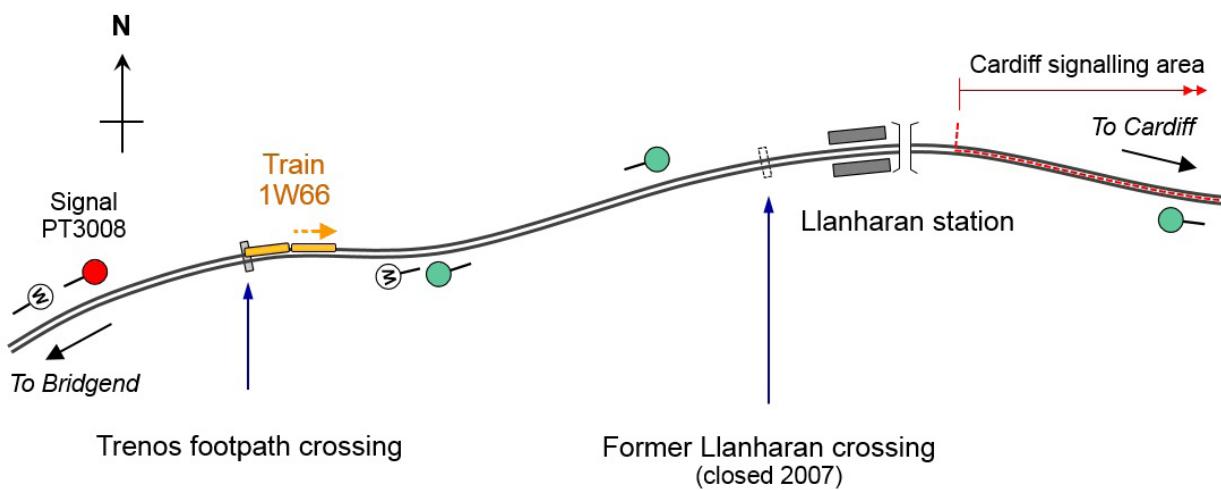
Figure 8: diagram at 15:32 hrs

- 27 The driver sounded the train's horn again, nine seconds before the crossing, and applied the brake. The on-train data recorder confirms that the driver did not use the train's emergency brake. At 15:32 hrs, the train stopped with its rear cab over the crossing (figure 8).

- 28 The driver looked out of the leading cab's right-hand window and saw the train's guard, who was travelling in the rear cab, speaking to the pedestrian. The guard believed the pedestrian was at immediate risk and shouted that she should get off the crossing. The driver then observed the pedestrian move off the crossing, and resumed the journey. He did not immediately report the incident despite the out of course stop. He attempted to contact the guard by the train's cab-to-cab telephone system, but this was not working.

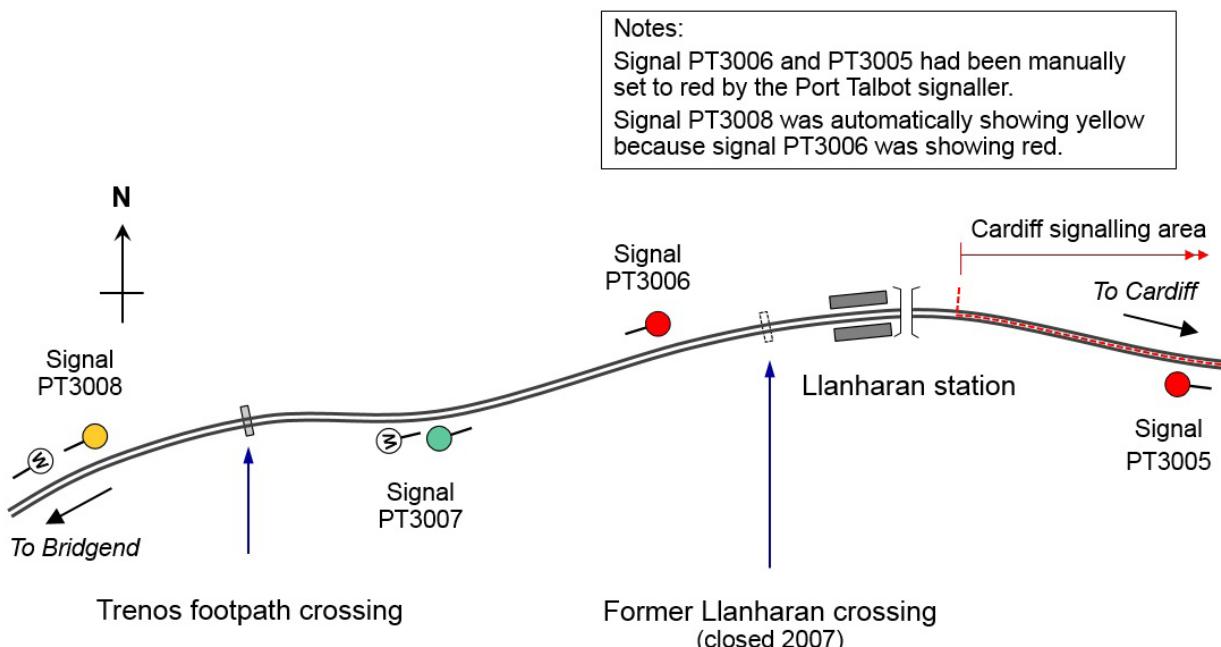
Figure 10: diagram at about 15:38 hrs

- 34 At about 15:38 hrs (figure 10), the Port Talbot signaller put signals PT3006 (up line) and PT3005 (down line), either side of Llanharan station to red so that he could caution trains. When trains are to be cautioned, they are first stopped. The driver is then instructed by the signaller to proceed at caution until the specified hazard is passed. A driver may be instructed to report back to the signaller.

- 35 Signals PT3006 and PT3005 would have been the correct signals to caution trains for the former Llanharan crossing, but the signals needed to protect Trenos crossing were signal PT3007 (down line) and signal PT3008 (up line).

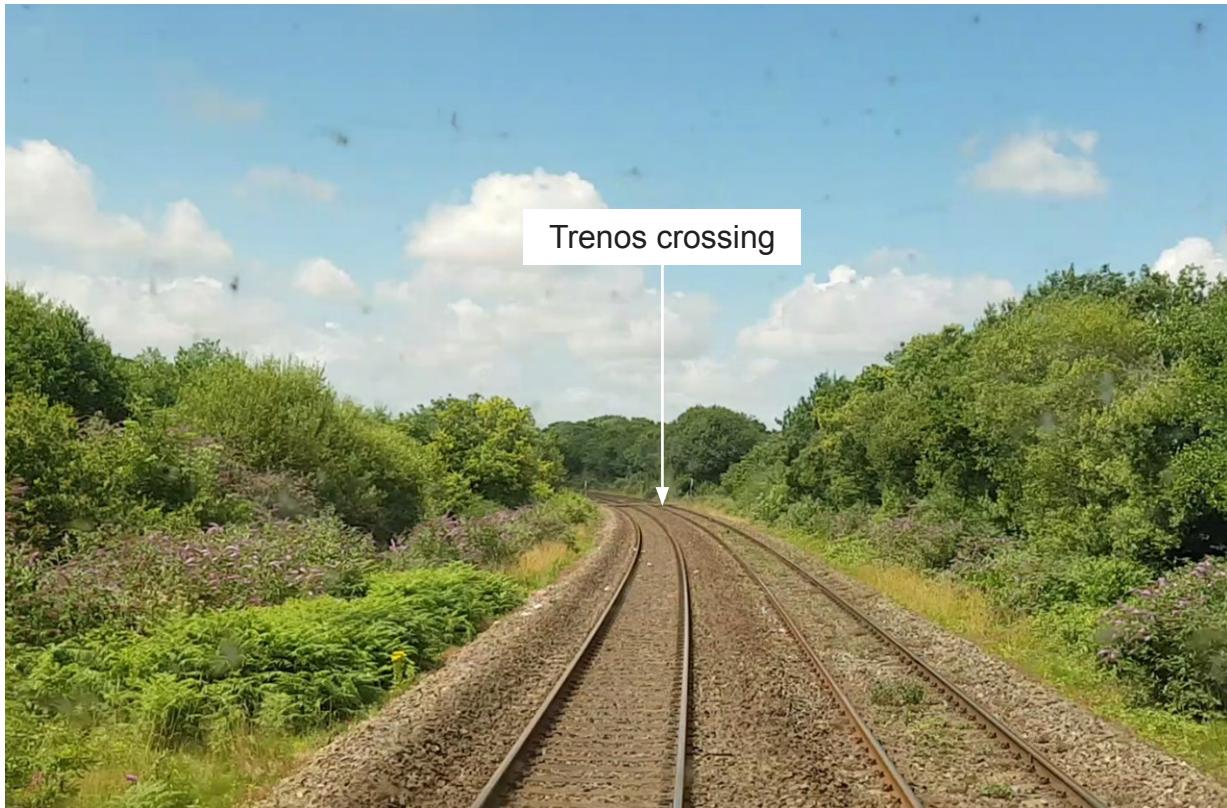
Figure 14: Driver's cab view from a similar train travelling on the down line used by the incident train. Trenos crossing is about 130 metres ahead (5.5 seconds for a train travelling at the speed of the incident train).

- 41 The train was 130 metres (5.5 seconds) from the crossing (figure 14) when the driver applied the train's emergency brake. The train was travelling at 54 mph (87 km/h) on a section of line where the maximum permissible speed was 75 mph (121 km/h).
