# ***AAIB Bulletin***

***6/2018***

## **AAIB Correspondence Reports**

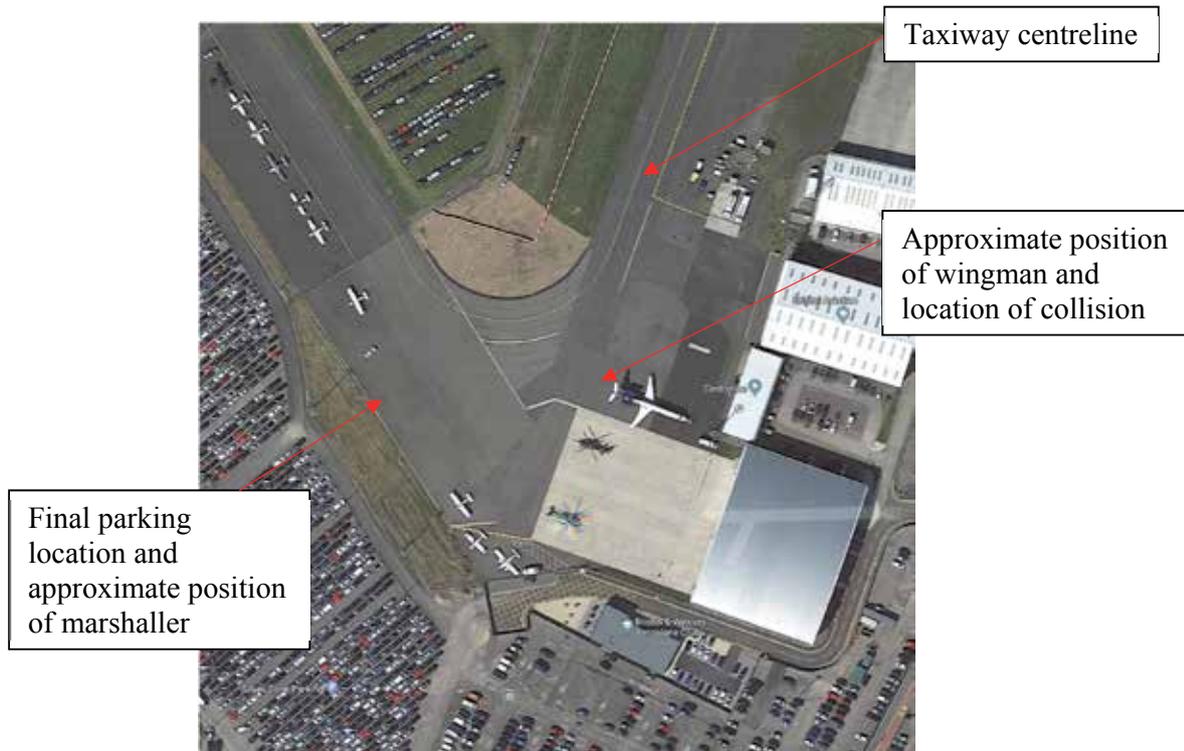
**Figure 2**

Image showing the taxiway and a parked aircraft in the same position as the accident aircraft in front of the hangar

The accident was recorded by one of the airport's CCTV cameras located on the southern corner of the large silver building shown in Figure 2, looking north towards the taxiway.

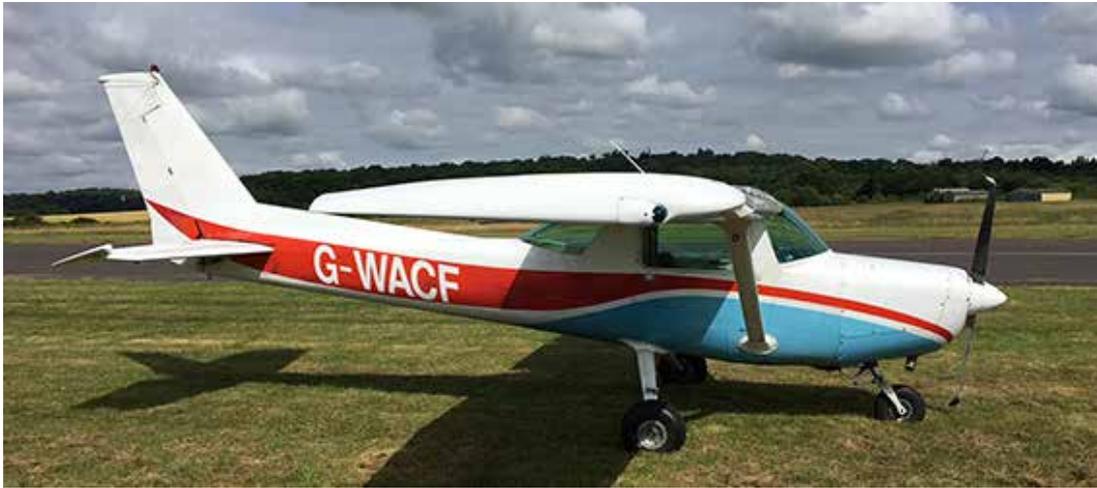
**Figure 1**

The approach appeared stable until, at approximately 100 ft aal, the student started to make over-corrections to the aircraft's pitch attitude, while trying to achieve the correct airspeed. The instructor observed the aircraft pitching up and down and saw the mainwheels touchdown before the aircraft bounced, in a nose-up attitude, to approximately 15 ft aal. However, the nose then dropped, the aircraft landed nosewheel-first and it porpoised along the runway while the groundspeed reduced.

G-WACF, with damage to the propeller and to the nose landing gear apparent

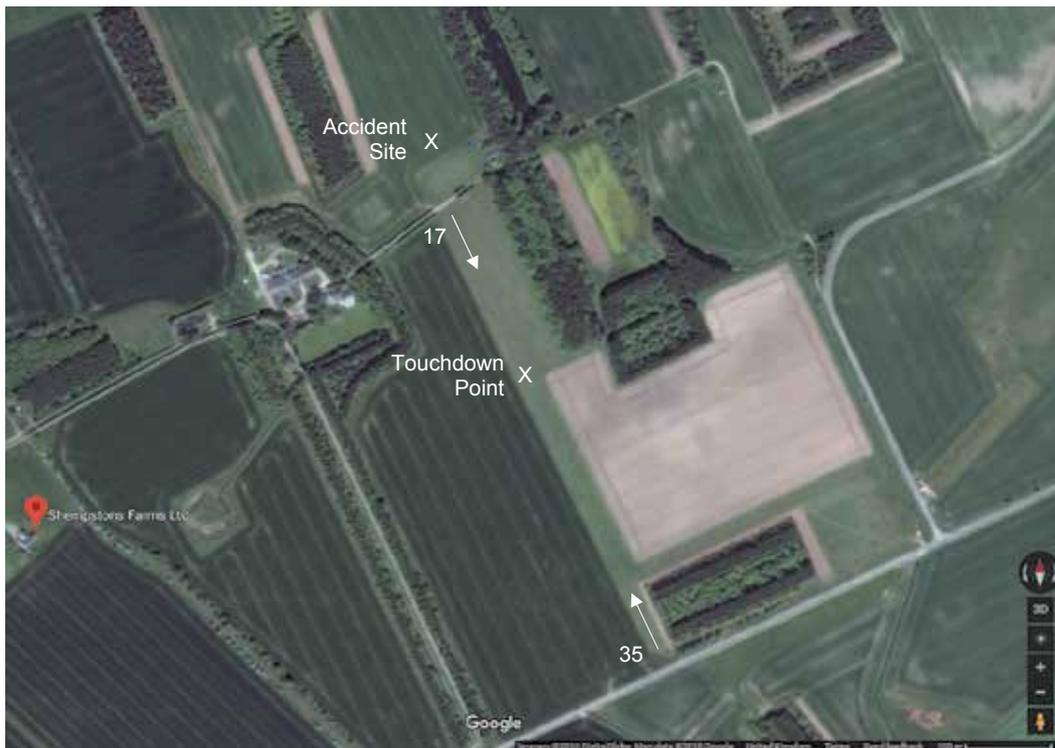
**Figure 1**

During the flight the wind increased to about 13 kt and the pilot made three approaches followed by go-arounds. The touchdown on the fourth approach was later than normal (Figure 1) and at 60 KIAS which, combined with the tailwind component, resulted in a high ground-speed. The aircraft wheel brakes are not normally used for landing deceleration and the pilot was unable to stop before running off the end of the runway. The aircraft entered a rough ploughed field causing the main landing gear to dig in and it came to rest inverted. The pilot required assistance to vacate the aircraft and suffered a minor back injury. The engine and propeller suffered shock loading and the structure of the canopy, upper fuselage and right main landing gear was damaged.

Accident site - Shempstons Field, near Lossiemouth

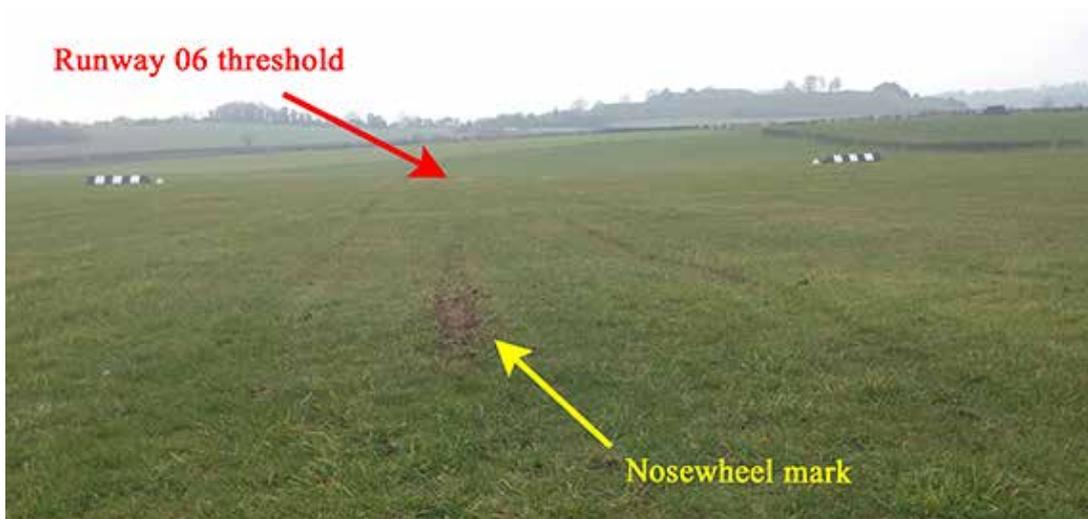
**Figure 1**

A third approach was flown, for another 'short field' landing, and the aircraft touched down on a part of the runway close to the threshold that felt "bumpy" and had an uphill gradient. The aircraft bounced and both occupants believed that only the mainwheels had touched, but subsequent examination of the ground markings indicated the nosewheel had also made firm contact (Figure 1). This was substantiated by a witness, who described the third landing as heavier than the first two, and who believed the aircraft was in a relatively flat attitude when it bounced.

View of initial ground marks; the aircraft having touched down moving towards the camera position and then bounced

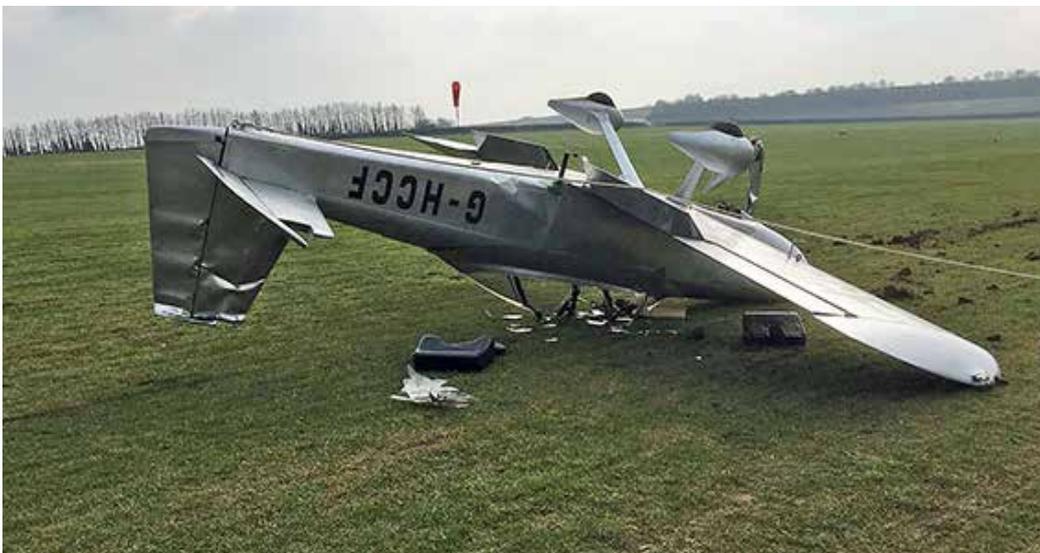
**Figure 2**

After the bounce, when the aircraft touched down again, the pilot asked the passenger to apply the brakes “more firmly” than he had during the previous landings. The aircraft ran straight and slowed quickly, but the nose dropped and, although the pilot moved the control stick fully aft, the propeller made ground contact. According to the passenger, the aircraft then “flipped over quite slowly” and came to rest inverted, with the canopy broken into several pieces (Figure 2).

G-HCCF inverted and with a line attached in preparation for righting

After examining the ground marks and damage, the passenger, who was also the aircraft's constructor and owner, observed that the nose landing gear had bent rearwards as a result of "digging in" to the soft ground during the landing; there was significant damage to the nose landing gear fork unit. The pilot commented, that prior to the aircraft inverting, there was no jolt and no noise was heard that could have warned him the nose landing gear was sustaining damage.

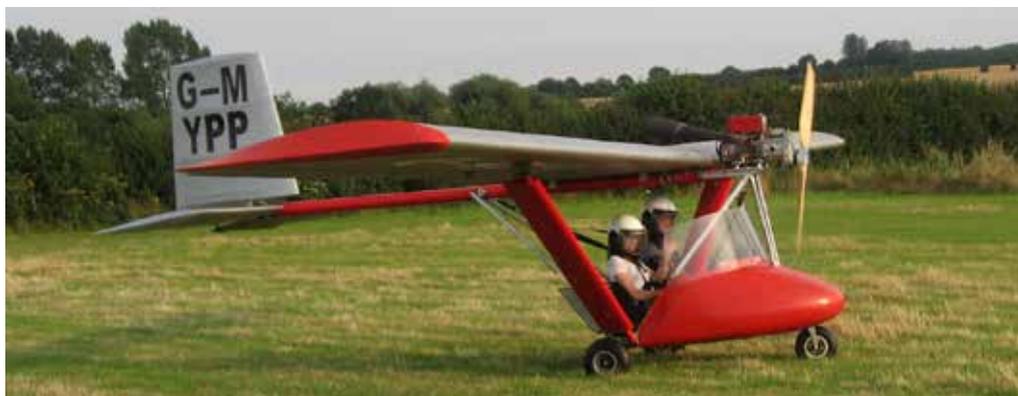
**Figure 1**

After the accident, the pilot discovered that a nipple on the throttle cable had detached, causing the engine to throttle back to idle. He noted that the aircraft (Figure 1), which had last flown four weeks previously, is a low inertia microlight and “does not have a great glide ratio”. He estimated that the elapsed time from the loss of power to impact was 10 seconds.
