# Near miss with a train driver at Stafford station, 2 March 2018

## Important safety messages

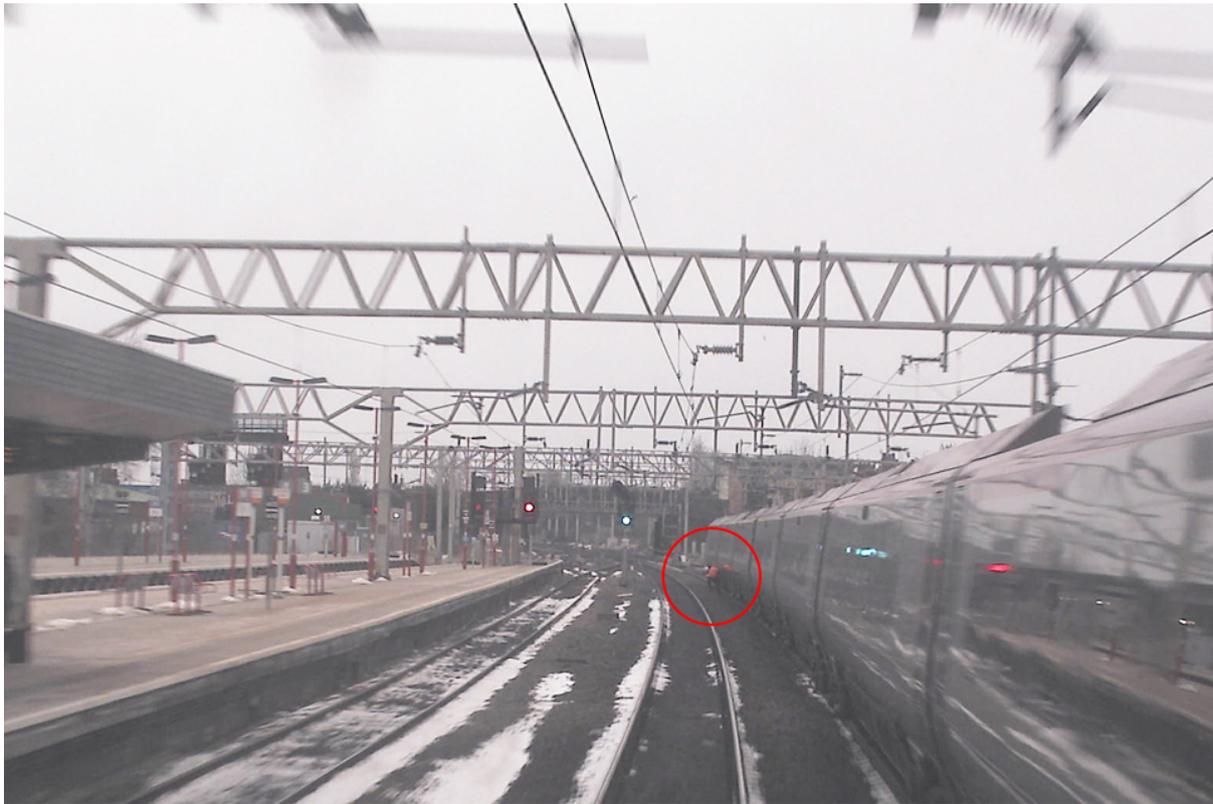
Forward facing CCTV image from the northbound (image courtesy of Virgin Trains). The driver of 1A34 is circled.

At about 14:36 hrs, the northbound train approached Stafford at about 85 mph (137 km/h) on the Down Stafford Fast line. As the driver of this train passed the front of train 1A34, he saw someone on the track towards the rear of it. The driver sounded the train's horn and applied the train's brakes. The driver of train 1A34 became aware of the approaching train and lay down alongside his train to avoid being struck. He was clear of the approaching train about three seconds before it passed him.

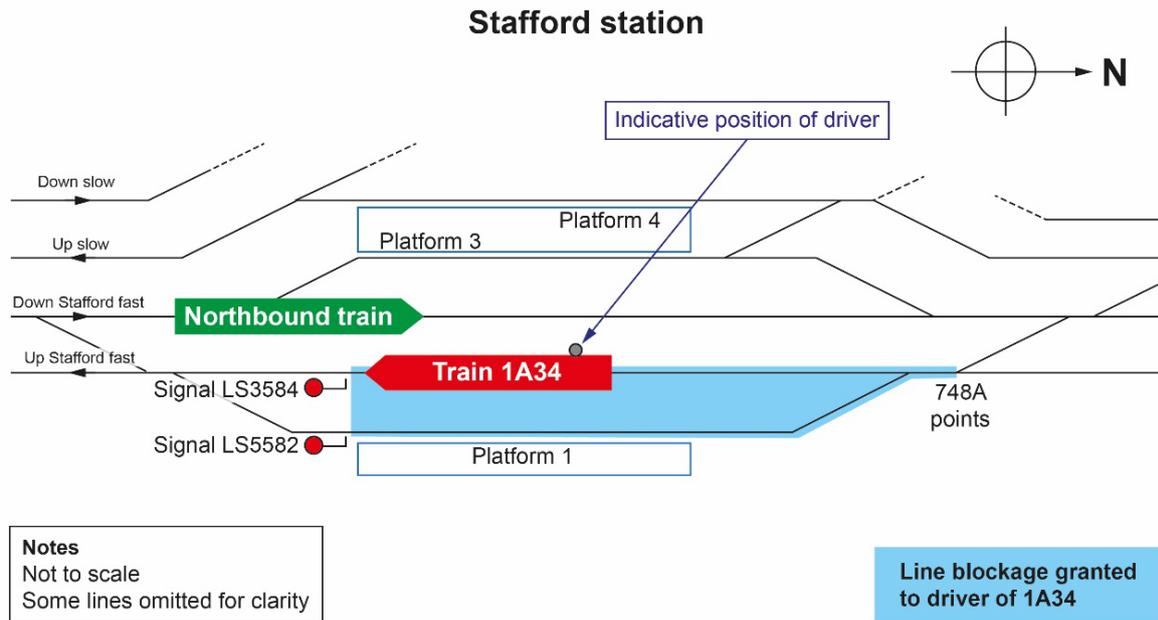
After seeking advice over the radio from maintenance support staff, the driver asked the signaller to route train 1A34 into platform 1 so that he could examine the train. The signaller was unable to do this due to the proximity of train 1A34 to a junction north of Stafford, which meant the route already set for it along the Up Stafford Fast line could not be cancelled. Instead the signaller instructed the driver to move his train to the next signal on the Up Stafford Fast line, signal number LS3584, which is located in Stafford station.

**Track diagram showing Stafford station and the position of the trains involved**

At 14:04 hrs, when train 1A34 was at a stand at signal LS3584, the driver called the signaller again. During this conversation, the driver asked the signaller to block the Down Stafford Fast line and the line through platform 1, which would stop any train movements on these lines (the driver concluded that the Up Stafford Fast was already blocked by the presence of his stationary train). The request to block the Down Stafford Fast line and the line through platform 1 was repeated back by the signaller. The driver stated that he would need these line blockages to gain access to the outside of his train, as he needed to isolate the brakes on a carriage towards the rear and then carry out a test to check that the wheels on that carriage were rotating correctly.
