# Passenger train striking rail on the track at Cradlehall, near Inverness, 25 February 2018

## Summary of the incident

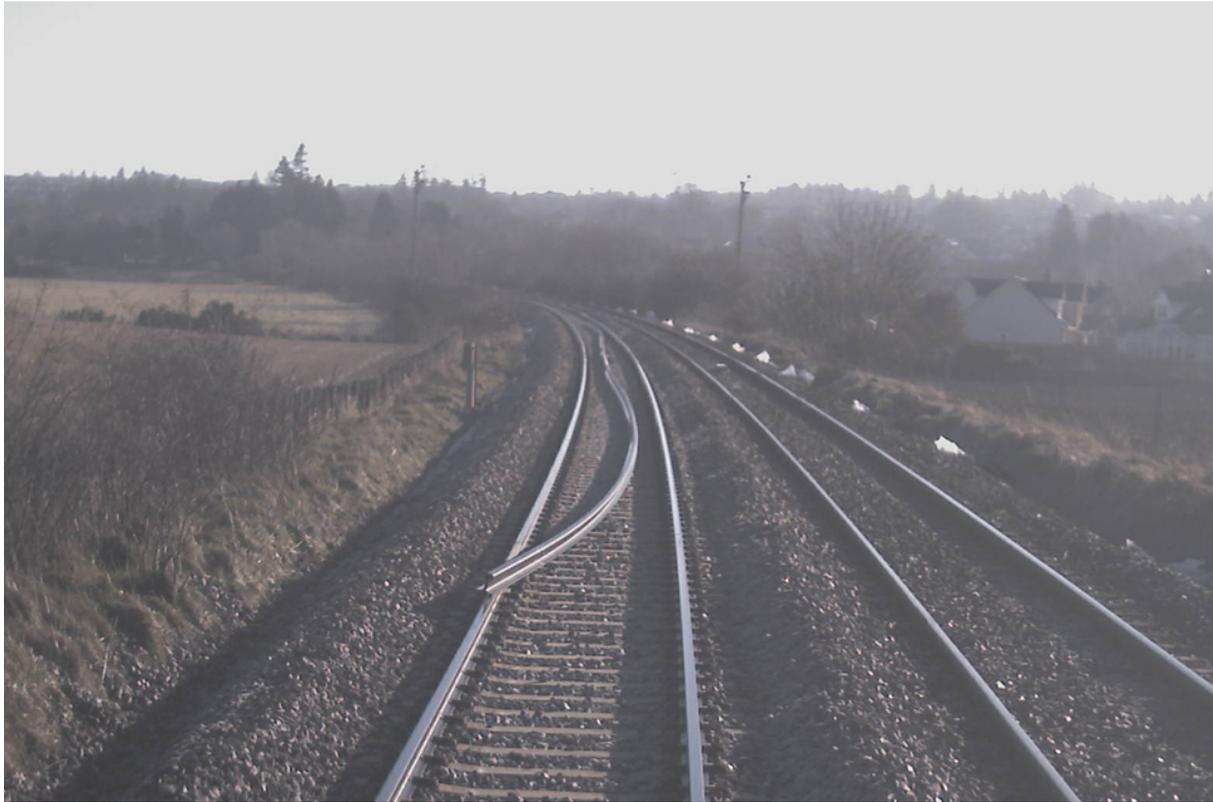
On 25 February 2018 at about 09:47 hrs, train 1E17, the 09:40 hrs service from Inverness to London, travelling at about 53 mph (85 km/h), struck the end of a 130 metre long section of rail. The rail had been left between the two running rails (in the four-foot) with one end resting on the left-hand rail of the up line, following an overnight engineering possession at Smithton, near Cradlehall, a short distance south of Inverness.

Image from Forward Facing CCTV of train 1E17 showing the rail just prior to impact (image courtesy Virgin Trains East Coast)

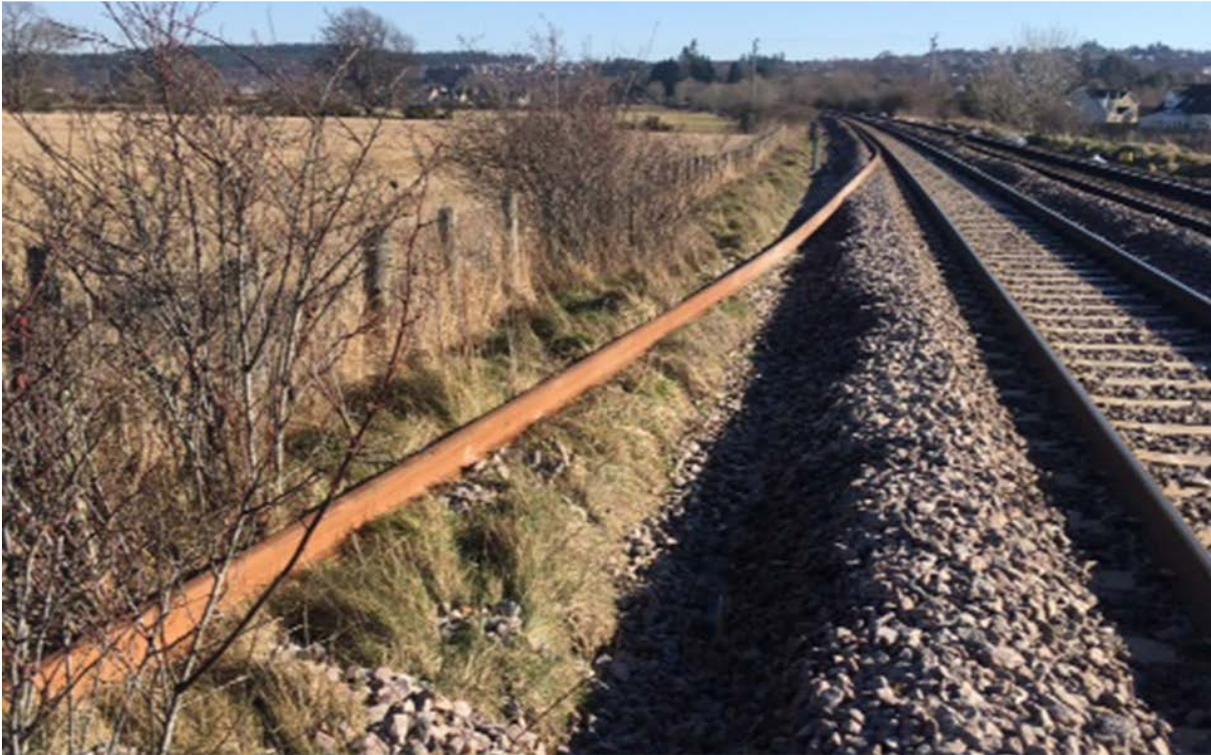
The train pushed the whole length of rail from the four-foot into the cess (beside the line) but did not derail. Had circumstances been slightly different there is little doubt that the impact from the rail could have derailed the train, resulting in a far more serious accident.

The rail after being struck by the train

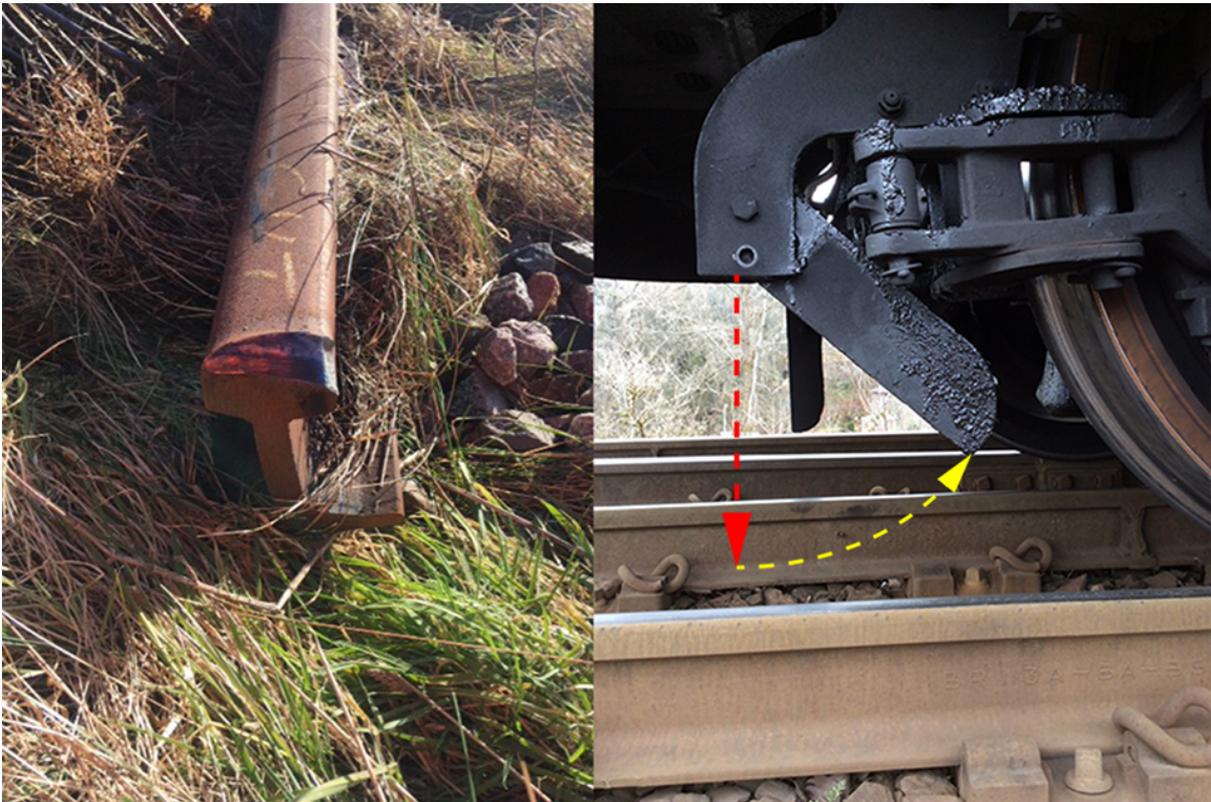
The train driver checked the train but did not identify any damage. He contacted the signaller and the train was authorised to continue its journey. When the train called at Dunkeld and Birnam, the train driver undertook another visual check of the train, at the request of the train operator's maintenance controller. The train driver then reported that the lifeguard had been damaged. The train was authorised to continue to Perth, where the passengers were transferred to another train. The damage to the lifeguard shows that it had struck the end of the rail at an angle and deflected the rail to the left, and pushed the whole length of rail from the four-foot into the cess as the train slowed to a stand. The impact had sheared one of the two bolts that retains the lifeguard in place.

(Left-hand image) the end of the rail, showing the impact mark and (right-hand image) the damaged lifeguard
