Service Inquiry

CHALLENGER 2 Incident
at Castlemartin Ranges,
Pembrokeshire

14 Jun 17

SERVICE INQUIRY INVESTIGATION INTO THE ACCIDENT INVOLVING A CHALLENGER 2 AT CASTLEMARTIN RANGES, PEMBROKESHIRE ON 14 JUN 17

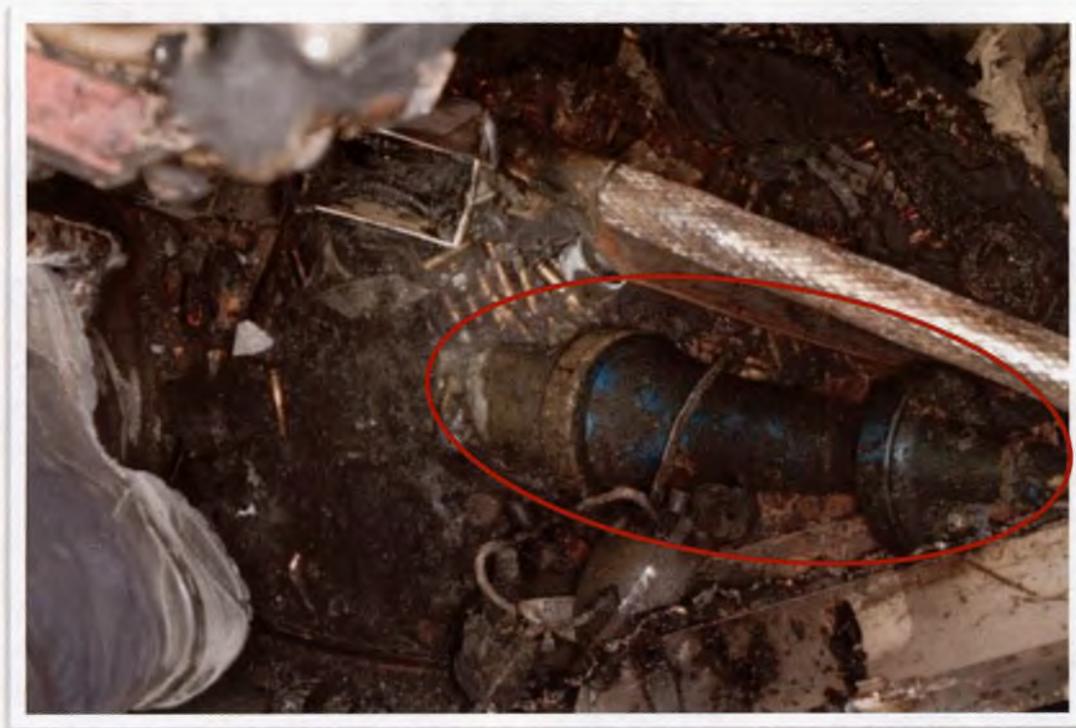
Figure 1.4.25: Discarding Sabot – Training Round on Tank Floor (circled in red) the ECBA has been removed

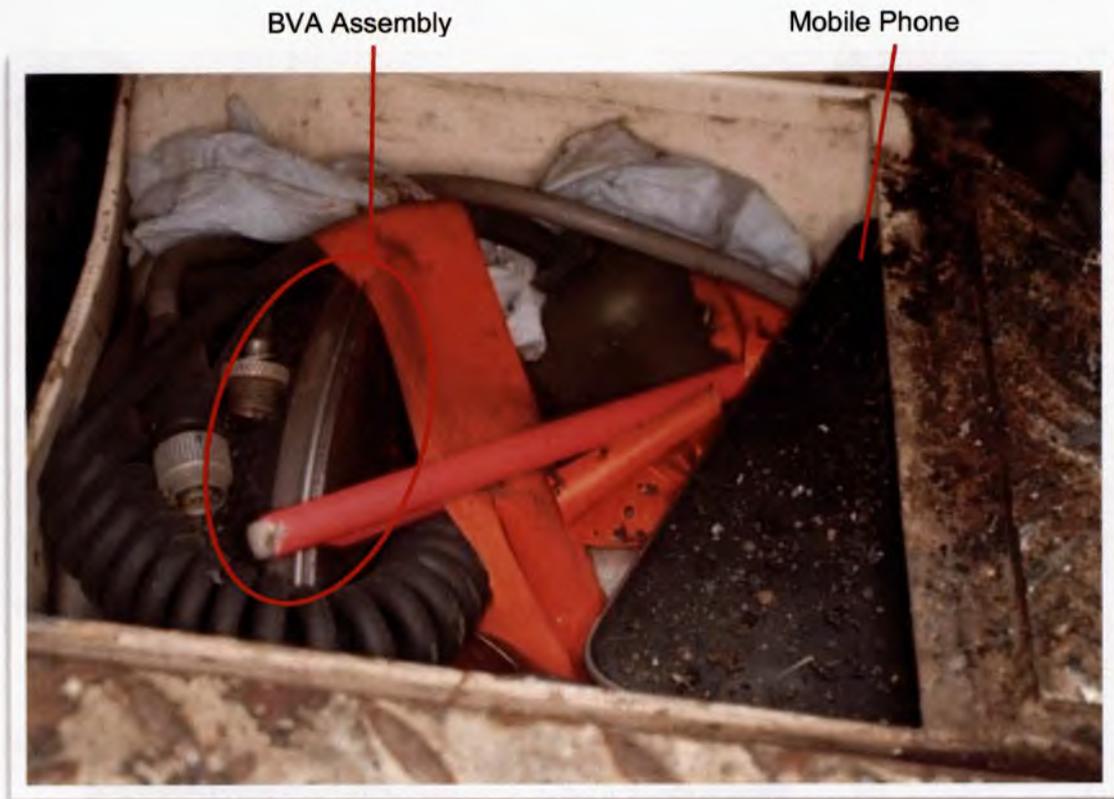
Figure 1.4.29: Contents of Ration Stowage Box as Discovered

⁴⁷ The presence of the mobile phone in the Ration Stowage is discussed further in Paragraph 1.4.138.

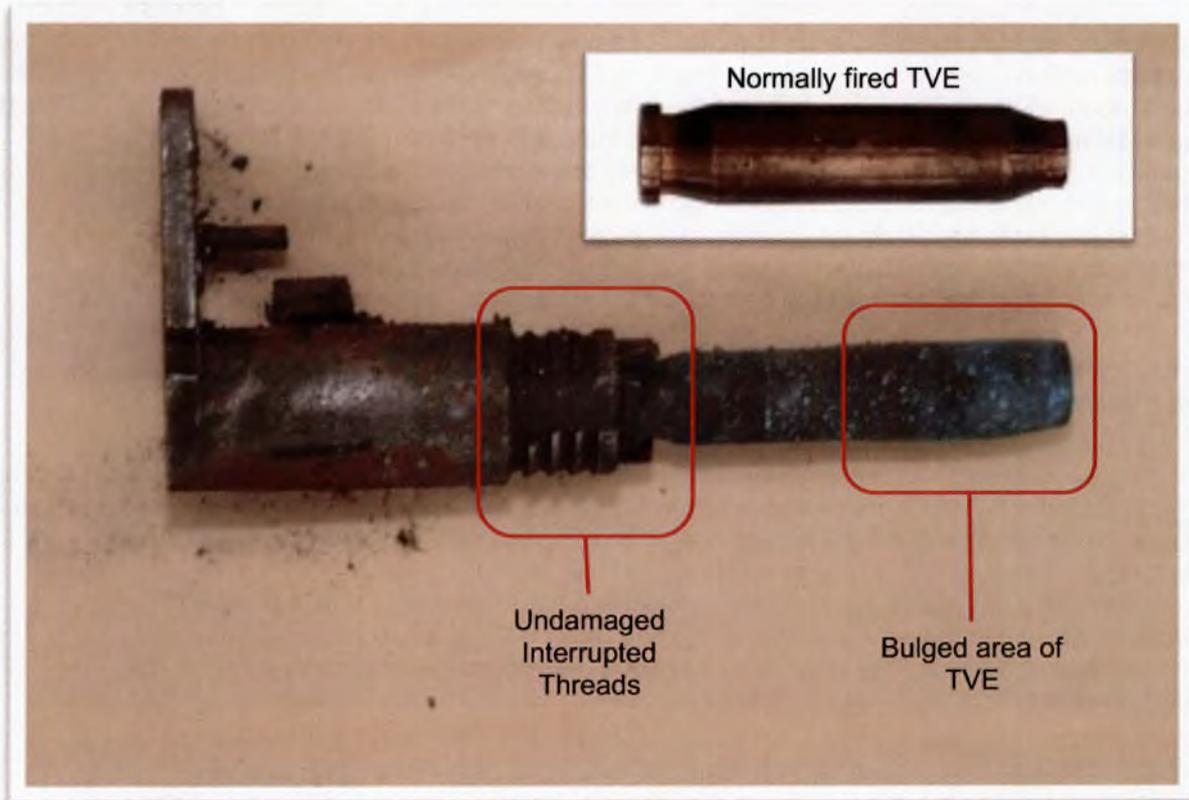
**Figure 1.4.32: Recovered Firing Needle Assembly with Attached Tube Vent Electric
Inset: Normally Fired TVE for Reference**

- a. The witness marks from the firing needle on the primer cup indicated that the TVE had been fired using the Firing Circuit of the Main Armament;
- b. The TVE was found to be bulged throughout its length, indicating that it was fired whilst not correctly chambered within the BVA;
- c. The lack of damage to the interrupted threads on the FNA assembly indicates that it was not secured within the thrust housing at the time of ejection from the Breech Block.

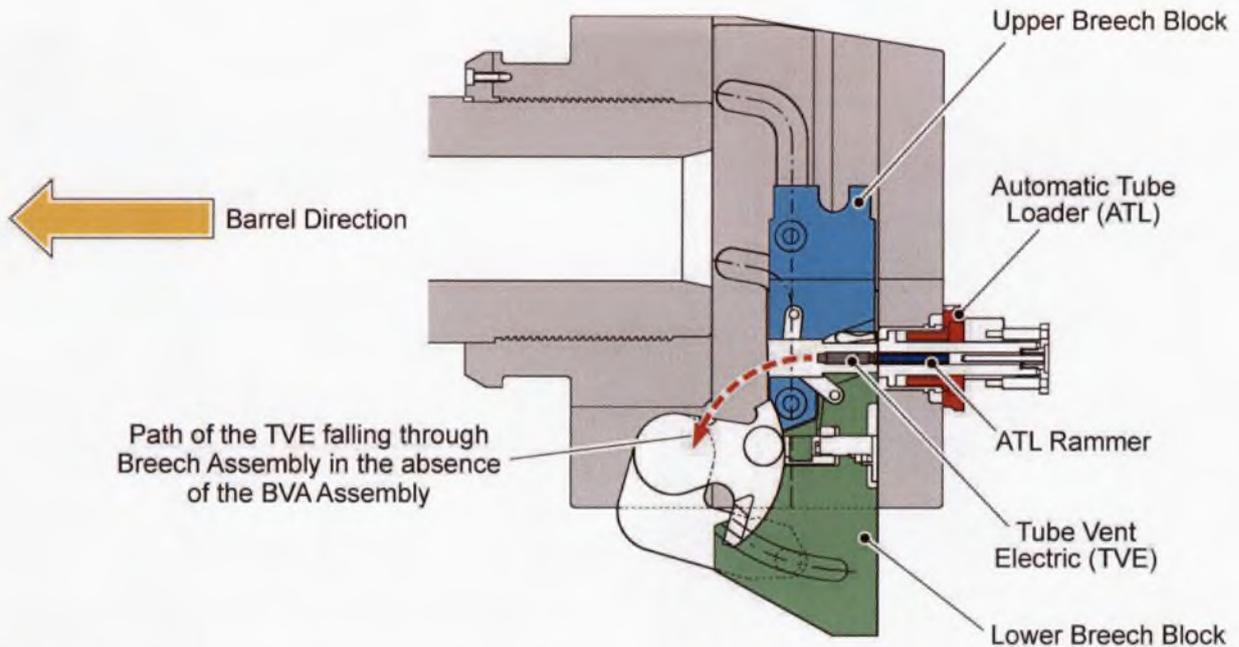
Figure 1.4.34: Loading a Tube Vent Electric with the Automatic Tube Loader with the Bolt Vent Axial Missing⁵⁰

indicated by the TVEDU displaying "NOT LOADED" with a red warning light (see Paragraph 1.4.29). The post-accident discovery of an unfired TVE on the floor of the turret indicates that the Loader very likely attempted to ram a TVE into the BVA using the ATL.

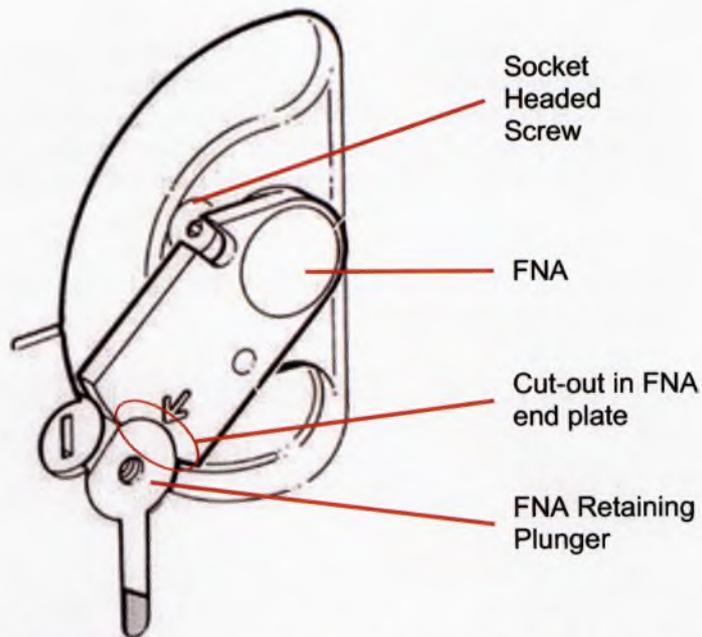
Figure 1.4.38: The Firing Needle Assembly Fitted to the Lower Breech Block

1.4.152. The Panel concluded that a loader can fit an FNA into the Lower Breech Block without realising that a BVA Assembly is absent.
