AAIB Bulletin

8/2018

Aircraft Type and Registration:	Piper PA-28RT-201 Cherokee Arrow IV, G-BHAY	
No & Type of Engines:	1 Lycoming IO-360-C1C6 piston engine	
Year of Manufacture:	1979 (Serial no: 28R-7918213)	
Date & Time (UTC):	11 September 2017 at 0956 hrs	
Location:	Wolferton, Norfolk	
Type of Flight:	Private	
Persons on Board:	Crew - 1	Passengers - 1
Injuries:	Crew - 1 (Fatal)	Passengers - 1 (Fatal)
Nature of Damage:	Engine front fuselage, wings and landing gear severely disrupted	
Commander's Licence:	Private Pilot's Licence	
Commander's Age:	58 years	
Commander's Flying Experience:	1,129 hours (of which 406 were on type) Last 90 days - 15 hours Last 28 days - 10 hours	
Information Source:	AAIB Field Investigation

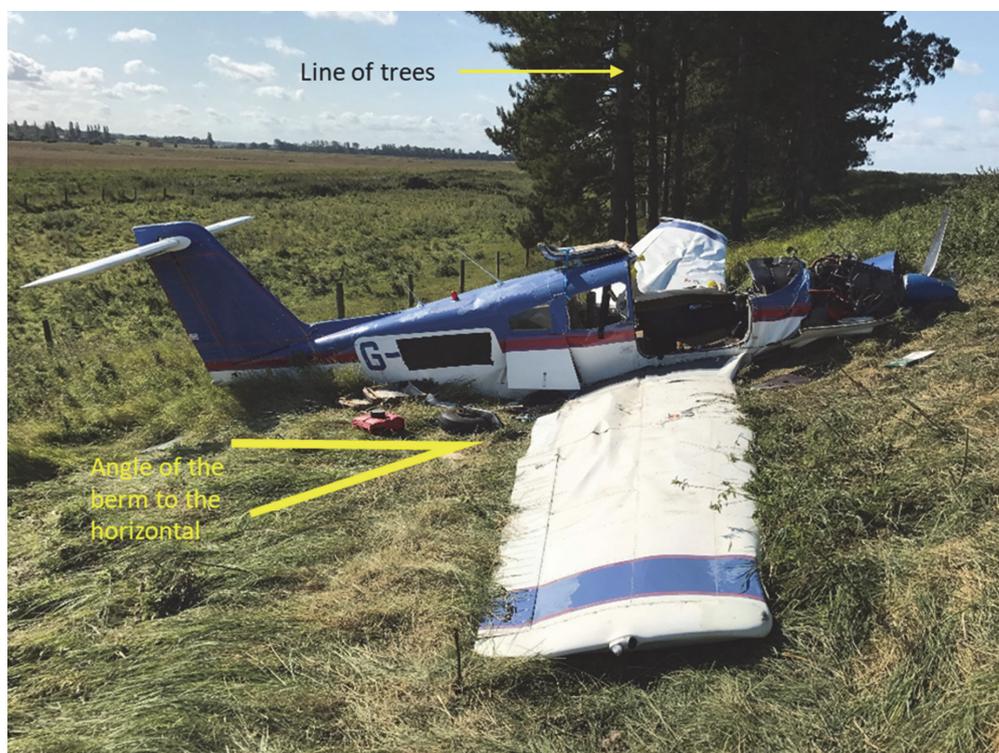
Figure 3
Accident site

The accident site was on private agricultural land towards the top of a berm (the old sea wall) which formed part of the secondary inland sea defences on the north Norfolk coast. There was a line of coniferous trees to the west of the accident site, visible in Figure 3; these were about 25 ft high.

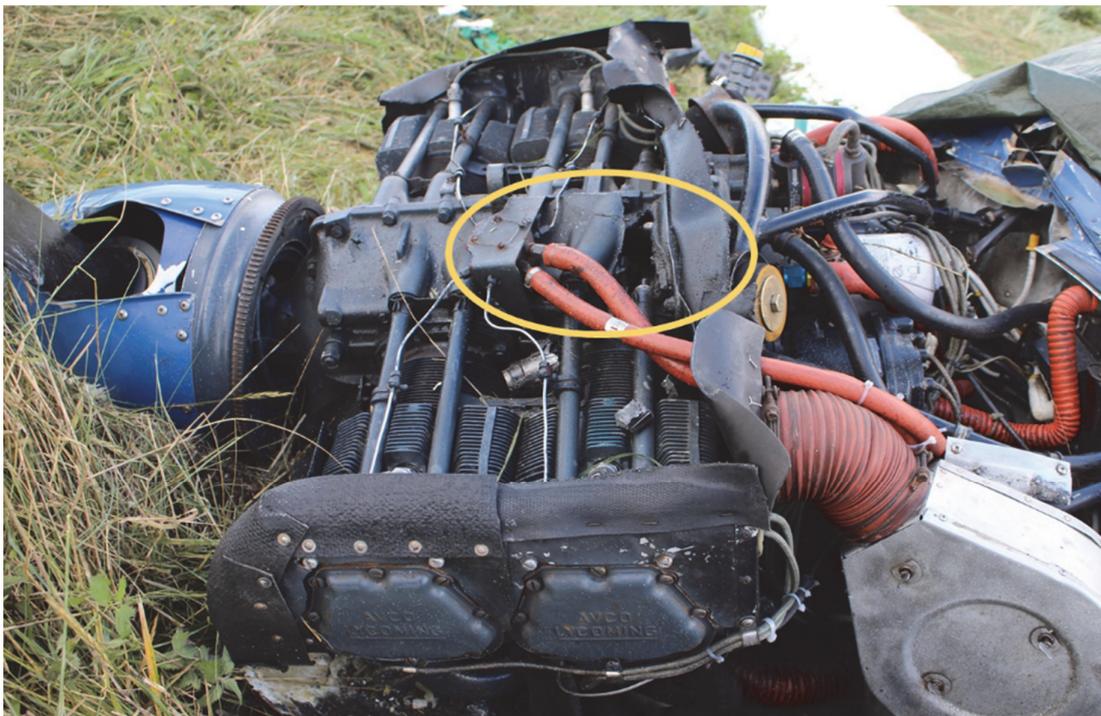
Figure 4
Crankcase damage

Both wing tanks contained fuel and approximately 40 imp gal (48 US gal) were drained from the fuel tanks at the accident site. The top of the engine was exposed and the crankcase had a large hole near the base of the No 4 cylinder, exposing the remains of the No 4 piston connecting rod. Figure 4 shows the damage to the crankcase.

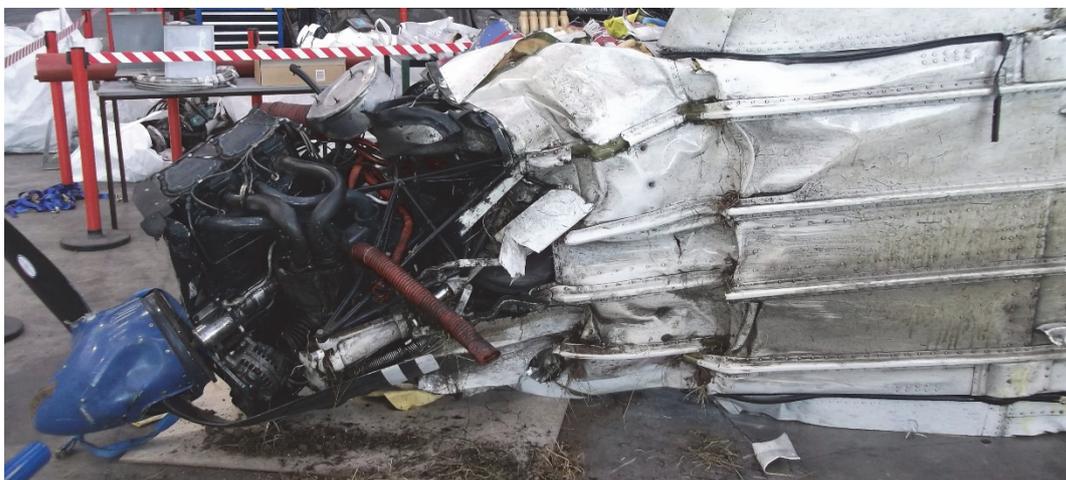
Detailed examination showed that the rudder, tailplane and elevator were attached correctly and relatively undamaged but that the area beneath the engine and cockpit around the fire wall was crushed and severely buckled upwards and rearwards by the vertical deceleration when the aircraft struck the berm. The entire underside of the fuselage was covered in engine oil and oil was still seeping from fuselage skin joints and seams. Figure 5 shows the condition of the forward underside of the fuselage and Figure 6 shows oil seeping from the fuselage skin joints.

Forward underside of the fuselage

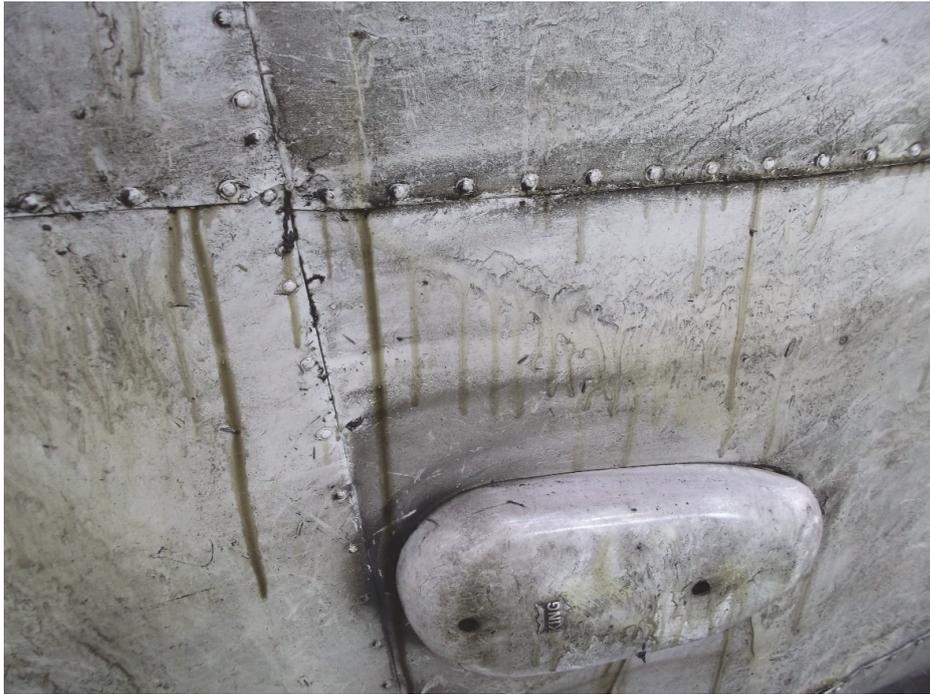
Figure 6

Oil seeping from the fuselage skin joints

The No 1 and No 2 pistons show significant exhaust 'blow-by' and contamination of the oil control rings and this led to the severe fouling of the No 2 cylinder spark plugs. This was probably the point where the pilot detected the engine rough running and prompted his MAYDAY call. It is known that blow-by can cause pressurisation of the crankcase which in turn causes oil to be ejected from the breather. The breather exit tube is situated behind the nose landing gear bay on the underside of the aircraft and excessive oil loss through the breather tends to cover the area behind the breather and be carried by the airflow rearwards, consistent with the oil-soaked fuselage underside in this case.

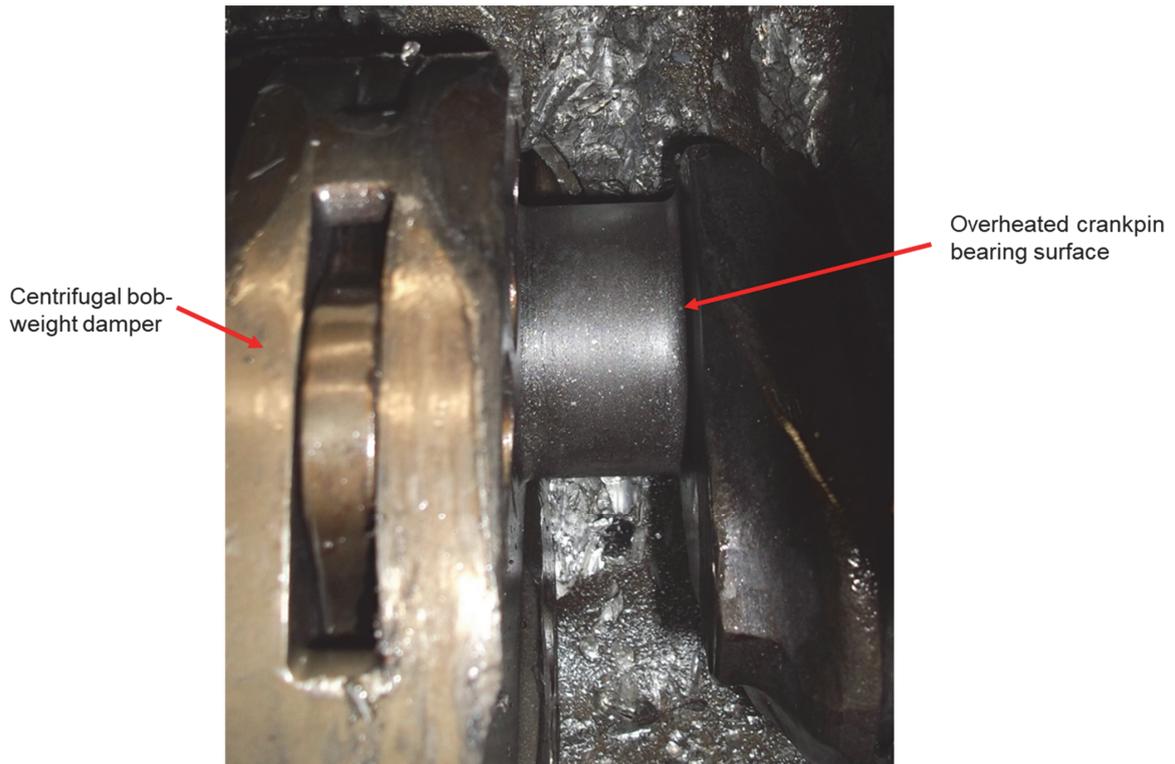
The crankshaft was in one piece and but showed signs of rubbing and discolouration due to excessive heat on the rear main journal, the No 4 crankpin and the No 2 crankpin. There were also debris impact marks on the surfaces of the No 3 and No 4 crankpin surfaces. Figure 7 shows the overheated condition of the No 4 crankpin.

No 4 crankpin condition

In general, big-end bearings are the first to suffer as a lubricating system starts to fail. In this case, the No 4 big-end loosened as its bearing overheated, disintegrated and induced stresses in the half-cap bolts, which failed, allowing the connecting rod to detach from the crankshaft. This allowed the connecting rod free to flail as the engine continued to run for its last few seconds, with the No 4 big-end half-cap, bolts and bearing remains becoming caught up in the bobweight damper sweeping them around between it and the No 3 big-end and connecting rod, causing it to disintegrate. The No 4 connecting rod eventually forced its way out of the crankcase and the engine stopped.

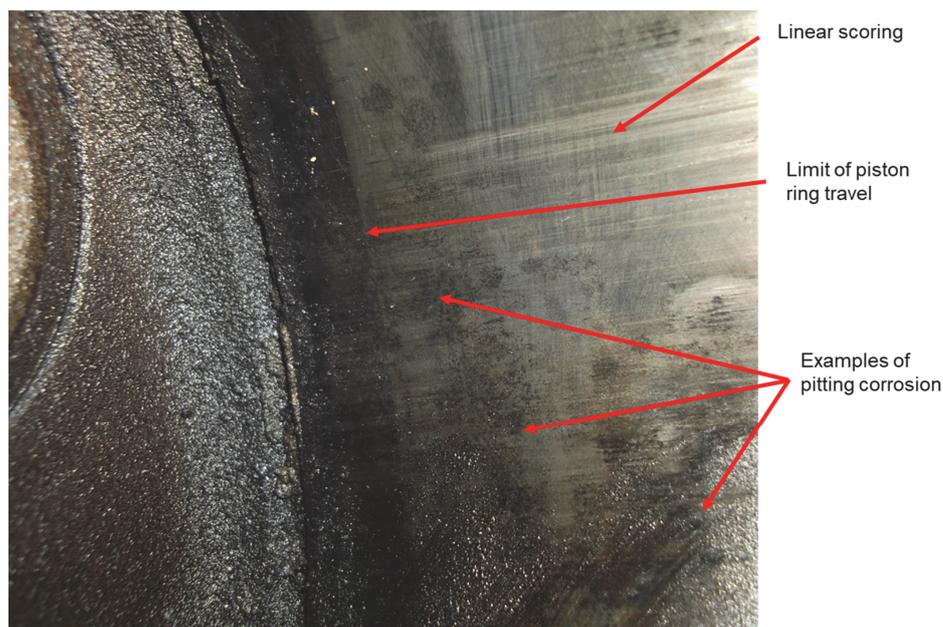
The No 1 and No 2 cylinder liners had linear scoring within the piston-swept area. There was heavier localised scoring where debris had been picked up on the piston skirt and small areas of pitting corrosion were present in both cylinders, were smoothed by the action of the piston and oil control rings. The pitting corrosion was more prevalent in the No 2 cylinder and heavier pitting corrosion was present at the top of both cylinders, outside the piston-swept area. Figure 8 shows the corrosion in the No 2 cylinder.

An example of the pitting corrosion in the No 2 cylinder

Between November 2015 and July 2016 the aircraft was parked outside at Newcastle International Airport, nine miles from the sea and in inclement weather conditions. There is no evidence that the engine had been inhibited during the aircraft's period of inactivity and it is likely that corrosion took hold during this period. This was evident in the No 1 and No 2 cylinder walls, with localised pitting corrosion at the top of the cylinder and within the piston-swept area. The engine manufacturer's Service Letter (Number L180B, dated 13 November 2001) is clear on the actions to be taken to prevent engine deterioration and notes that active corrosion can occur in a short period of time.

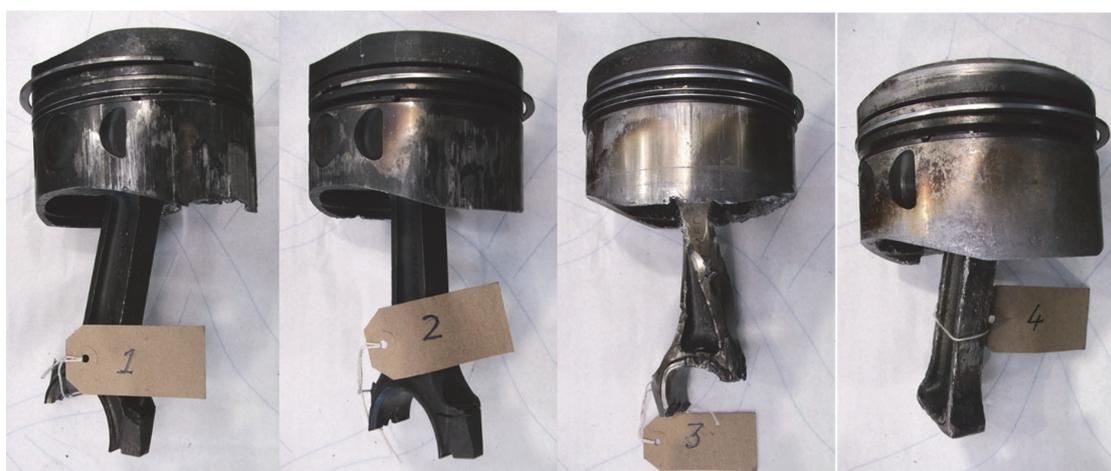
By contrast the No 3 and No 4 pistons were in better condition and had stopped in their respective cylinders when their big ends detached from the crankshaft. There was no evidence of blow-by and no scoring of the piston skirts. However, the underside of the pistons was covered in multiple debris strike marks and the No 3 connecting rod was bent and twisted and its half-cap, end bolts and bearing shells pulverised. The No 4 connecting rod and associated parts had similar damage and fragments of the No 3 and No 4 bearings had evidence of excessive heating and swaging whilst under load. Figure 9 shows the condition of the pistons and damage to the connecting rods.

Pistons and connecting rods

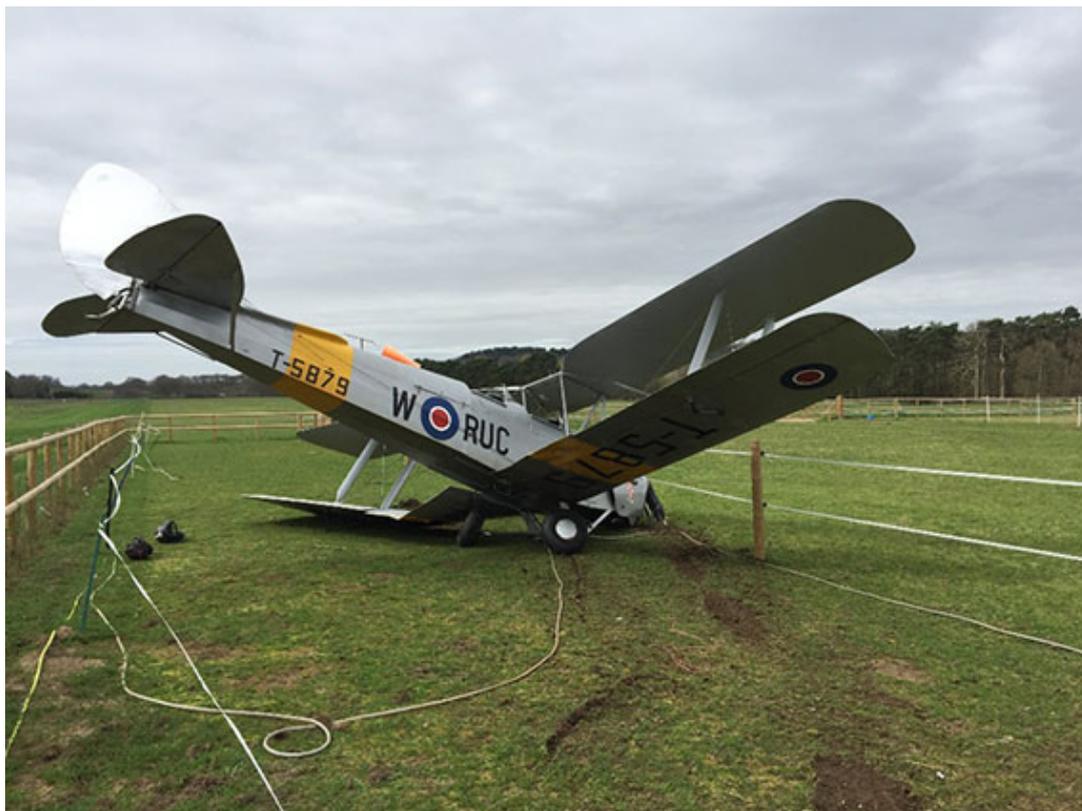
Figure 1

The pilot in command (PIC), flying in the front seat, was providing familiarisation training for a new syndicate member, who was in the rear seat. The wind was assessed to be approximately 12 kt at 25° from the left; within, but close to, the crosswind limit for the takeoff. The PIC was satisfied that the new syndicate member was a capable pilot and allowed him to have control for the takeoff. During the takeoff roll, the aircraft became airborne 5 kt below the normal 'unstick' speed. At this time, the PIC called "airspeed" and was about to take control when a gust lifted the left wing. The right wing stalled, causing the aircraft to descend and turn to the right from a height of approximately 10 ft. The aircraft struck a wooden fence running parallel to the grass runway and came to rest on its nose with a buckled landing gear (Figure 1).

G-AXBW where it came to rest to the right of the grass strip

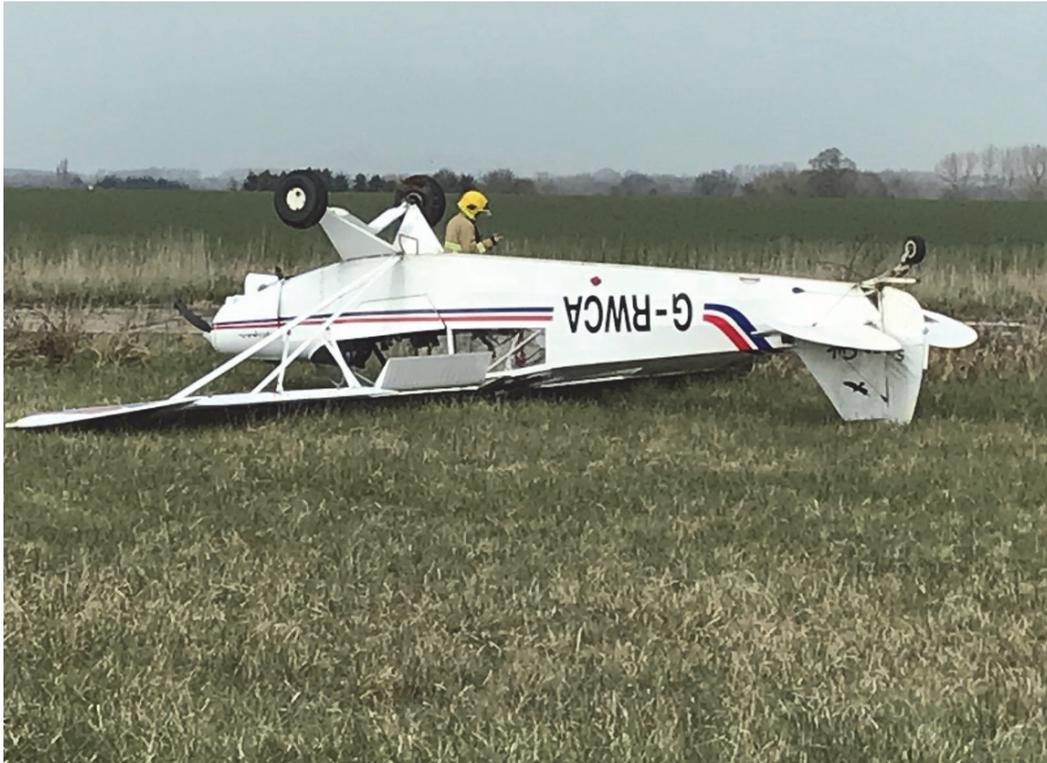
Figure 1

Accident site

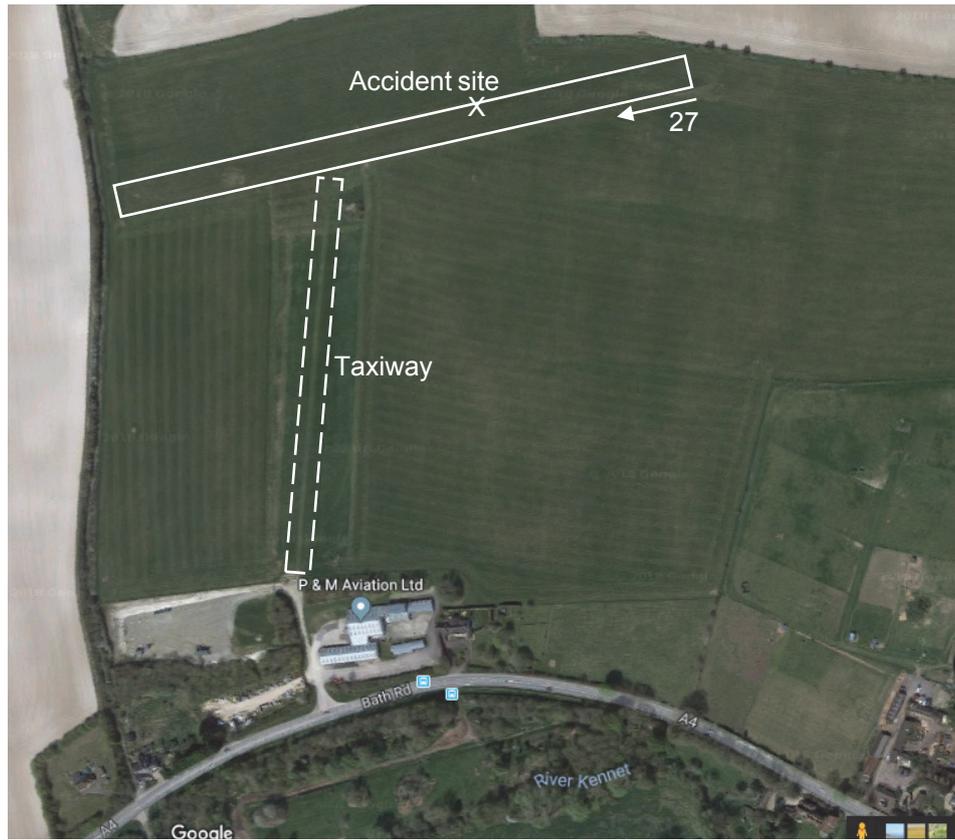
Figure 1
Accident site – Manton Airfield, Wiltshire

The aircraft was being flown from Cotswold Airport, Gloucester to the manufacturer's facility, at Manton Airfield, Wiltshire for its annual inspection and renewal of the Permit to Fly. The wind conditions were 180° at 10 kt and the pilot elected to use Runway 27, which is a 350 m mown and rolled grass farm field strip, with a steep taxiway down to the manufacturers facility (Figure 1).

The pilot flew a low pass at approximately 100 ft to ensure the runway was clear and then proceeded to land normally. After approximately 100 m of the landing roll and at 30 kt, the left wheel struck the edge of a hollow, which caused the aircraft to bounce and roll to the right. The right wingtip touched the ground and the aircraft pirouetted almost 180° before coming to rest on its right side (Figure 2). The pilot made the aircraft safe and exited from the cockpit uninjured. It was later noted by the manufacturer that ground near the threshold of Runway 27 may have been disturbed by animal activity.

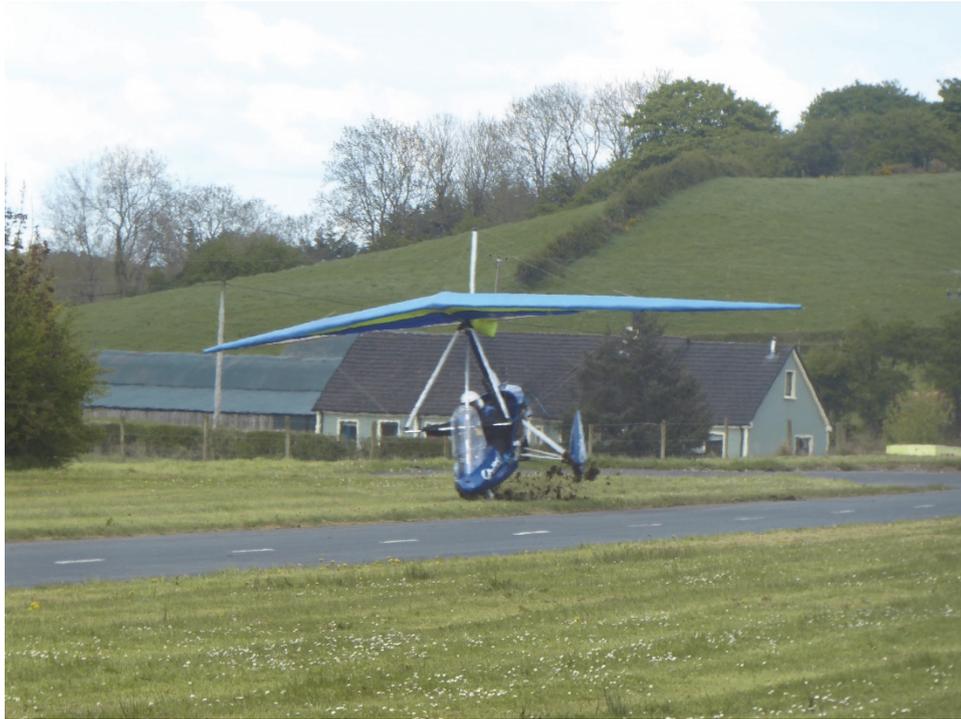
Figure 1

The pilot reported that being cold after the flight from Hunsdon may have affected his judgment. He also believed he was distracted by the departing aircraft, causing him to slow down to increase separation from them, and that consequently the aircraft had insufficient airspeed to flare properly and stalled onto the runway.

G-CEMZ landing on its nosewheel
